# **TIME-CRITICAL REMOVAL ACTION REPORT**

*Onalaska Wood Pyrolysis  
Onalaska, Lewis County, Washington*

Prepared by:

December 2021

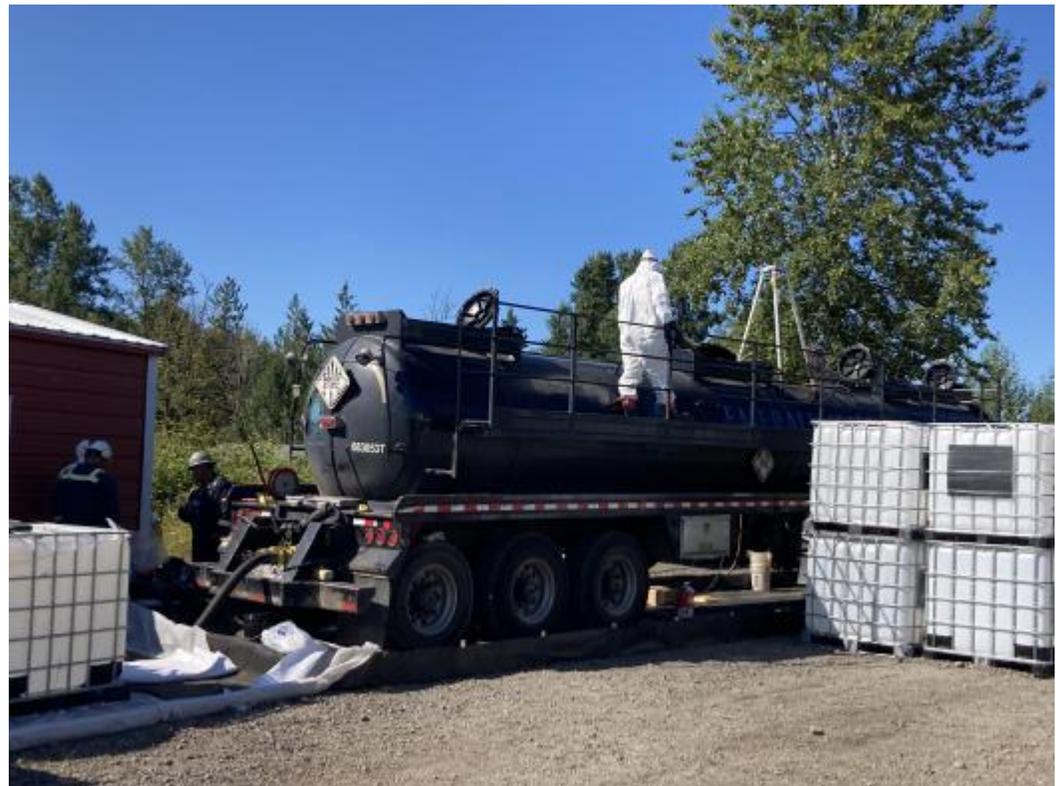
<b>Photo No.</b> <b>320</b>	<b>Date:</b> 07/23/2021
<b>Photo Coordinates</b>	
<b>Lat</b>	46.572372
<b>Long</b>	-122.7287
<b>Direction Photo Taken:</b> <b>S</b>	
<b>Description:</b>  Clean Harbors contractors conducting confined space entry into the tank of the vacuum truck to clean out the wood tar blocking the tank valve.

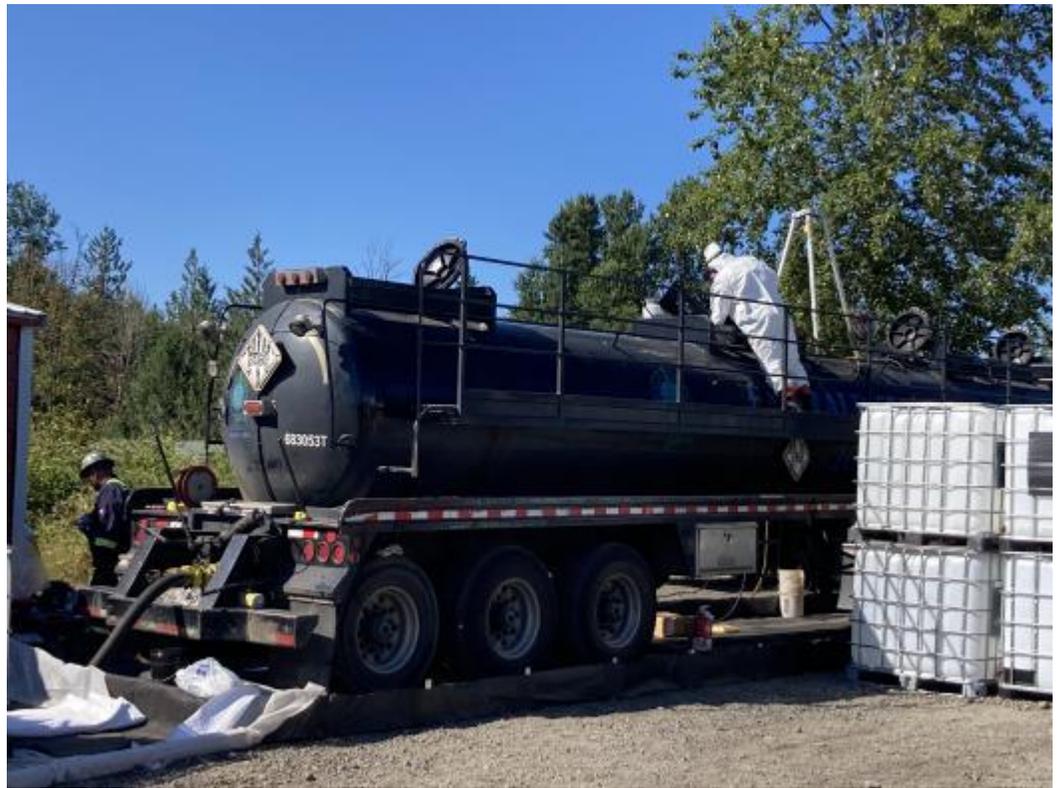
<b>Photo No.</b> <b>321</b>	<b>Date:</b> 07/23/2021
<b>Photo Coordinates</b>	
<b>Lat</b>	46.572431
<b>Long</b>	-122.728753
<b>Direction Photo Taken:</b> <b>S</b>	
<b>Description:</b>  Clean Harbors contractors conducting confined space entry into the tank of the vacuum truck to clean out the wood tar blocking the tank valve.

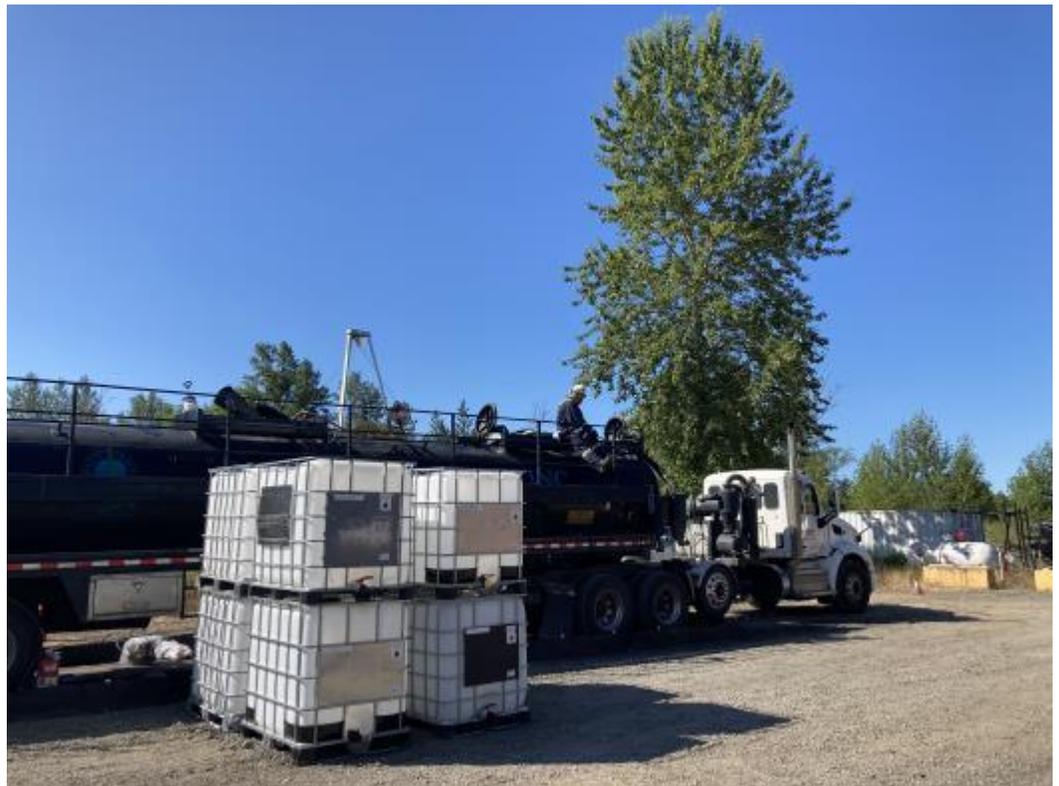
<b>Photo No.</b> <b>322</b>	<b>Date:</b> 07/23/2021
<b>Photo Coordinates</b>	
<b>Lat</b>	46.572083
<b>Long</b>	-122.728997
<b>Direction Photo Taken:</b> <b>S</b>	
<b>Description:</b>  Clean Harbors contractors conducting confined space entry into the tank of the vacuum truck to clean out the wood tar blocking the tank valve.

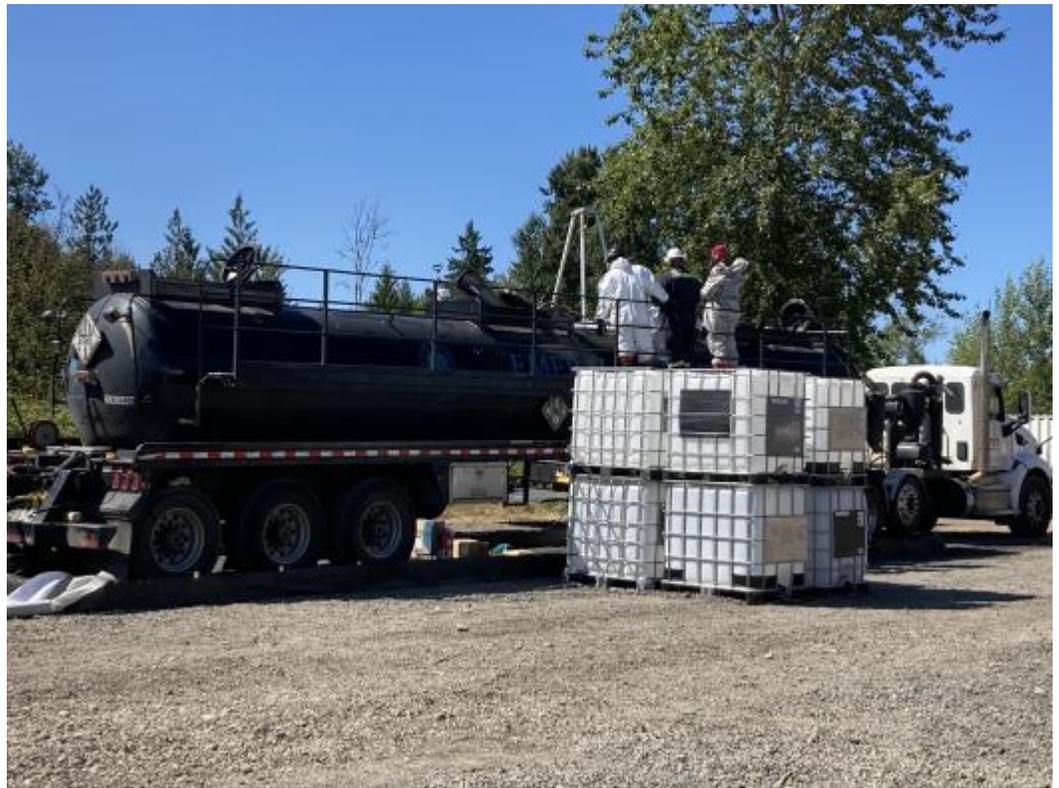
<b>Photo No.</b> <b>323</b>	<b>Date:</b> 07/23/2021
<b>Photo Coordinates</b>	
<b>Lat</b>	46.572528
<b>Long</b>	-122.728919
<b>Direction Photo Taken:</b> <b>S</b>	
<b>Description:</b>  Clean Harbors contractors conducting confined space entry into the tank of the vacuum truck to clean out the wood tar blocking the tank valve.

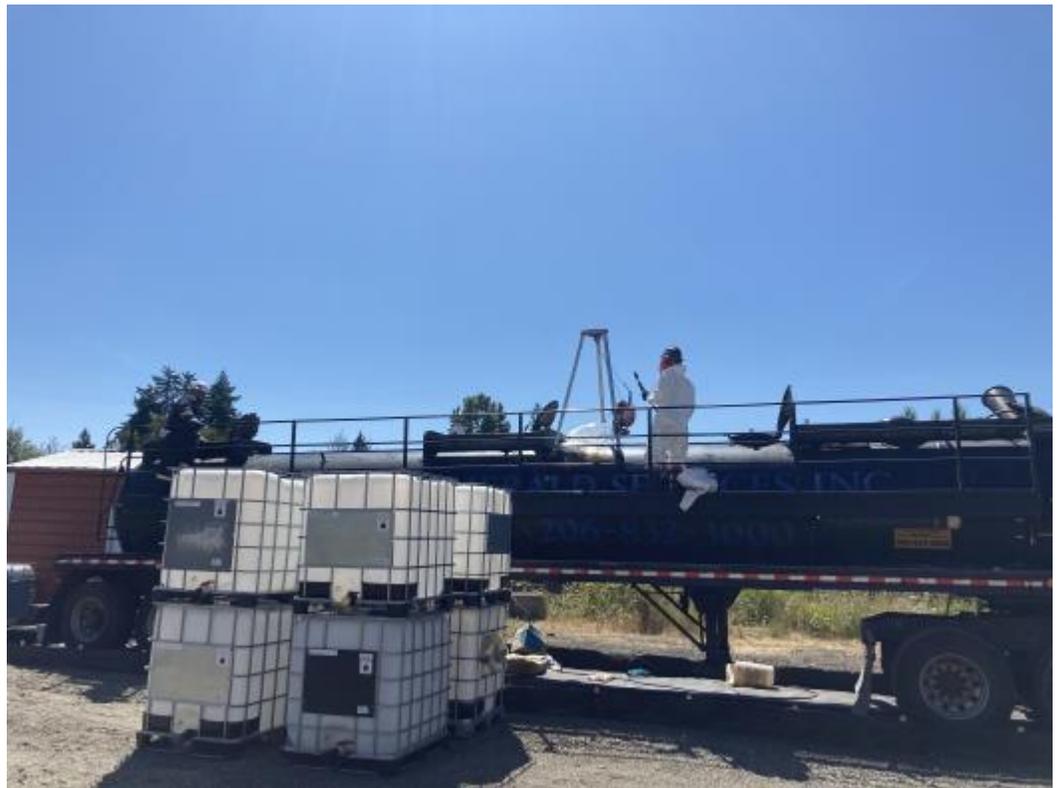
<b>Photo No.</b> <b>324</b>	<b>Date:</b> 07/23/2021
<b>Photo Coordinates</b>	
<b>Lat</b>	46.599086
<b>Long</b>	-122.761244
<b>Direction Photo Taken:</b> <b>SE</b>	
<b>Description:</b>  Clean Harbors contractors conducting confined space entry into the tank of the vacuum truck to clean out the wood tar blocking the tank valve.

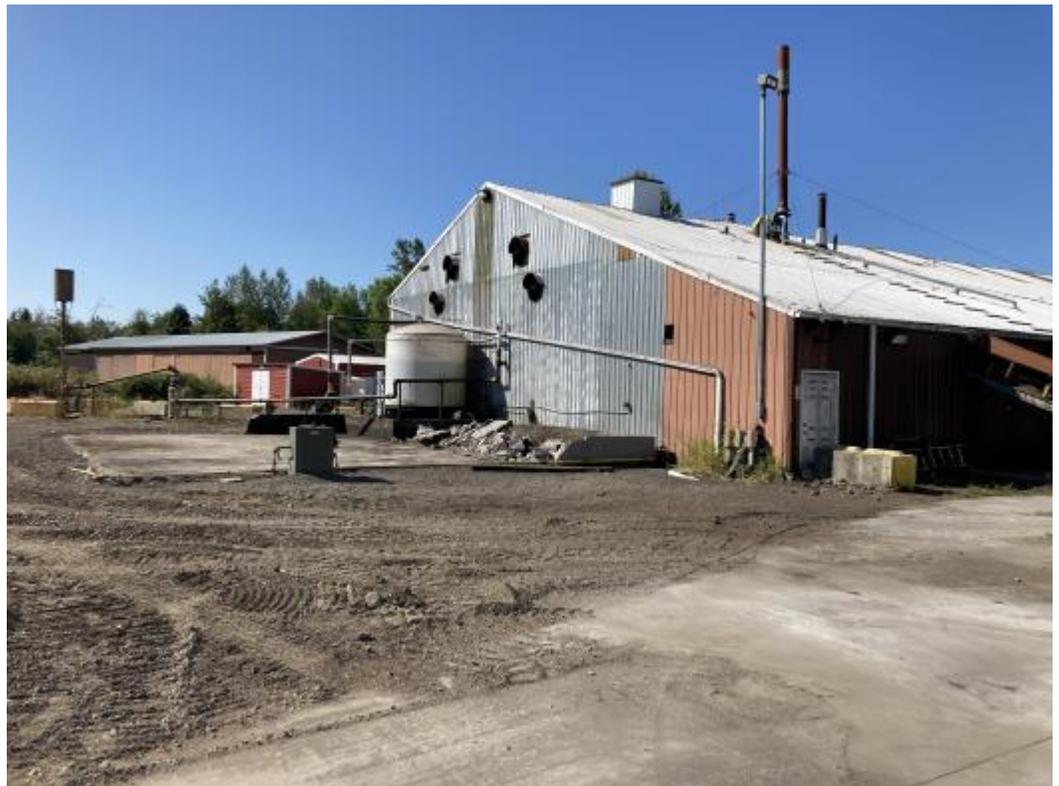
<b>Photo No.</b> <b>336</b>	<b>Date:</b> 07/29/2021
<b>Photo Coordinates</b>	
<b>Lat</b>	46.572697
<b>Long</b>	-122.728683
<b>Direction Photo Taken:</b> <b>S</b>	
<b>Description:</b>  Final site walk. Former Secondary Containment Area. Remaining AST is a water tank.

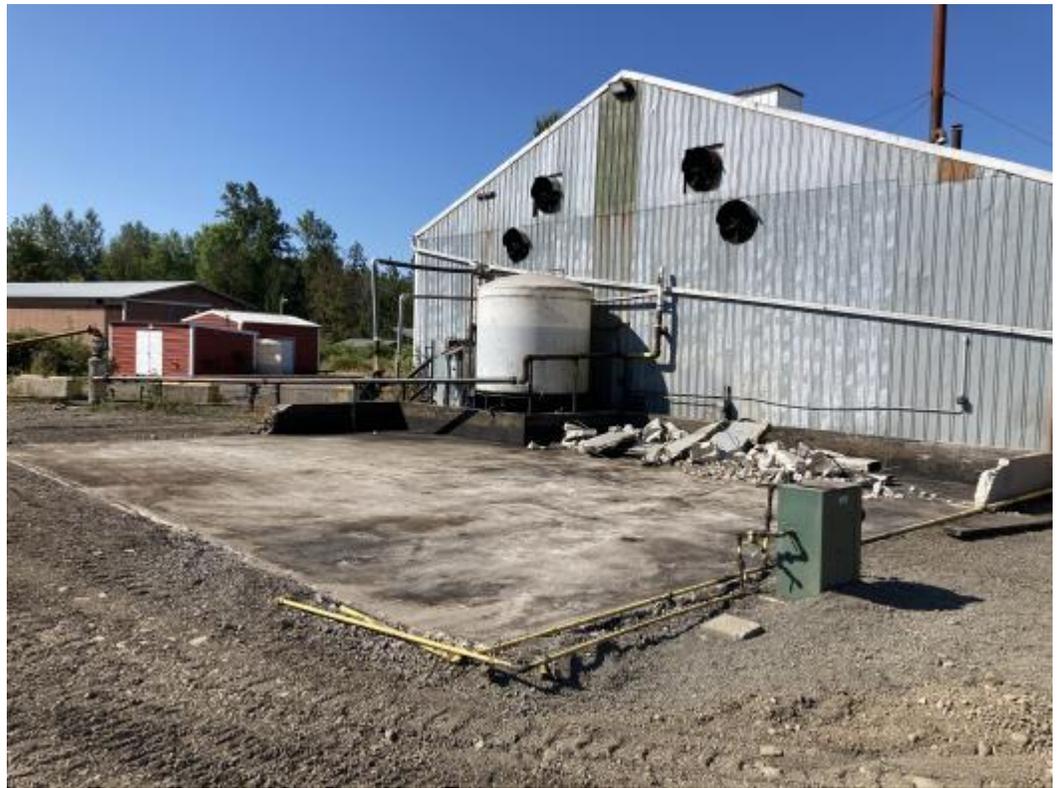
<b>Photo No.</b> <b>337</b>	<b>Date:</b> 07/29/2021
<b>Photo Coordinates</b>	
<b>Lat</b>	46.572631
<b>Long</b>	-122.728653
<b>Direction Photo Taken:</b> <b>SW</b>	
<b>Description:</b>  Final site walk. Former Secondary Containment Area. Remaining AST is a water tank.

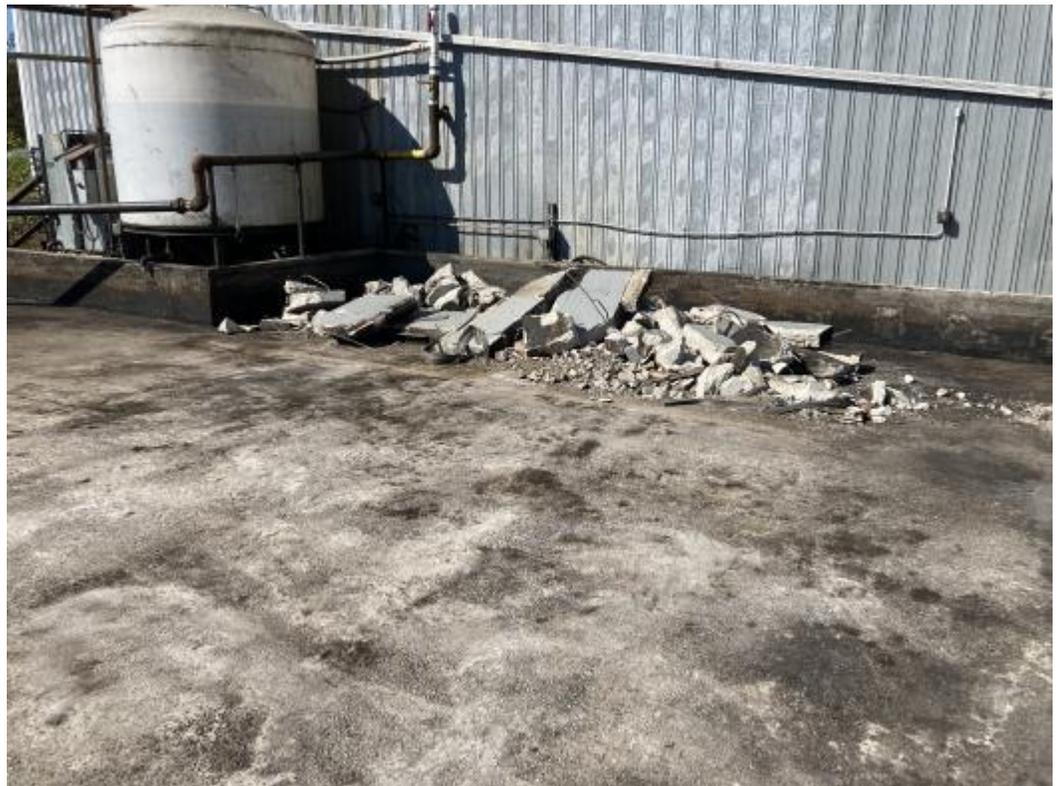
<b>Photo No.</b> <b>338</b>	<b>Date:</b> 07/29/2021
<b>Photo Coordinates</b>	
<b>Lat</b>	46.572583
<b>Long</b>	-122.7287
<b>Direction Photo Taken:</b> <b>SW</b>	
<b>Description:</b>  Final site walk. Former Secondary Containment Area. Remaining AST is a water tank. Debris generated from the demolition of the concrete wall left against the side of the Pyrolysis Building.

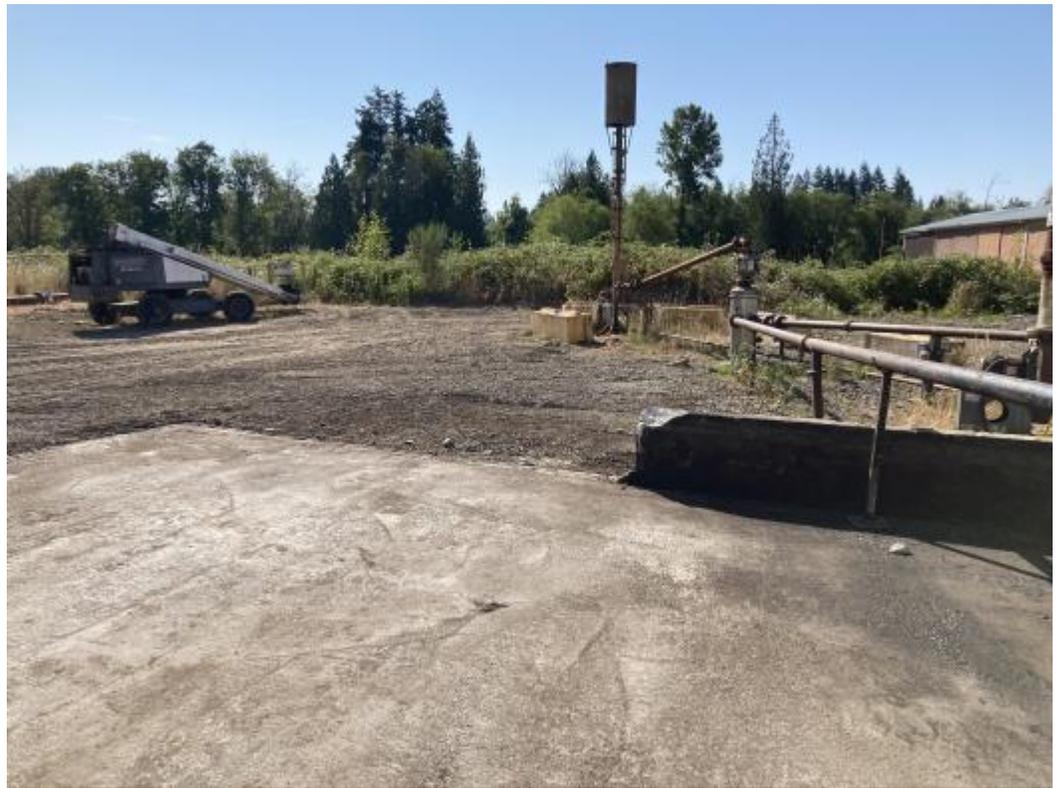
<b>Photo No.</b> <b>339</b>	<b>Date:</b> 07/29/2021
<b>Photo Coordinates</b>	
<b>Lat</b>	46.572528
<b>Long</b>	-122.728706
<b>Direction Photo Taken:</b> <b>SE</b>	
<b>Description:</b>  Final site walk. Remaining infrastructure and abandoned boom lift at left as viewed from the Secondary Containment Area.

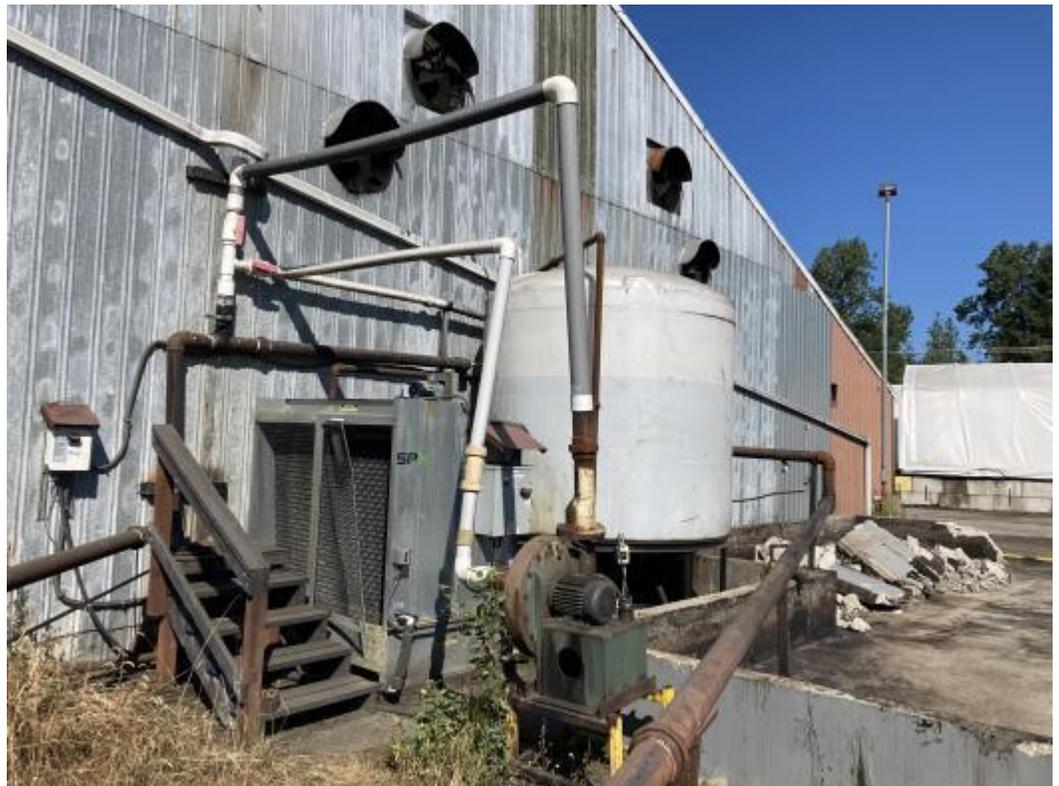
<b>Photo No.</b> <b>340</b>	<b>Date:</b> 07/29/2021
<b>Photo Coordinates</b>	
<b>Lat</b>	46.572481
<b>Long</b>	-122.728644
<b>Direction Photo Taken:</b> <b>NW</b>	
<b>Description:</b>  Final site walk. Water AST and infrastructure left at the former Secondary Containment Area.

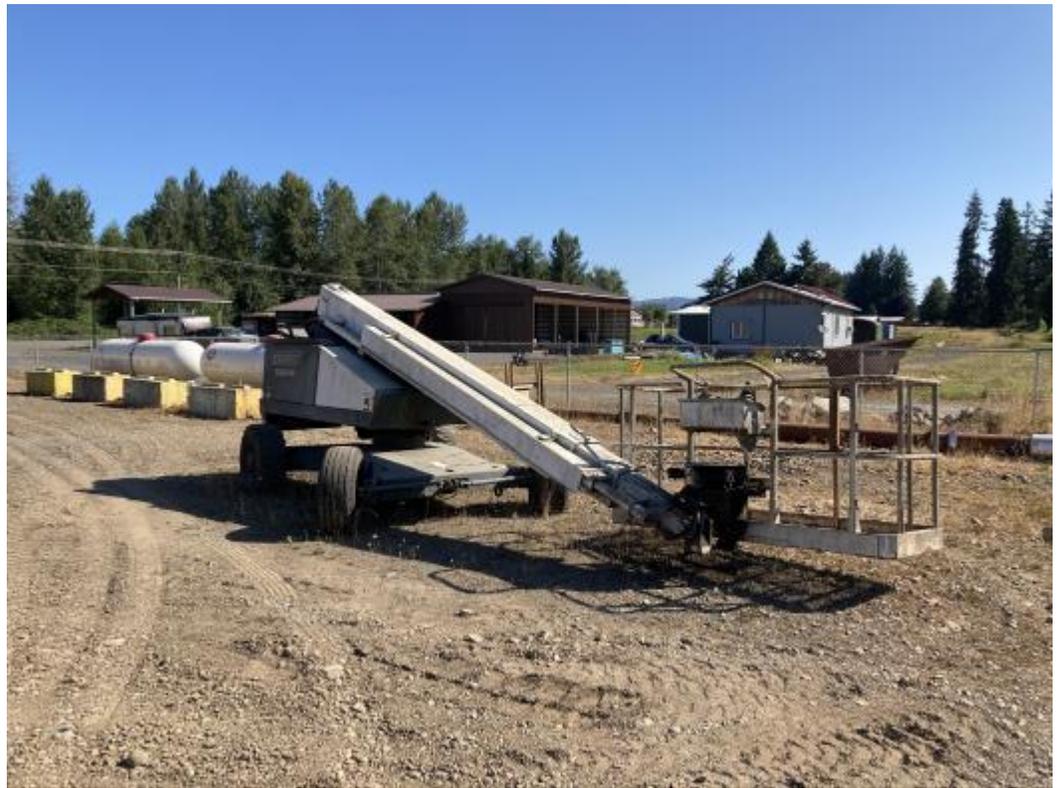
<b>Photo No.</b> <b>341</b>	<b>Date:</b> 07/29/2021
<b>Photo Coordinates</b>	
<b>Lat</b>	46.572339
<b>Long</b>	-122.728478
<b>Direction Photo Taken:</b> <b>NE</b>	
<b>Description:</b>  Final site walk. Abandoned boom lift.

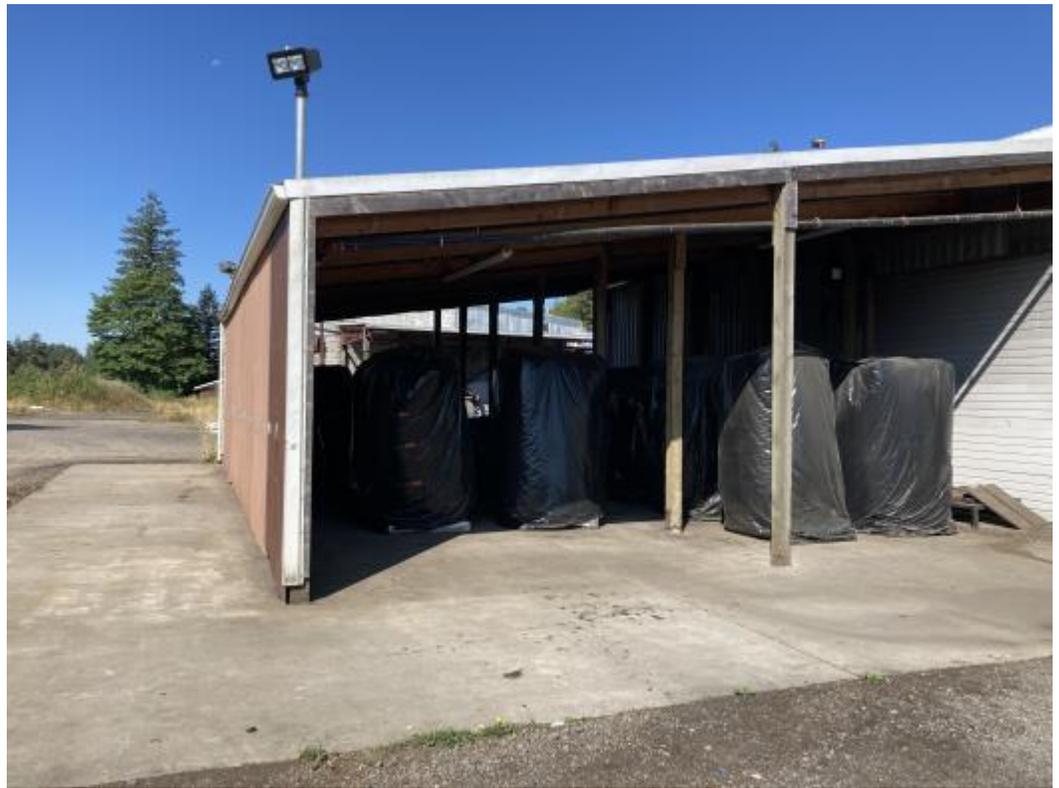
<b>Photo No.</b> <b>345</b>	<b>Date:</b> 07/29/2021
<b>Photo Coordinates</b>	
<b>Lat</b>	46.572328
<b>Long</b>	-122.728797
<b>Direction Photo Taken:</b> <b>W</b>	
<b>Description:</b>  Final site walk. Biochar staged at the Lean-to Area.

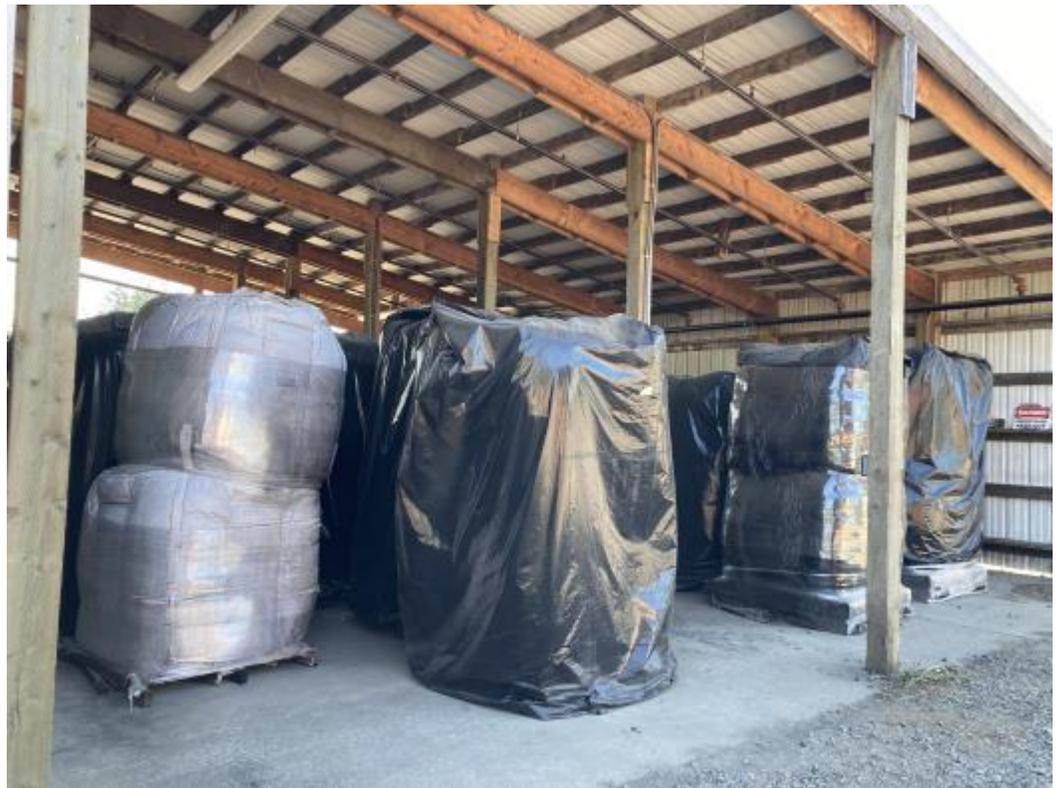
<b>Photo No.</b> <b>348</b>	<b>Date:</b> 07/29/2021
<b>Photo Coordinates</b>	
<b>Lat</b>	46.572308
<b>Long</b>	-122.72915
<b>Direction Photo Taken:</b> <b>E</b>	
<b>Description:</b>  Final site walk. Biochar staged at the Lean-to Area.

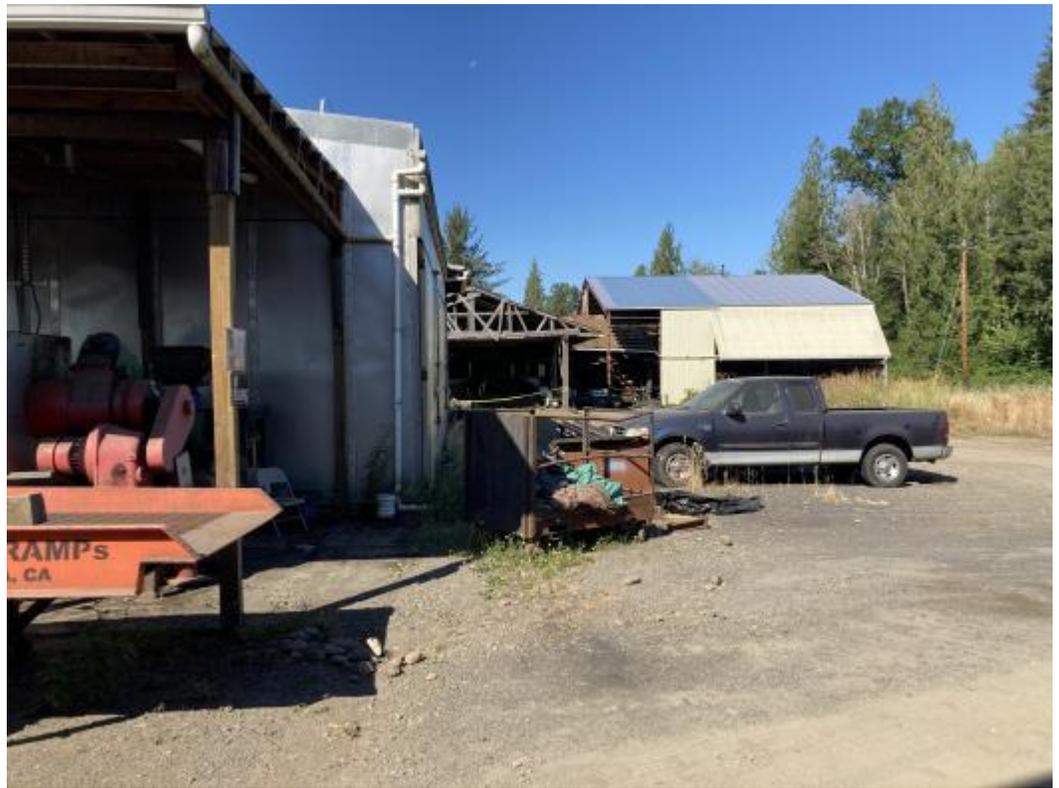
<b>Photo No.</b> <b>349</b>	<b>Date:</b> 07/29/2021
<b>Photo Coordinates</b>	
<b>Lat</b>	46.572344
<b>Long</b>	-122.729181
<b>Direction Photo Taken:</b> <b>SW</b>	
<b>Description:</b>  Final site walk. Abandoned truck, Dry Kiln Building, and North Warehouse as viewed from the Pyrolysis Building.

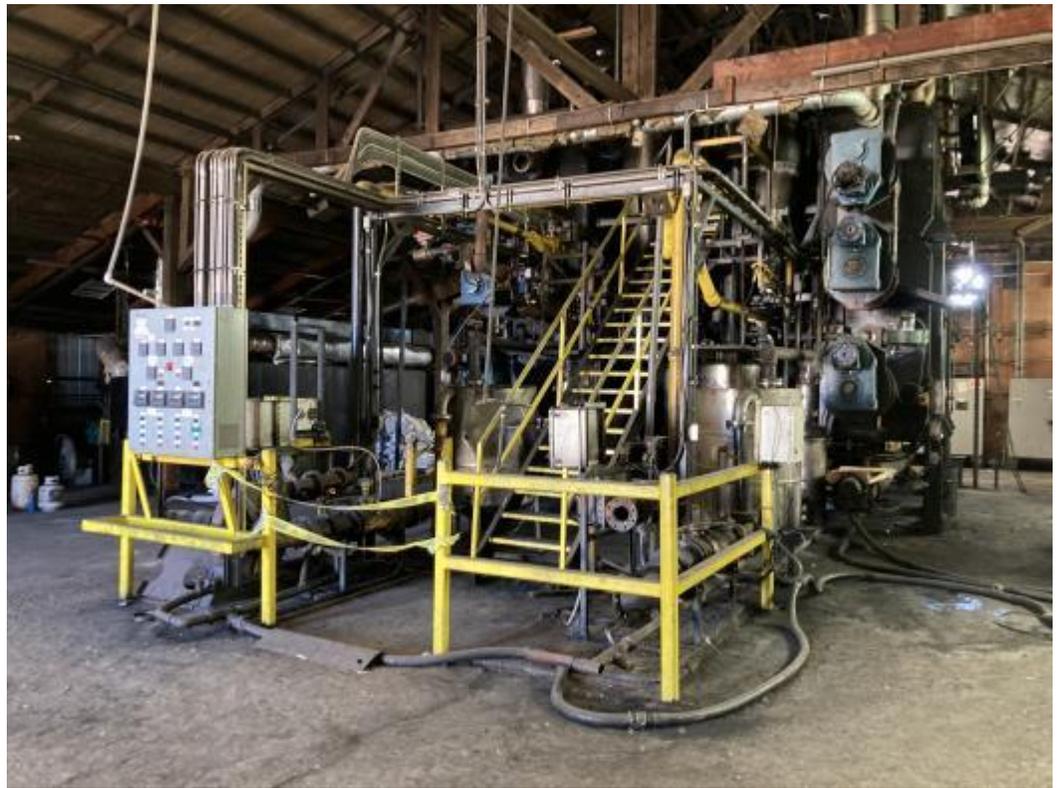
<b>Photo No.</b> <b>357</b>	<b>Date:</b> 07/29/2021
<b>Photo Coordinates</b>	
<b>Lat</b>	46.572392
<b>Long</b>	-122.729081
<b>Direction Photo Taken:</b> <b>NE</b>	
<b>Description:</b>  Final site walk. Interior of the Pyrolysis Building. Yellow caution tape indicates no activity took place beyond that point.

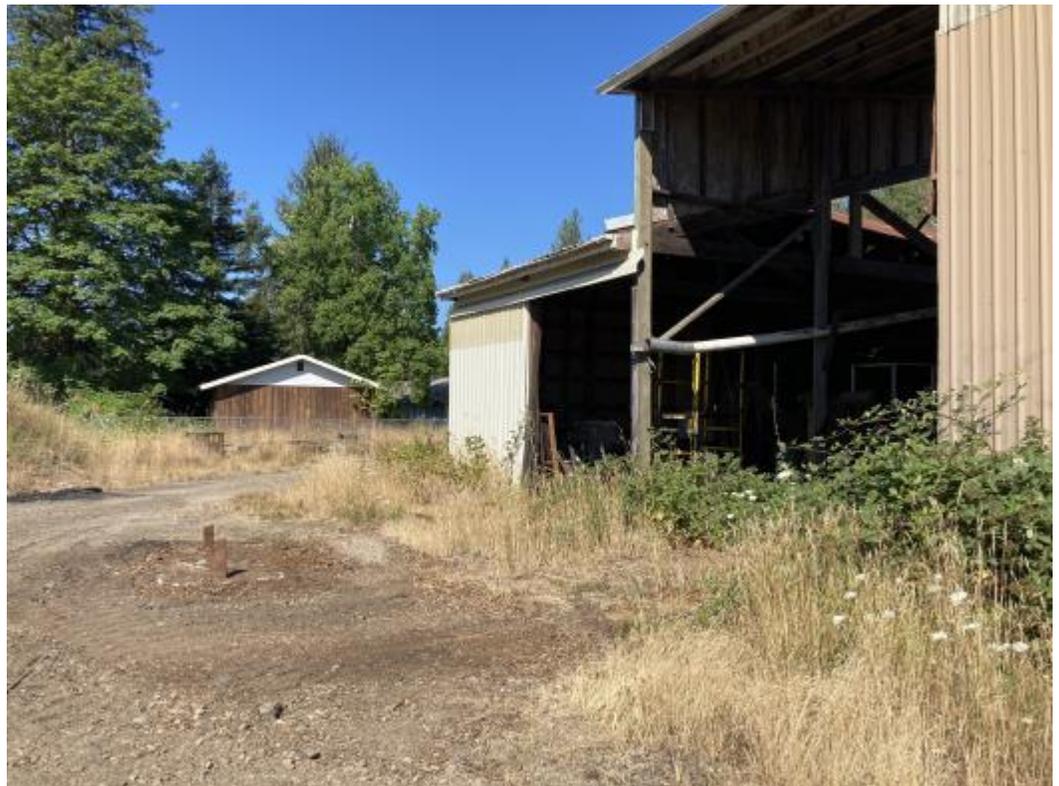
<b>Photo No.</b> <b>382</b>	<b>Date:</b> 07/29/2021
<b>Photo Coordinates</b>	
<b>Lat</b>	46.572106
<b>Long</b>	-122.729714
<b>Direction Photo Taken:</b> <b>W</b>	
<b>Description:</b>  Final site walk. Southwest area of the Site. Exposed back area of the South Warehouse in the foreground. Abandoned residential house in the background.

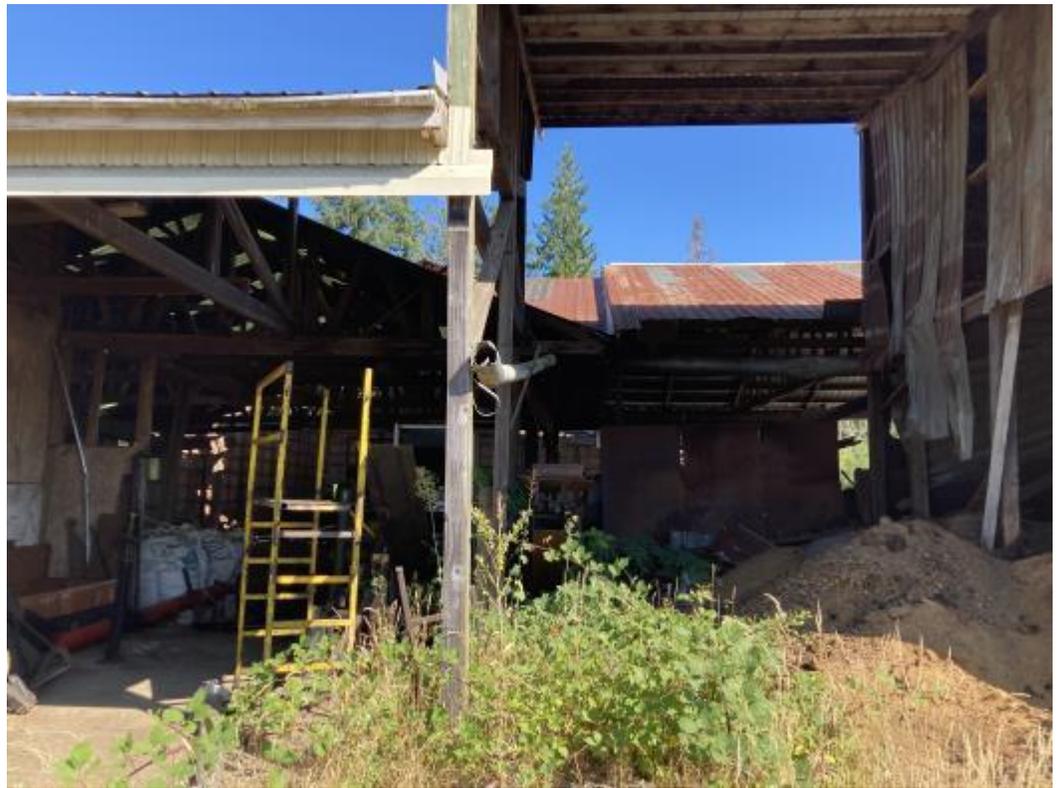
<b>Photo No.</b> <b>383</b>	<b>Date:</b> 07/29/2021
<b>Photo Coordinates</b>	
<b>Lat</b>	46.572083
<b>Long</b>	-122.729867
<b>Direction Photo Taken:</b> <b>N</b>	
<b>Description:</b>  Final site walk. Southwest area of the Site. Exposed back area of the South Warehouse.

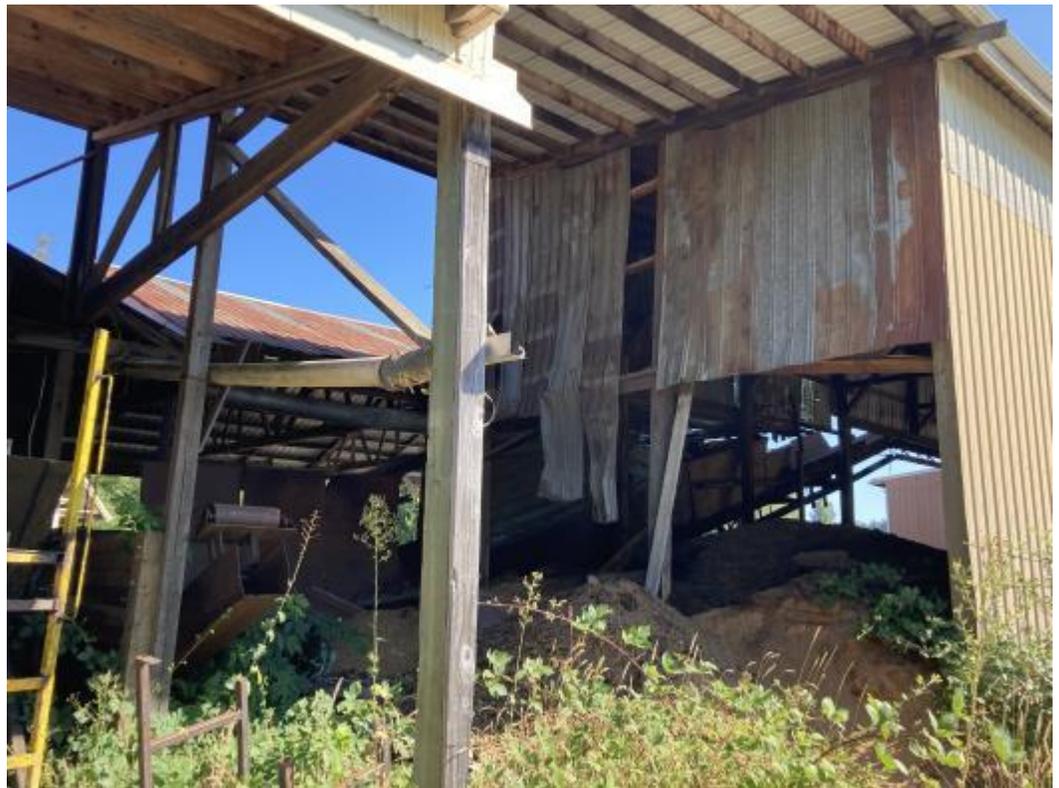
<b>Photo No.</b> <b>384</b>	<b>Date:</b> 07/29/2021
<b>Photo Coordinates</b>	
<b>Lat</b>	46.572072
<b>Long</b>	-122.729881
<b>Direction Photo Taken:</b> <b>NE</b>	
<b>Description:</b>  Final site walk. Southwest area of the Site. Exposed back area of the South Warehouse.

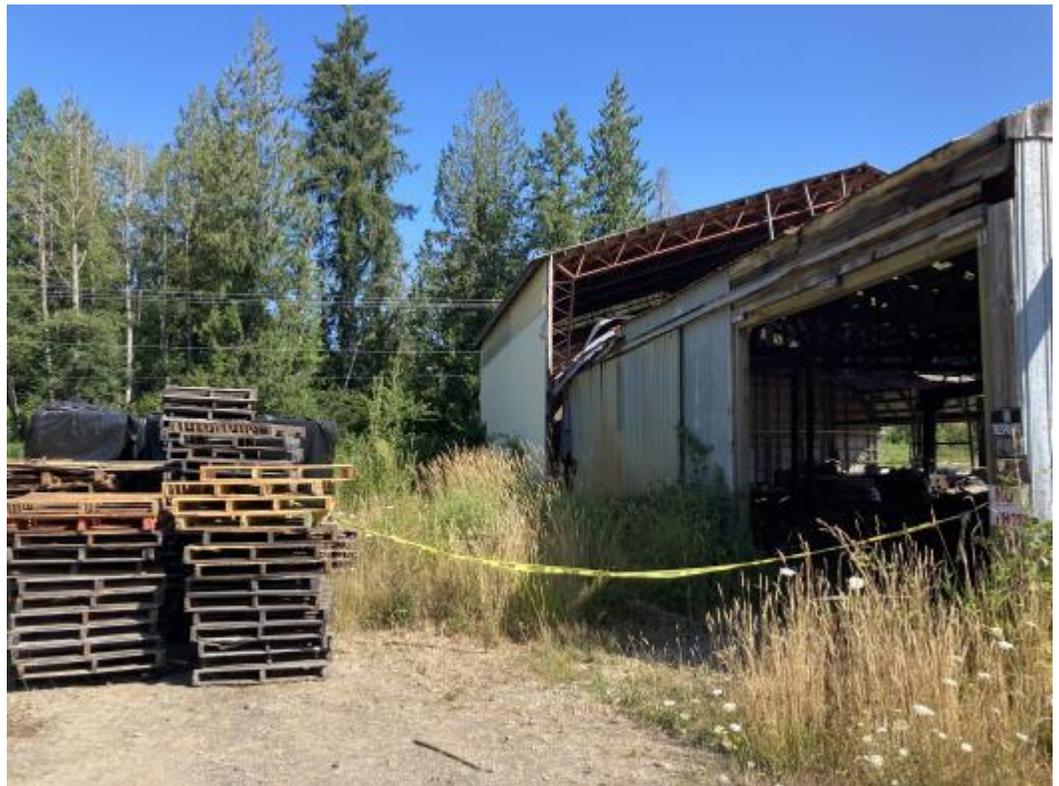
<b>Photo No.</b> <b>386</b>	<b>Date:</b> 07/29/2021
<b>Photo Coordinates</b>	
<b>Lat</b>	46.572047
<b>Long</b>	-122.730064
<b>Direction Photo Taken:</b> <b>N</b>	
<b>Description:</b>  Final site walk. Exposed back area of the condemned warehouse area. Abandoned pallets are at left.

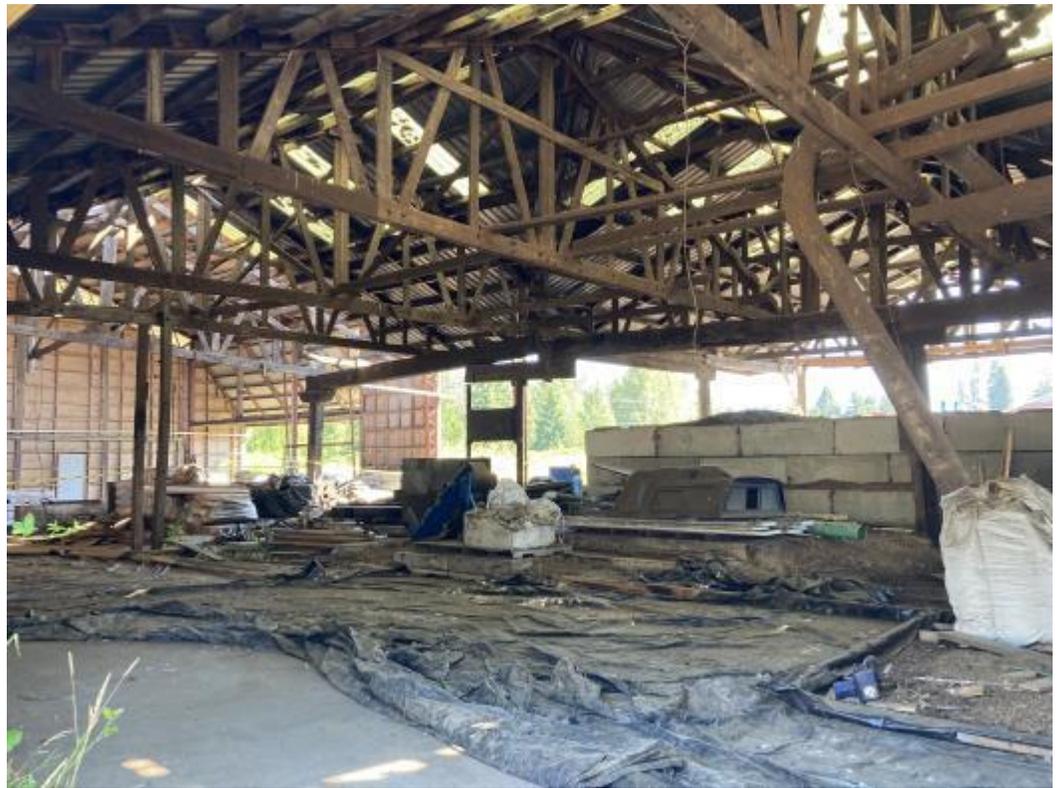
<b>Photo No.</b> <b>387</b>	<b>Date:</b> 07/29/2021
<b>Photo Coordinates</b>	
<b>Lat</b>	46.572094
<b>Long</b>	-122.730086
<b>Direction Photo Taken:</b> <b>NE</b>	
<b>Description:</b>  Final site walk. Exposed back area of the condemned warehouse.

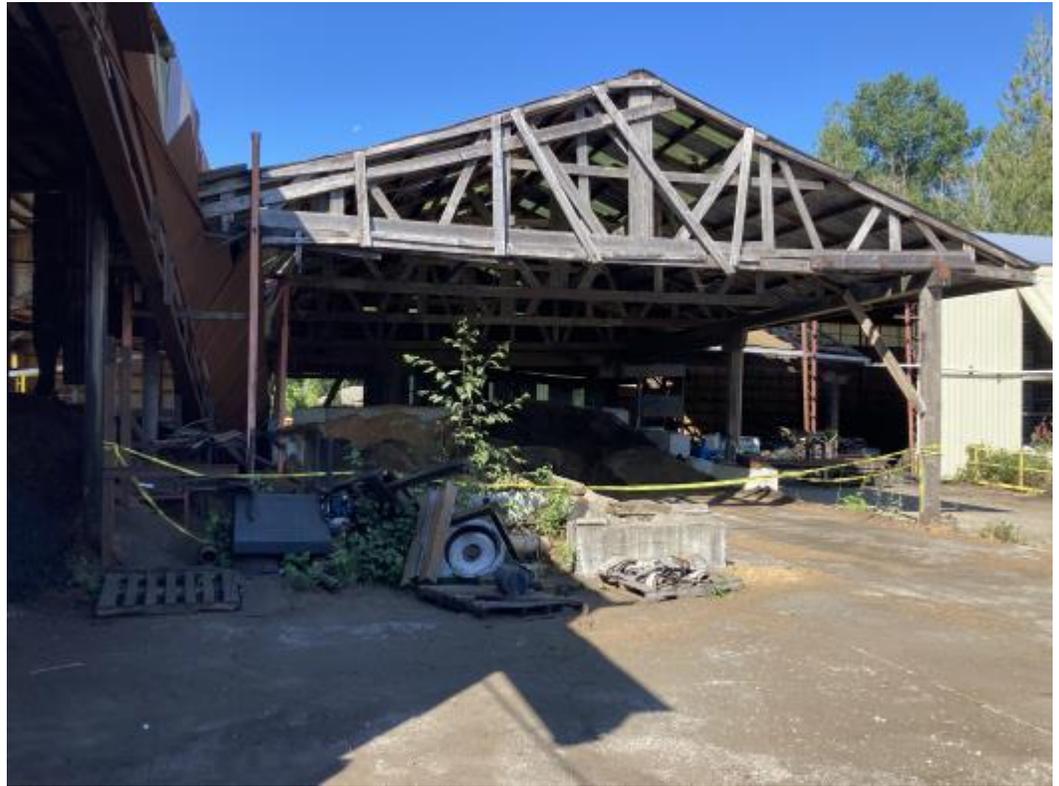
<b>Photo No.</b> <b>389</b>	<b>Date:</b> 07/29/2021
<b>Photo Coordinates</b>	
<b>Lat</b>	46.572025
<b>Long</b>	-122.729828
<b>Direction Photo Taken:</b> <b>W</b>	
<b>Description:</b>  Final site walk. Condemned warehouse area. Yellow caution tape indicates no activity took place beyond that point.

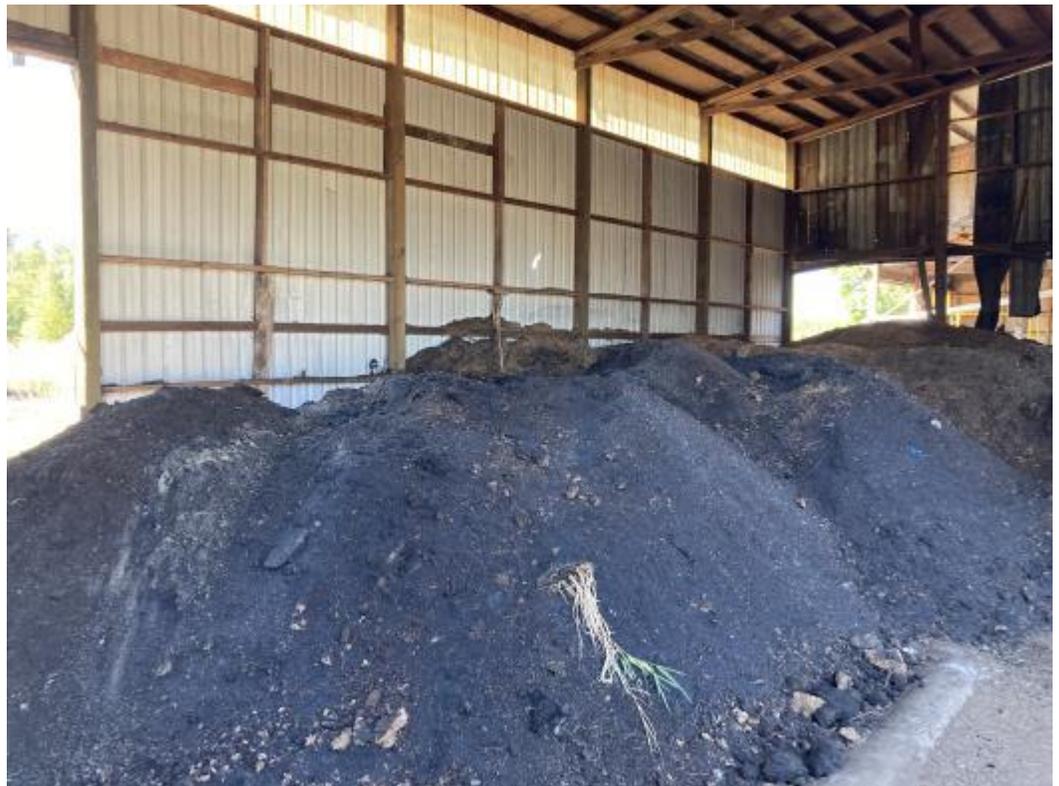
<b>Photo No.</b> <b>390</b>	<b>Date:</b> 07/29/2021
<b>Photo Coordinates</b>	
<b>Lat</b>	46.5722
<b>Long</b>	-122.729697
<b>Direction Photo Taken:</b> <b>SW</b>	
<b>Description:</b>  Final site walk. Wood chip and solidified waste stored in the South Warehouse.

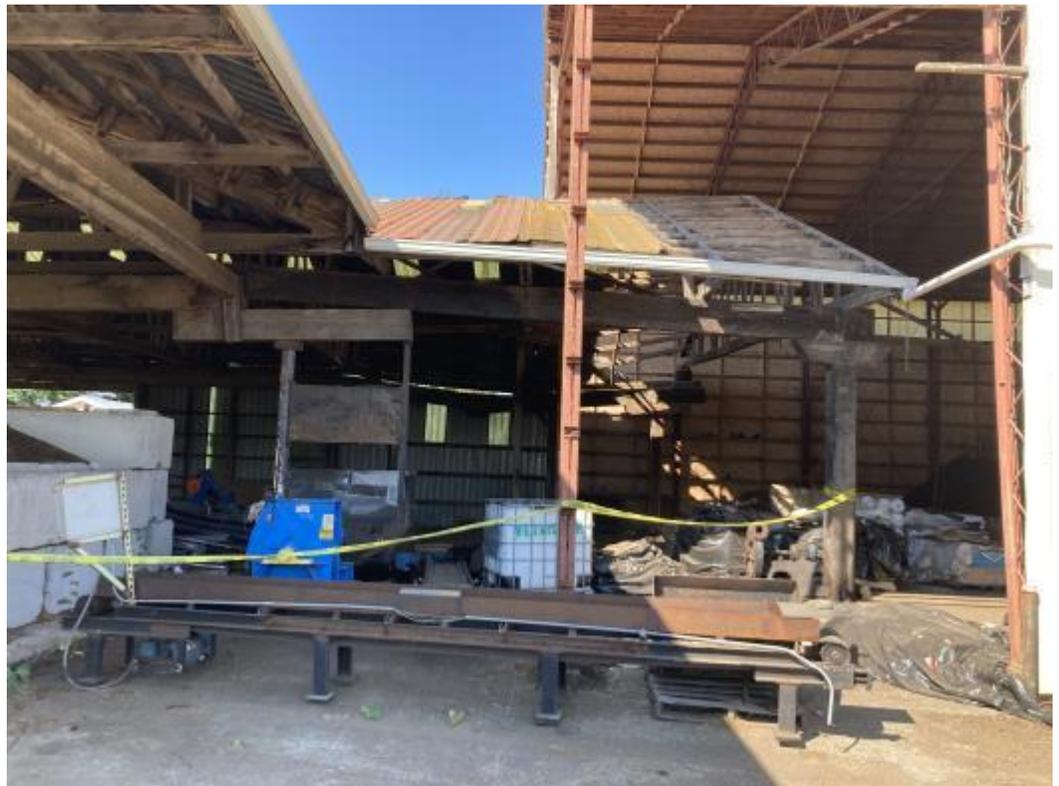
<b>Photo No.</b> <b>392</b>	<b>Date:</b> 07/29/2021
<b>Photo Coordinates</b>	
<b>Lat</b>	46.572328
<b>Long</b>	-122.729836
<b>Direction Photo Taken:</b> <b>SE</b>	
<b>Description:</b>  Final site walk. Condemned warehouse area. Yellow caution tape indicates no activity took place beyond that point.

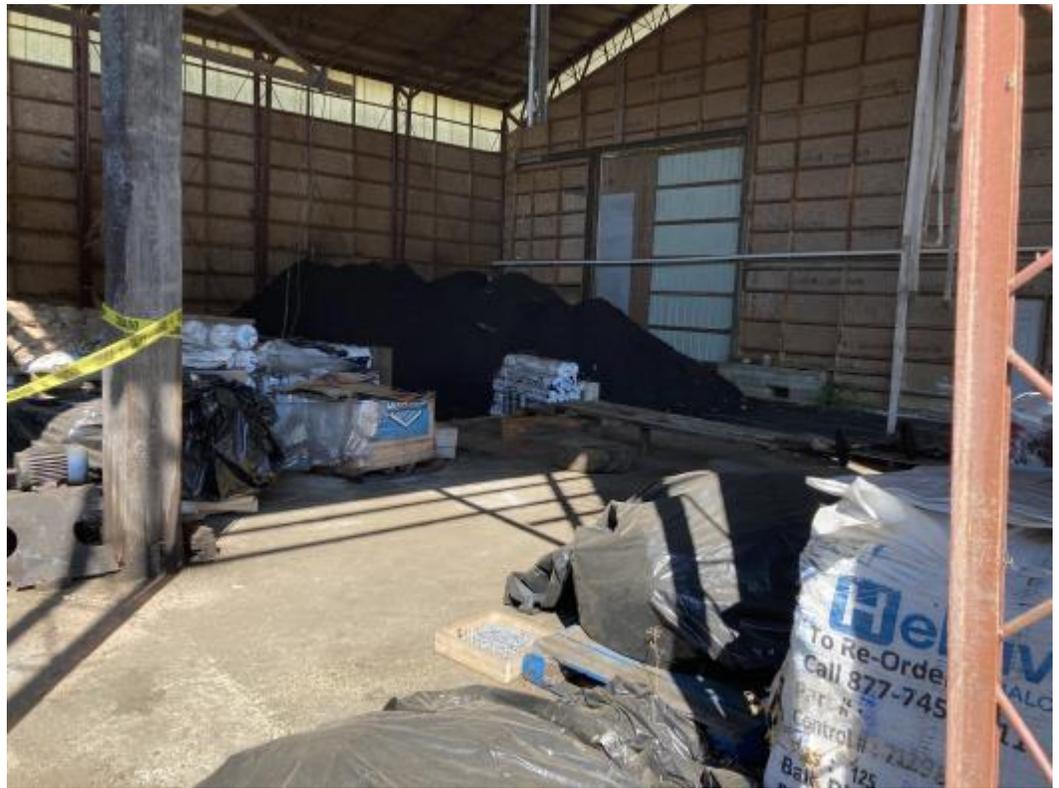
<b>Photo No.</b> <b>393</b>	<b>Date:</b> 07/29/2021
<b>Photo Coordinates</b>	
<b>Lat</b>	46.572361
<b>Long</b>	-122.729881
<b>Direction Photo Taken:</b> <b>NW</b>	
<b>Description:</b>  Final site walk. Biochar stored in the North Warehouse.

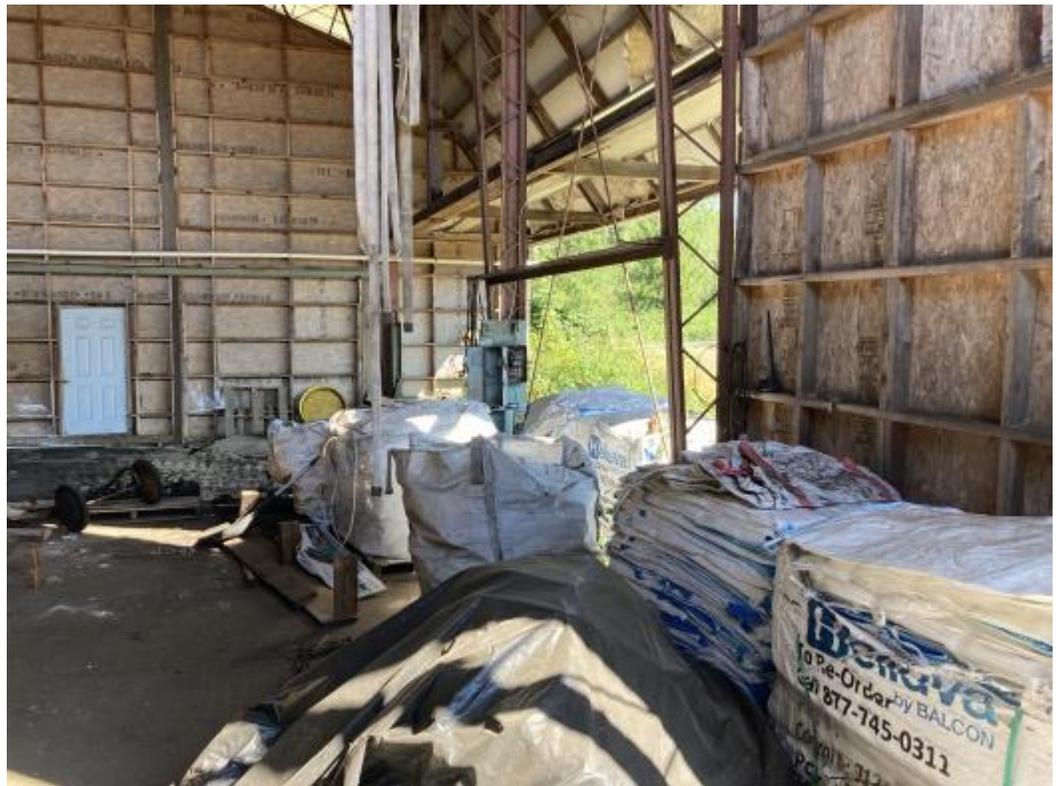
<b>Photo No.</b> <b>394</b>	<b>Date:</b> 07/29/2021
<b>Photo Coordinates</b>	
<b>Lat</b>	46.572344
<b>Long</b>	-122.729875
<b>Direction Photo Taken:</b> <b>N</b>	
<b>Description:</b>  Final site walk. Interior of the North Warehouse.
