# **TIME-CRITICAL REMOVAL ACTION REPORT**

*Onalaska Wood Pyrolysis  
Onalaska, Lewis County, Washington*

Prepared by:

December 2021

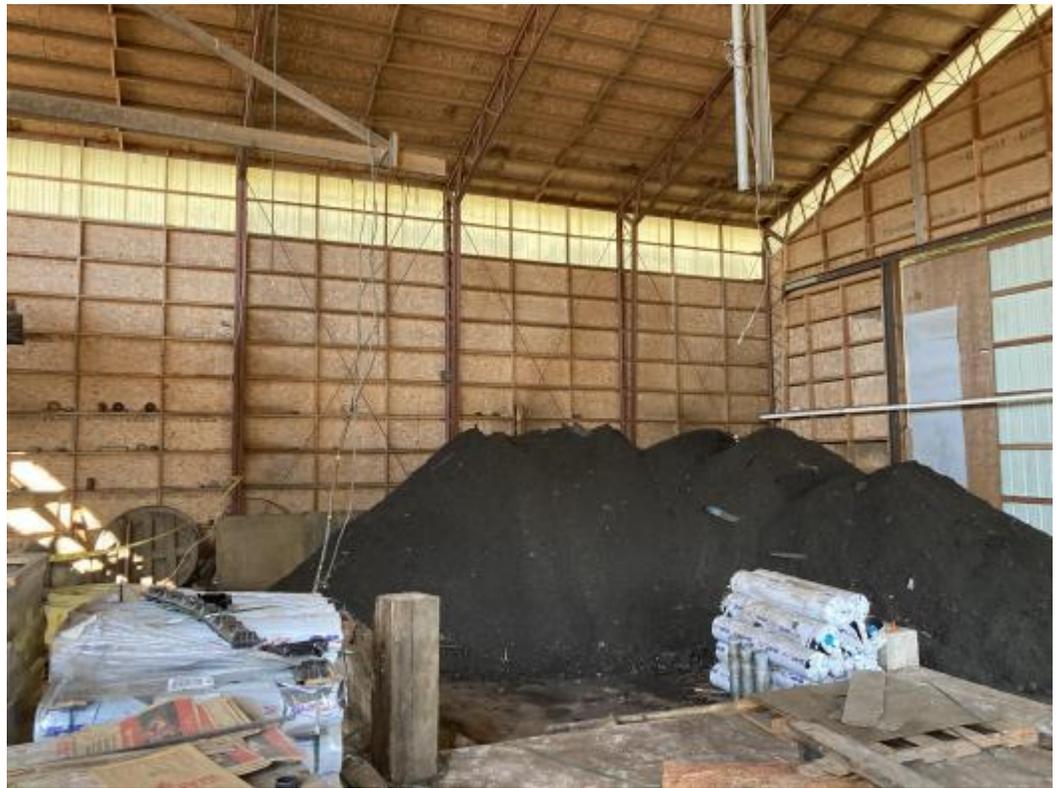
<b>Photo No.</b> <b>395</b>	<b>Date:</b> 07/29/2021
<b>Photo Coordinates</b>	
<b>Lat</b>	46.572311
<b>Long</b>	-122.729819
<b>Direction Photo Taken:</b> <b>W</b>	
<b>Description:</b>  Final site walk. Biochar stored in the North Warehouse.

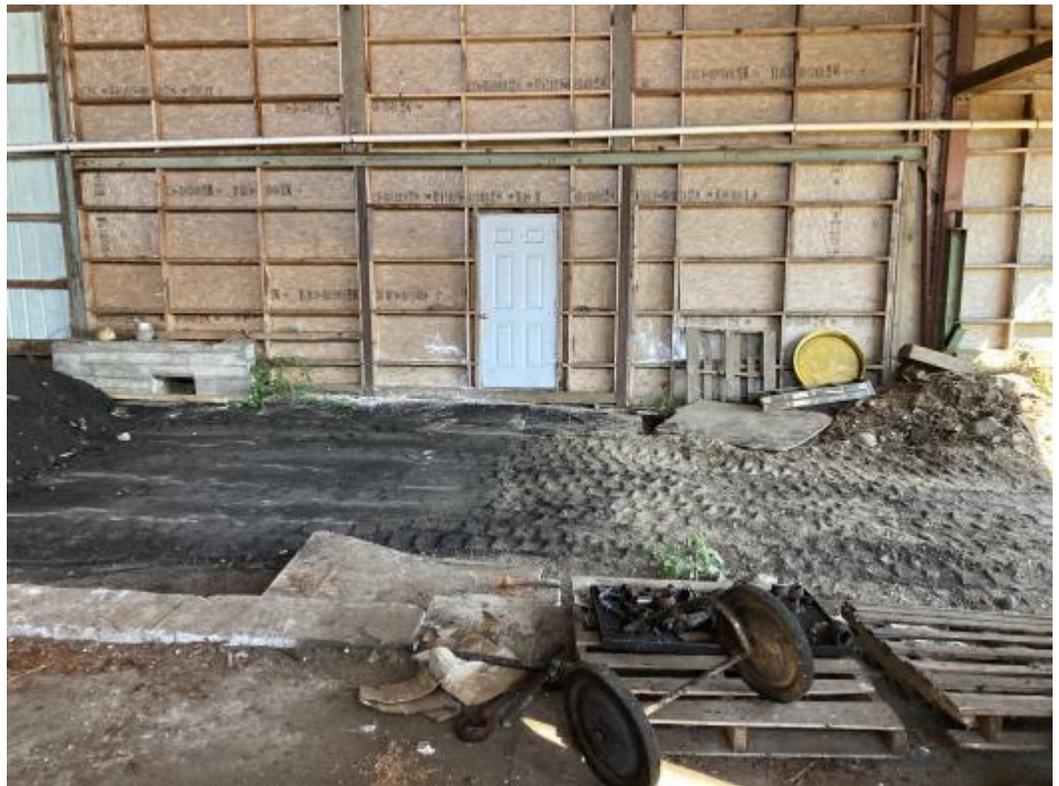
<b>Photo No.</b> <b>396</b>	<b>Date:</b> 07/29/2021
<b>Photo Coordinates</b>	
<b>Lat</b>	46.572333
<b>Long</b>	-122.72985
<b>Direction Photo Taken:</b> <b>N</b>	
<b>Description:</b>  Final site walk. Interior of the North Warehouse.

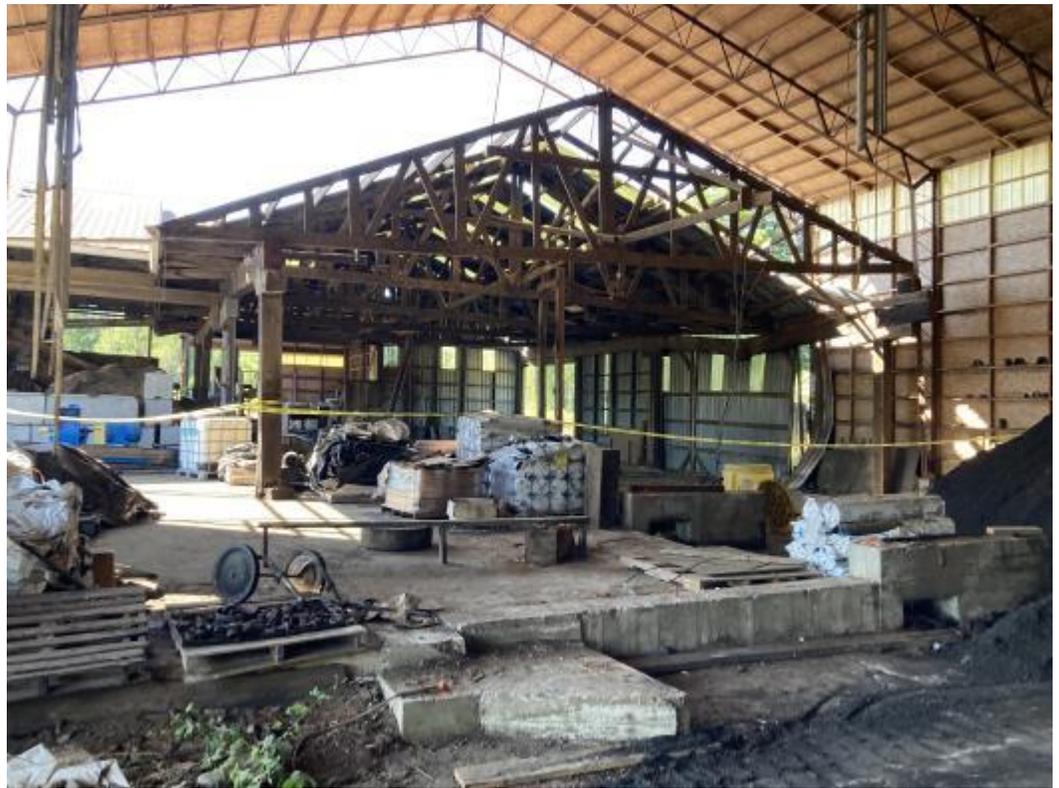
<b>Photo No.</b> <b>397</b>	<b>Date:</b> 07/29/2021
<b>Photo Coordinates</b>	
<b>Lat</b>	46.572344
<b>Long</b>	-122.729889
<b>Direction Photo Taken:</b> <b>SE</b>	
<b>Description:</b>  Final site walk. Interior of condemned warehouse as viewed from the North Warehouse.

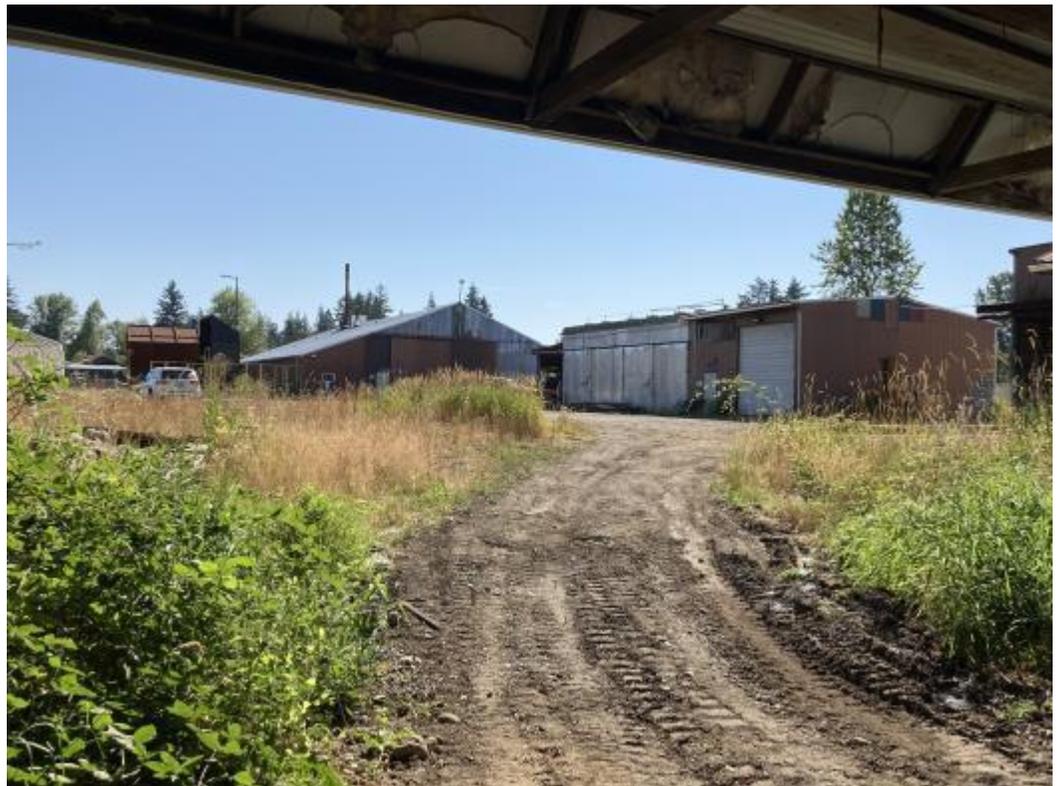
<b>Photo No.</b> <b>398</b>	<b>Date:</b> 07/29/2021
<b>Photo Coordinates</b>	
<b>Lat</b>	46.572344
<b>Long</b>	-122.729911
<b>Direction Photo Taken:</b> <b>E</b>	
<b>Description:</b>  Final site walk. Dirt road leading away from the North Warehouse as viewed from the North Warehouse

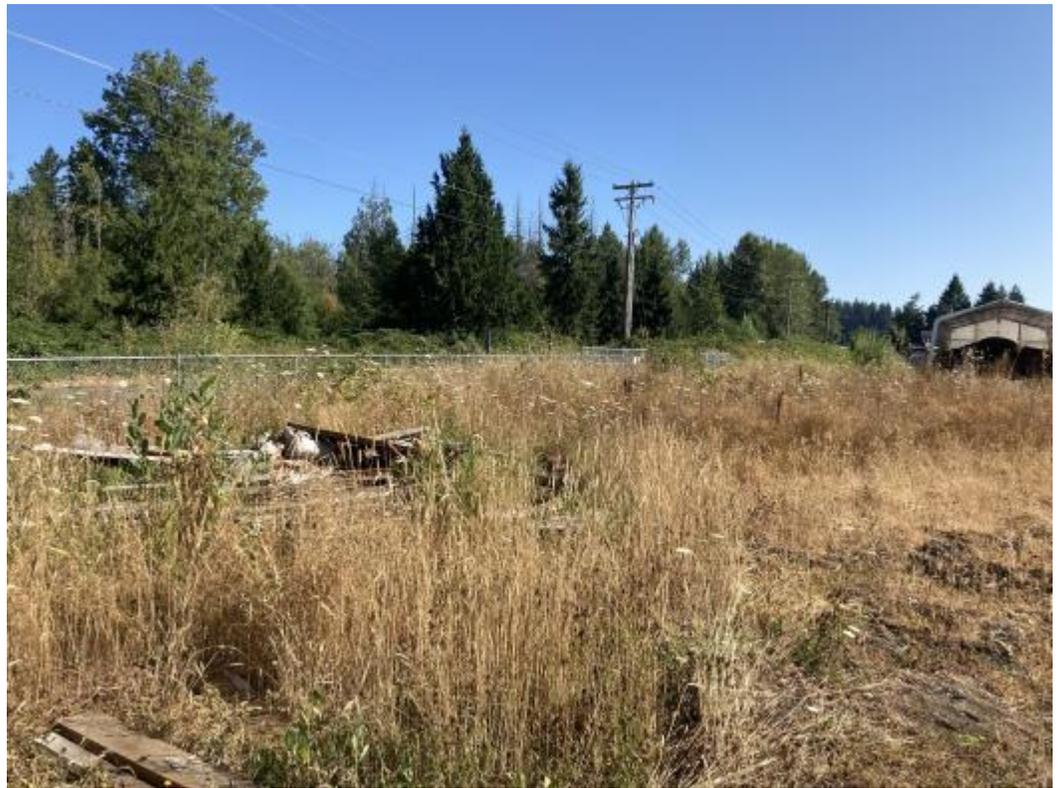
<b>Photo No.</b> <b>399</b>	<b>Date:</b> 07/29/2021
<b>Photo Coordinates</b>	
<b>Lat</b>	46.572372
<b>Long</b>	-122.72985
<b>Direction Photo Taken:</b> <b>NE</b>	
<b>Description:</b>  Final site walk. Area south of the fence line and southwest of the Site entrance.

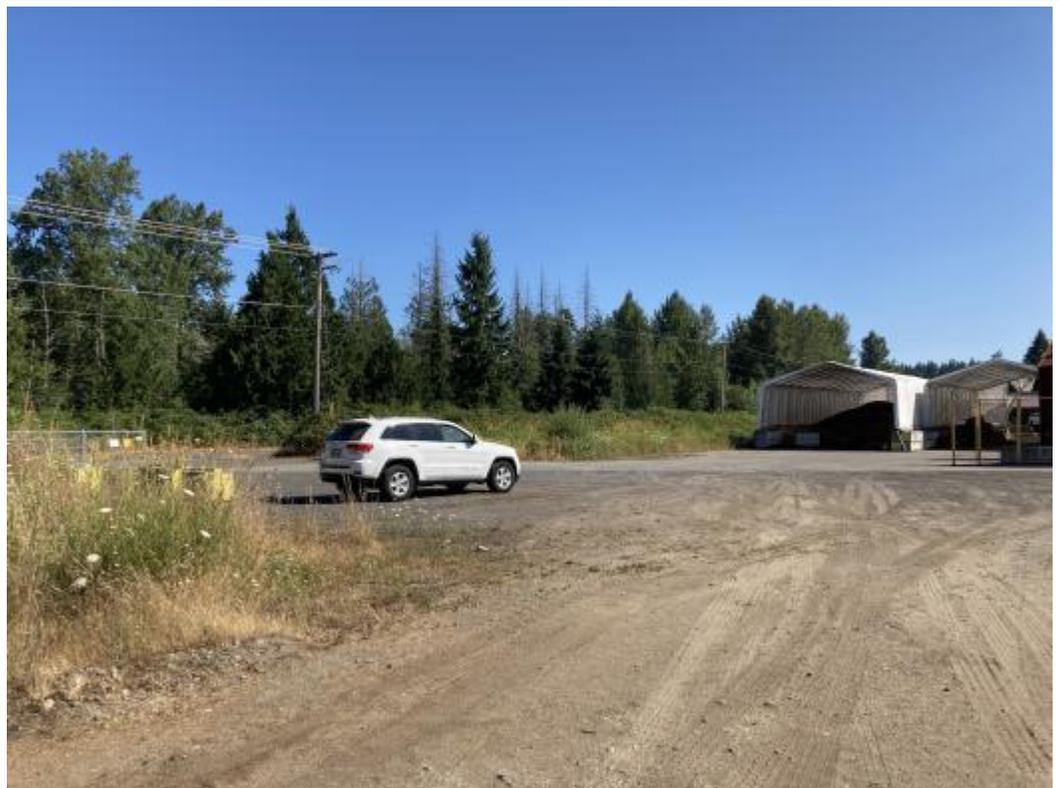
<b>Photo No.</b> <b>400</b>	<b>Date:</b> 07/29/2021
<b>Photo Coordinates</b>	
<b>Lat</b>	46.572303
<b>Long</b>	-122.729575
<b>Direction Photo Taken:</b> <b>NE</b>	
<b>Description:</b>  Final site walk. Area just south of the Site entrance.

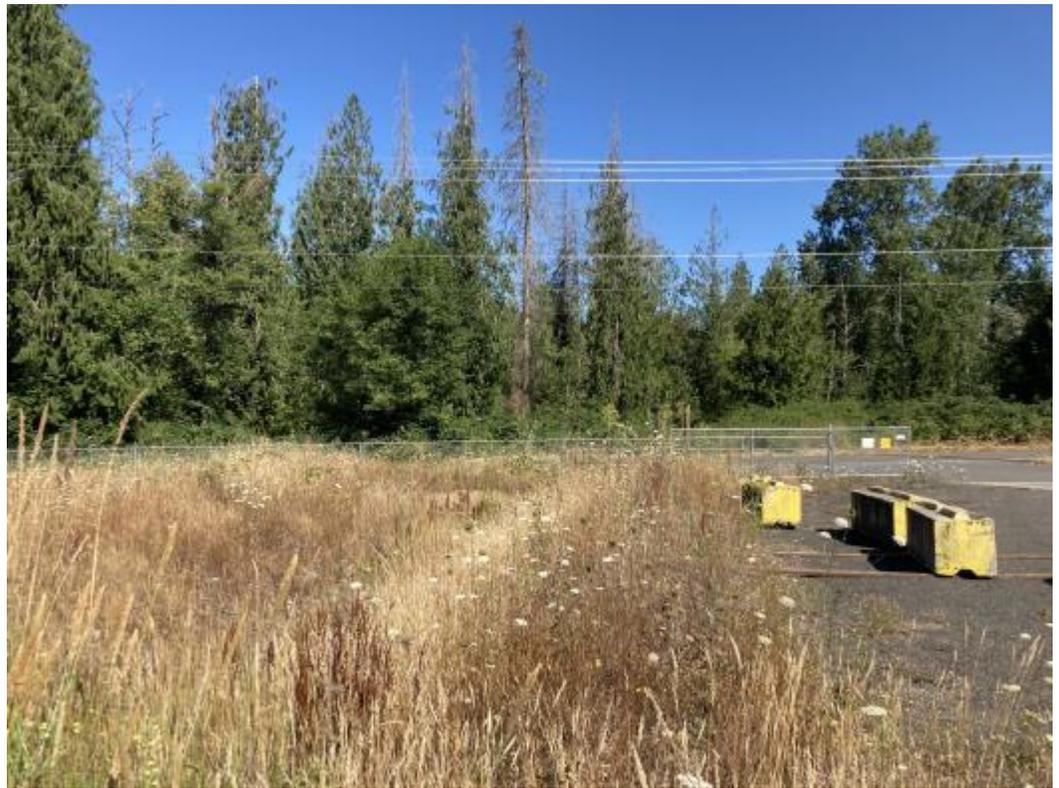
<b>Photo No.</b> <b>401</b>	<b>Date:</b> 07/29/2021
<b>Photo Coordinates</b>	
<b>Lat</b>	46.572394
<b>Long</b>	-122.729539
<b>Direction Photo Taken:</b> <b>NW</b>	
<b>Description:</b>  Final site walk. Area just southwest of the Site entrance.

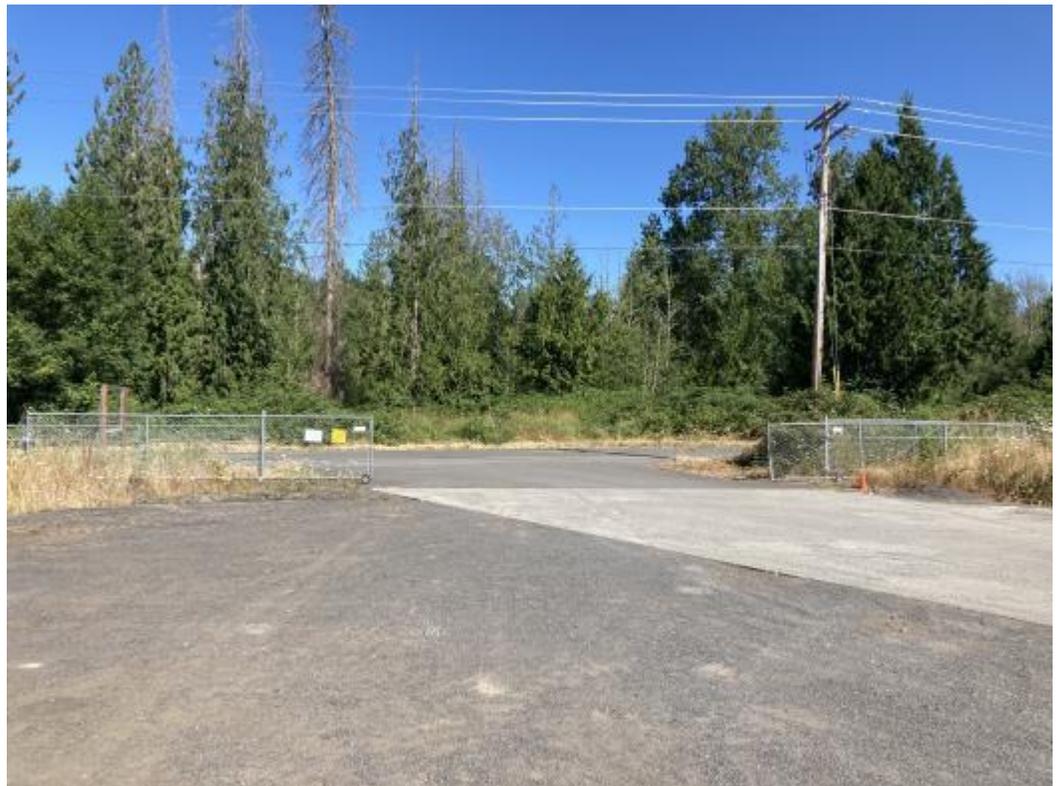
<b>Photo No.</b> <b>402</b>	<b>Date:</b> 07/29/2021
<b>Photo Coordinates</b>	
<b>Lat</b>	46.572511
<b>Long</b>	-122.729392
<b>Direction Photo Taken:</b> <b>NW</b>	
<b>Description:</b>  Final site walk. Site entrance as viewed from the Site.
