TRIP REPORT

***Treoil Industries Biorefinery
Ferndale, Whatcom County, Washington
Contract No.: 68HE0720D0005
Task Order No.: 68HE0722F0042***

March 2022

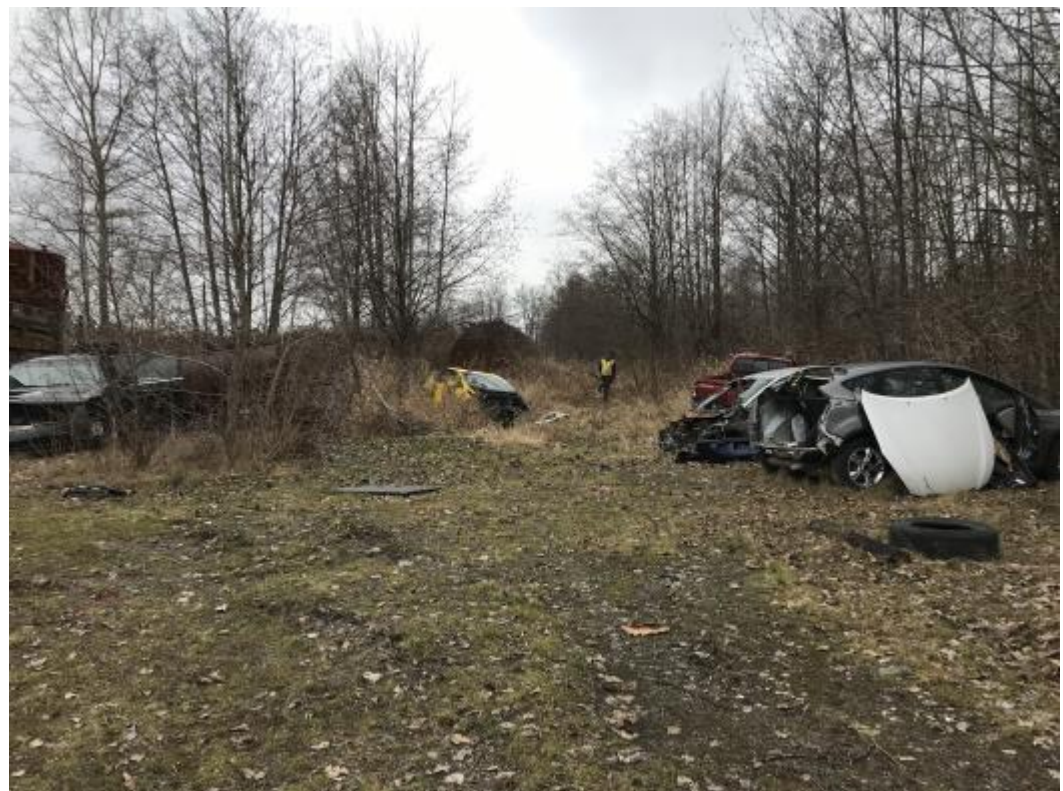
Photo No. 18	Date: 02/17/2022
Photo Coordinates	
Lat	48.8798
Long	-122.710092
Direction Photo Taken: N	
Description: Additional photos of wrecked vehicles.
