Subject: Final Koehler Junction 2023 Construction Completion Report, Revision 0
Bonita Peak Mining District OU1 RS
San Juan County, Colorado
U.S. EPA Region 8 START V, Contract No. 68HE0820D0001 Task Order
No. 68HE021F0043
Technical Direction No. 2143-2307-01
Task Monitor: Craig Myers, EPA On-Scene Coordinator

BONITA PEAK MINING DISTRICT
KOEHLER JUNCTION 2023 CONSTRUCTION REPORT

SAN JUAN COUNTY, COLORADO

Revision 0

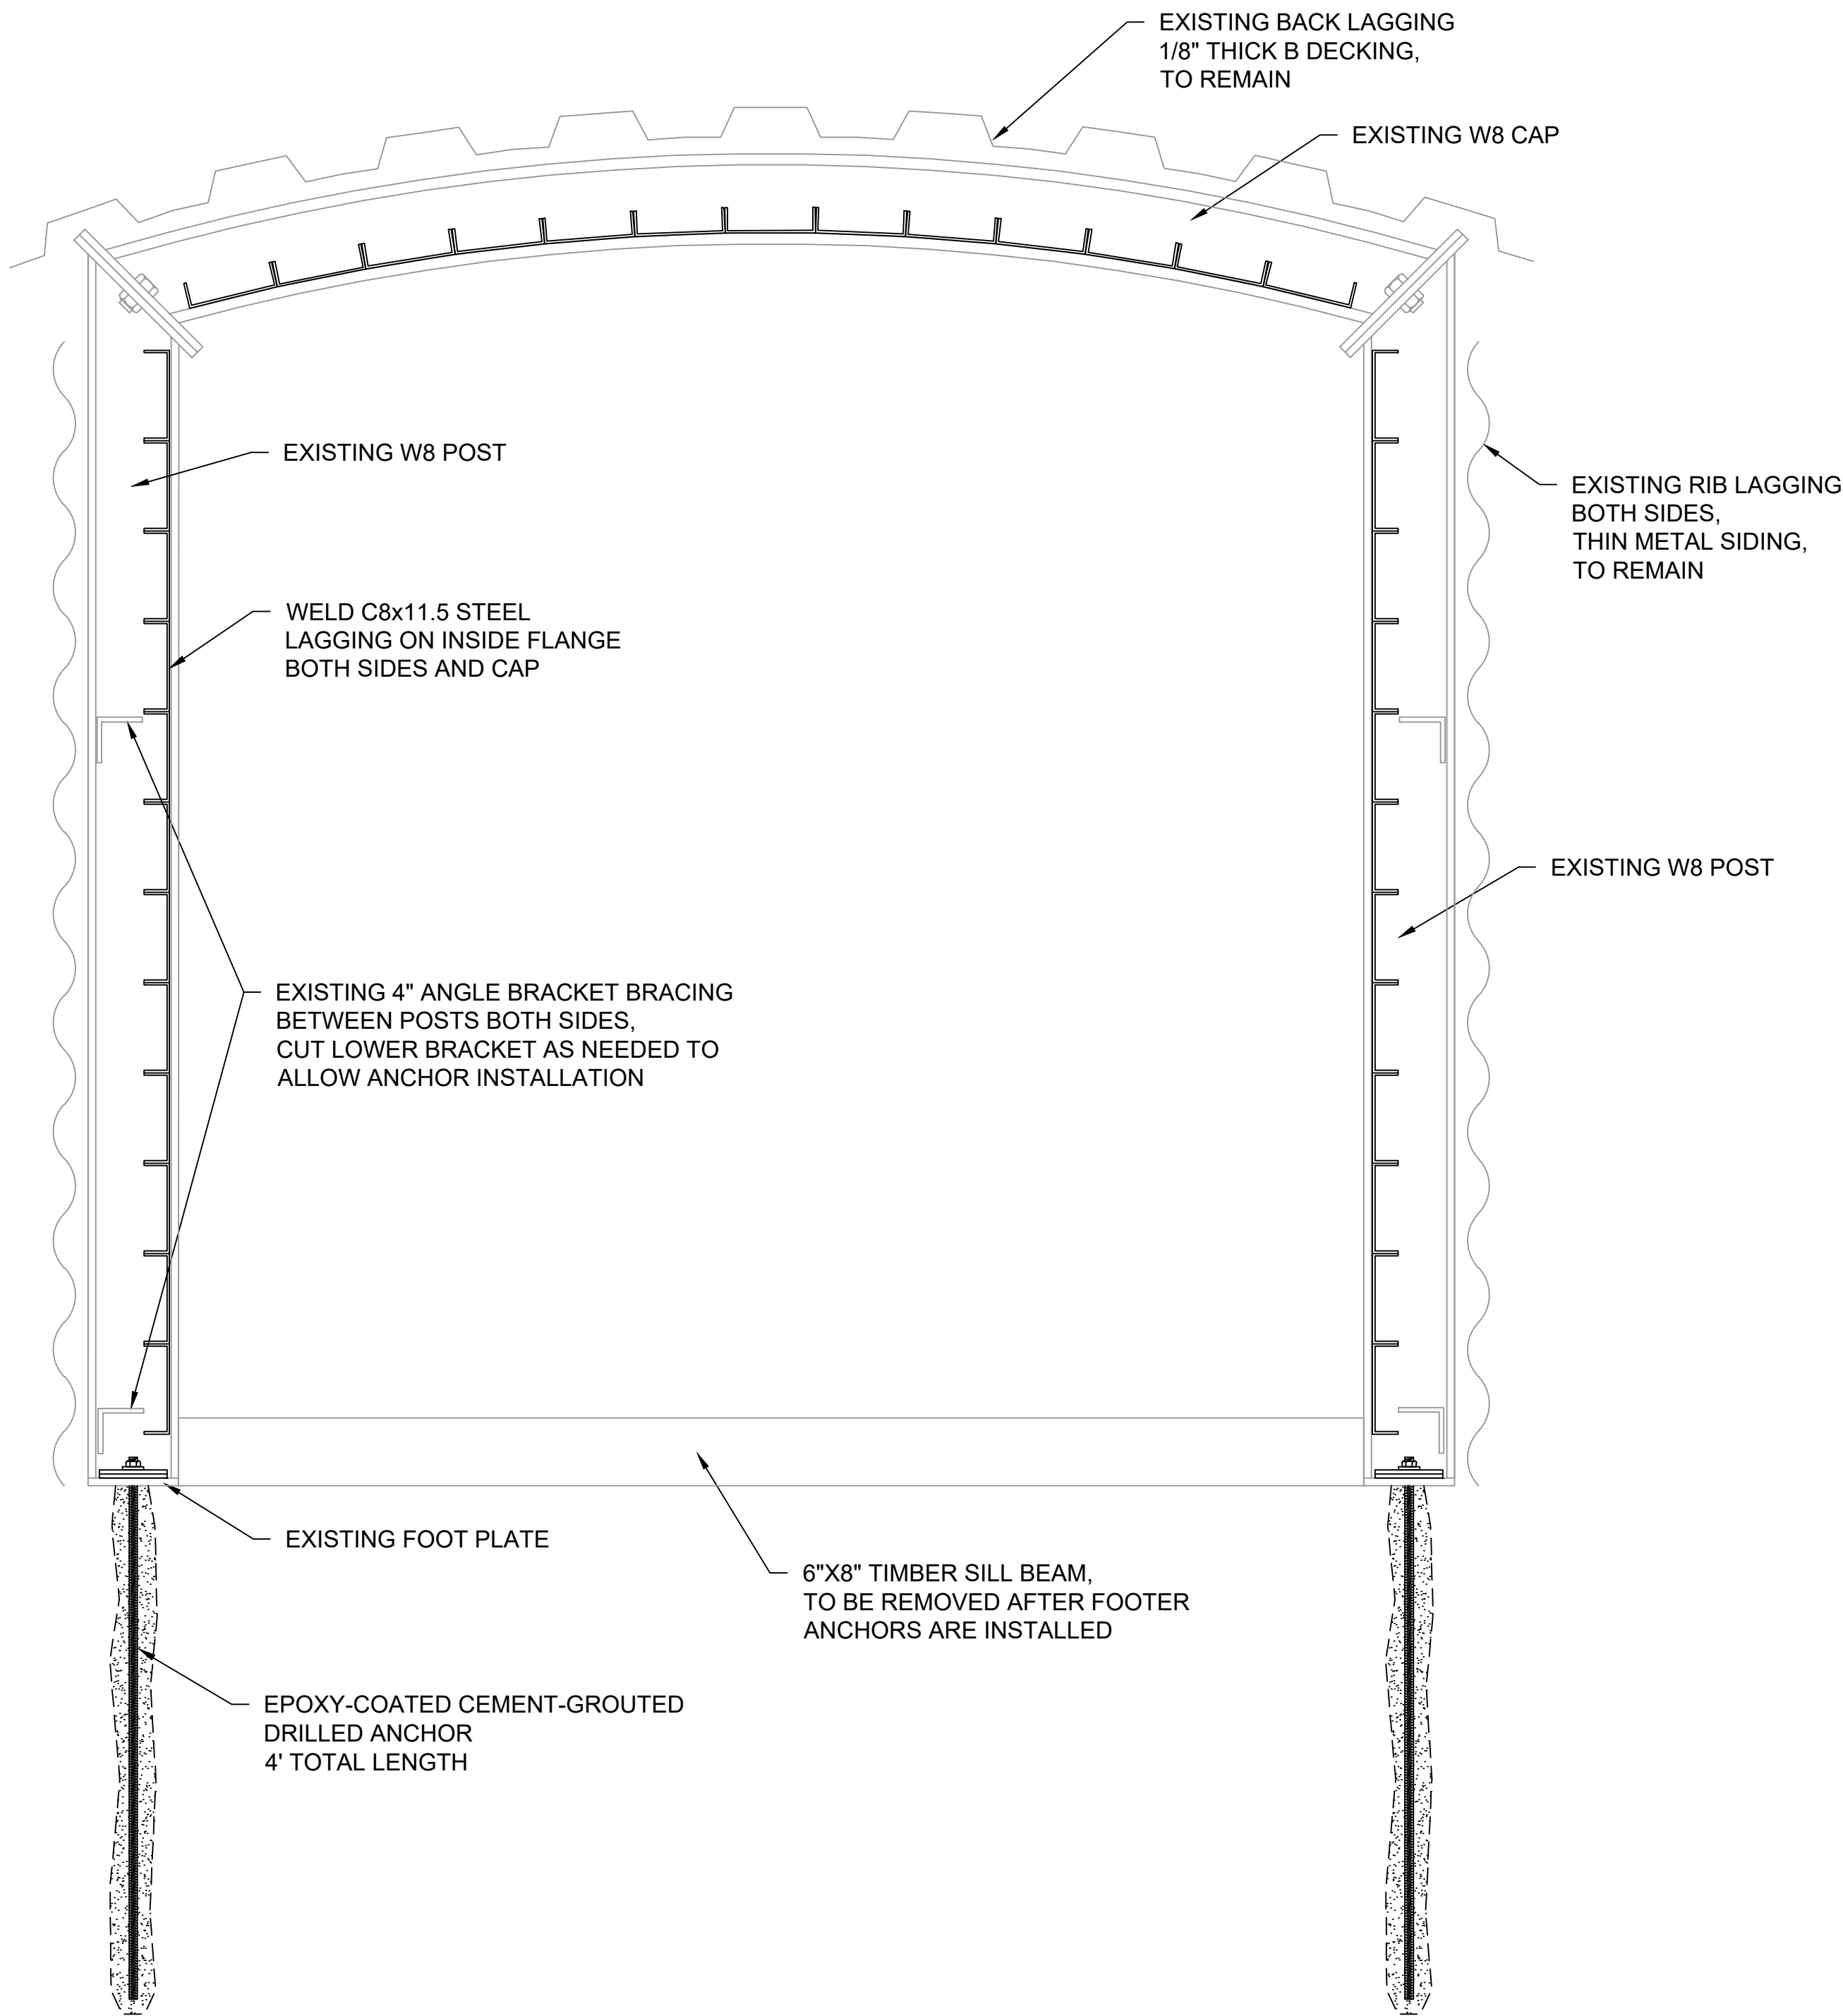
PROPOSED STEEL SET MODIFICATIONS

We generally agree with the ground support but note that it is not permanent, particularly in a very acidic mine environment. Degradation of both bolts and mesh is evident, particularly in areas where seeping mine water has corroded the metal. Long term stability of and continued safe access to Koehler Tunnel will require additional engineered support, specifically longer permanent rock bolts with synthetic mesh. This is shown on the drawings. The bolts are longer (6 foot) to extend past the zone of disturbance from the previous bolting. The bolts are also solid grade 75 threadbar with epoxy coating to resist corrosion. The mesh between the bolts is specified as synthetic and thereby not prone to corrosion. The current support will not be removed. The new bolts and mesh will be installed at the same stationing between existing bolts. In addition, 12-foot-long steel spiles will be installed in

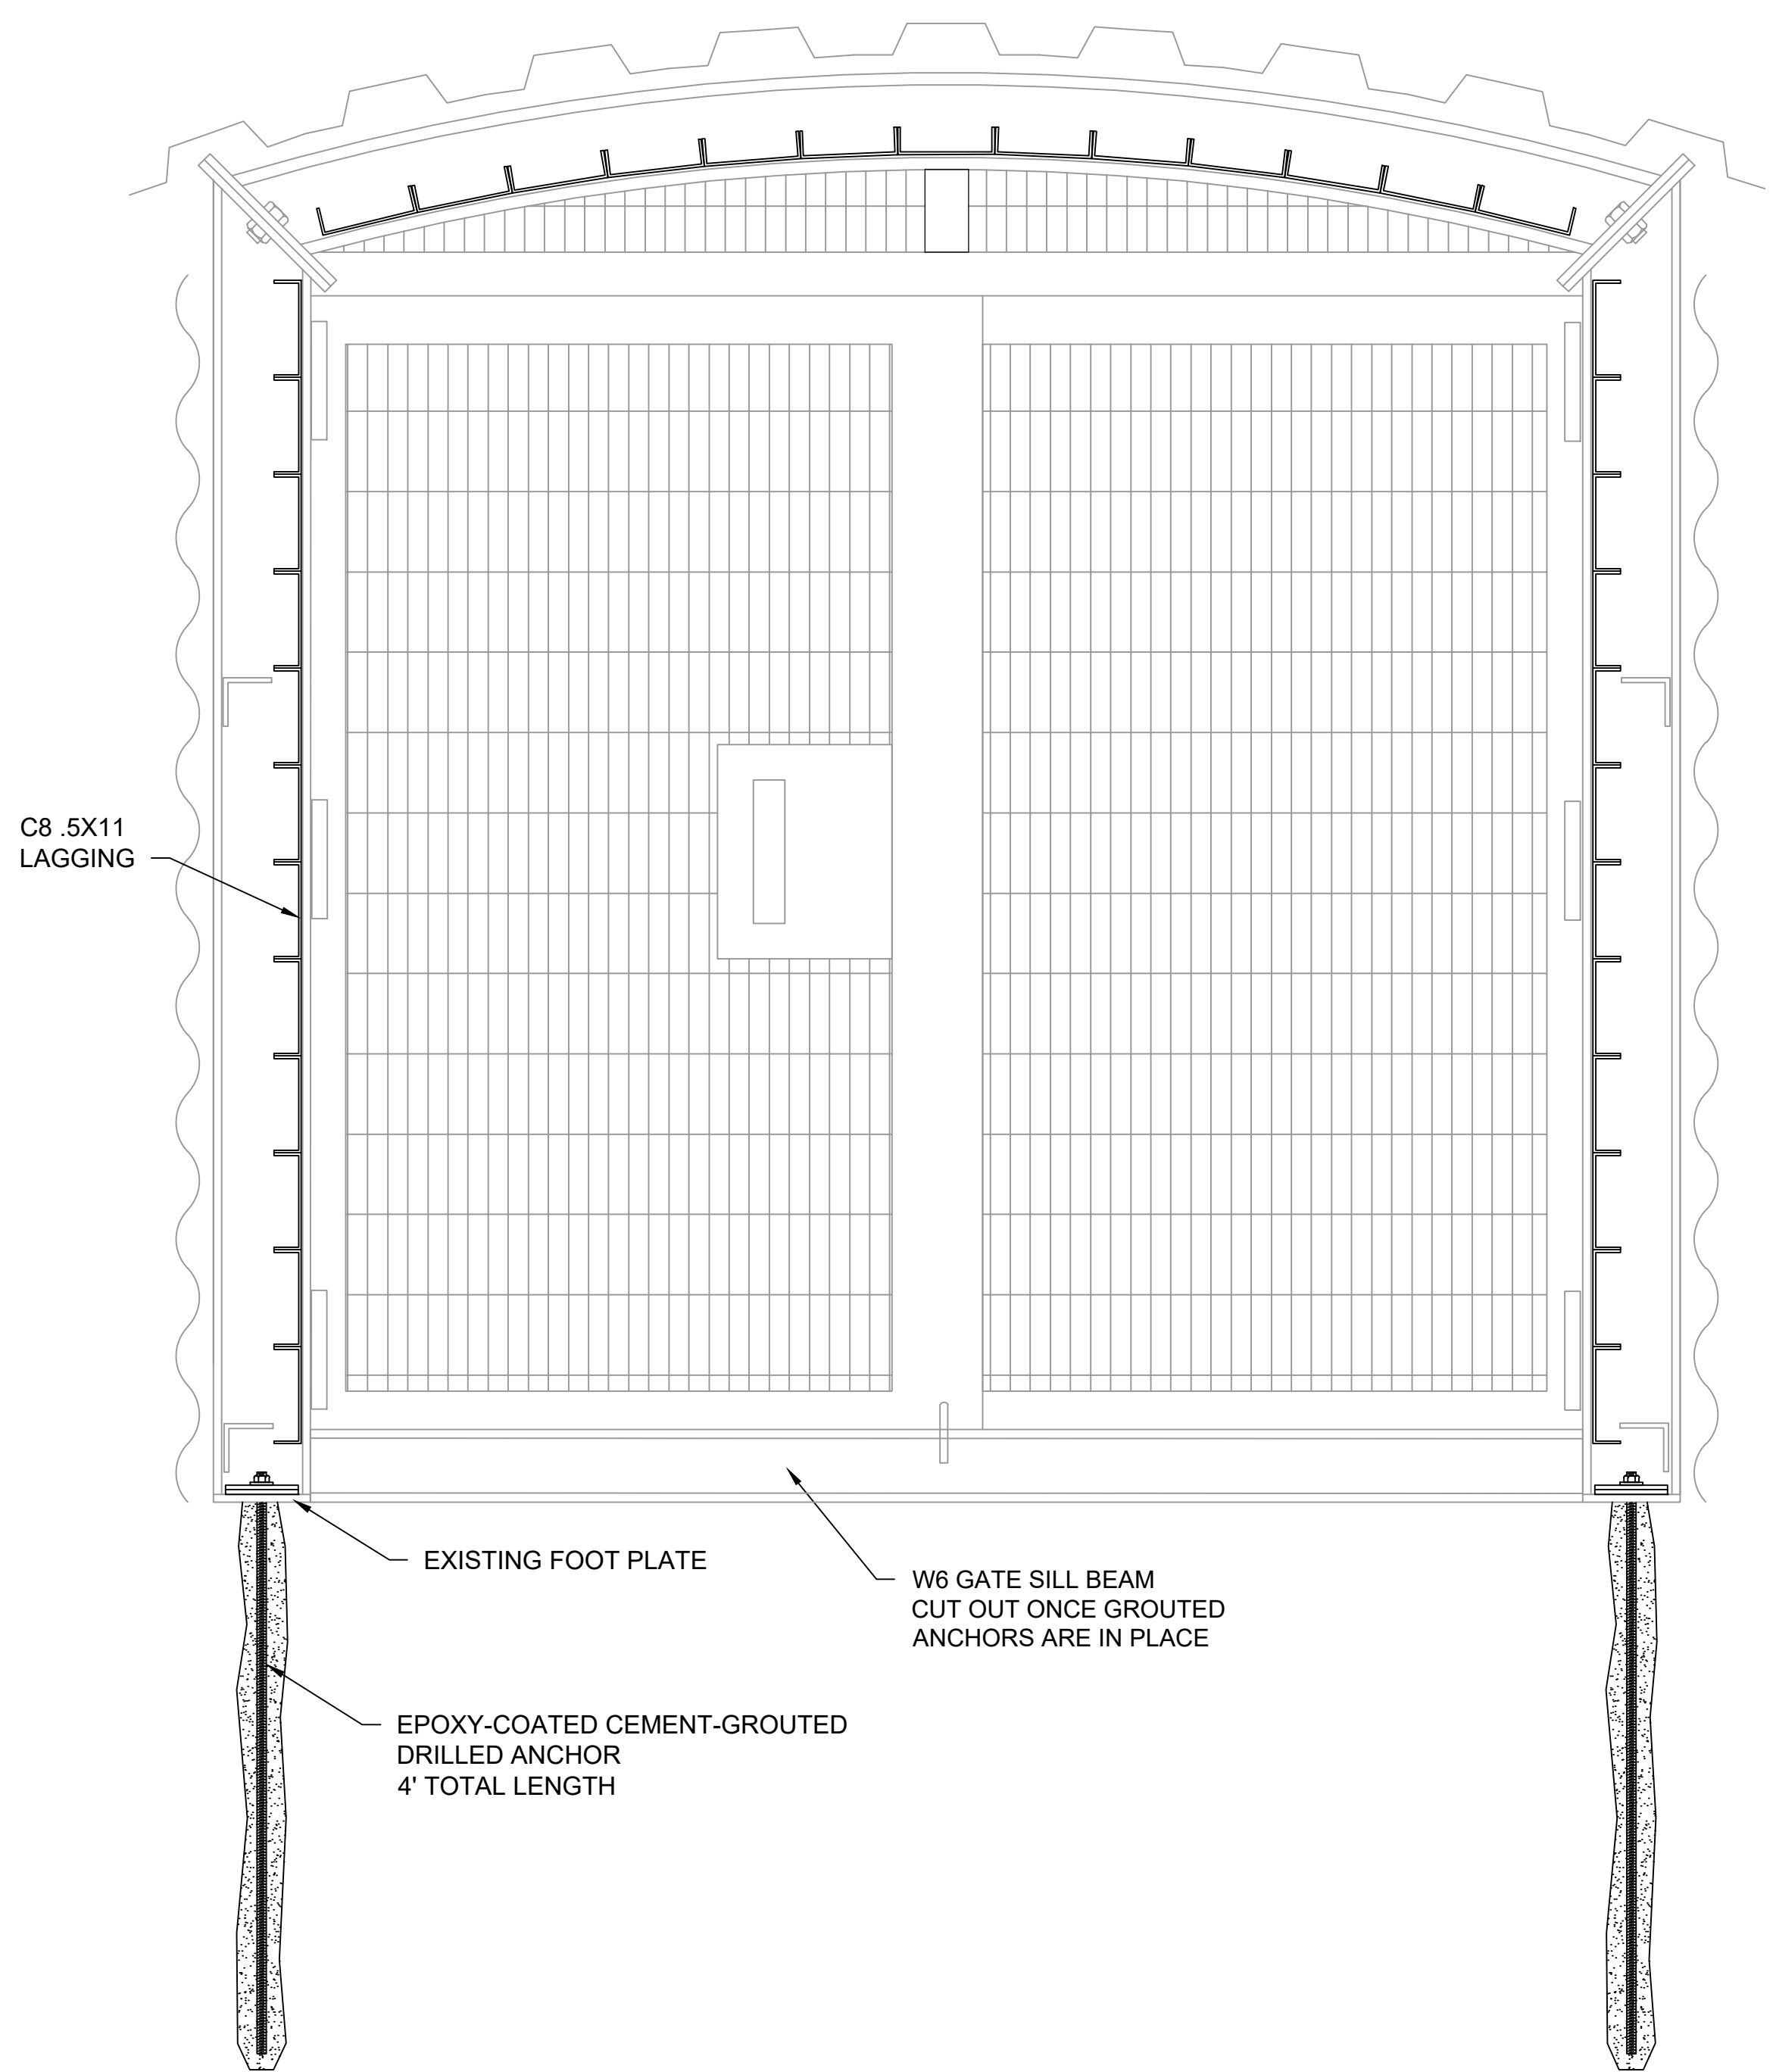
PROPOSED GATE MODIFICATIONS

NOTE:
PROTECT AND PRESERVE GATE
DURING CONSTRUCTION

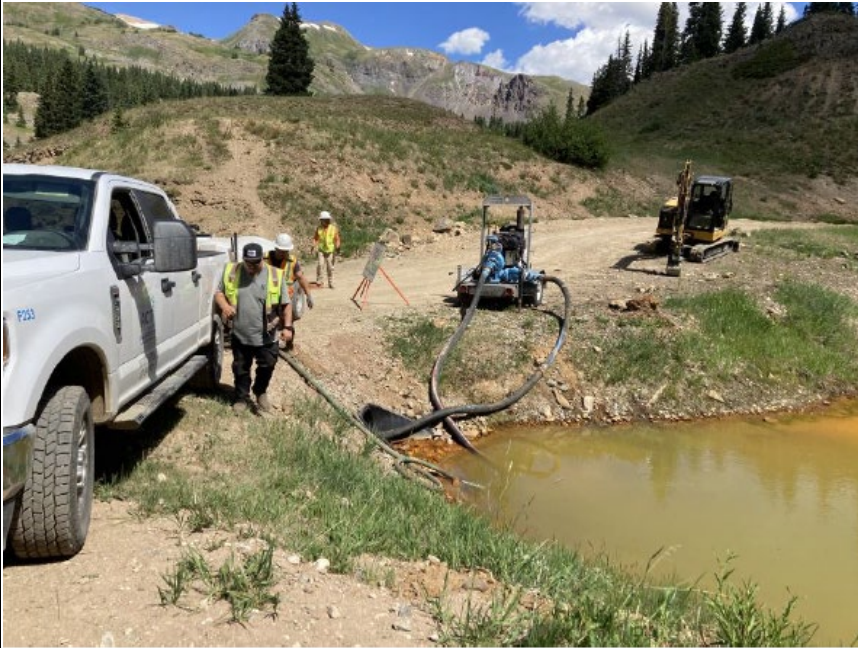
Photo: 1

Description: Water being pumped from the Koehler Junction settling pond in preparation for sludge removal from Koehler Tunnel. Water is being pumped into the culvert shown at center.	
Date: 07/24/2023

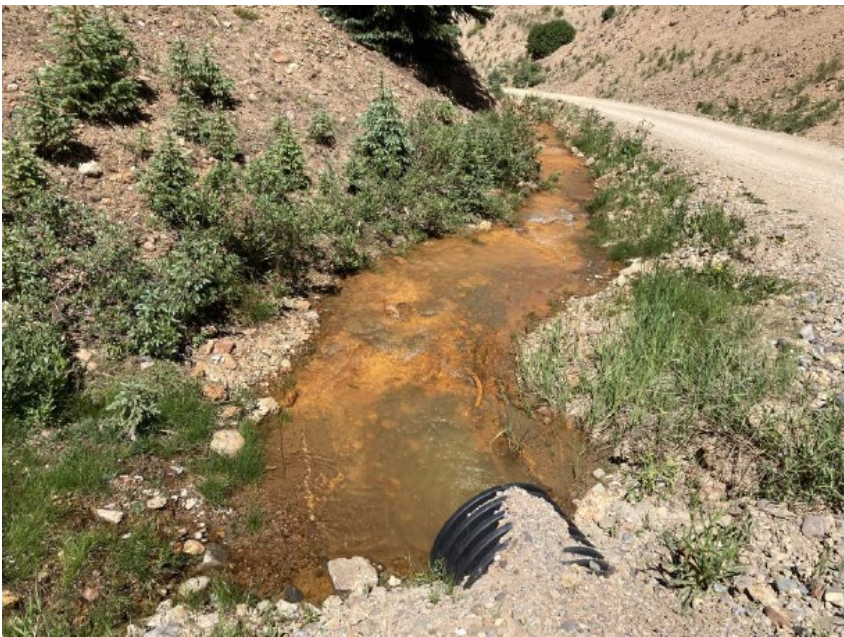
Photo: 2

Description: Pumped water from the Koehler Junction settling pond passing through the culvert towards Mineral Creek.	
Date: 07/24/2023

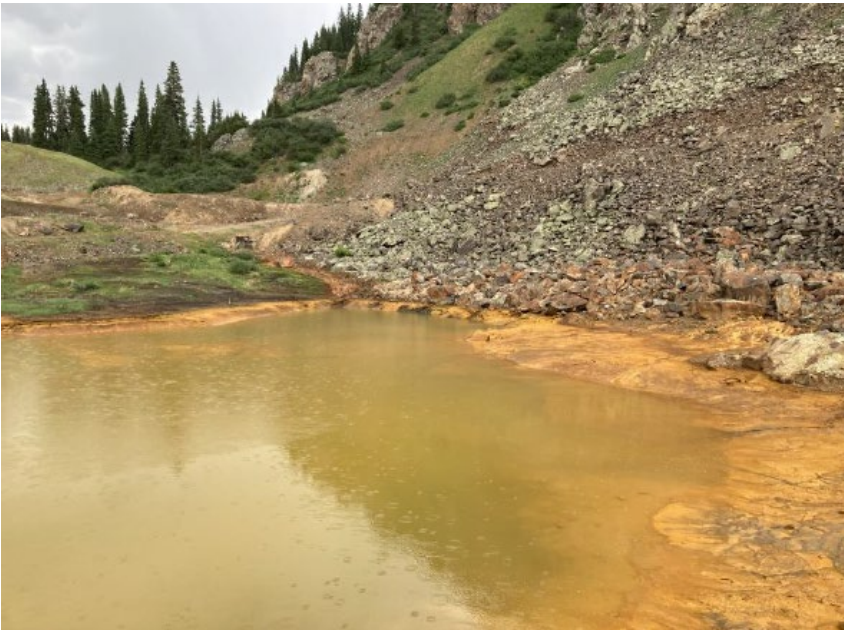
Photo: 3

Description: Koehler Junction settling pond after 6.5 hours of pumping water out of it. The orange-colored shore has been exposed as a result. Junction Mine can be seen left of center, beyond the back shore of the pond.	
Date: 07/24/2023

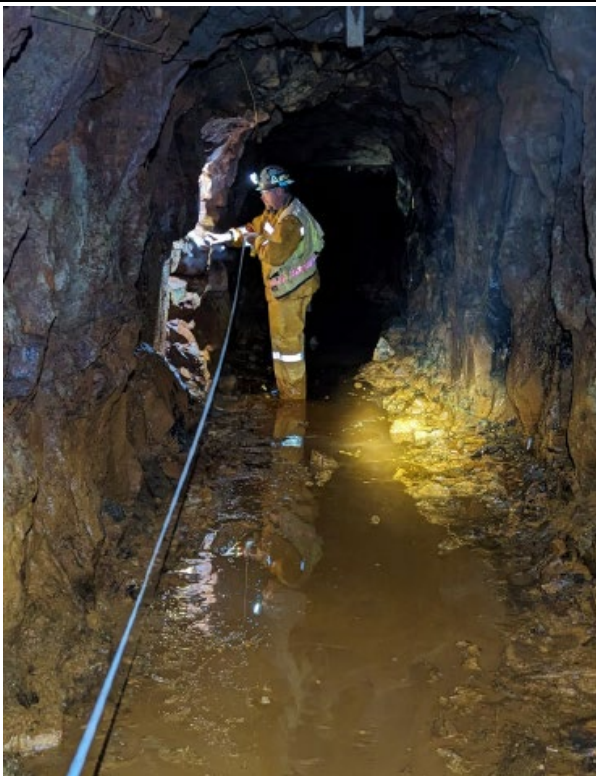
Photo: 14

Description: Measuring and marking out stations at 25-foot intervals along Koehler Tunnel.	
Date: 09/20/2023

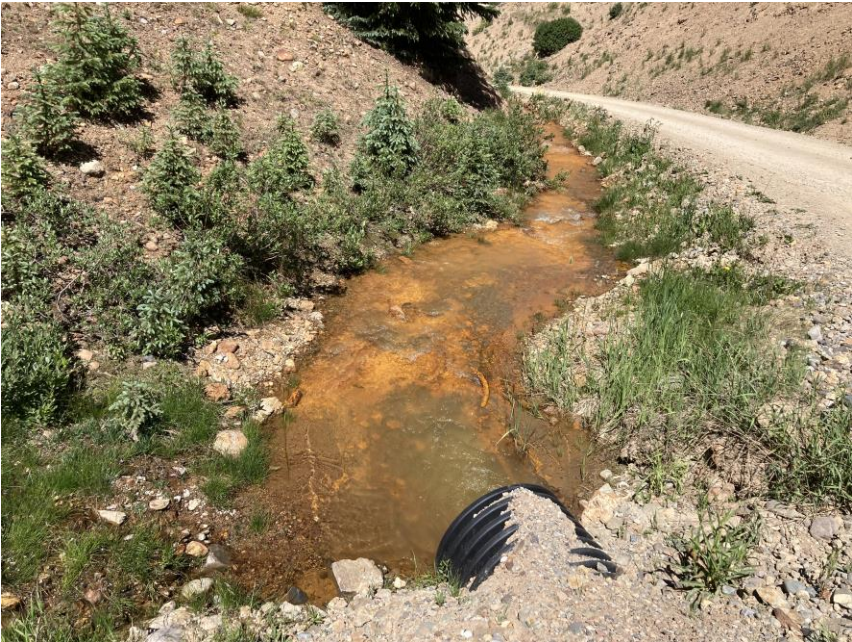
Photo: 2

Description: Water being pumped from the settling pond through the culvert at Koehler Tunnel.	
Date: 7/24/2023

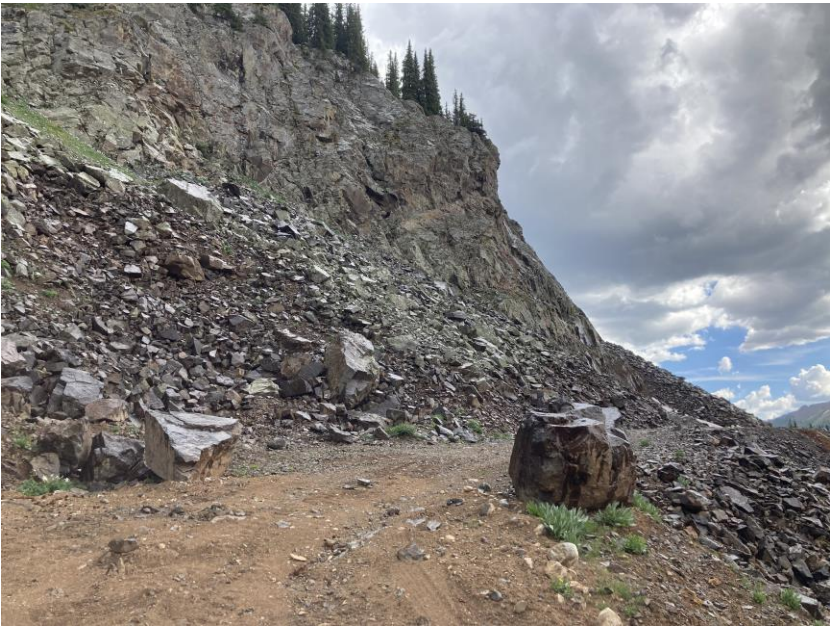
Photo: 3

Description: The boulders that ACT Enviro moved off the road that accesses the Koehler Tunnel. The boulders are to the right and left of the road.	
Date: 7/24/2023

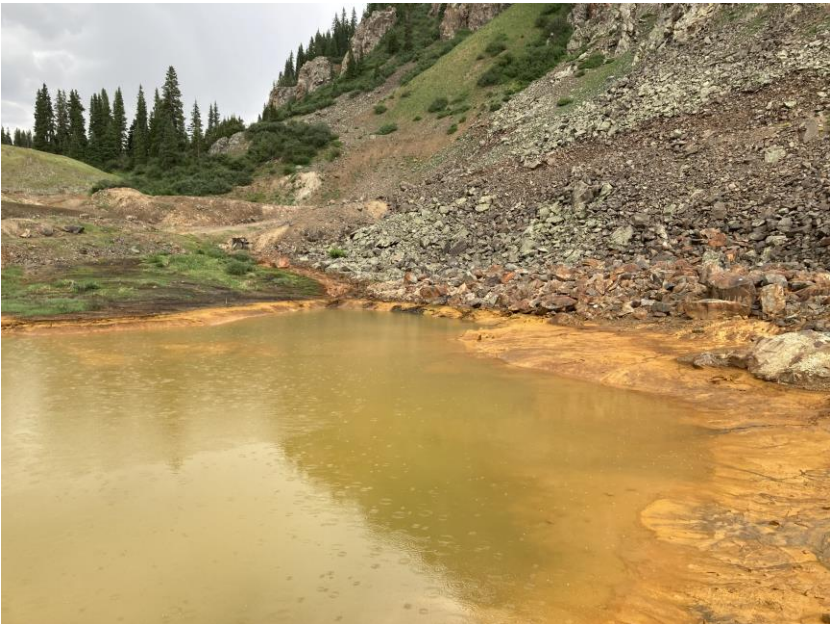
Photo: 4

Description: The Koehler Tunnel settling pond after 6.5 hours of pumping. Note the orange shore that is now exposed.	
Date: 7/24/2023

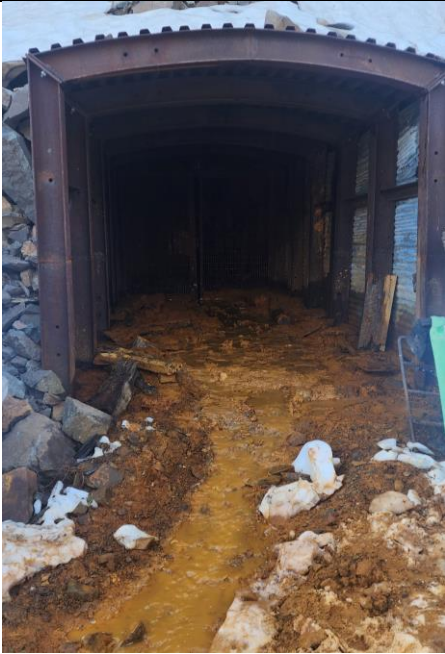
Photo: 1

Description: The Koehler Tunnel prior to any mucking activity.		
Date: 7/25/2023

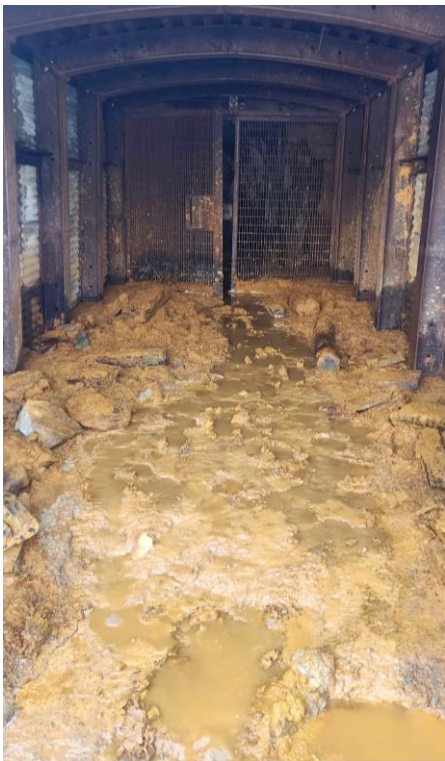
Photo: 2

Description: The Koehler Tunnel prior to any mucking activity.		
Date: 7/25/2023

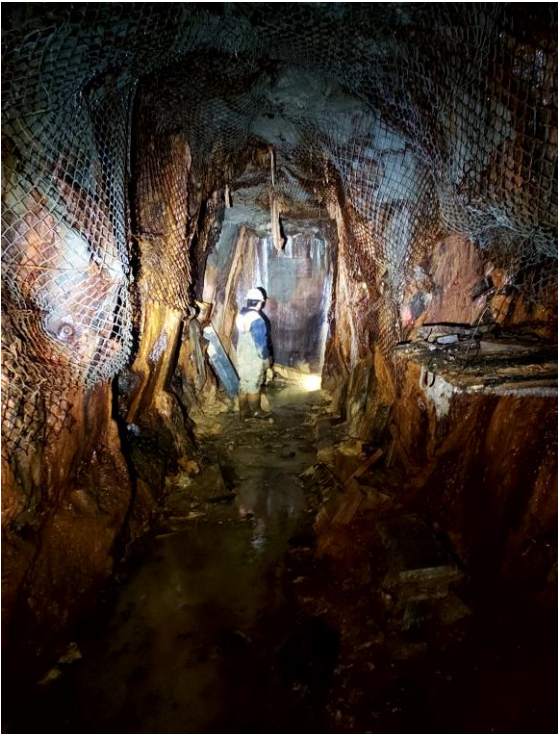
Photo: 3

Description: The Koehler Tunnel looking towards the bulkhead after mucking activities were completed.		
Date: 7/26/2023

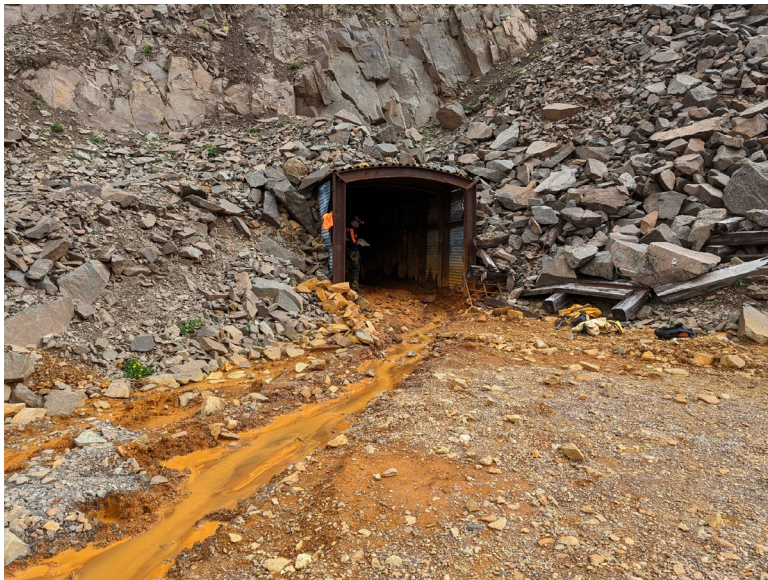
Photo: 2

Description: Water flowing from Koehler Tunnel and down slope into settling pond.	
Date: 9/20/2023

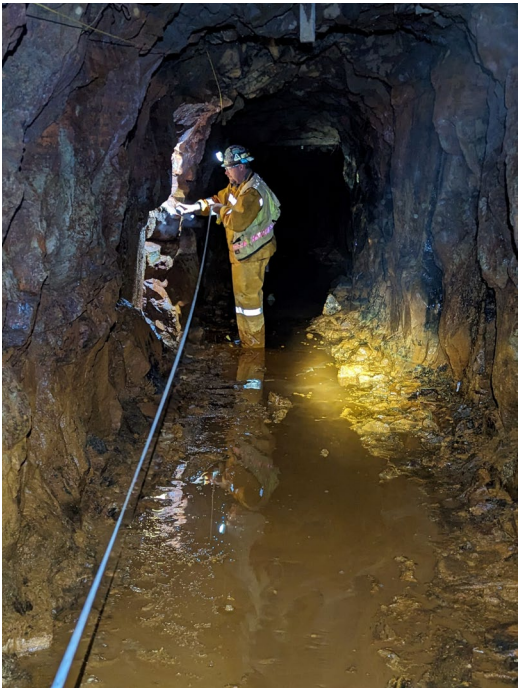
Photo: 3

Description: SE marking station at 25' intervals from portal to bulkhead.	
Date: 9/20/2023

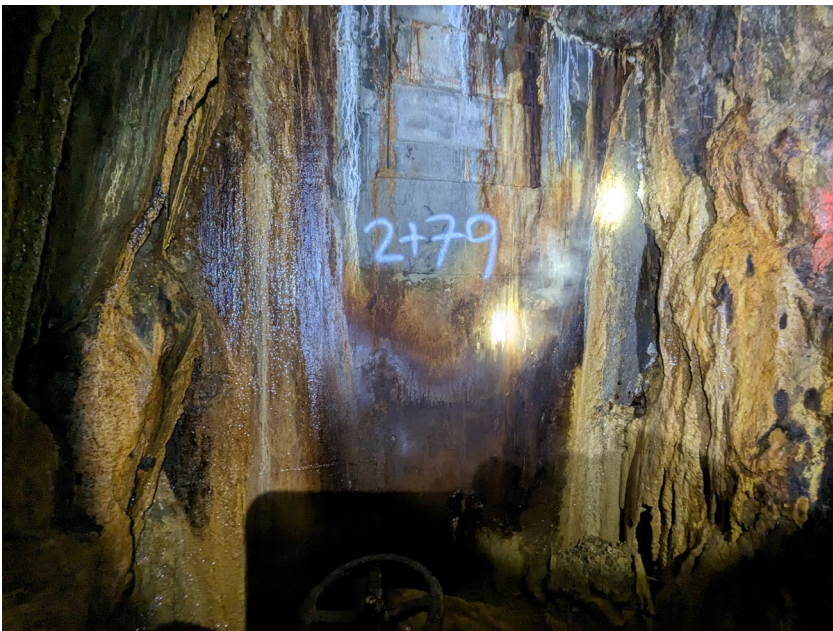
Photo: 4

Description: Bulkhead measured at 279' from portal.	
Date: 9/20/2023
