SUBJECT: Action Memorandum for a Removal Action at the Ogden June 2024 Mercury Spill Site pursuant to the On-Scene Coordinator's delegated authority under CERCLA Section 104.

Site Name: Ogden June 2024 Mercury Spill
Site Spill ID (SSID): B8K8
NRC Case Number: 1400761
CERCLIS Number: UTN000826432
Site Location: Harrison and 1100 St, Ogden, UT 84404
Lat/Long: 41.27553/-111.95143
Potentially Responsible Party (PRP):
NPL Status: Non-NPL
Removal Start Date: June 4, 2024

ATTACHMENT 1:
Initial Site Visit
Report Prepared by
Utah DEQ

SITE VISIT REPORT

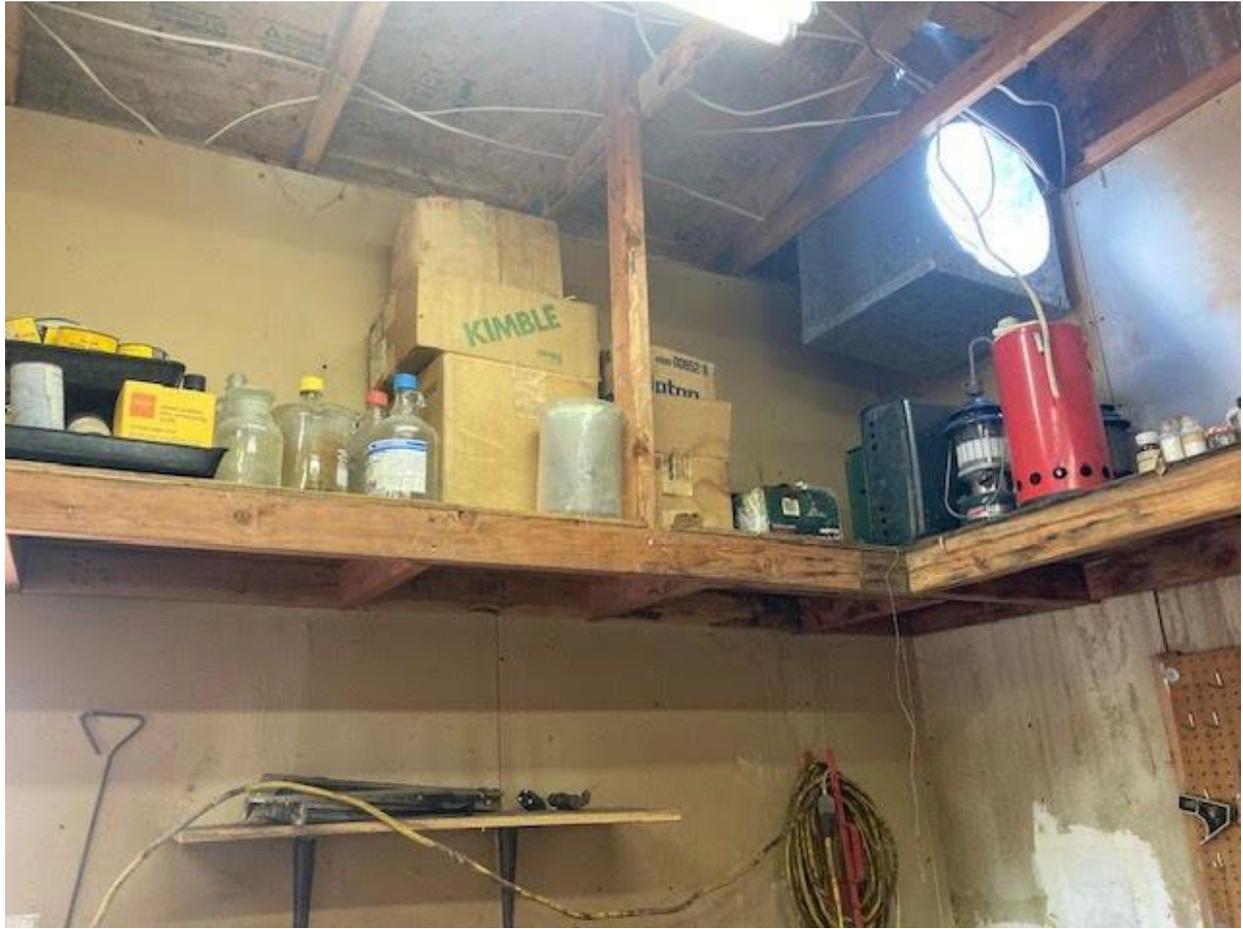
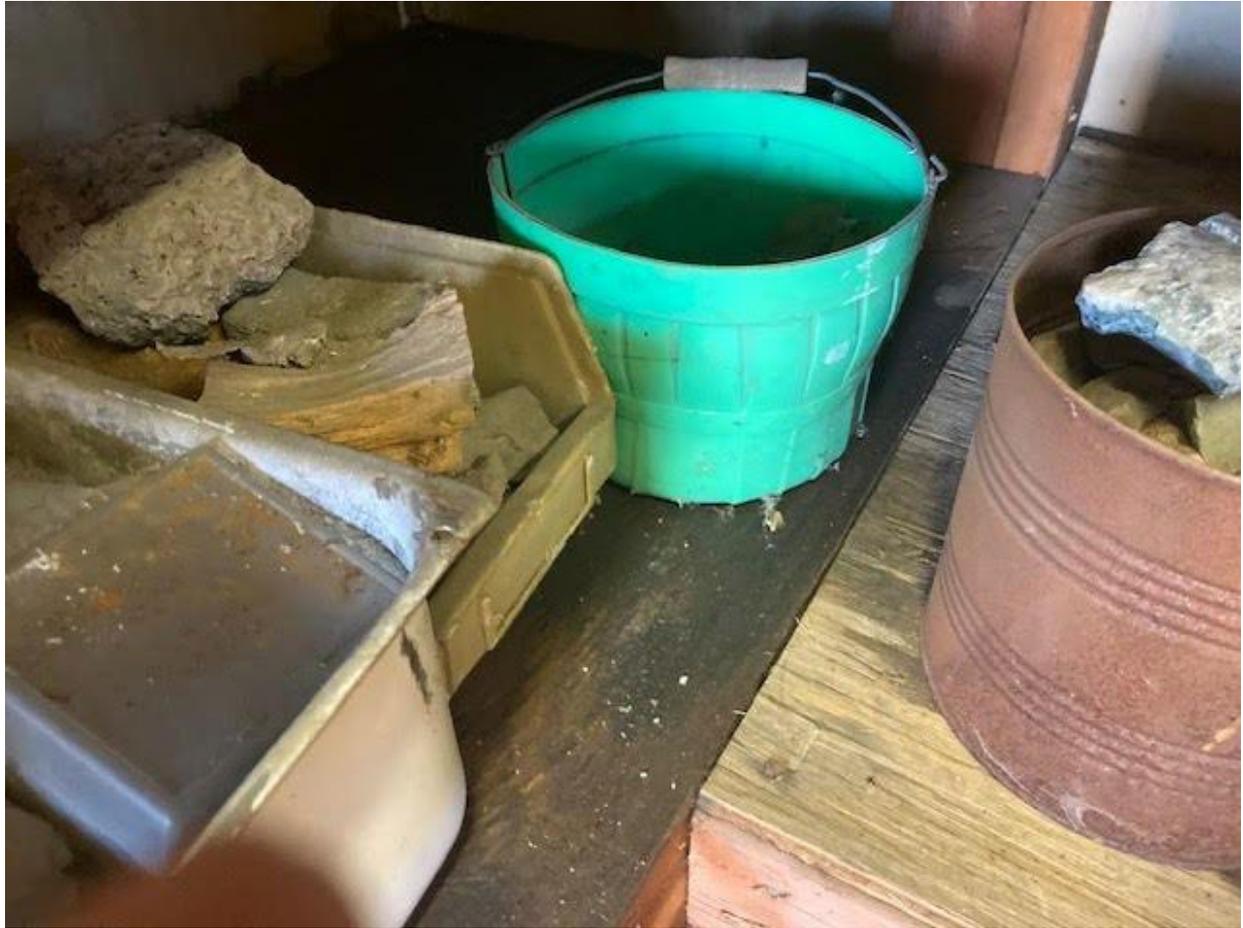
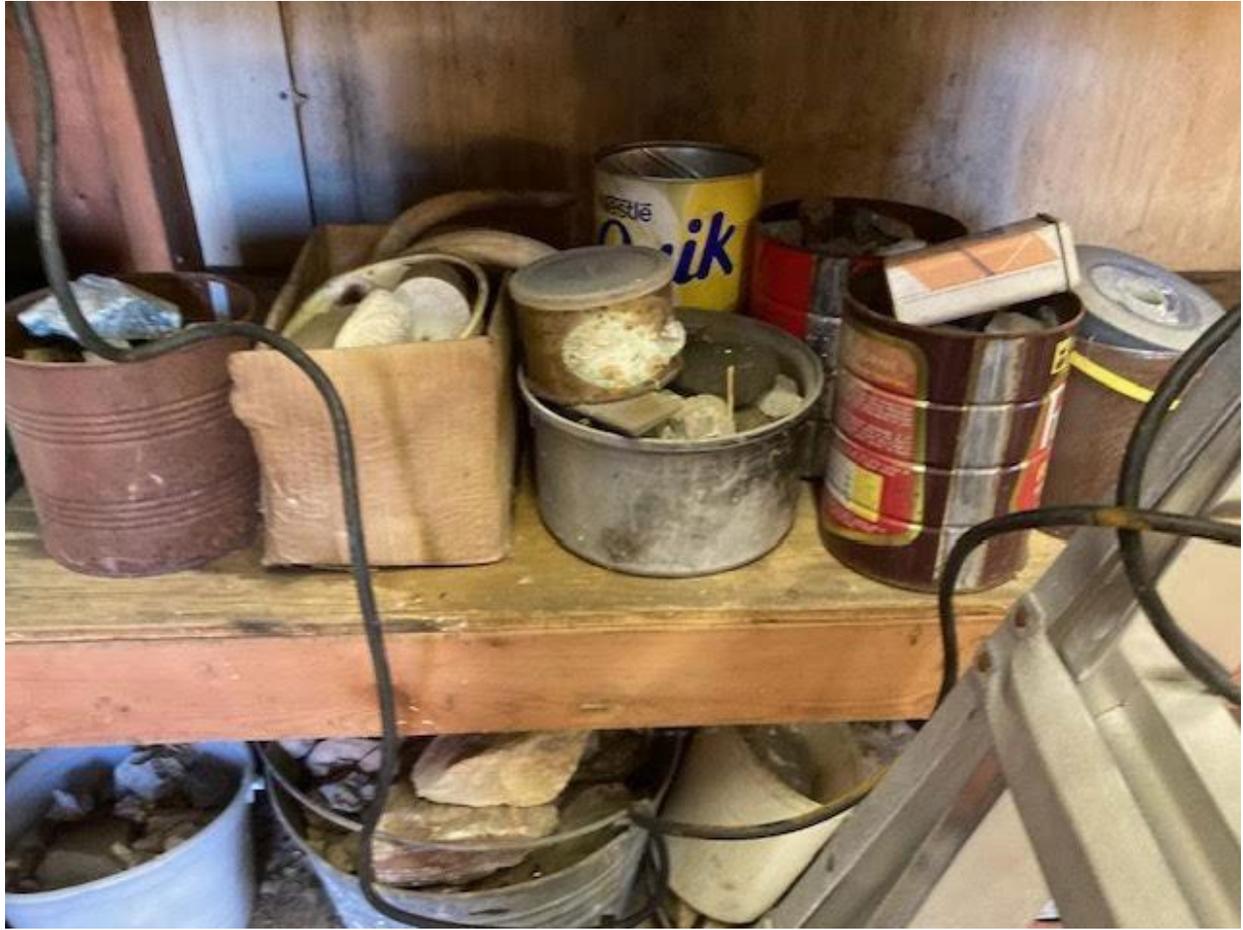
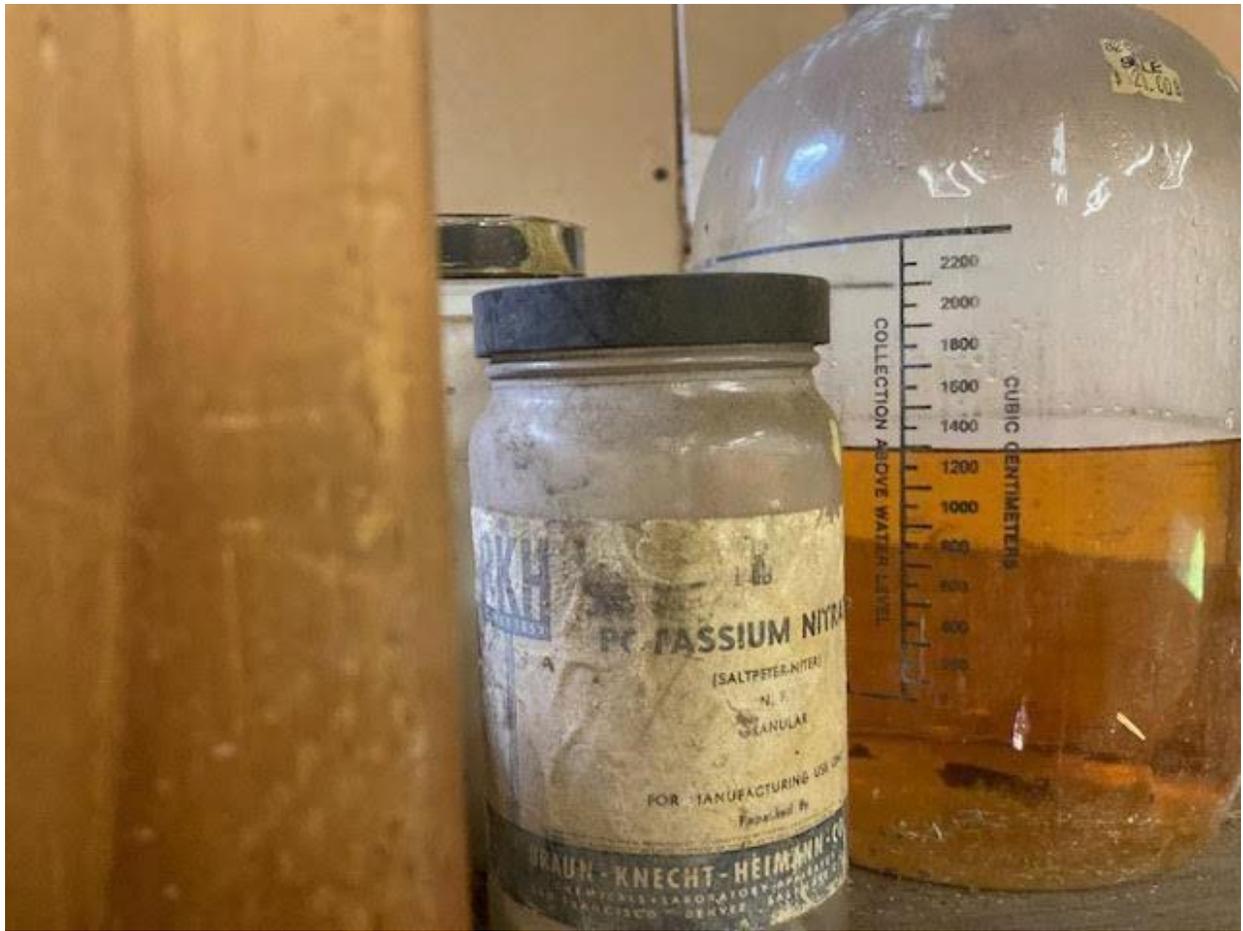
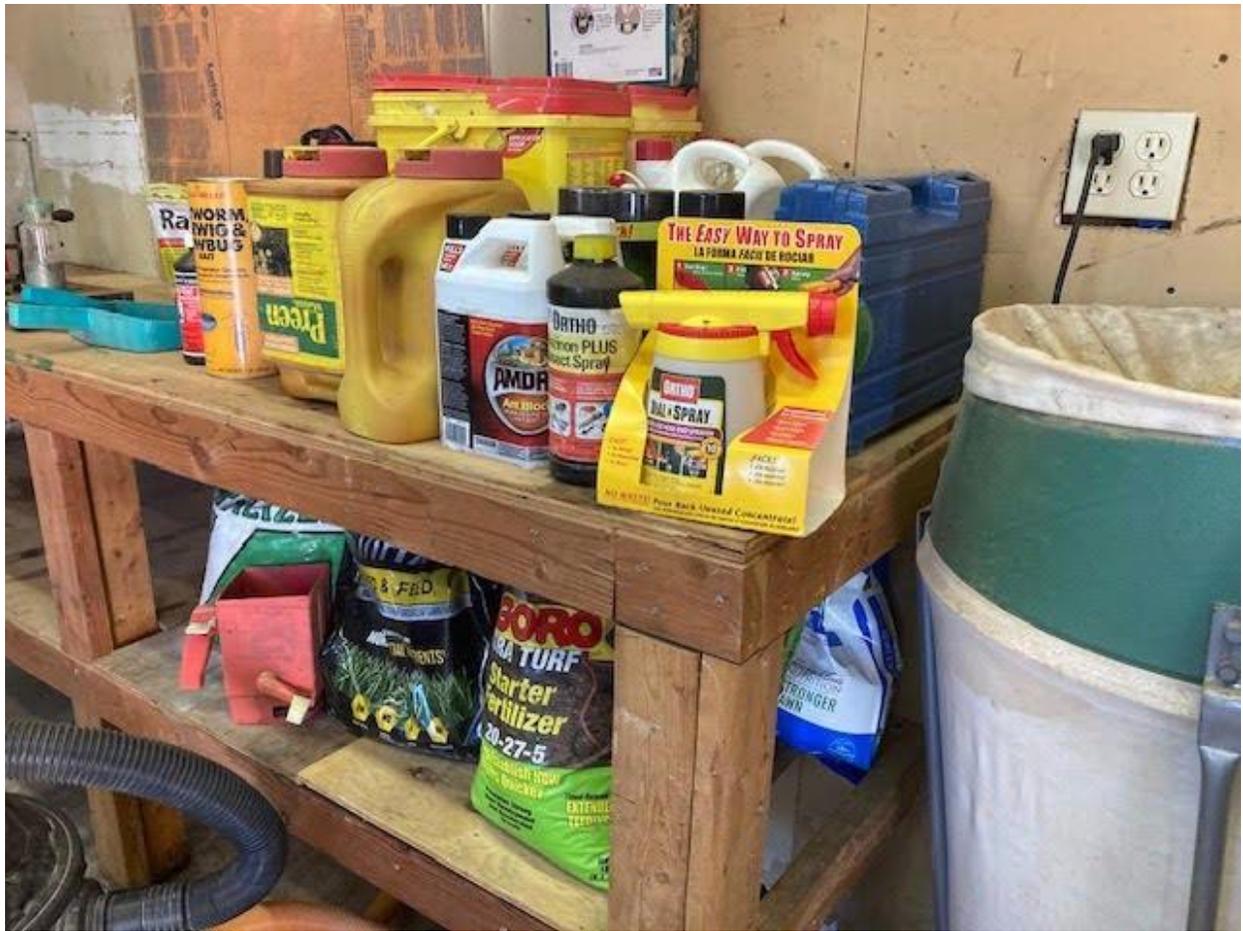
PHOTO LOG:

An elevated shelf along the east and north sides of the shed contained several bottles of other chemicals including the leaking bottle of mercury.

Free mercury was observed leaking from the bottom of a 1-liter plastic bottle, the mercury appeared to have saturated the underlying shelf.

While no free mercury was observed on the lower shelf or the concrete floor, they have likely been contaminated. The items that had been stored in the shed are likely contaminated as well and will need to be tested.
