Site Features Inventory Report

Barite Hill Mine McCormick, South Carolina

Prepared By: Michael Gobla, P.E.

July 2007

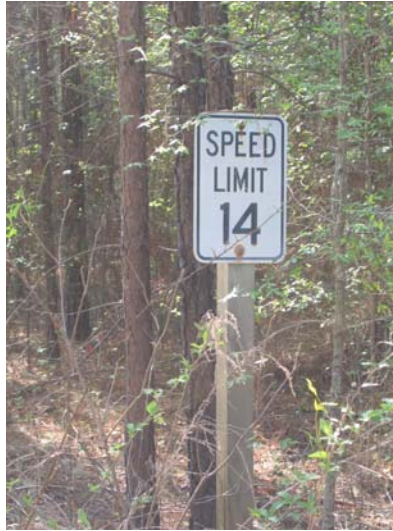
Figure 3. The main access road at the site has two of these speed limit signs.

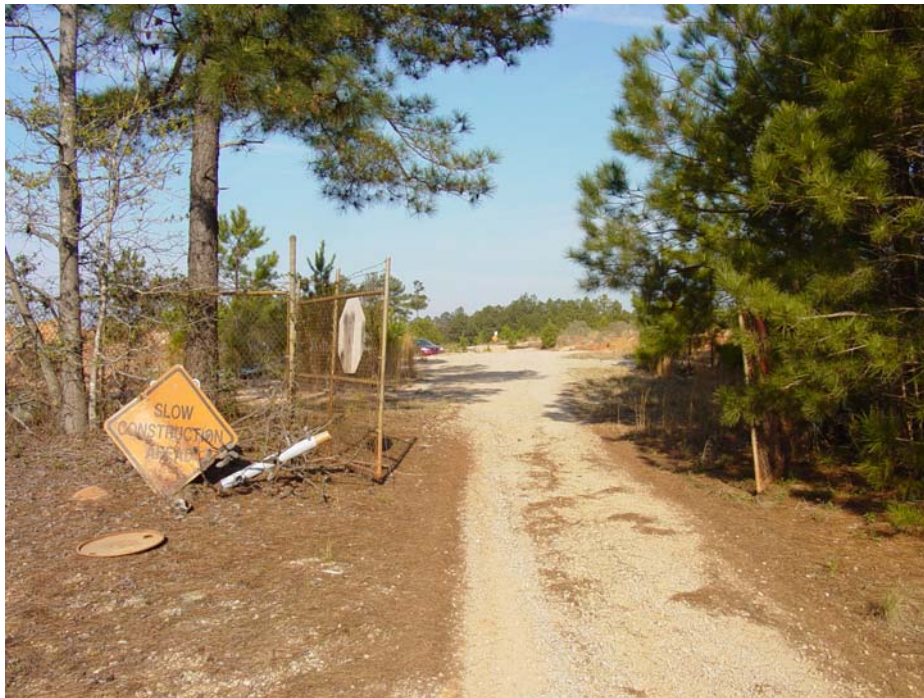
Figure 4. Photograph of the access gate near the mine office. A similar gate lies to the east at the site entrance.

Two access gates are located on the main entrance road. One is on the east side of the site near the mine entrance just off road 30. The other gate (see Figure 4) is near the center of the property just east of the principal mine disturbed areas and is adjacent to the mine office building. The gates each consist of two 10-foot swinging units providing an opening of approximately 20 feet at the mine entrance and a 19.5- foot-wide opening in the gate adjacent to the mine office building.

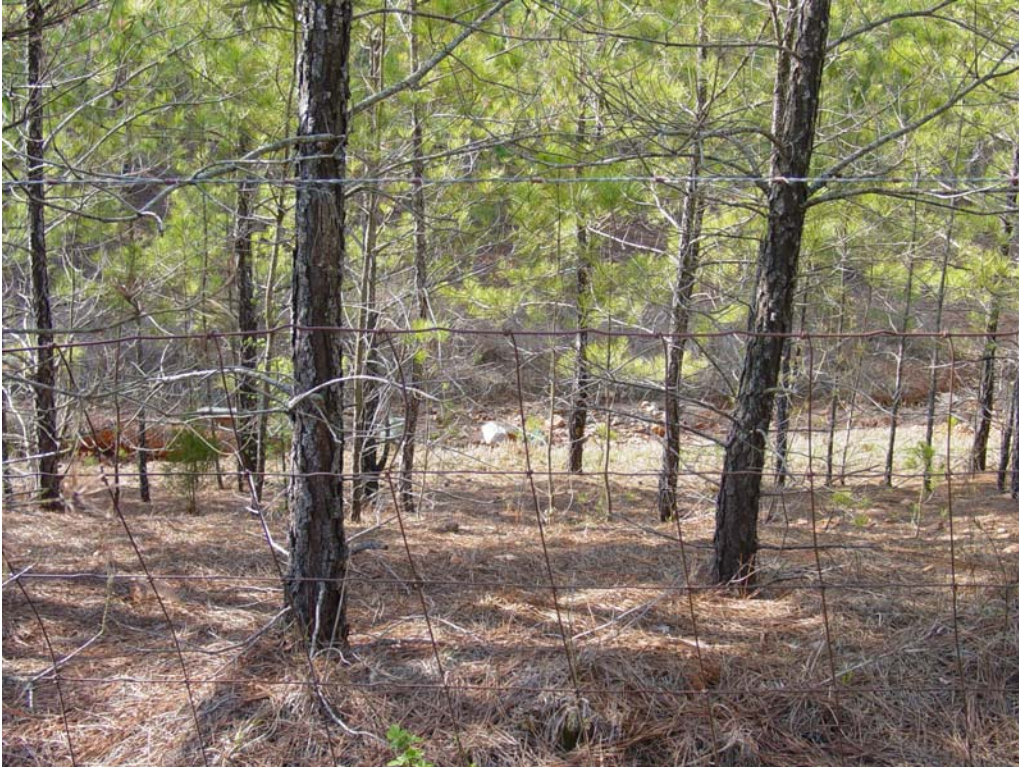
Figure 5. Close up view of fencing around the Process Plant Contingency Pond showing a smooth-wire grid and an upper single strand of barbed wire.

All of the process ponds are fenced. The pond fencing consists of a smooth wire grid with from one to three upper strands of barbed wire. When all three strands of barbed wire are present the fence forms a barrier which is approximately 6-feet tall. The Process Plant Contingency Pond fence is down in one segment on the south side and the entrance to the fenced area is open on the northwest side of the pond, thus access to all of the Process Plant area ponds is not properly controlled.

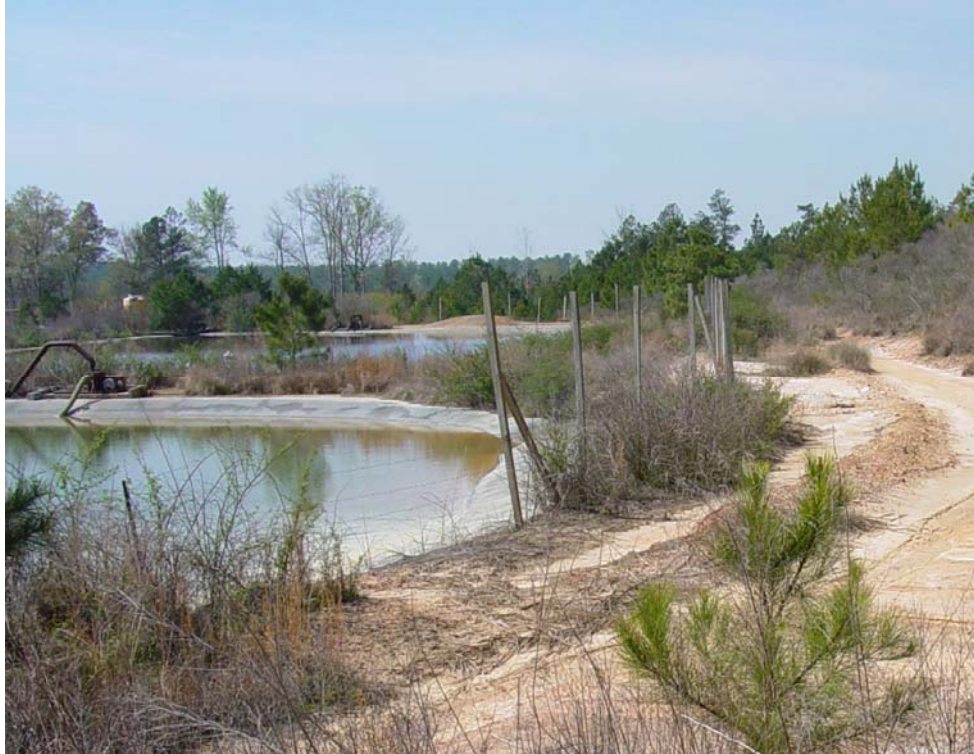
The fencing around the Permanent Heap Process Ponds is largely intact. This fencing varies from a 6-foot tall smooth wire grid topped by barbed wire to a simple three strand barbed wire fence on the east side of the ponds. A swing gate made from tubular steel controls the vehicle access point into the Permanent Heap Barren Pond.

Figure 6. Photograph showing a transition in the fencing at the Permanent Heap Rinse Pond. At left is a three strand barbed wire fence, at right is the taller fence with a smooth wire grid and upper strands of barbed wire.

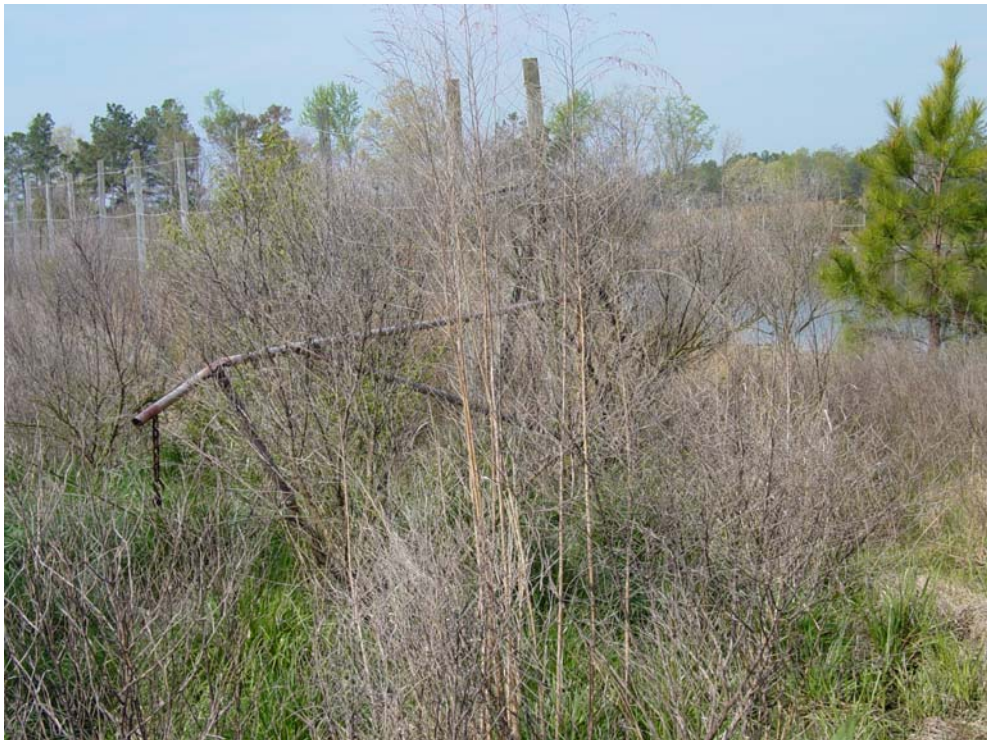
Figure 7. Metal gate located at the southeast side of the Process Plant Barren Pond.

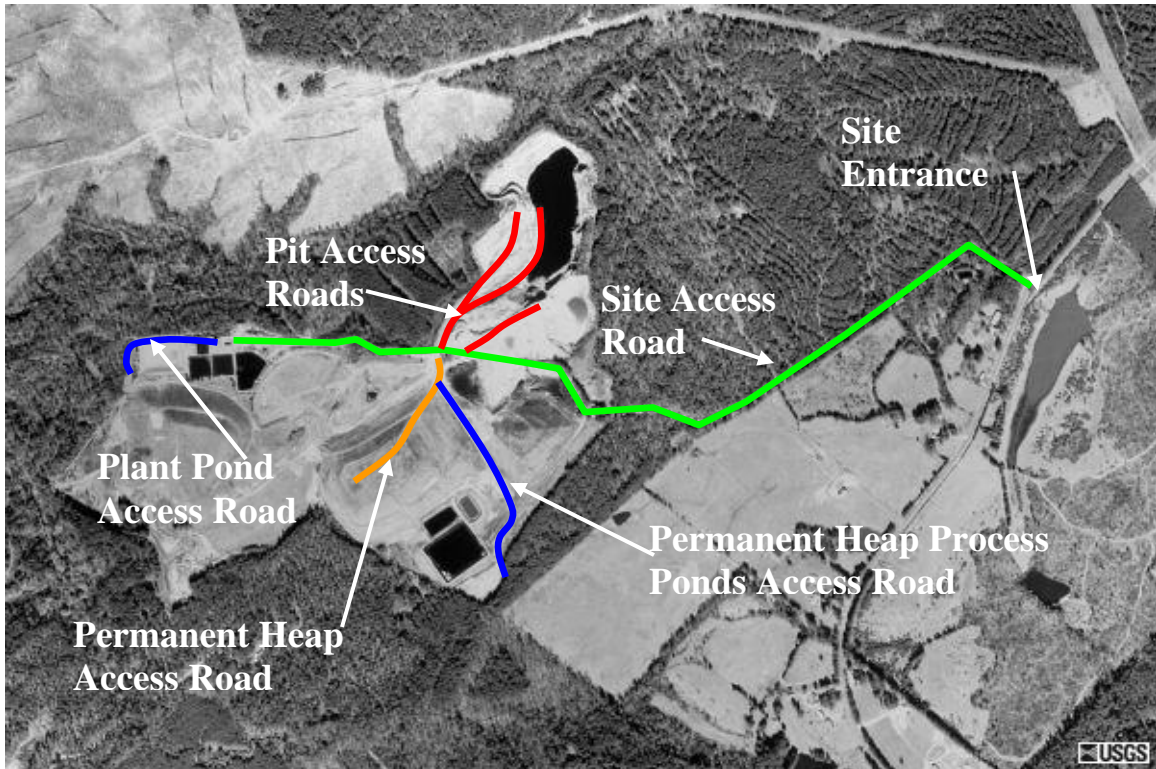
Figure 8. Aerial photograph of the Barite Hill Mine showing existing access roads.

The site access road is 20 feet wide over most of its length, but is about 30 feet wide adjacent to the mine pit. The other site roads are 10 to 12 feet wide and are being encroached by growth of the adjacent vegetation. The access road leading to the Permanent Heap Process Ponds requires trimming of the vegetation if it is to stay open to vehicle movement. Except for a very short segment of broken pavement in the site entrance where it connects to road 30, the site roads are not paved. The Permanent Heap Process Ponds Access Road is being encroached by vegetation and requires brush removal if it is to remain open. The Pit Access Roads are littered with large rocks and can not be traversed by passenger vehicles.

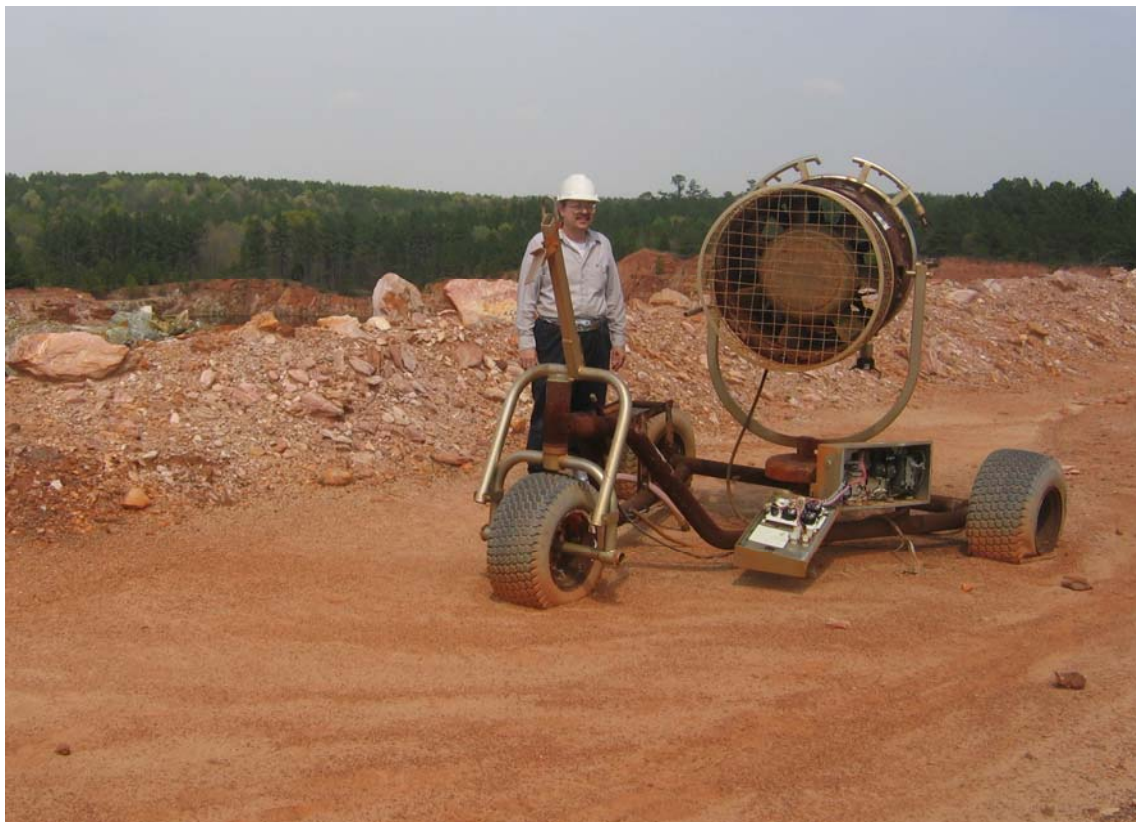
Volunteer vegetation is not seen on the south side of the pit even though the soil and rock appears to be oxidized. A snow making machine was used along the south highwall to evaporate excess water from the pit (Figure 11). The mist fallback from the device would have contaminated the ground with acid salts which would inhibit vegetation establishment for a time; but now these salts should have been flushed from the soil. It is likely that the south highwall is too far away from existing vegetation for any seed to have been deposited in this area.

Figure 11. Snow making machine on top of the south highwall was used to evaporate excess site water.

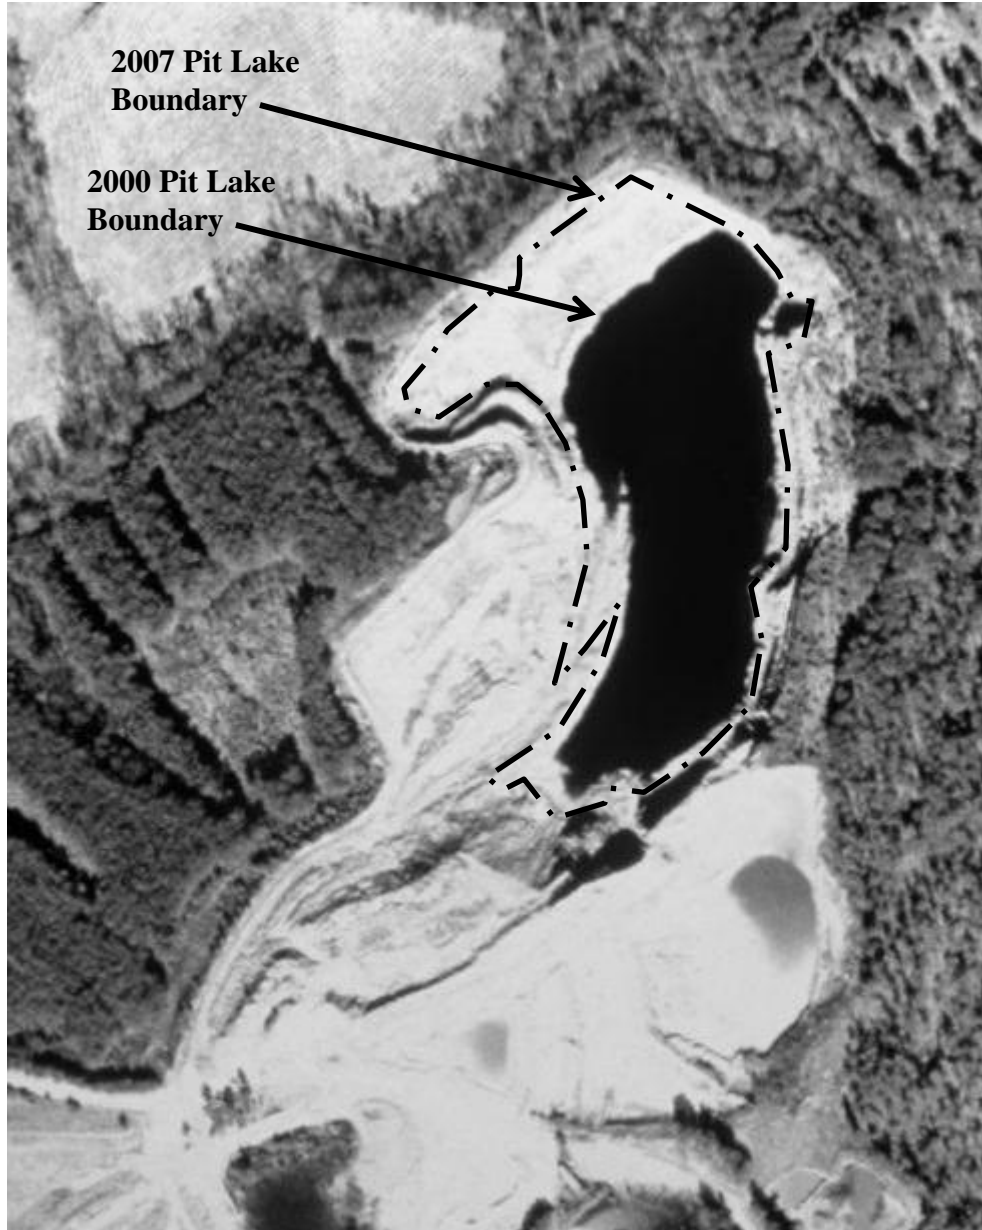
At Barite Hill the water level in the pit is presumed to have been rising since the mining activity ceased in mid-October, 1994. It is presumed that the pit began filling as soon as mining ended. There would be no incentive to keep water out of the pit after all of the ore had been extracted. The aerial photograph shown in Figure 17, shows the pit lake as it appeared in the year 2000 which would have been 6 years after the end of mining. Also, water in the pit appears to have increased up to the present time. The approximate extent of the pit lake as it currently exists has been added to the aerial photograph shown in Figure 17.

Figure 17. Aerial photograph of the Barite Hill Pit in the year 2000 showing the pit lake about 6 years after mining ended. The pit lake boundary in 2007 (about 12 years after mining ended) has been drawn onto the image.

An increase of 8.8 acre-feet of water is indicated for an average year using conservative assumptions. Note that the value for runoff (30 % of rainfall) is an assumed number. It is difficult to determine without having either several years of actual monitoring data, or by running an evaporative model. While large storms will result in up to about 70 % to 80 % runoff, smaller precipitation events will have little runoff into the pit because the dry ground surface will absorb the initial rainfall, then as rain continues some component

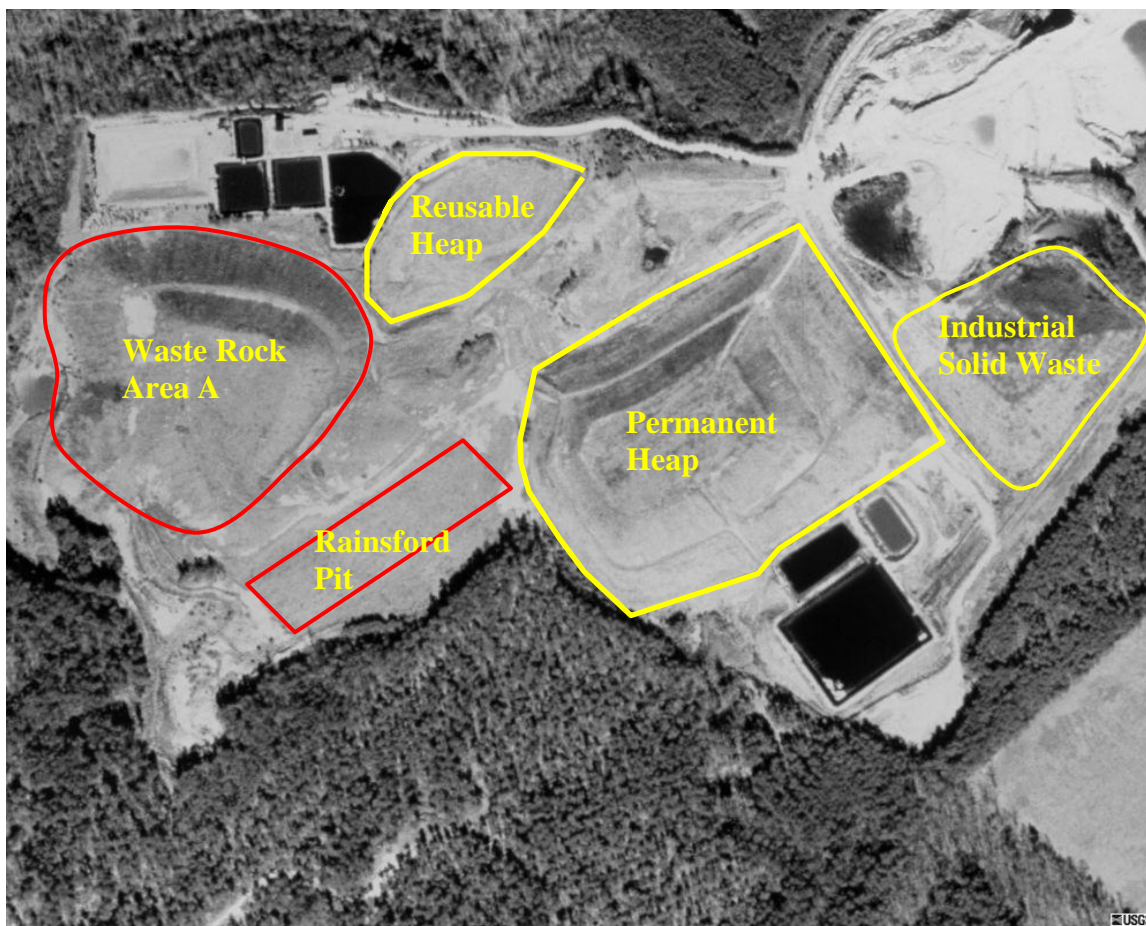
Figure 19. Aerial photograph of the Barite Hill Mine process areas showing waste rock and spent ore repositories.

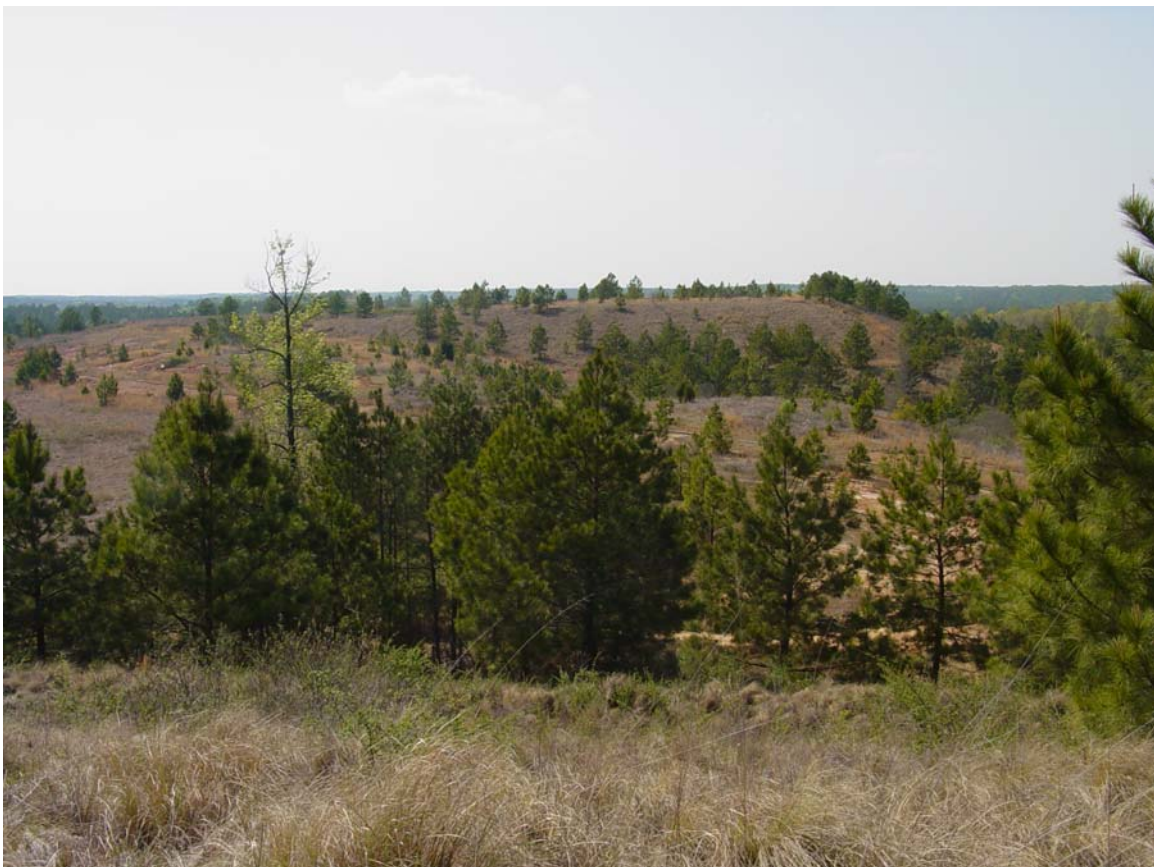
Waste Disposal Area A covers 17 acres and has been capped with clay, cover soil and is vegetated. An area of dead vegetation was observed on the north side of the repository. The cause is believed to be acid and metals toxicity, but, no active acid seep was evident. It is likely that there is a small acid seep which is active during wet conditions. The perimeter diversion ditch on the north side of the repository has eroded its channel and further upstream on the northeast side the same ditch is actively headcutting. The banks

Figure 20. Photograph of the east slope of Waste Disposal Area A which is the high ridge line in the distance. View is from the Permanent Heap Leach Pad looking to the west.

are vertical and will soon begin to erode and gully. The gully action will eventually extend from the ditch banks up into the capped area and will degrade the cap. These ditch banks must be stabilized to protect the integrity of the cap. The top, west, and south sides of the repository were not inspected. It is understood that the former “Sediment Dam A” structure built on the west side of the repository has been removed and that a small sediment pond remains which is being allowed to silt in. Downstream from this facility is a beaver pond which is capturing sediment and water flowing from this portion of the site. It is concluded that this repository is turning acidic and may become a significant source of acid seepage in the future. Acid seepage is likely to be greatest on the west side where the bedrock forms a low point. Maintaining the integrity of the cap is essential to minimize the rate of acid discharge from this repository.

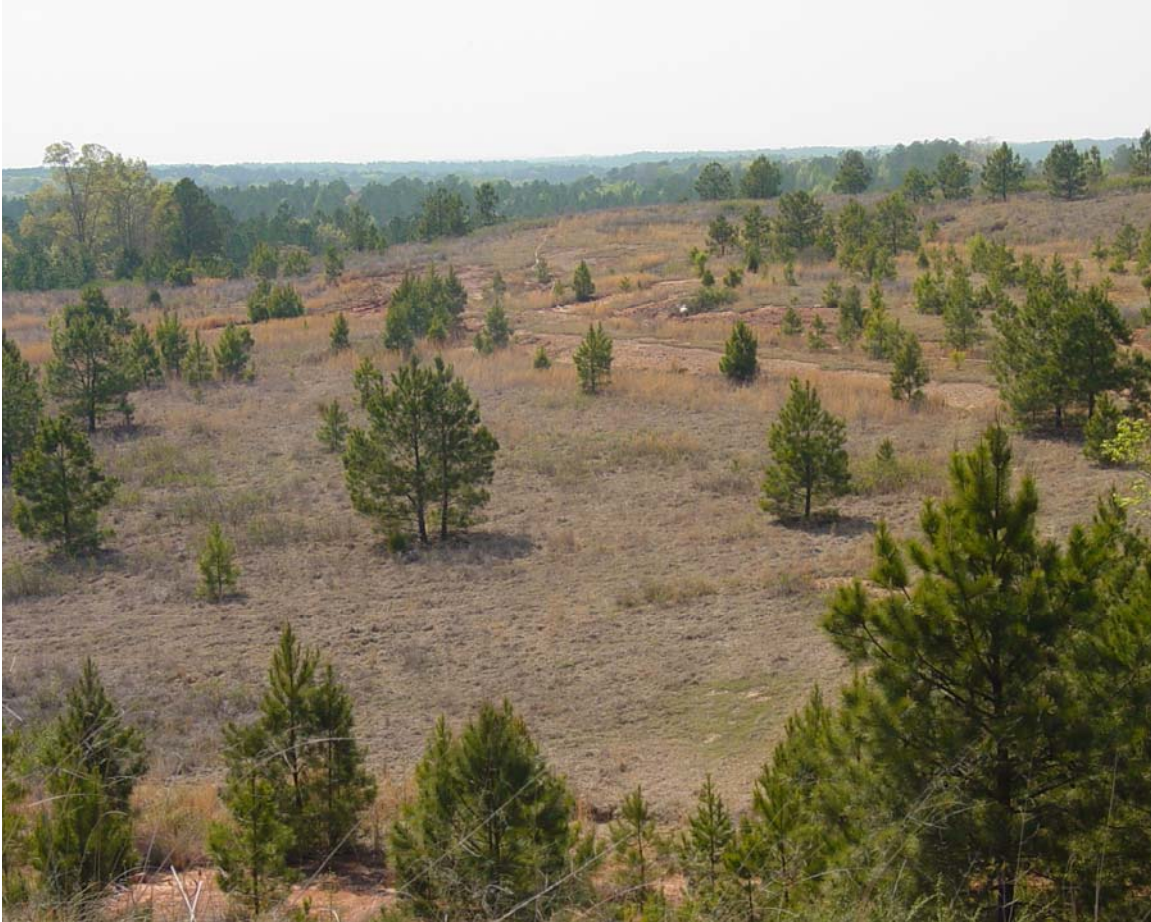
The Rainsford Pit exposed some of the most reactive sulfide rock at the site. The mining company completely backfilled this pit with waste rock and constructed a clay cap over the backfill. The south and west sides of this facility were not inspected due to time limitations. The top, north, and east sides were found to be in good condition with a well vegetated cap. There are minimal concerns regarding this part of the site at this time; however, it is expected that portions of the fill above the water table will turn acid if they have not already done so.

Figure 22. Photograph taken from the top of the Permanent Pad looking to the southwest at the Rainsford Pit area (the flat area in the lower 2/3 of the photograph).

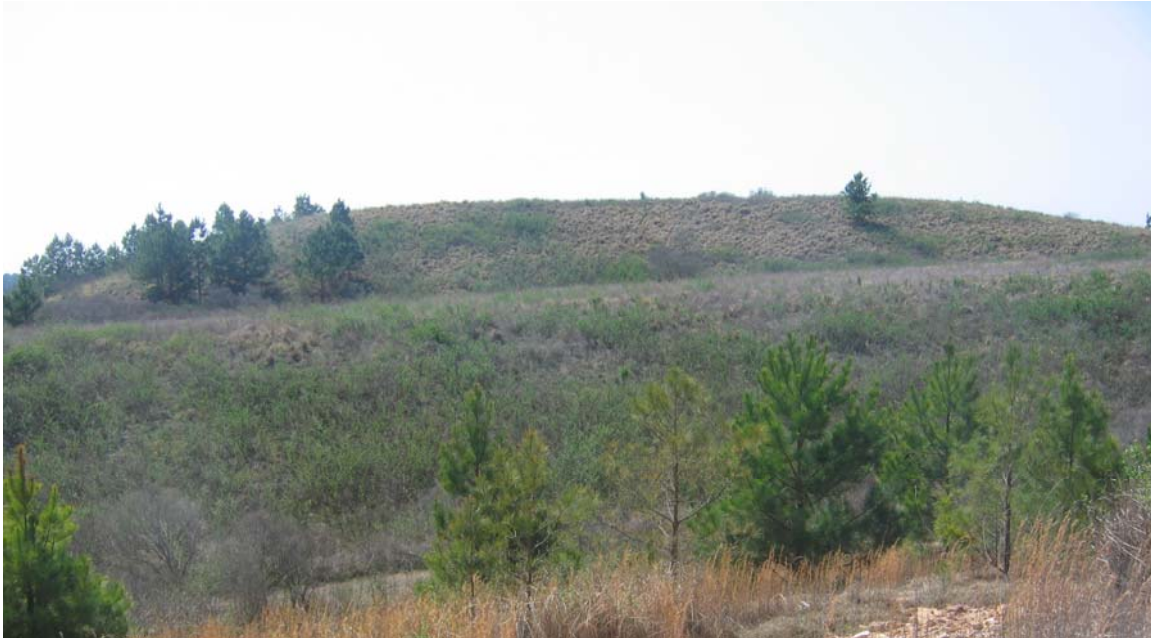
Figure 27. Photograph of the east slope of the Permanent Heap Leach Pad.

Seepage from the liner drains to the south and discharges through geomembrane-lined troughs into the Permanent Heap Pregnant Pond and the Permanent Heap Rinse Pond. The seepage is acidic and likely has clogged the lower flow pathways. New acid seeps have formed along the south toe of the pad as seen in Figures 27 and 28. Other problems with this facility are ruts on the cap due to trespass ATV use, and erosion of the south side down chute. The down chute is a steeply inclined ditch which takes clean storm water from the mid-slope berm down to the base of the slope for discharge to receiving waterways. The bedding under the riprap has eroded out and caused the riprap to be dislodged. Erosion is cutting into the cap. On the northwest side of the facility is a second down chute. This chute is less steep but is constructed from acid fill so it is partly barren of vegetation and is likely a source of acid runoff. The disturbed areas lead to increased infiltration and acid generation.

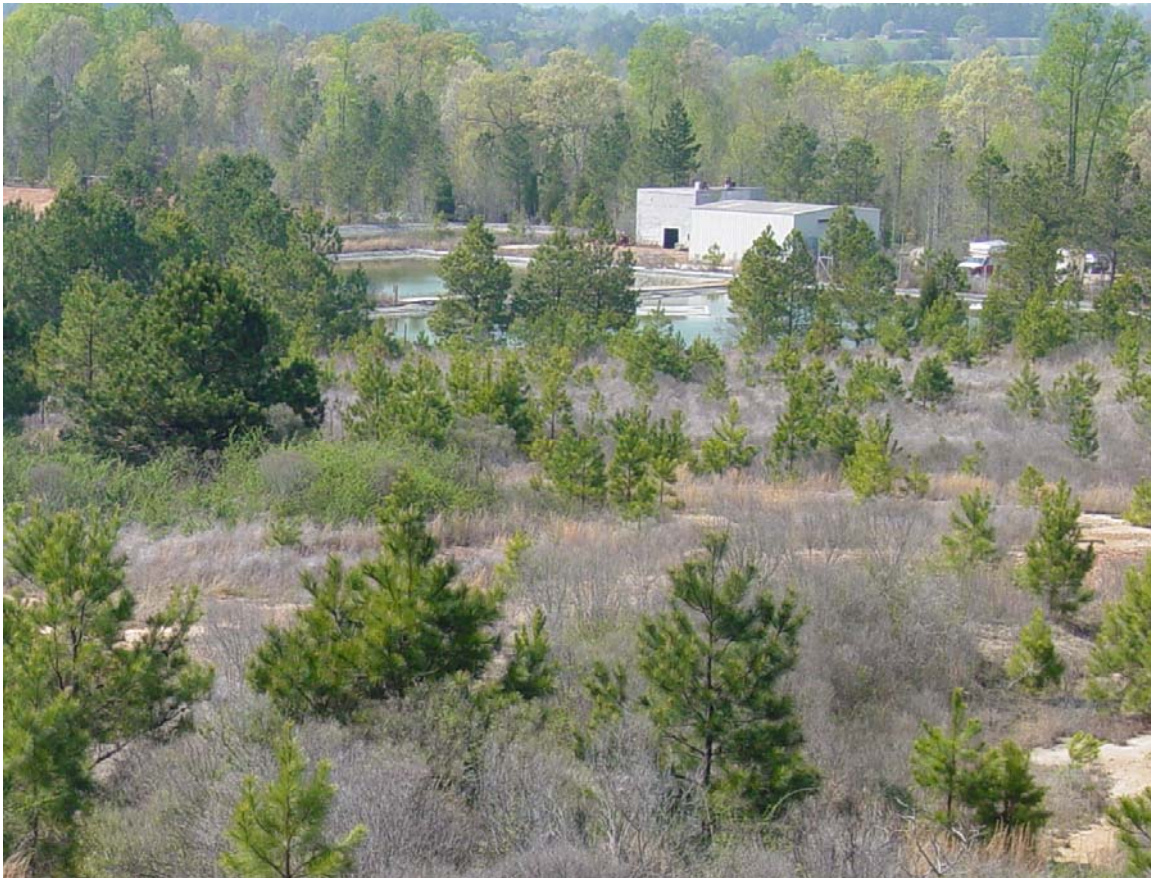
The Reusable Heap Leach Pad was constructed with an asphalt liner. It covers an area of approximately 6 acres. It appears that about 15 feet of spent ore was left on the pad. The area has been capped and the vegetation is in good condition except for one small seep on the northeast edge which has killed vegetation and caused a small amount of erosion. This problem is not significant enough to warrant any other action than monitoring.

Figure 32. Photograph of the reclaimed Reusable Heap Leach Pad. Disturbed areas at right are rock outcrops which are just outside the limits of the pad.

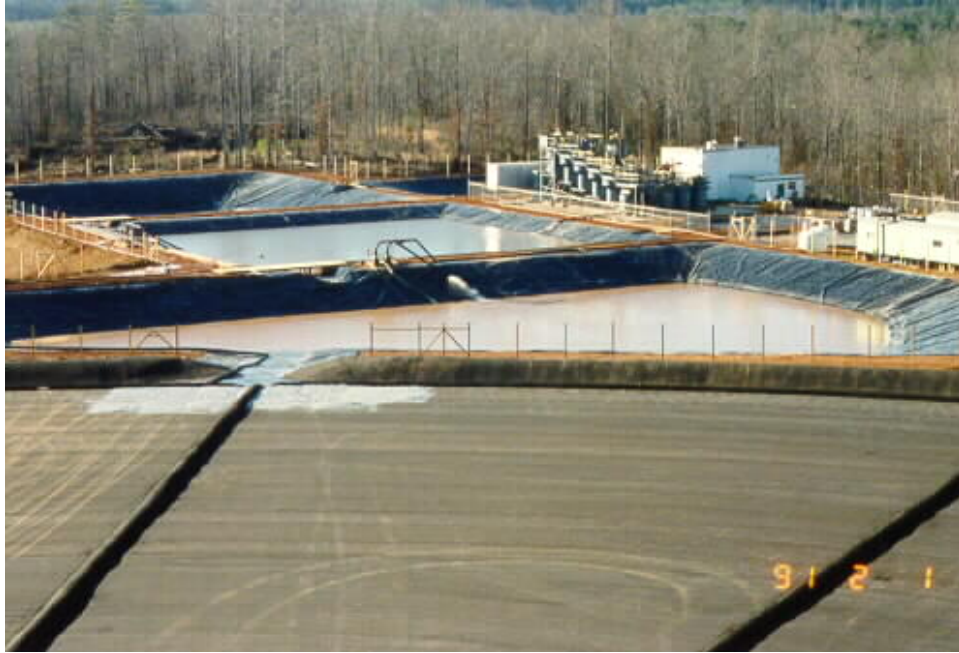
Figure 33. Photograph showing the Reusable Leach Pad (lower half of photograph) at the Barite Hill mine prior to ore placement in 1991 (From the Scotia International Website). Note how the pad is designed to discharge cyanide solution seepage to the Plant Pregnant Pond.

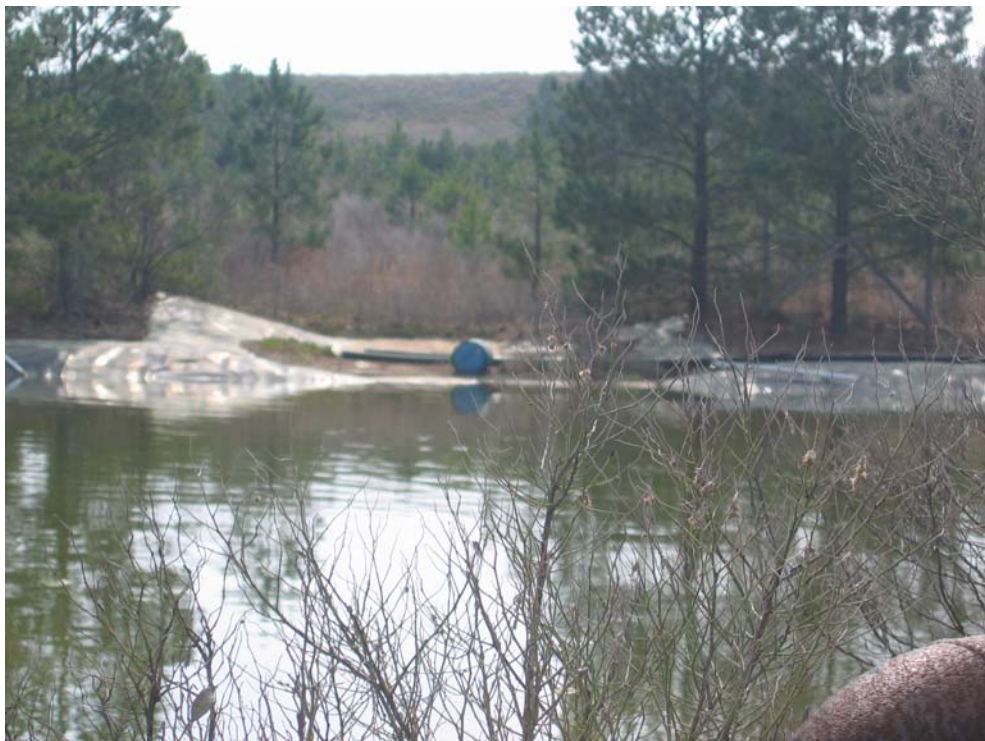
Figure 34. Photograph looking across the Plant Pregnant Pond showing the geomembrane-covered seepage outlet from the Reusable Heap Leach Pad.

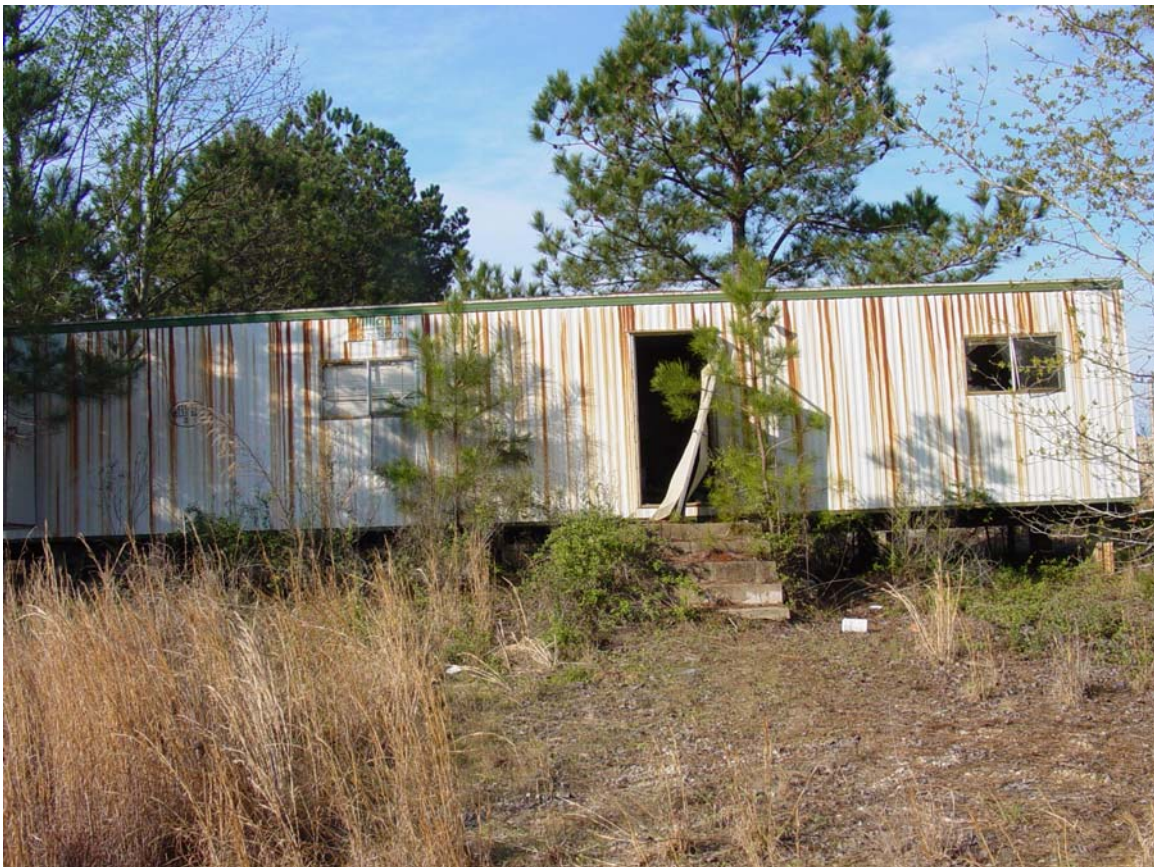
The mine office is a modular trailer 12 feet by 56 feet long. There is an air conditioning unit on one end of the building. An ice chest, typical of that seen at grocery stores lies outside behind the building (potential for entrapment). The office building has broken windows and inside much of the furniture has been broken, turned upside down and papers scattered about. It appears that this is the work of trespassers. Despite the trespass damage and disarray, the project records were found inside the building. The land ownership files were found and given to Mr. Francendesce. Technical reports and relevant project maps were removed by the Bureau of Reclamation. The recovered reports are listed in the references section of this report, and key project maps have been copied and are included in Appendix A. Time did not allow for all project records and maps to be examined, about 3 hours were spent in the building. There may still be valuable records present that should be gone through.

Figure 35. The mine office is a modular building structure.

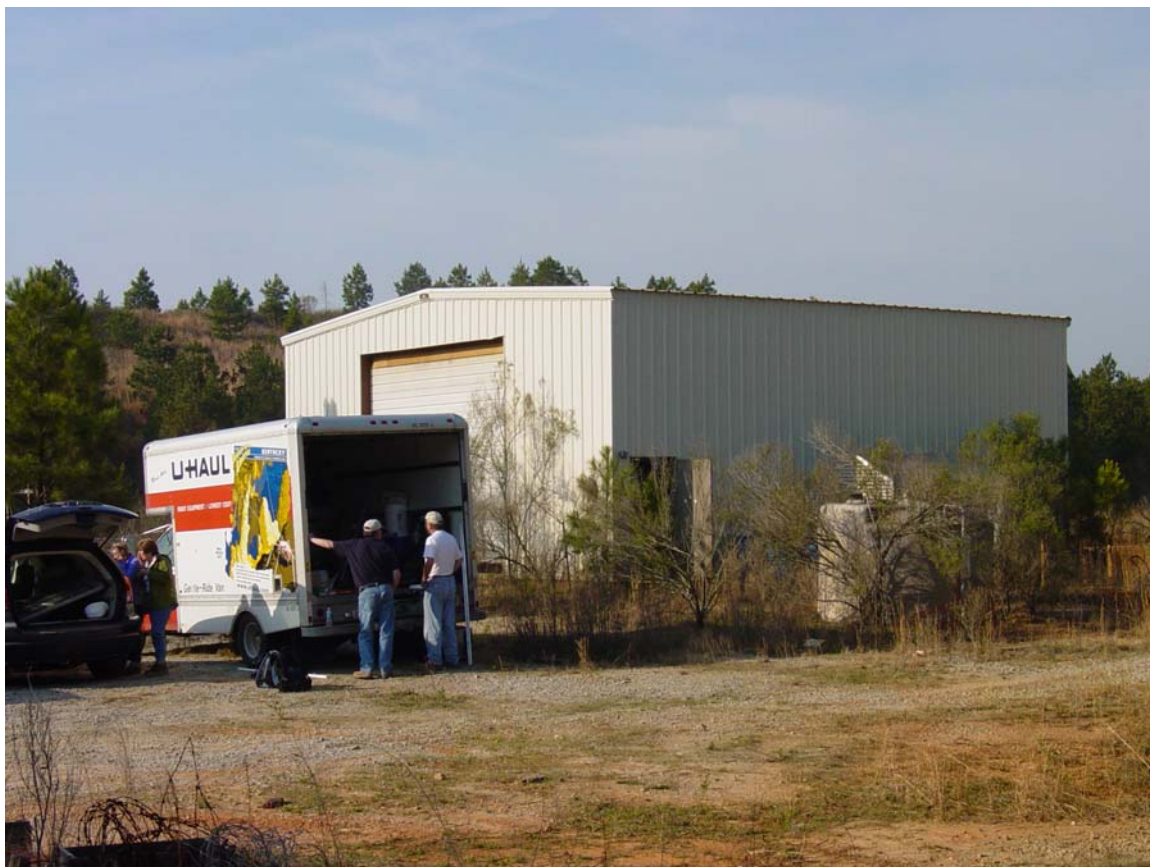
The Water Treatment Plant is a steel (column and beam) structure. It is insulated and sheathed with metal siding and has a metal roof. The garage door is damaged and inoperable. Inside the building were two wood pallets containing both opened and unopened bags of caustic soda. Liquid acid and caustic solutions were stored nearby in tanks outside of the building. These chemicals were disposed of during the initial Emergency Response by EPA.

Figure 36. Water Treatment Plant structure contained a 25 gpm treatment system for treating process waters and landfill leachate to meet discharge standards.

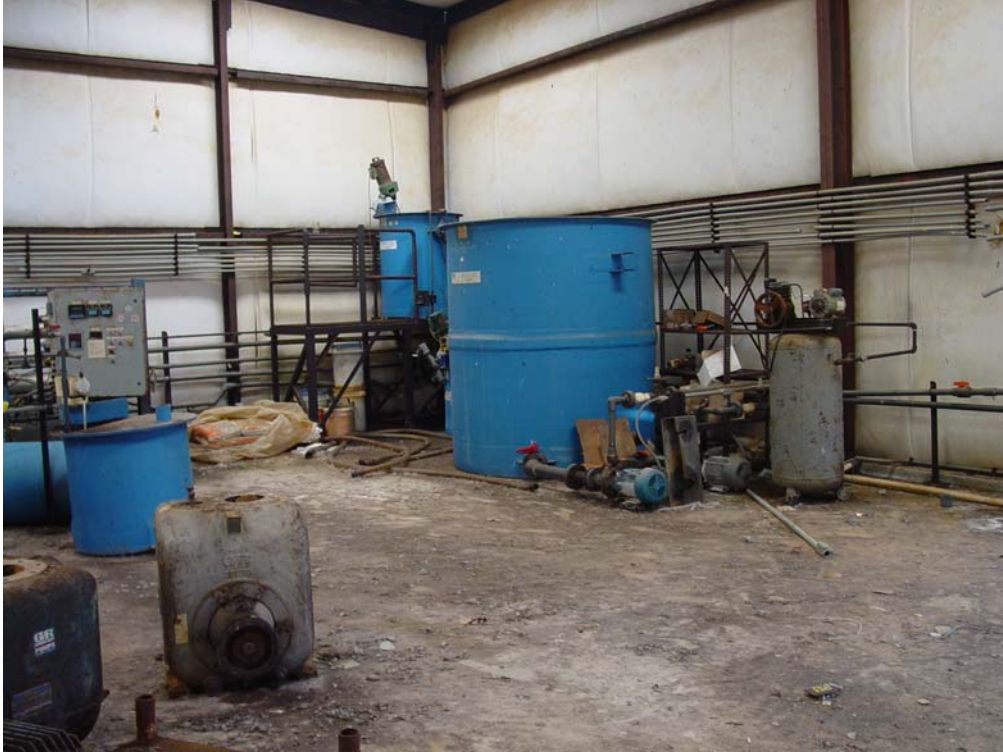
Figure 37. View of tankage and motors remaining inside the partially dismantled Water Treatment Plant.

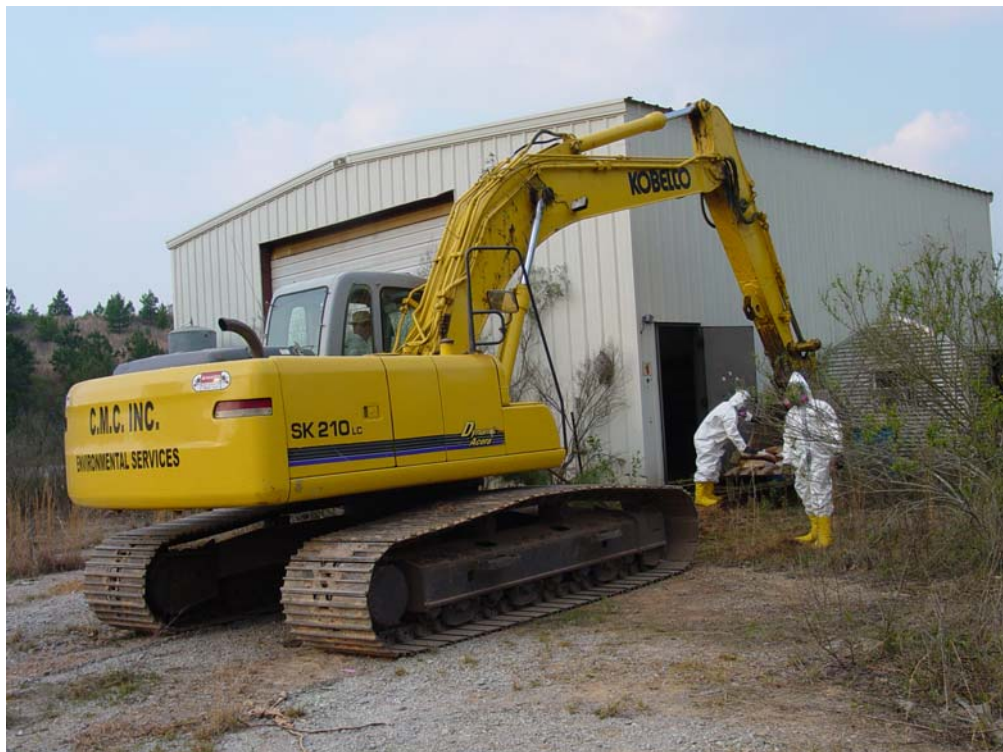
Figure 38. Workers removing sacks of sodium hydroxide from the Water Treatment Plant as part of the Emergency Response.

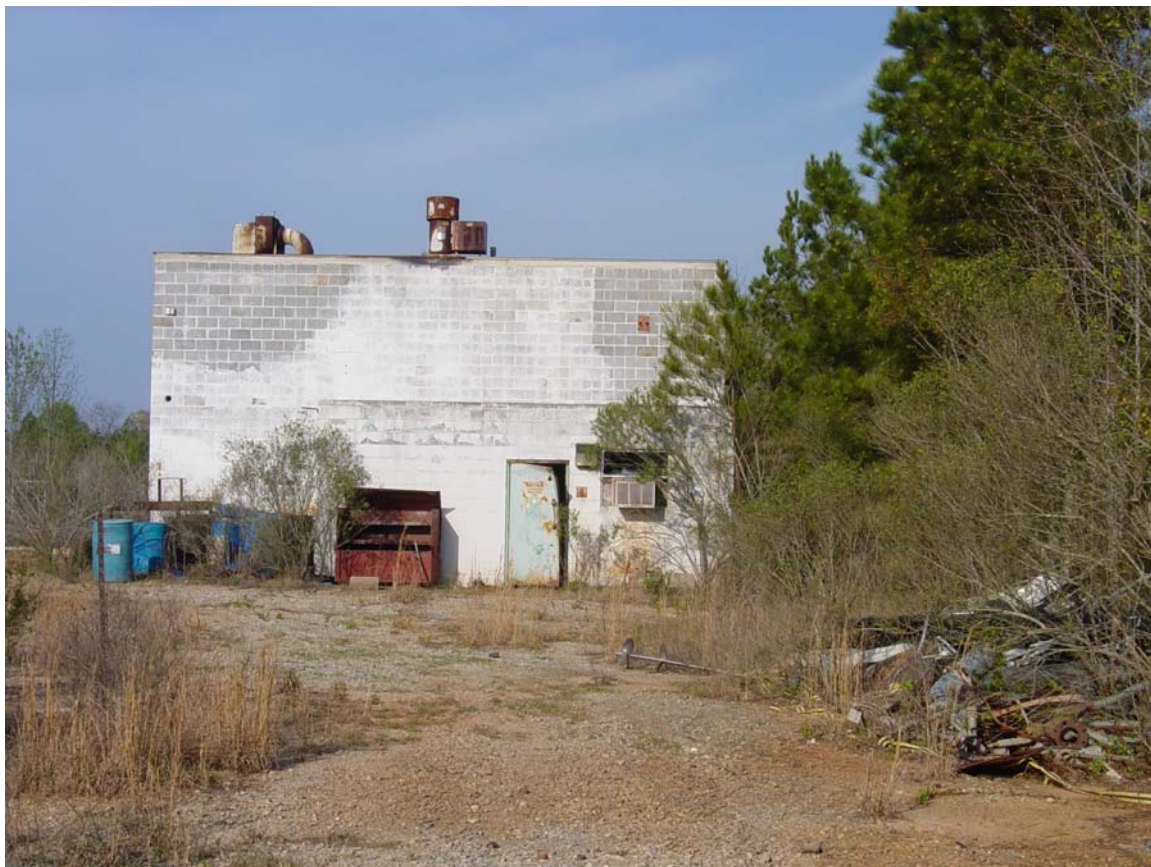
Figure 39. The gold assay and melting furnace building. Note fume ventilation system components on the roof.

Fire assaying was performed to distinguish ore from lower grade rock which is considered waste. The fire assay method utilizes litharge (lead oxide) to gather gold and silver from pulverized ore and form a metallic bead. Fumes from the assaying process contain heavy metals. Lead, and metals in the ore such as bismuth and selenium volatilize during the melting process and are gathered by the fume capture systems and are vented. Over time these ventilation systems become contaminated with a build up of heavy metal oxide dusts. These ventilation systems are considered to be hazardous material because of the potential for acute heavy metals poisoning.

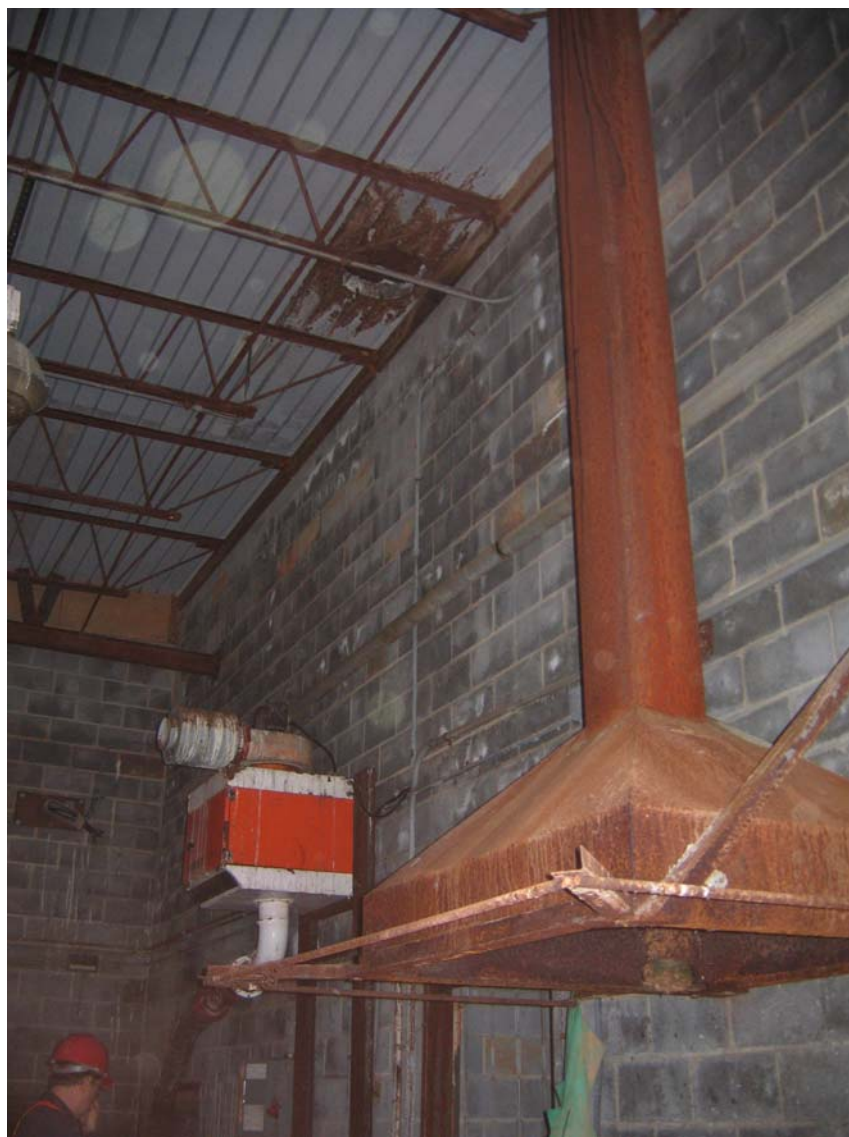
Figure 40. Two fume ventilation systems used for the fire assay process. At left is a portion of the fume ventilation system for the small melting/assay furnace, at right is the fire assay acid fume hood and ventilation duct leading to the roof.

Three separate ventilating systems were found in the building. Two appear to be a part of the assaying operation (Figure 40), the third system was associated with the gold and silver production (Figure 41). All of the ventilation systems have the potential to contain heavy metal oxide flue dust. Contamination was evident in the assay systems, no attempt was made to open the larger production ventilation system. A small assay/melting furnace was on the ground just outside the building. The vent opening at the top of the small furnace also appeared to be coated with metal oxides.

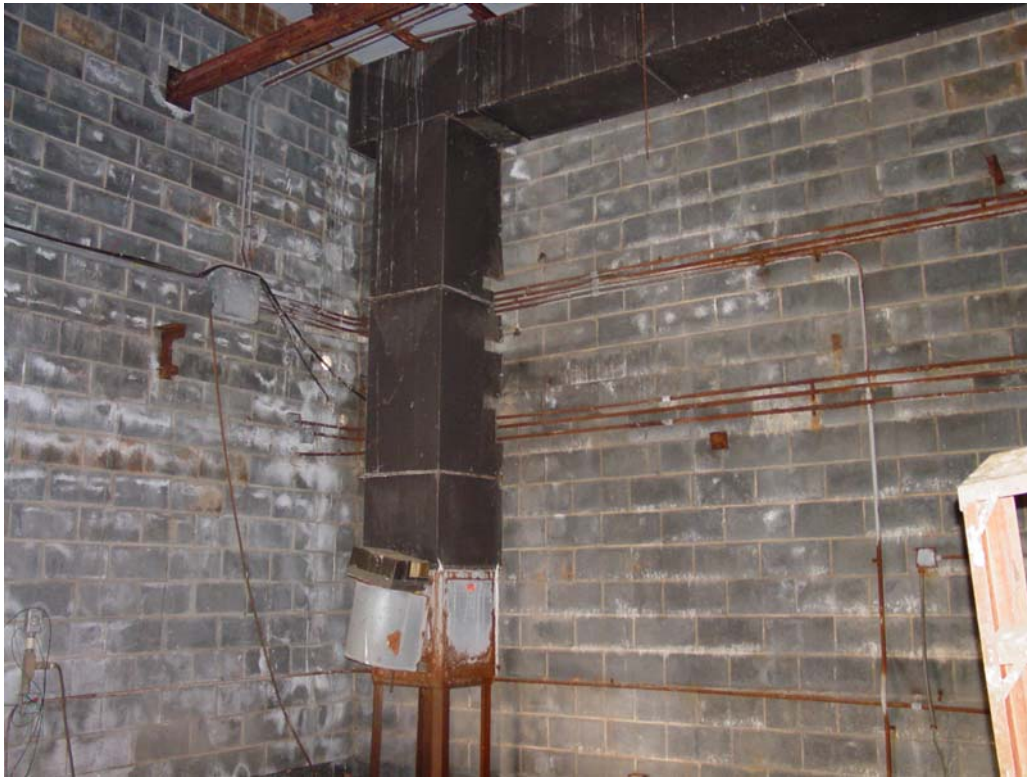
Figure 41. Ducting for large fume ventilation system used during gold production.

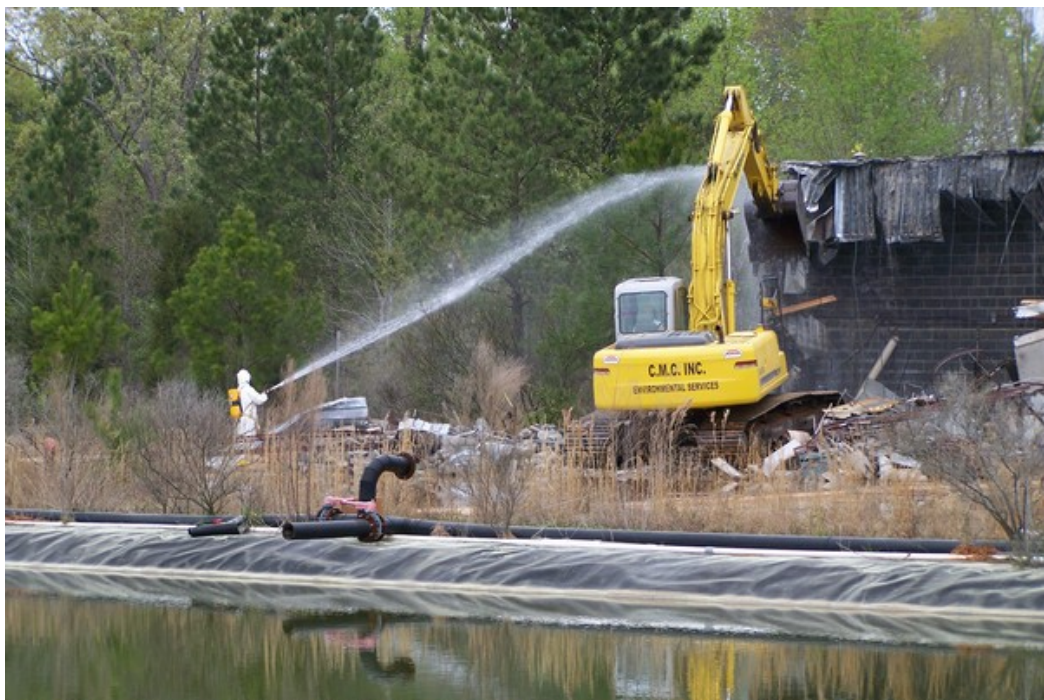
Figure 42. Demolition of the Gold Assay and Melting Furnace Building on March 30, 2007 as part of the Emergency Response.
