Site Features Inventory Report

Barite Hill Mine McCormick, South Carolina

Prepared By: Michael Gobla, P.E.

July 2007

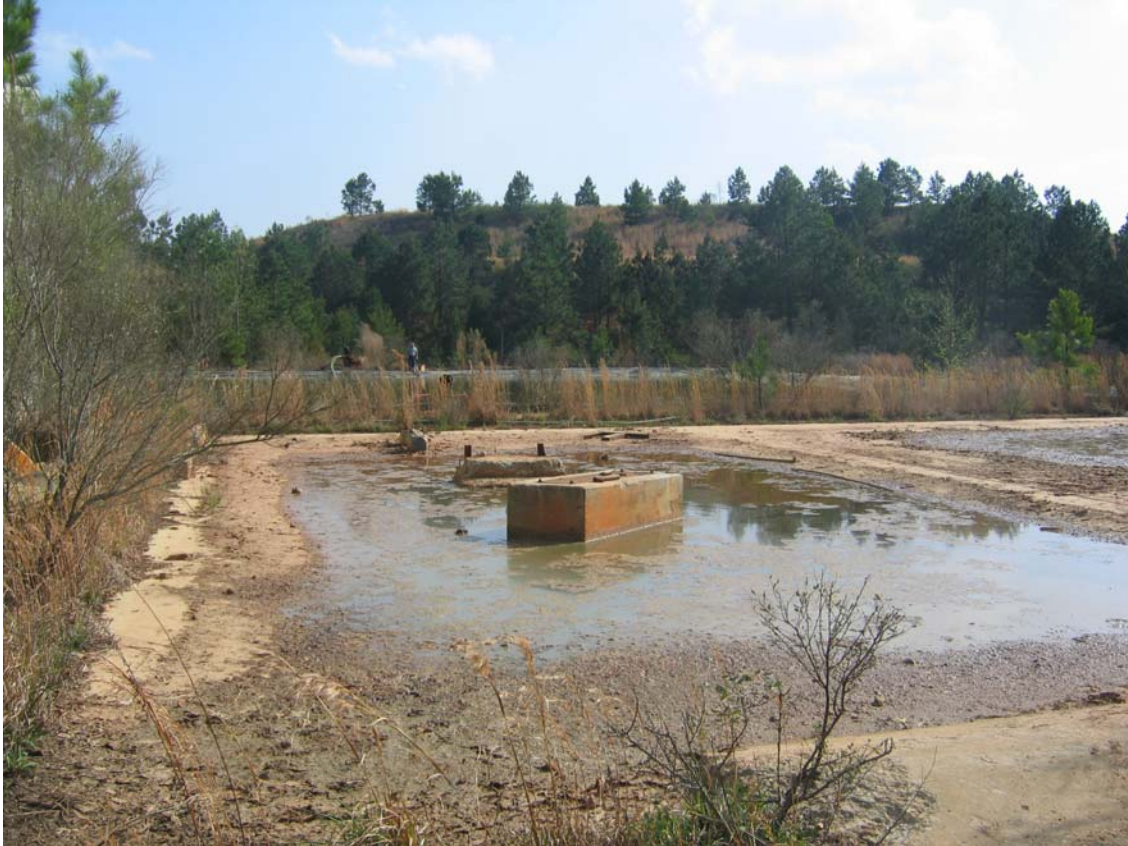
At present, only the foundations for the Process Plant remain. As can be seen in the accompanying photograph, the foundation included a concrete slab with bermed edges for spill containment. This containment would have overflowed to the adjacent process ponds in the event of a large spill. No significant issues are associated with these foundations.

Figure 44. Photograph of the foundations remaining at the Process Plant area.

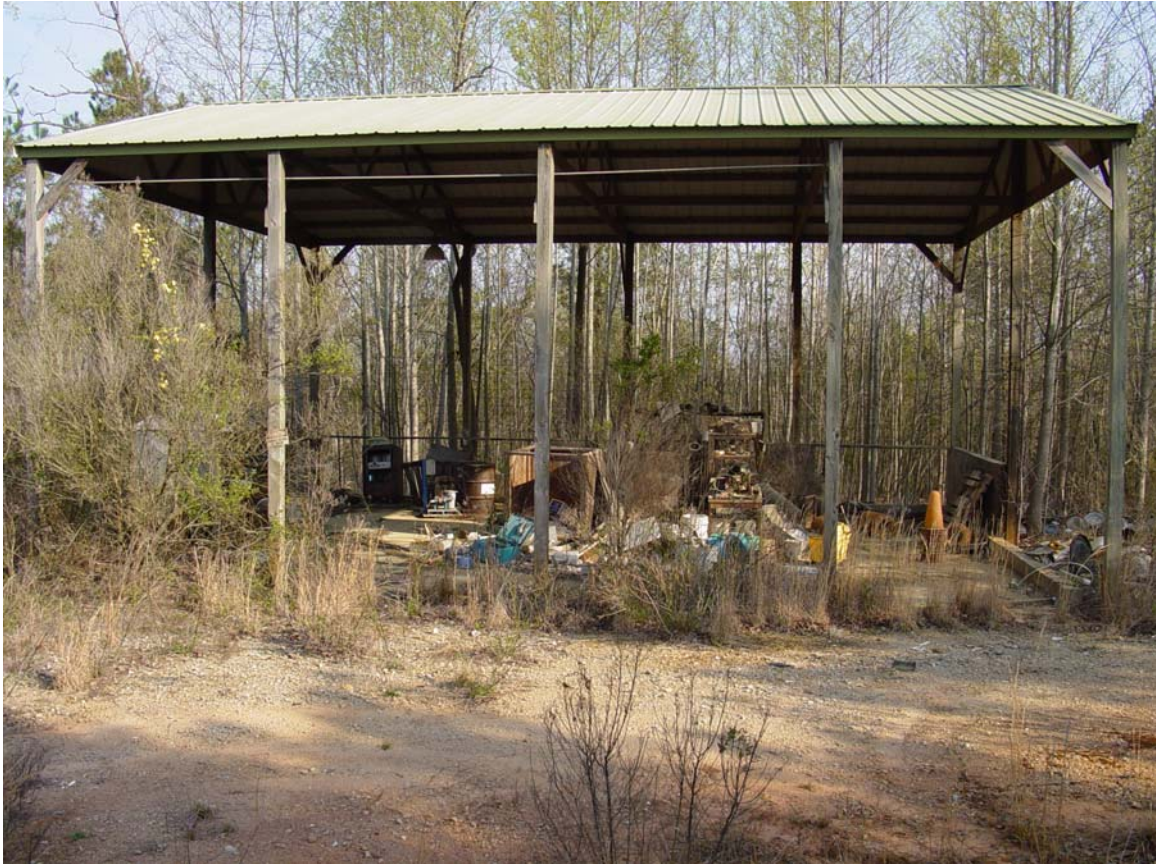
This structure was used to store materials during site operations. At present there is a variety of inert debris including a 55-gallon drum filled with steel wool, broken glass, plastic, and cardboard. Several sacks of cement are present, but exposure to the elements has hydrated them. A 55-gallon drum labeled “Methyl-ethyl Keytone” was sampled by others for analysis.

Figure 45. The Pole Barn storage shed facility.

There are many boards with protruding nails on the ground in and adjacent to the Pole Barn. The wood, glass, and other inert debris should be disposed of.

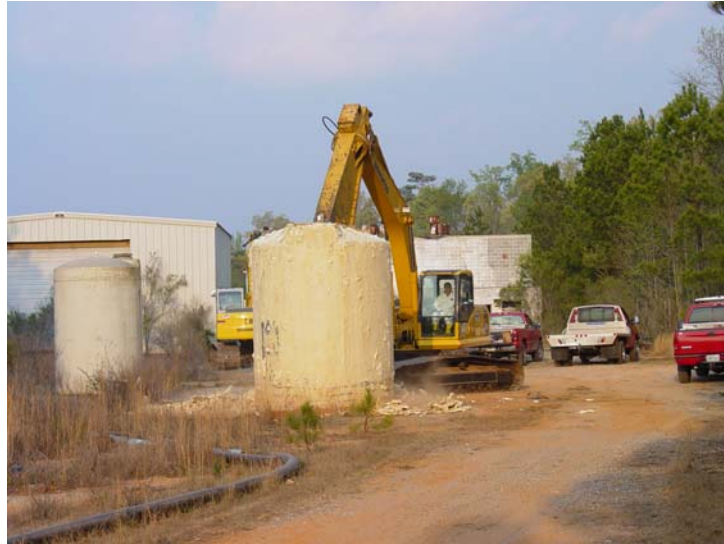
Four polyethylene tanks associated with the gold processing system were found at the site. Three of these tanks were outside in the process area. One containing a caustic solution and one containing acid were identified. Both of these tanks were taken to the mine pit, cut open and their contents emptied into the contaminated water in the pit for disposal. Liquid in a 1,500 gallon polyethylene tank next to the Permanent Heap Barren Pond was sampled by others and is pending analysis. This tank would have contained cyanide solution used to recharge the barren fluid for additional leaching.

Figure 46. Removing foam insulation from the 3,000 gallon tank containing caustic prior to taking it to the pit. Another tank is seen to the left.

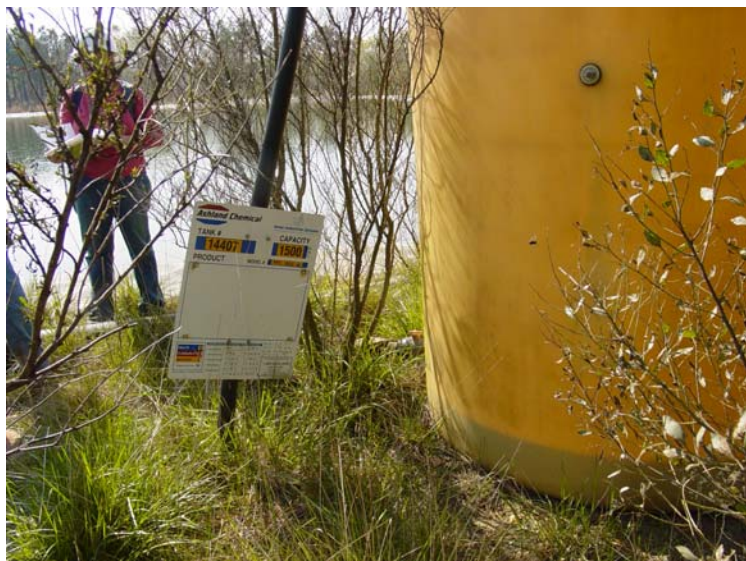
Figure 47. Tank next to the Permanent Heap Barren Pond was used for make up cyanide solution. The fluid was sampled for analysis by others.

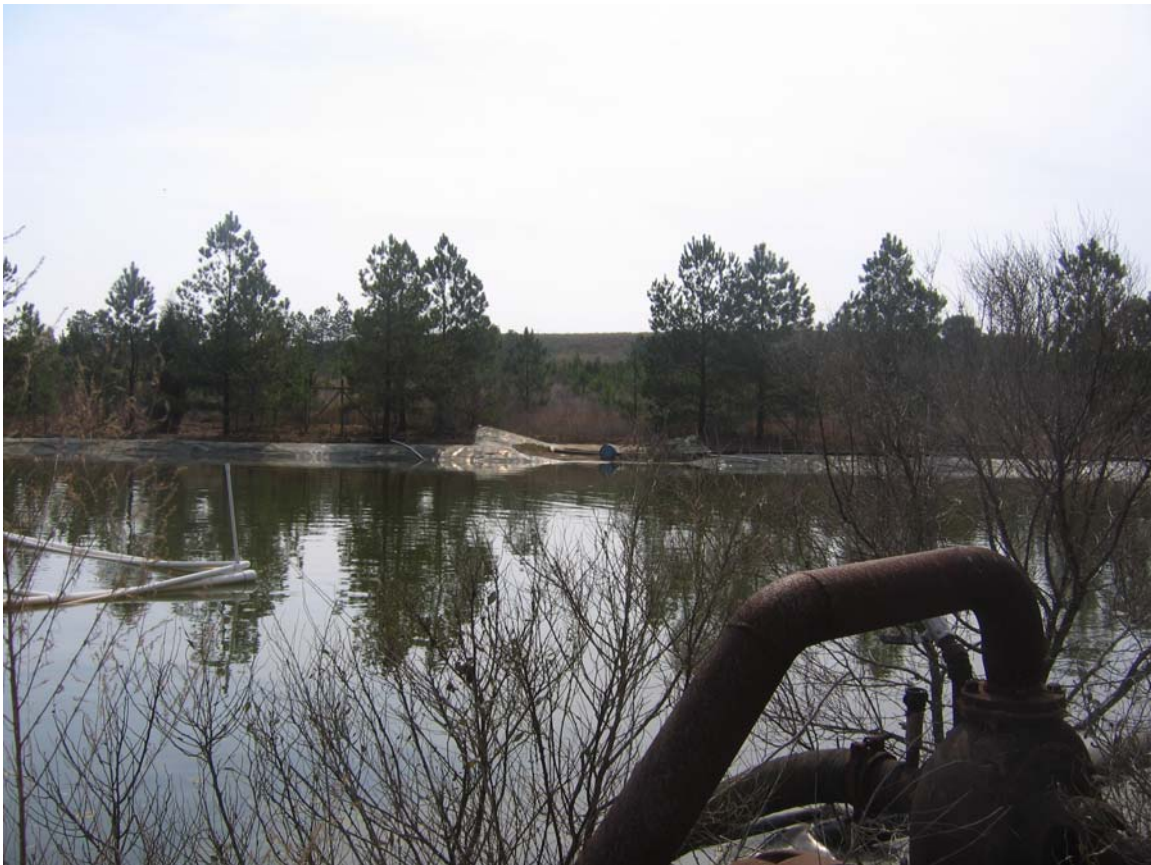
This pond was designed to capture and store seepage discharge (pregnant cyanide solution) from the reusable heap-leach pad. The pregnant solution contained dissolved gold, silver, copper, and other metals. The solution in the pond has a pH of 9.3 standard units. The pond is sized to contain a volume of 1.37 million gallons

Figure 51. Photograph of the Process Plant Pregnant Pond. The view across the pond shows the seepage inflow area from the Reusable Heap-Leach Pad. An electric pump can be seen at lower right.

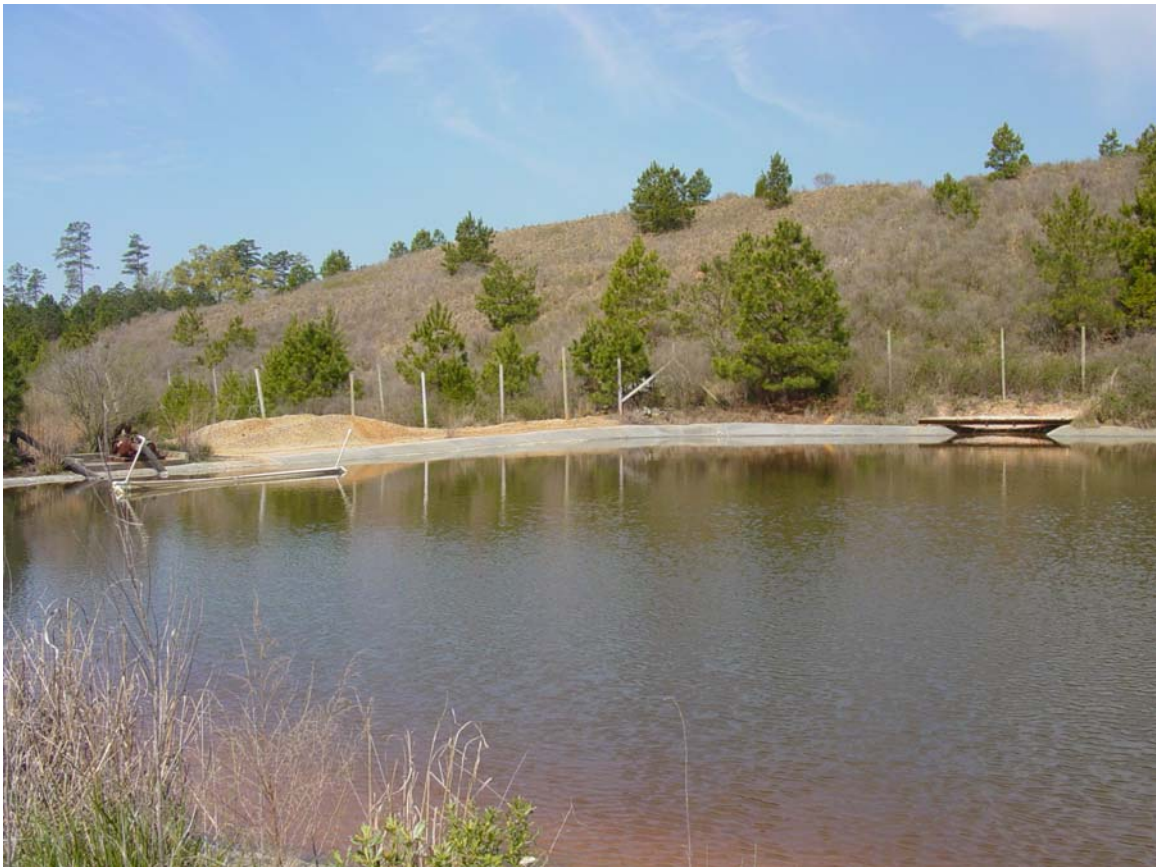
Labeled as a Pregnant / Rinse Pond on design drawings, the Permanent Heap Pregnant Pond was constructed in the fall of 1992 (Westec, 1992). The pond has a 30-mil-thick PVC bottom liner and a 40-mil-thick UV resistant PVC upper liner. Between these two liners is a geonet drain leading to a gravel-filled leak detection sump. An 8-inch diameter PVC perforated drain pipe is placed in the sump and it is accessed by connection to a solid PVC pipe riser which penetrates the liners and is attached to them using boots. The fill around this pond appears to be acidic spent ore. Sampling by others indicates that the leak detection sump contains water with 30,000 ppb (30 ppm) cyanide and it needs to be neutralized.

Figure 58. Photograph of the Permanent Heap Pregnant Pond looking towards the west. The southwest portion of the capped and reclaimed Permanent Heap forms the hillside in the background of the photograph. Note the small pile of acidic material adjacent to the pump station on the left side of the photograph.

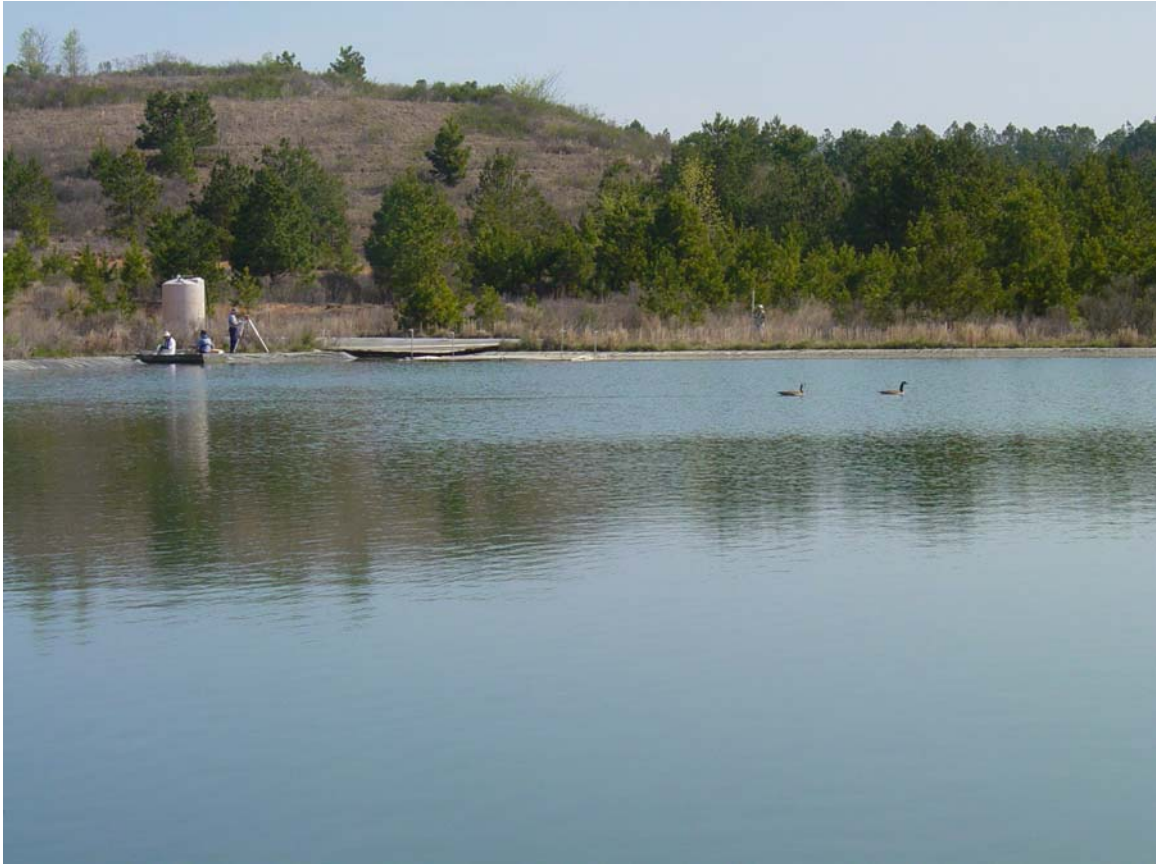
Constructed in January 1992, this pond covers nearly 2.5 acres. It has a capacity of 5,500,000 gallons. Originally used to contain barren solution, this pond receives seepage flows from the Landfill Repository via a buried drainage pipeline. The pond is full and it will likely turn acid in the future.

Figure 60. Permanent Pad Barren Pond is the largest of the lined impoundments. The Canadian Geese had a nest on the side of the pond which contained two eggs.

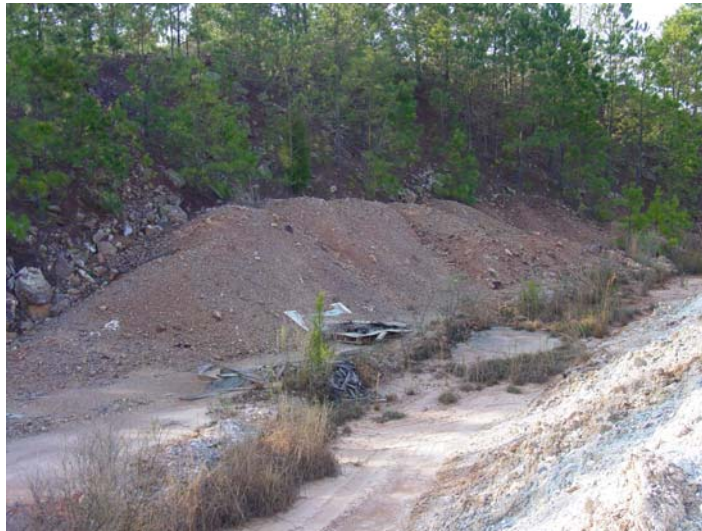
During site operations there were two areas used for topsoil storage. The western most area was reclaimed. The remaining Topsoil Stockpile Area is located just south of the Barite Hill Pit. There is a very small amount of topsoil remaining in this area (about 20 cubic yards). A much larger stockpile (several thousand cubic yards) of slaked lime remains on hand in this area. The slaked lime was used as a soil amendment and to neutralize the water in the mine pit. This is a valuable resource which can be used for further site remediation.

Figure 61. Small pile of topsoil remaining in the Topsoil Stockpile Area.

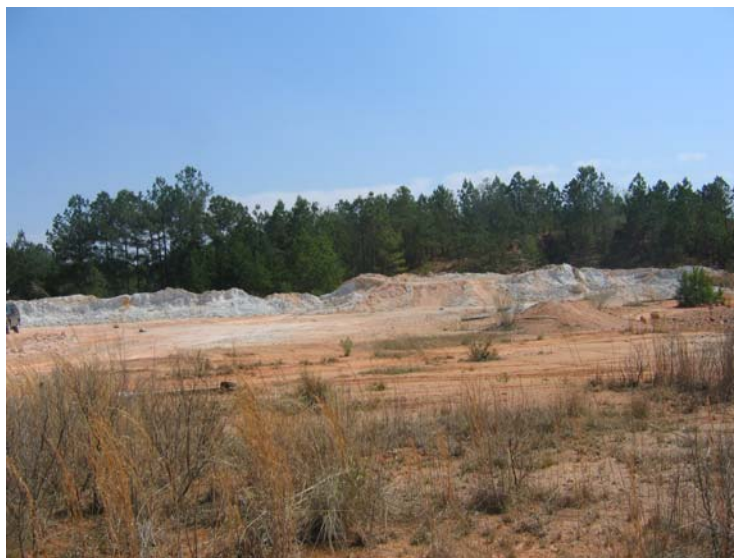
Figure 62. Slaked lime stockpile is a valuable resource.

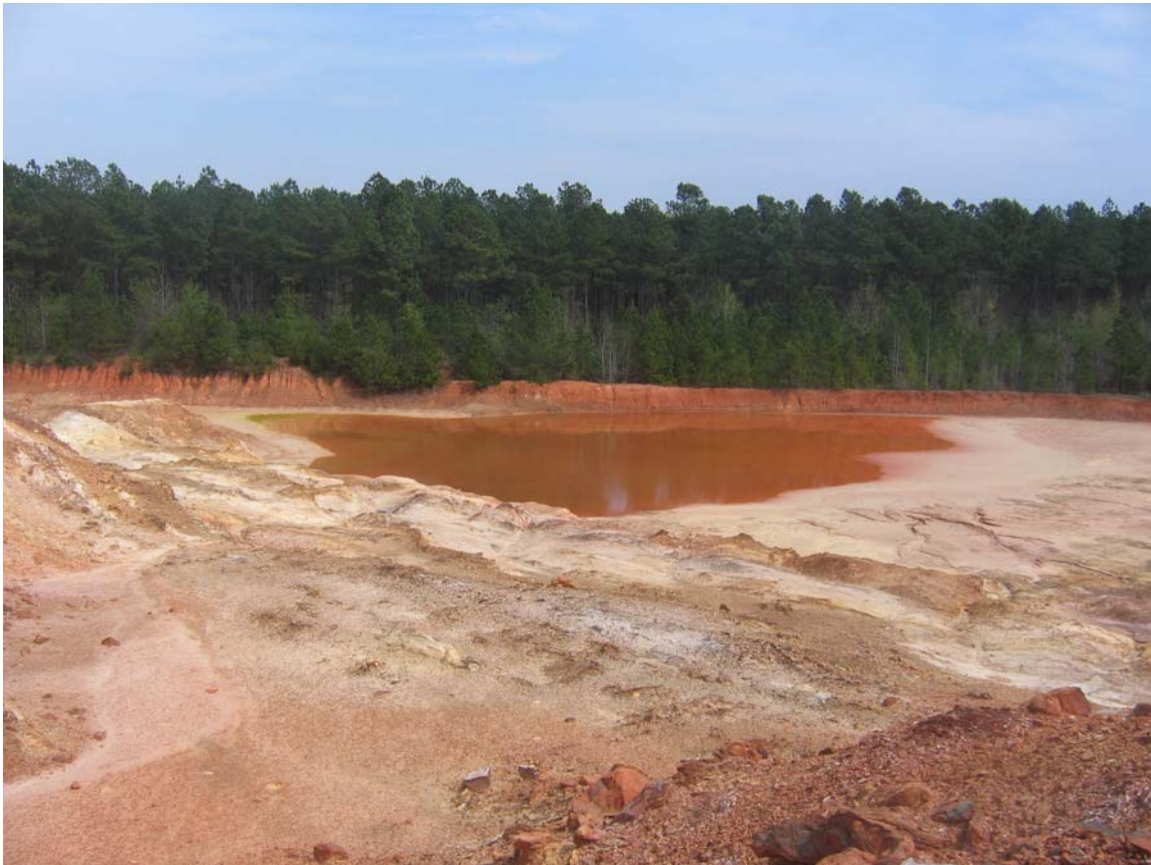
The Clay Soil Borrow Pit is an area of the site from which clay was removed for use in constructing the clay caps over the waste rock and spent ore repositories. This pit does not have any drainage outlet, so water ponds in the area and slowly seeps into the ground. It is possible that this seepage is flowing into the adjacent Barite Hill Pit. This area needs to be reclaimed. No drawings were found for this area. The disturbance is roughly estimated to be 4 acres in size.

Figure 63. Photograph of the Clay Soil Borrow Pit.

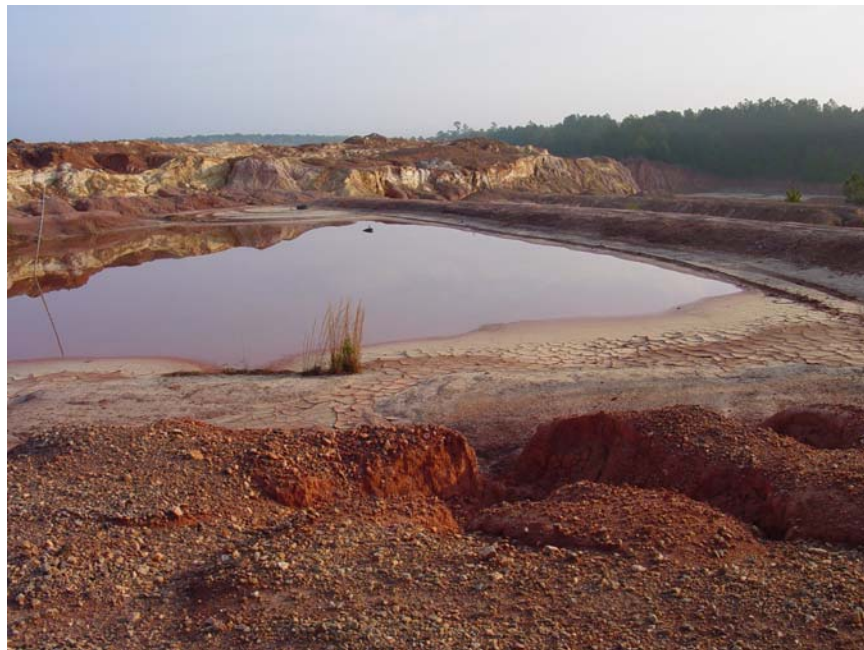
The sediment pond is located in a area of 1.9 acres of disturbance. It includes a fill embankment which retains the reservoir. The embankment has no spillway. What appears to be good quality water is impounded behind the embankment. This pond is of more value for the water it captures and stores than its function as a sediment control feature. The water can be used for dust control and washing down equipment used in site reclamation work.

Figure 66. Sediment Pond located south of the Barite Hill Pit.

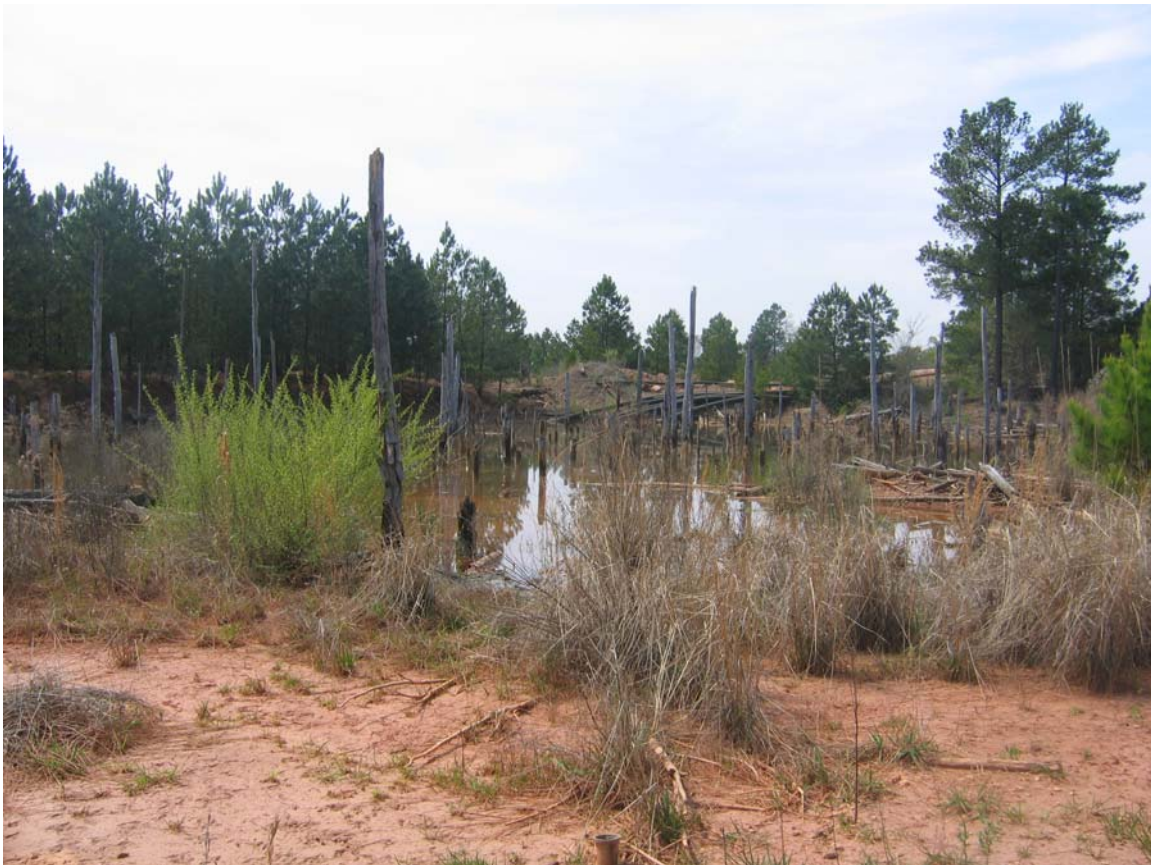
It is also noted that a wetland and pond has formed to the north of the Landfill as a result of the placement of the access ramp and the Solid Waste Landfill cutting off the former surface drainage route. What relation the water in the wetlands has to the Landfill is not known but should be further considered. Again a survey of the water elevation in the wetlands and its new spill point is needed and should be compared to the Landfill drawings to see if it is possible for this water to enter the facility.

Two wetlands/pond areas have formed on the site. One area which appears to be a pond with wetland vegetation is northeast of the former crusher area. The other area is more of a pond which formed as a result of the access ramp being constructed to the Industrial Solid Waste Landfill. This area is on the northwest side of the landfill. It is not known if the water from this ponding is affecting the landfill and it needs further evaluation.

Figure 67. Ponding area adjacent to the Industrial Solid Waste Landfill.

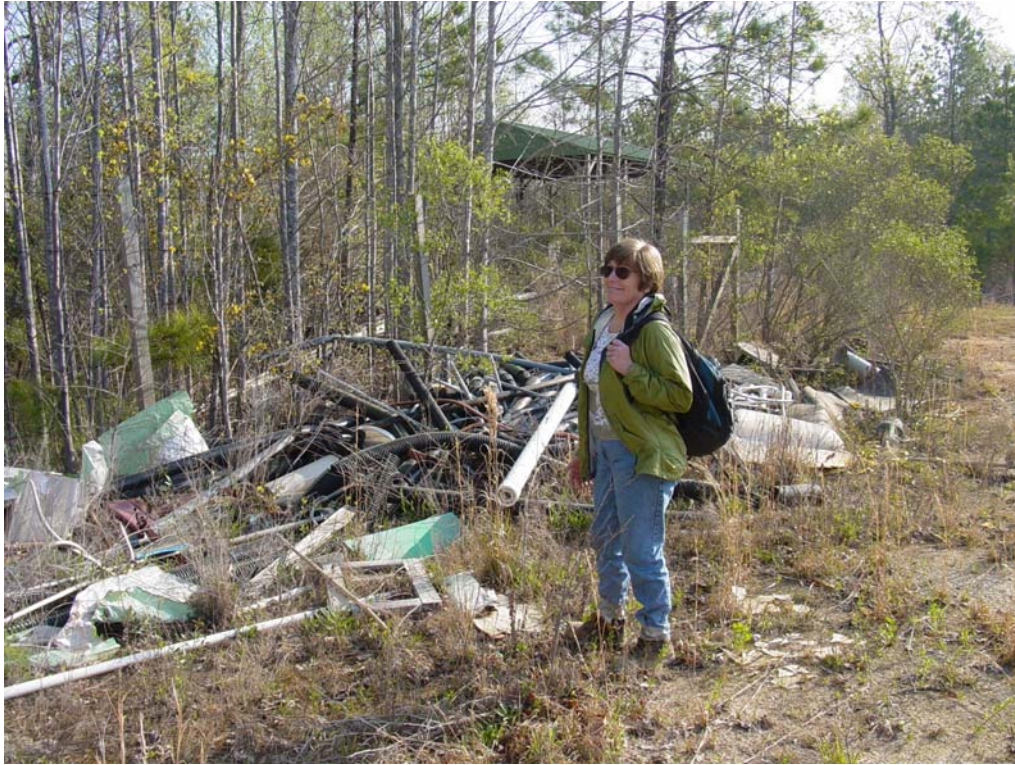
A few debris piles were found at the site. Next to the contingency pond is a pile of geonet drain. The debris in the Pole Barn has already been described. There are two piles of debris outside this structure containing wood, metal pipe, plastic pipe, sheet metal and rubber. Near the mine office is a pile of rusted metal and several piles of pipe segments. HDPE pipe segments are present in one of the piles. The HDPE pipe should be retained for future use. Other types of plastic pipe have deteriorated from exposure to sunlight and should be disposed.

Figure 69. Debris pile near the Pole Barn.
