**LOUISIANA ABANDONED OIL FACILITY
SITE ASSESSMENT SUMMARY REPORT**

**Quality Petroleum, Inc.-Hoffman, et al.
Caddo Parish, Louisiana
FPN: E06614
EPA ID: 09-E-1181**

May 23, 2008

**Prepared by:
Ecology & Environment, Inc.
Baton Rouge, Louisiana**

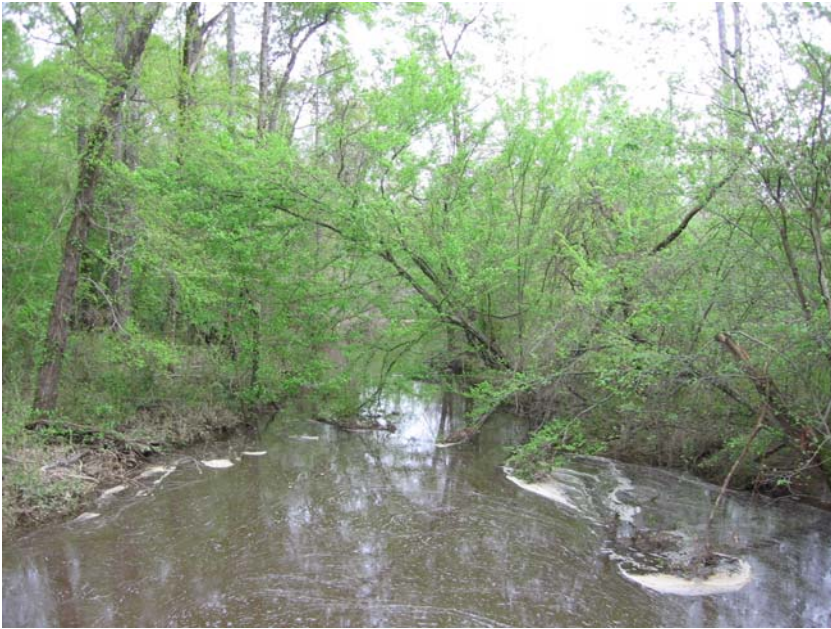
Site Name: Quality Petroleum, Inc.-Hoffman, et al. **Project No.:** E06614
Photo No.: 0104 **Direction:** SW **Contract No.**
Date: 04/01/2008 **Time:** 1:34:00 PM **Photographer/Witness:** Farrar, Will/N/A
Description: E06614: Unnamed NHD tributary of Caddo Lake just upstream of facility drainage outfall.

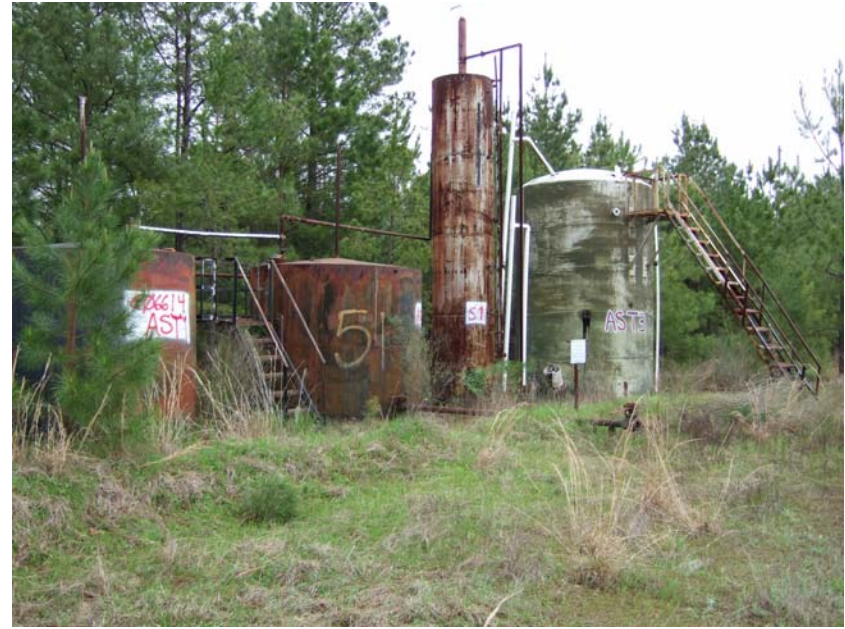
Site Name: Quality Petroleum, Inc.-Hoffman, et al. **Project No.:** E06614
Photo No.: 0201 **Direction:** NW **Contract No.**
Date: 04/05/2008 **Time:** 9:28:00 AM **Photographer/Witness:** Sekerka, Robert/Johnson, Colin
Description: E06614: AST1, AST2, AST3, and S1 in CONT1.

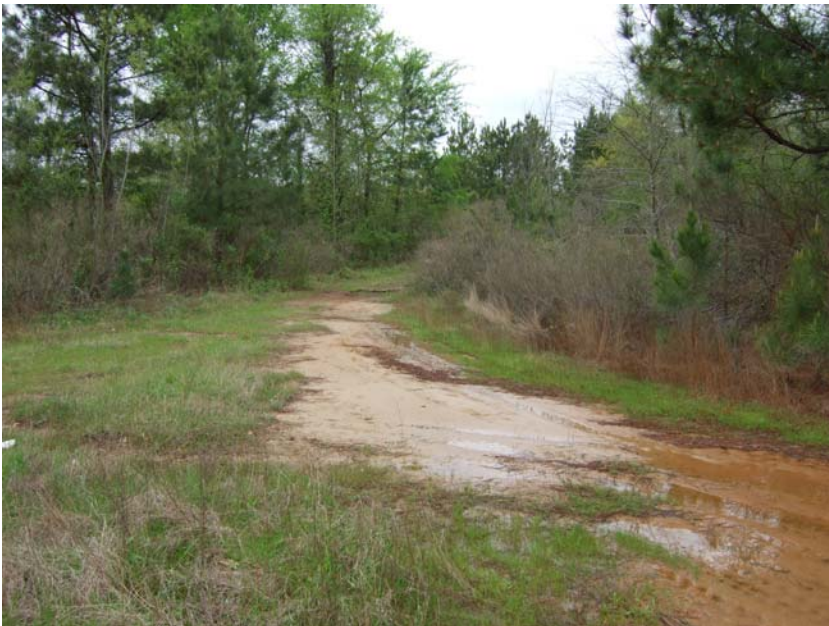
Site Name: Quality Petroleum, Inc.-Hoffman, et al. **Project No.:** E06614
Photo No.: 0225 **Direction:** SW **Contract No.**
Date: 04/05/2008 **Time:** 10:15:00 A **Photographer/Witness:** Sekerka, Robert/Johnson, Colin
Description: E06614: Drainage ditch on north side of facility access road.
