**REMOVAL PROGRAM  
AFTER ACTION REPORT  
FOR THE  
STENTON TRUST MILL DRUM SITE  
SANFORD, YORK COUNTY, MAINE  
3 SEPTEMBER 2008 THROUGH 30 SEPTEMBER 2008**

Weston Solutions, Inc.  
Superfund Technical Assessment and Response Team III (START)  
3 Riverside Drive  
Andover, Massachusetts 01810

February 2009

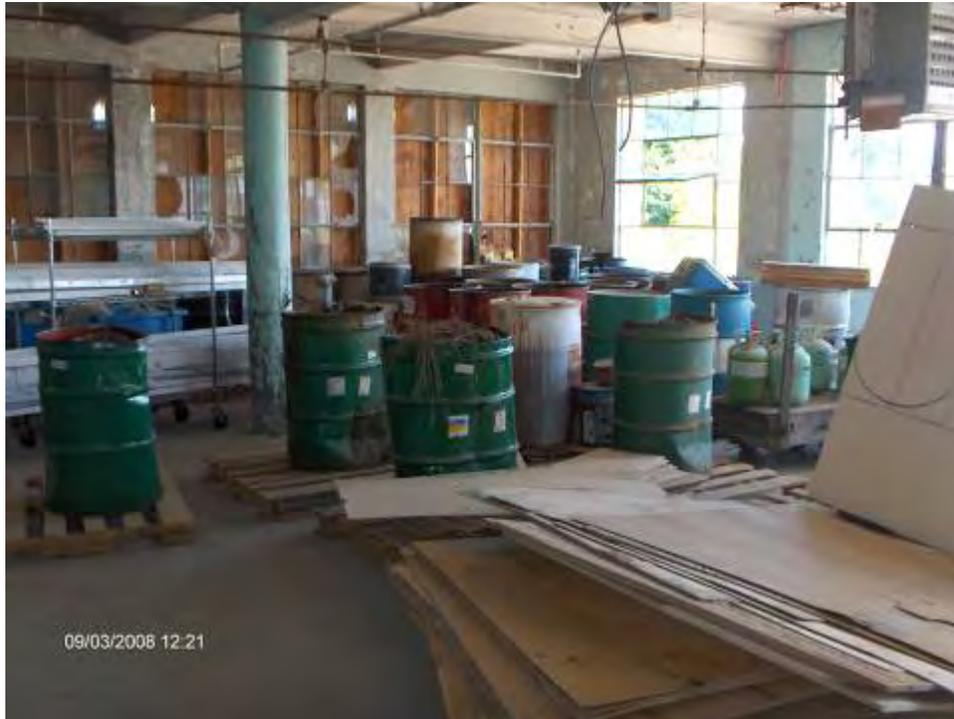
**SCENE:** View of the waste staging area located on the first floor of the East Tower of the on-site building.

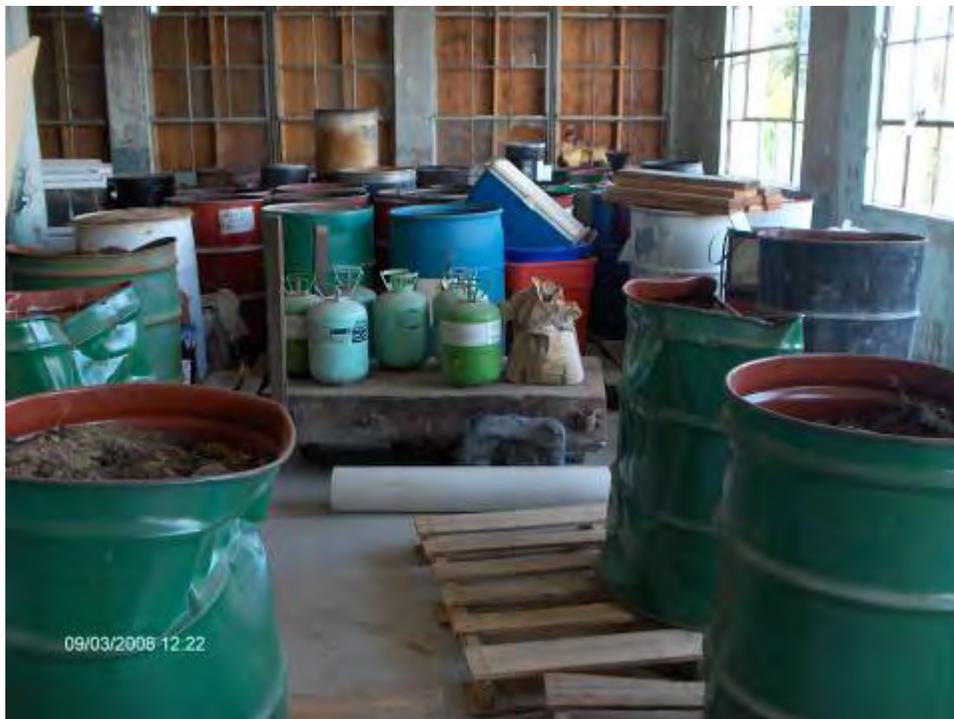
**SCENE:** View of drums and containers stored in the waste staging area located on the first floor of the East Tower of the on-site building.

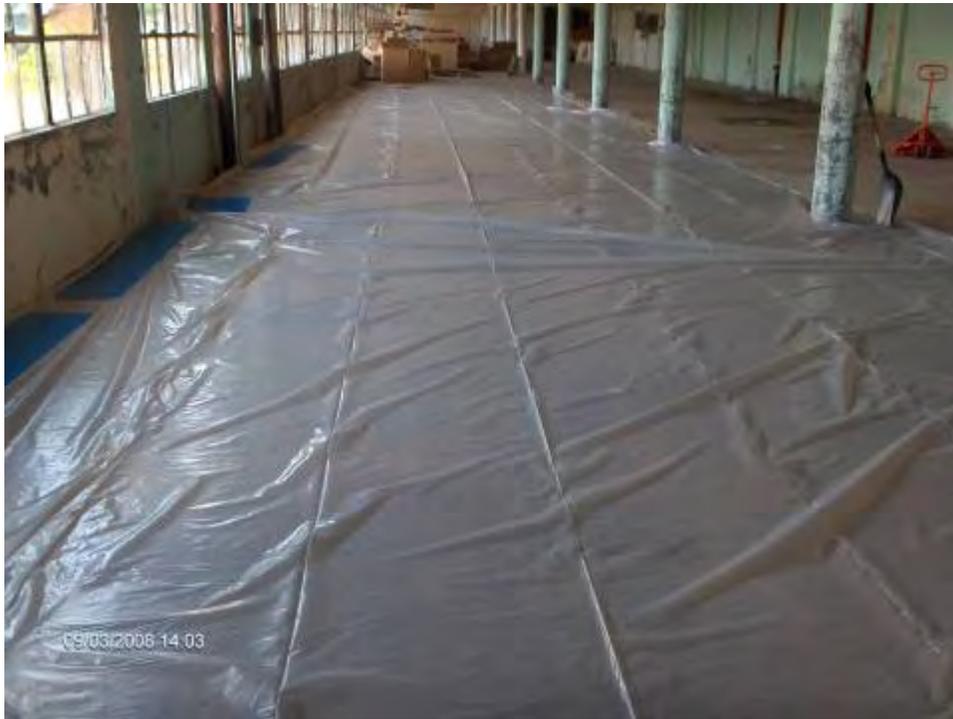
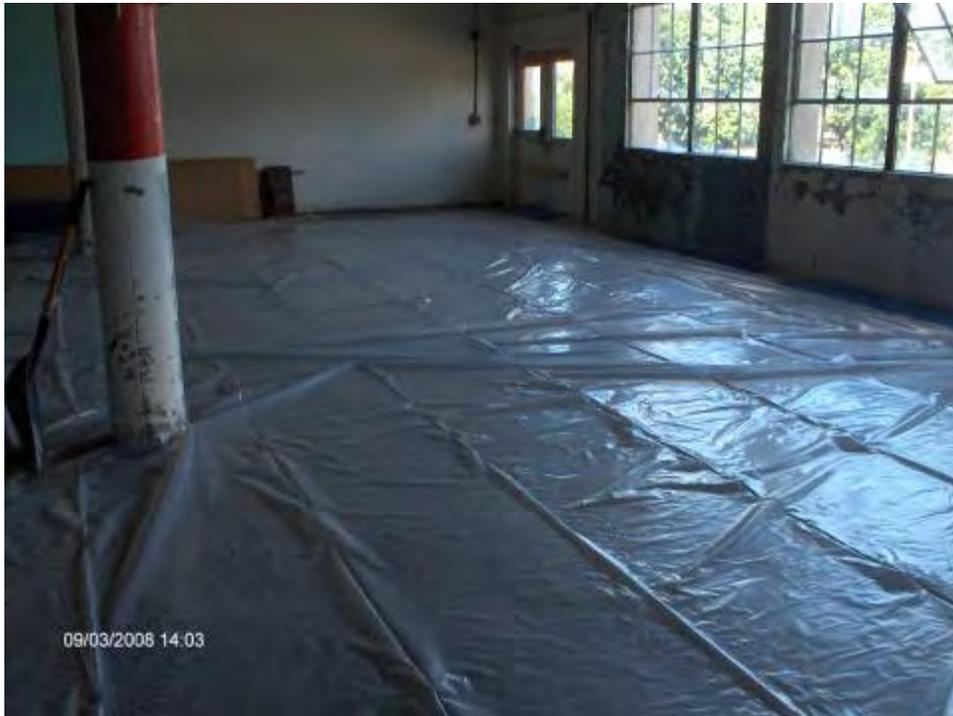
**SCENE:** View of polyethylene (poly) sheeting covering the floor of the waste staging area prior to waste collection activities.

**SCENE:** View of poly sheeting covering the floor of the waste staging area prior to waste collection activities.

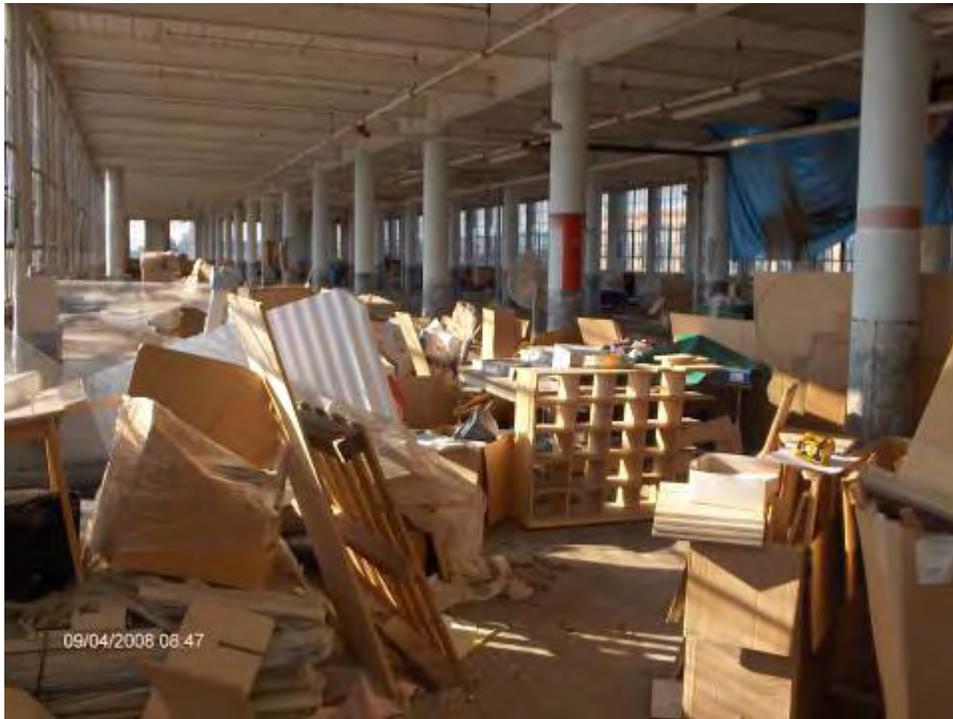
**SCENE:** View of the fifth floor of the East Tower of the on-site building.

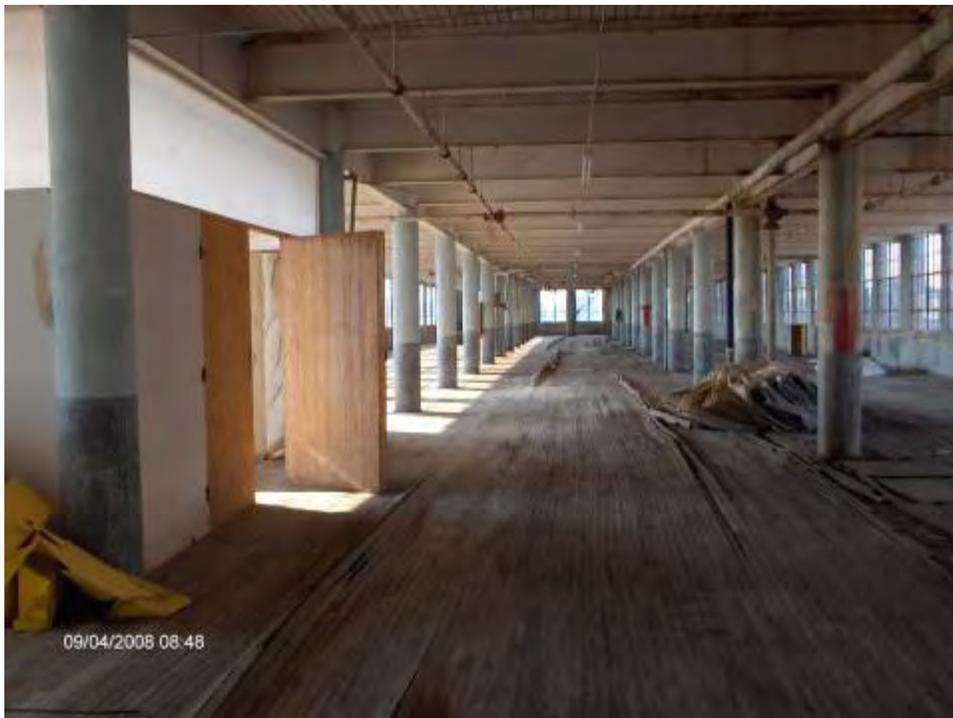
**SCENE:** View of the fourth floor of the East Tower of the on-site building.

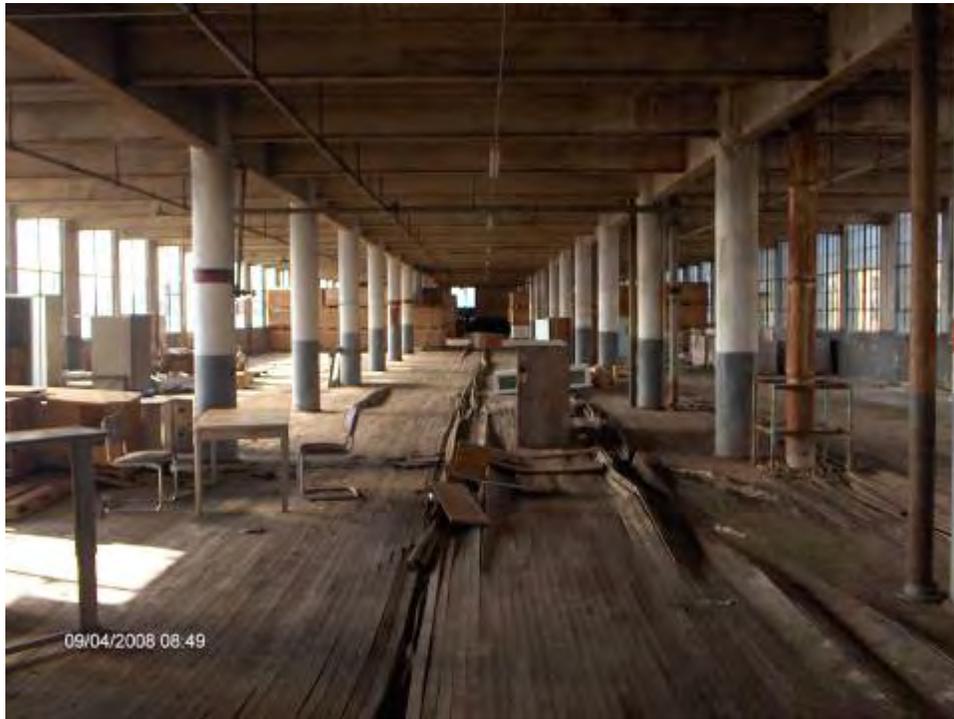
**SCENE:** View of the third floor of the East Tower of the on-site building.

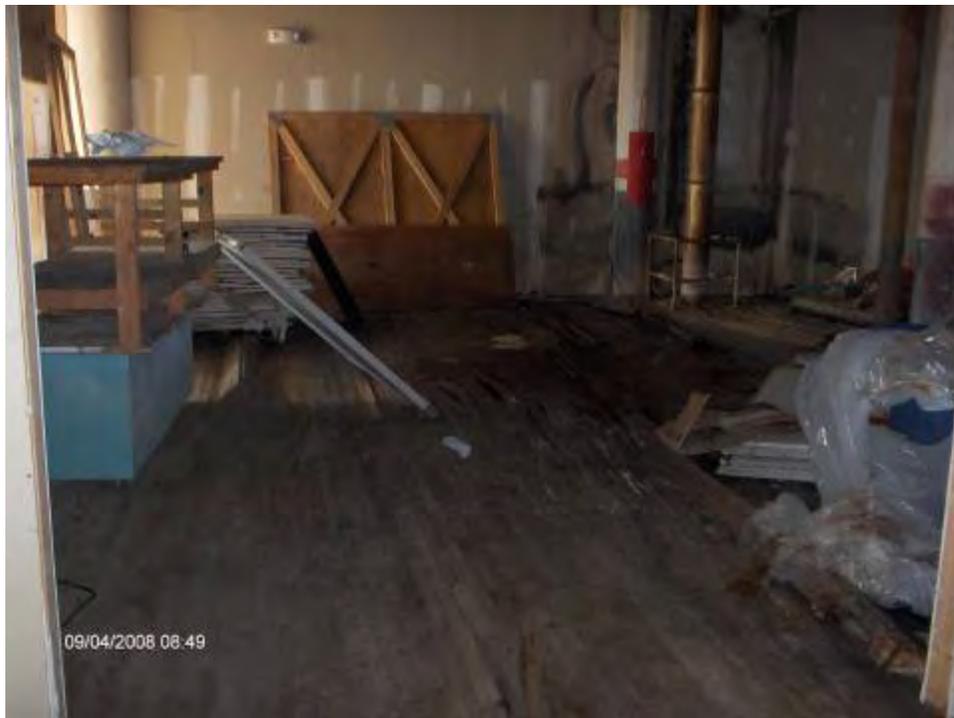
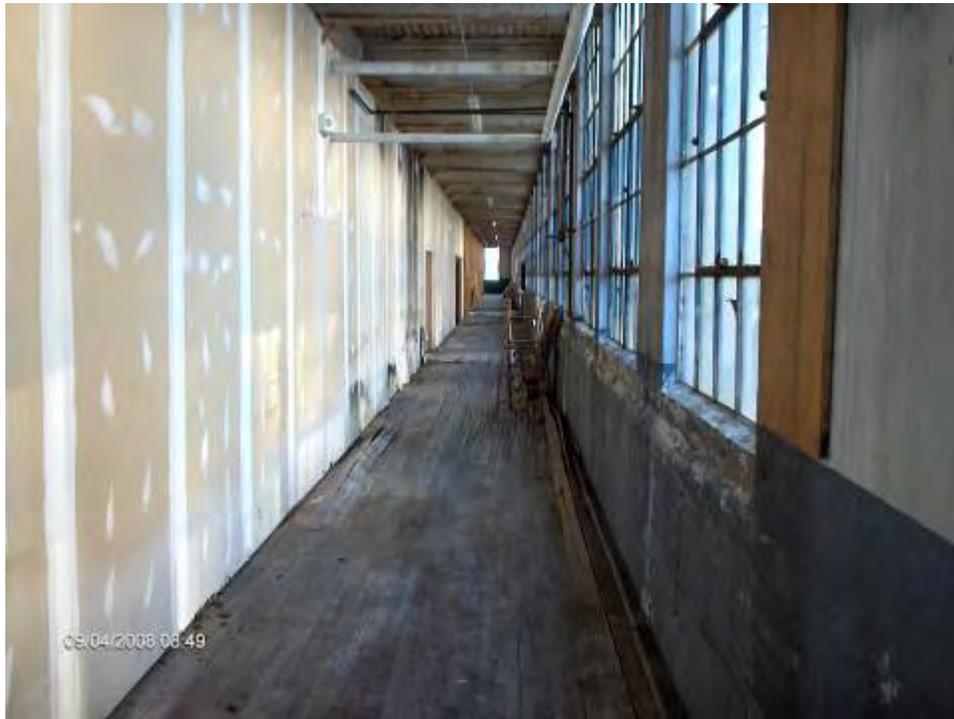
**SCENE:** View of a portion of the second floor of the East Tower of the on-site building.

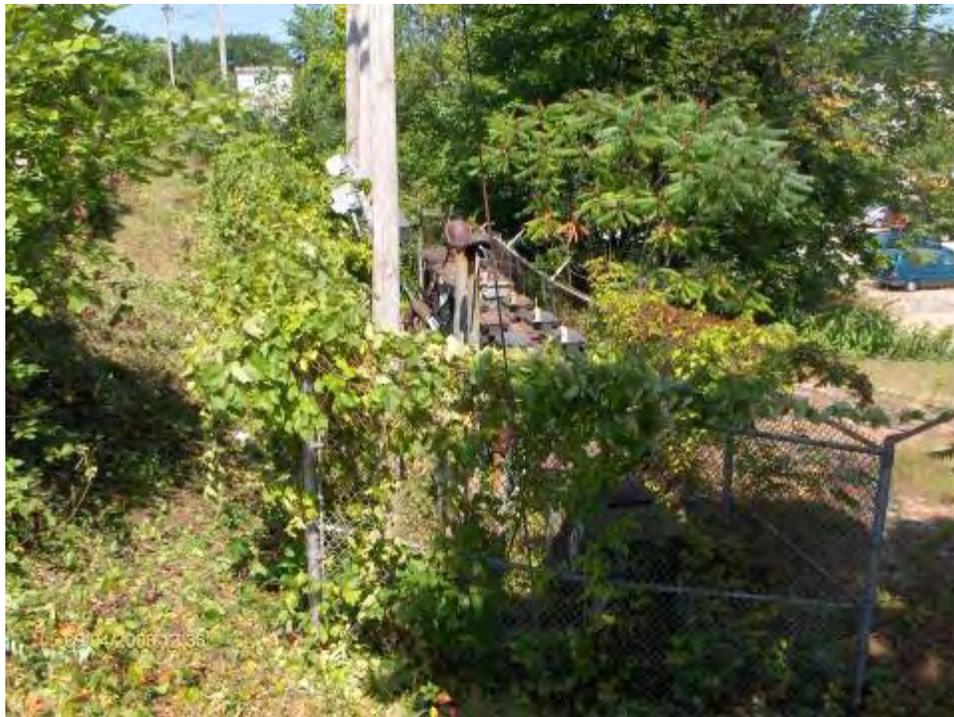
**SCENE:** View of the transformer pad, located east of the on-site building, during brush clearing. Photograph taken facing northeast.

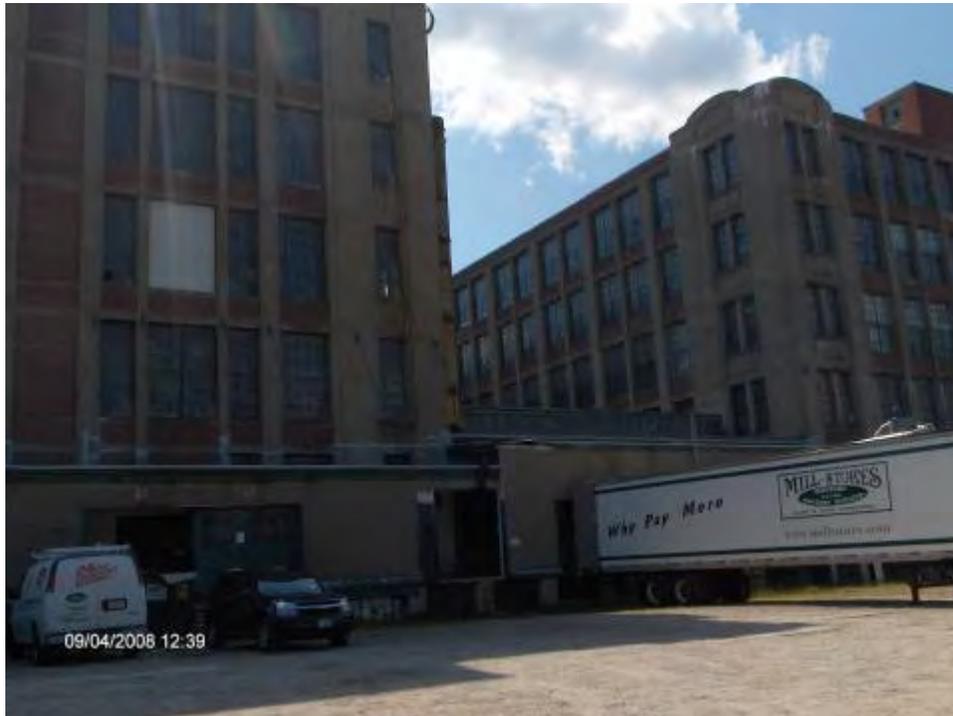
**SCENE:** View of the on-site building with the East Tower on the left and the West Tower on the right. Photograph taken facing southwest.

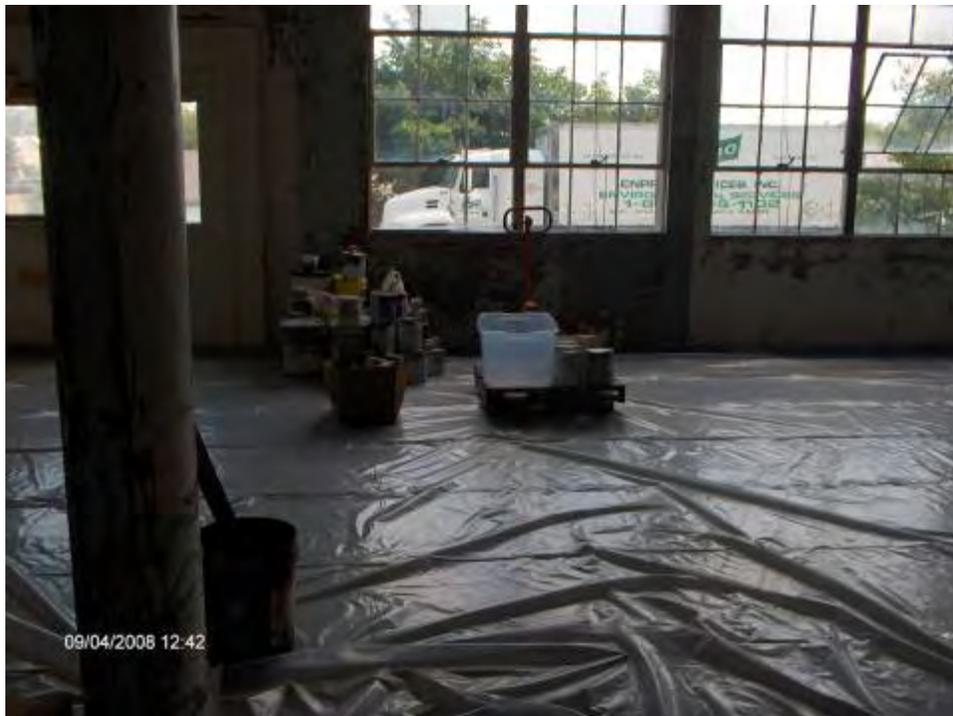
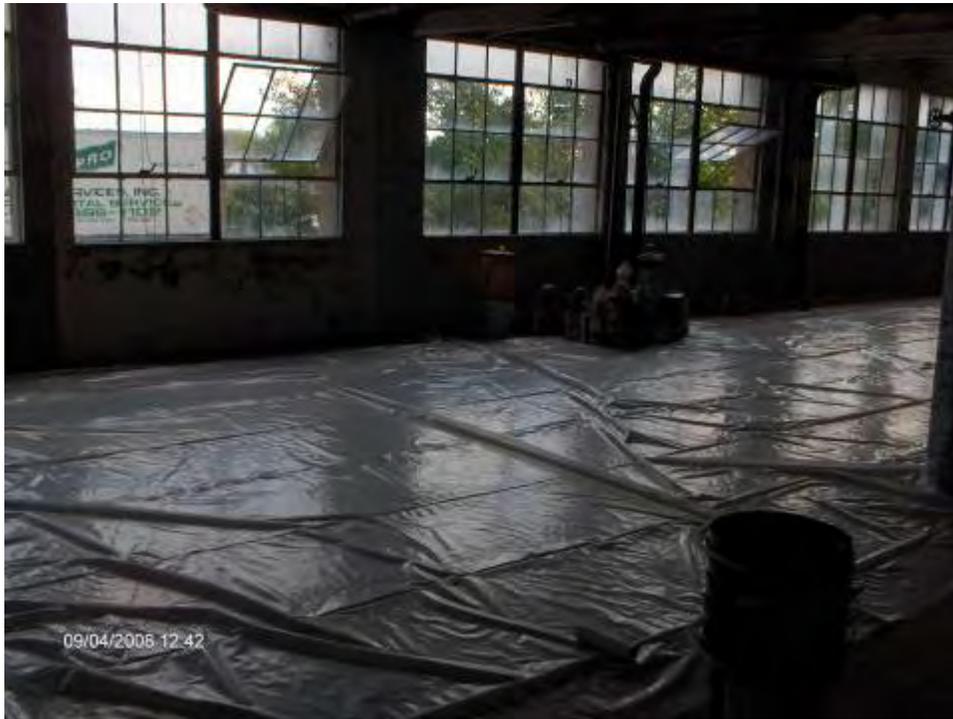
**SCENE:** View of paint waste, gathered from locations in the on-site building, staged on the poly sheeting covering the floor of the waste staging area.

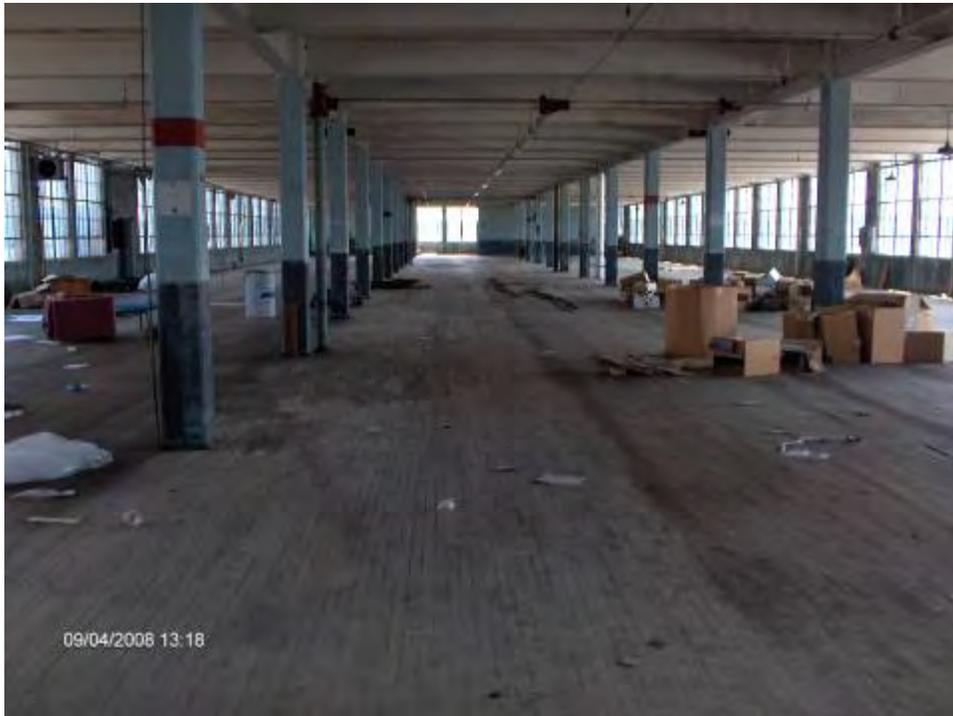
**SCENE:** View of the fourth floor of the West Tower of the on-site building.

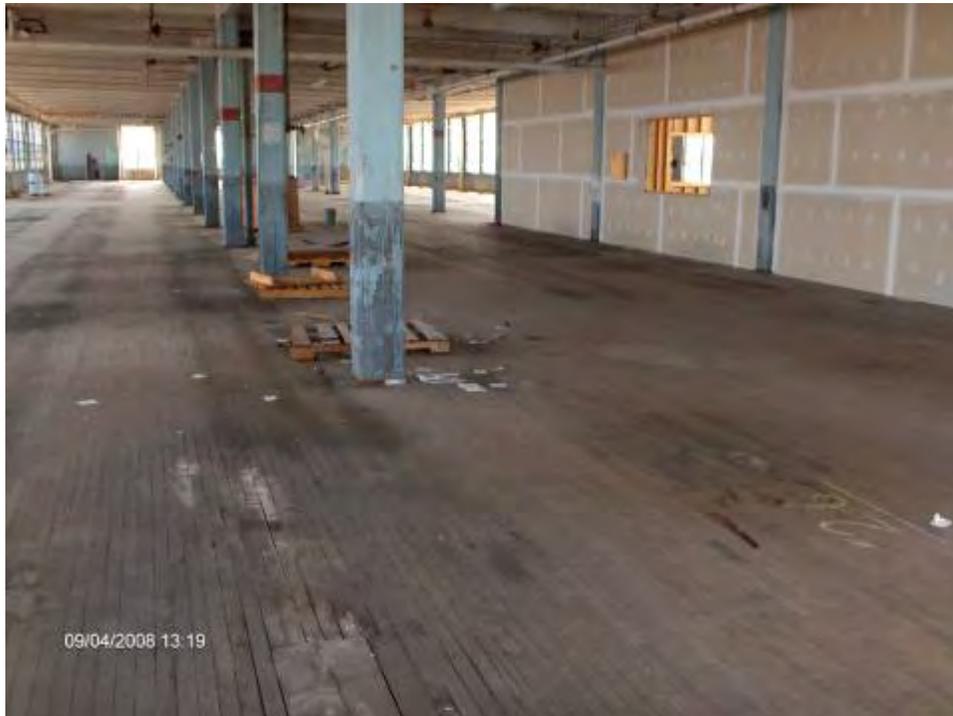
**SCENE:** View of the fifth floor of the West Tower of the on-site building.

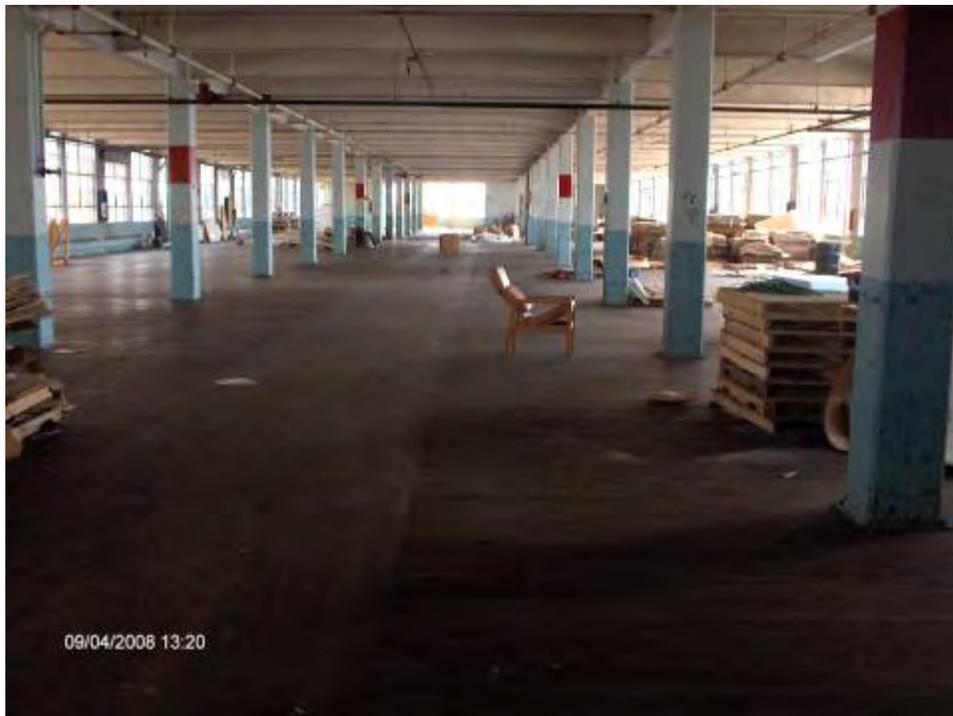
**SCENE:** View of the third floor of the West Tower of the on-site building.

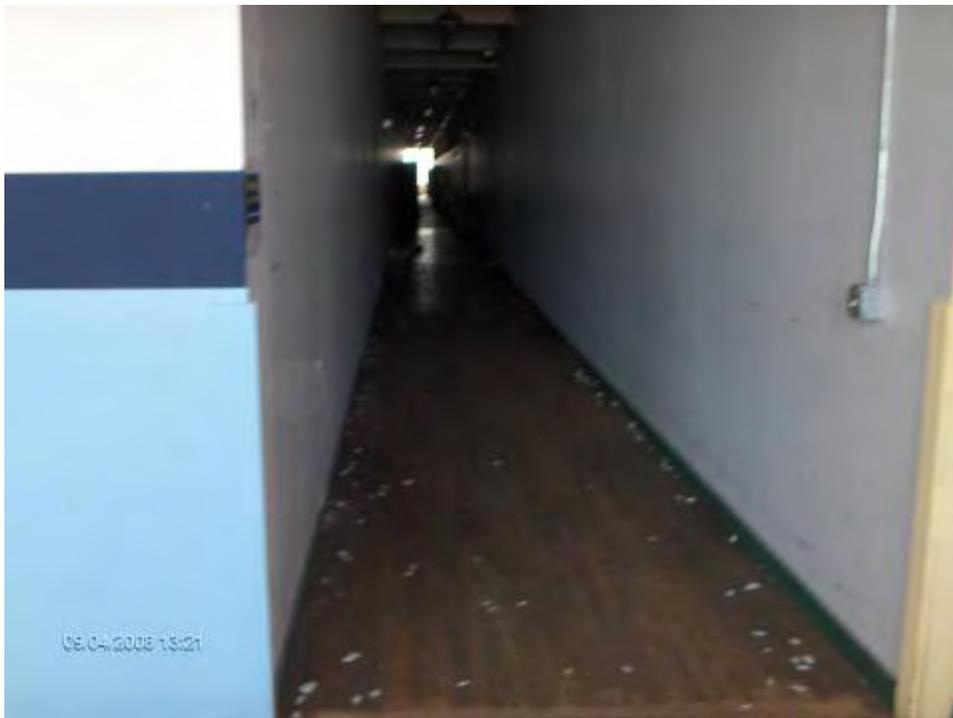
**SCENE:** View of a portion (central section) of the second floor of the West Tower of the on-site building.

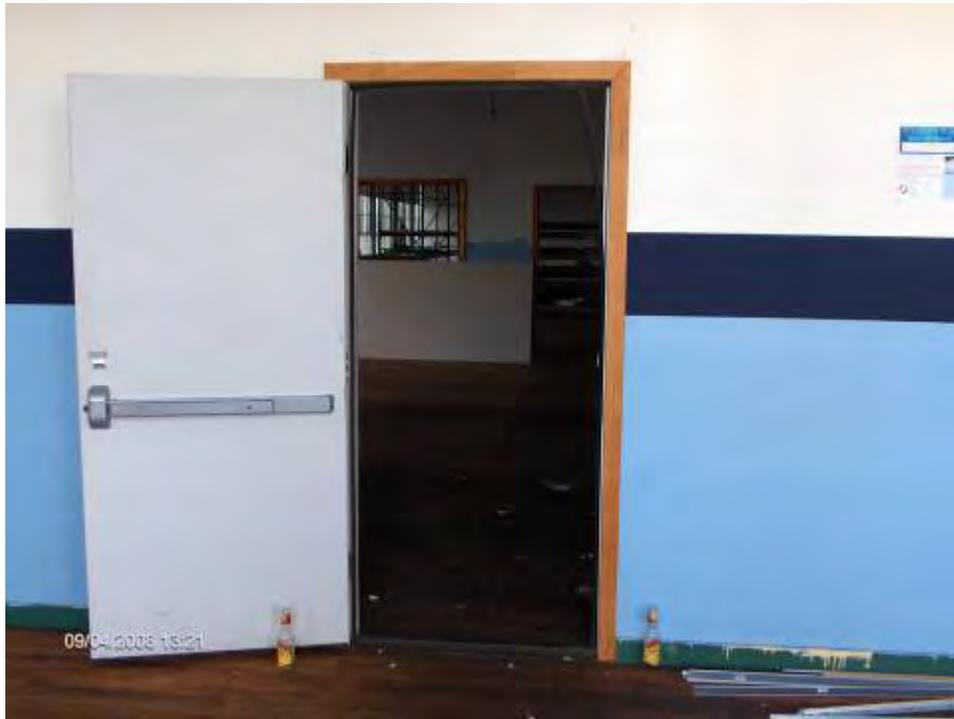
**SCENE:** View of a portion (eastern section) of the second floor of the West Tower of the on-site building.

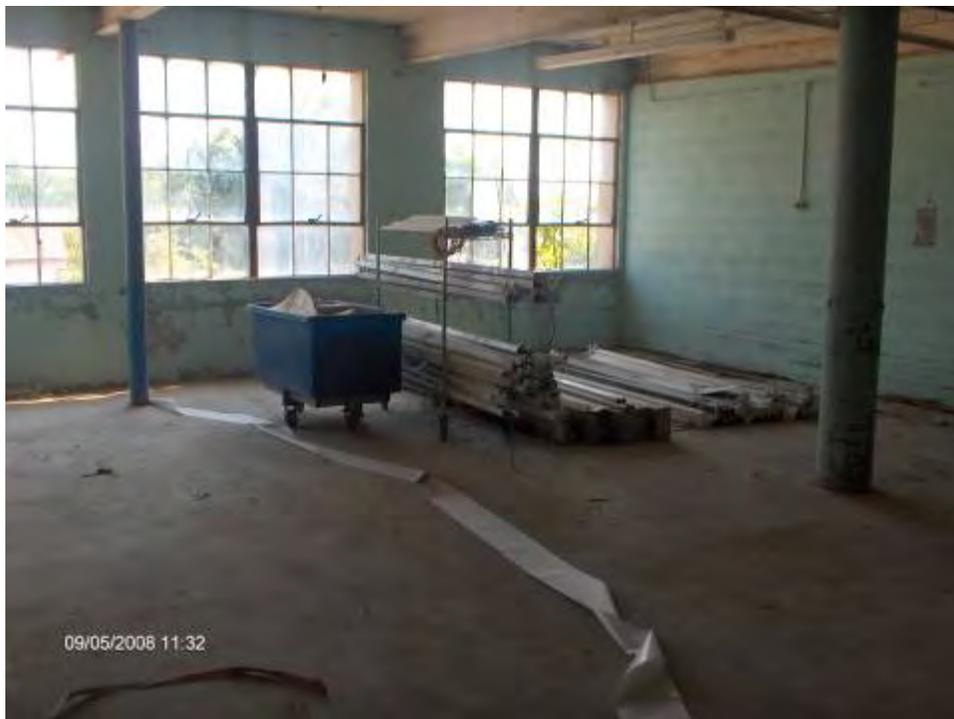
**SCENE:** View of fluorescent light bulbs, gathered from locations in the on-site building, stored in the waste staging area.

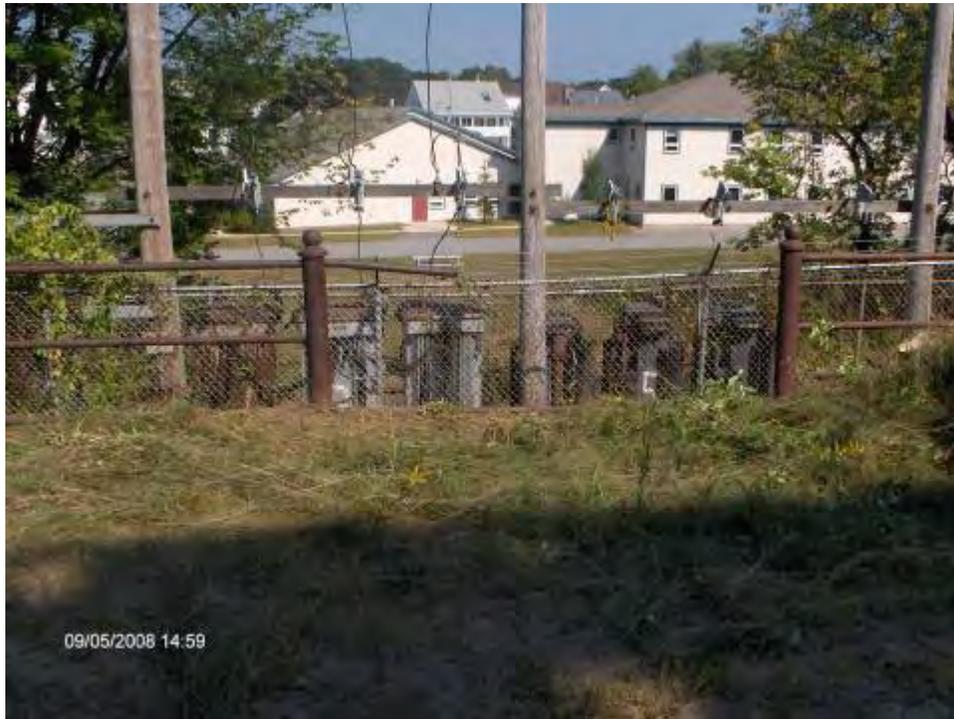
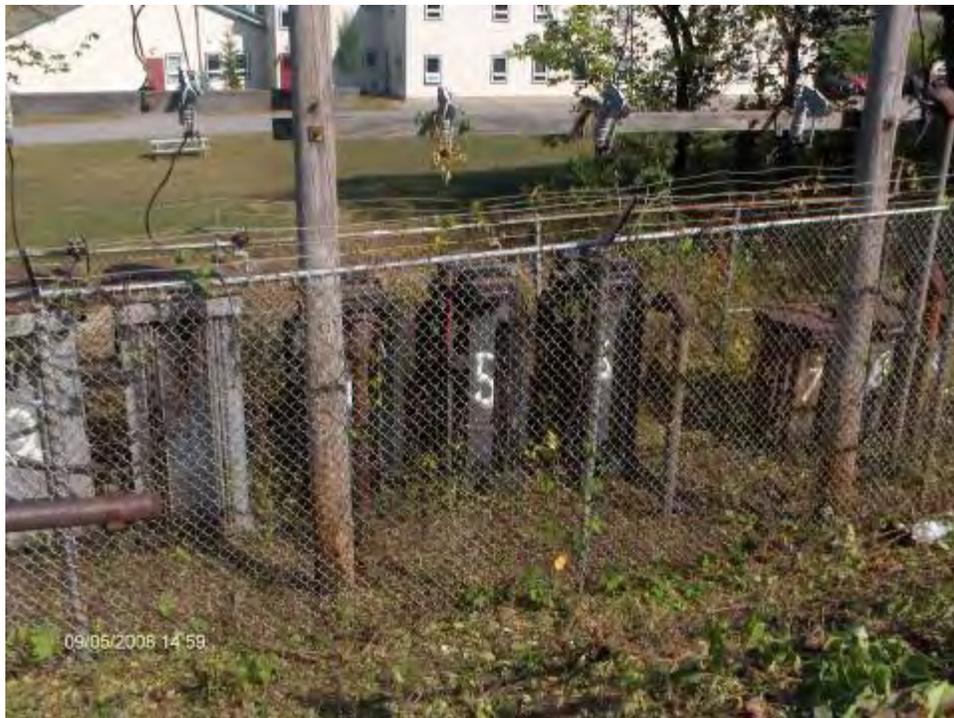
**SCENE:** View of the transformer pad, located east of the on-site building, following the completion of brush clearing activities. Photograph taken facing east.

**SCENE:** View of the transformer pad, located east of the on-site building, at the completion of brush clearing activities. Photograph taken facing east.

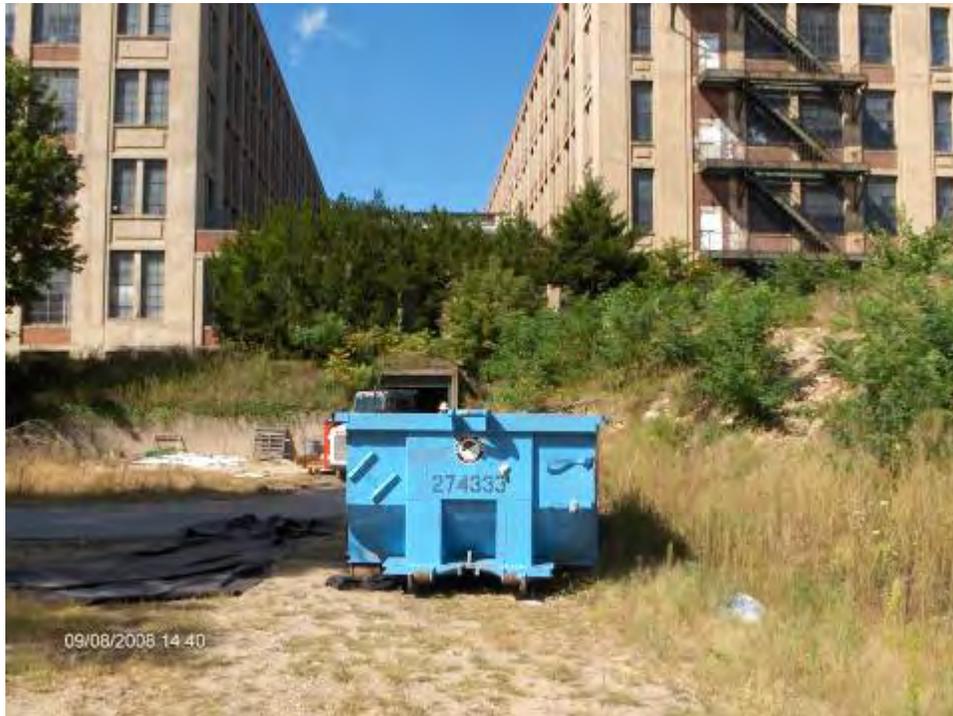
**SCENE:** View of the first roll-off container delivered to the southern portion of the site. The roll-off container was filled with electronic waste gathered from throughout the building. Photograph taken facing north.

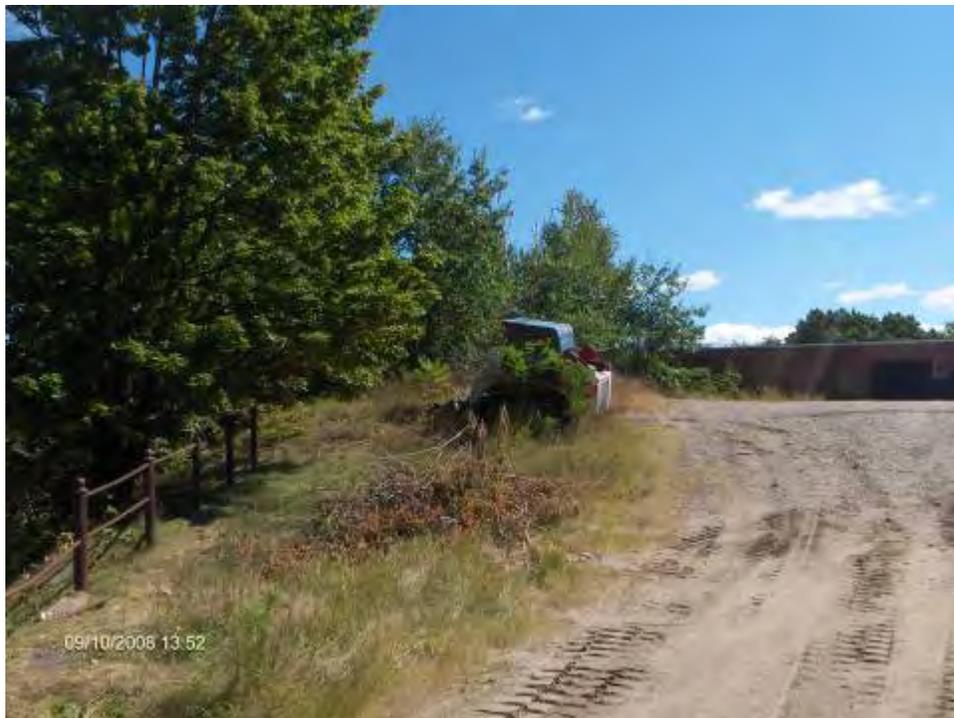
**SCENE:** View of the Bobcat® gathering material to backfill the petroleum-contaminated soil excavation area located adjacent to the East Tower of the on-site building. Photograph taken facing southeast.

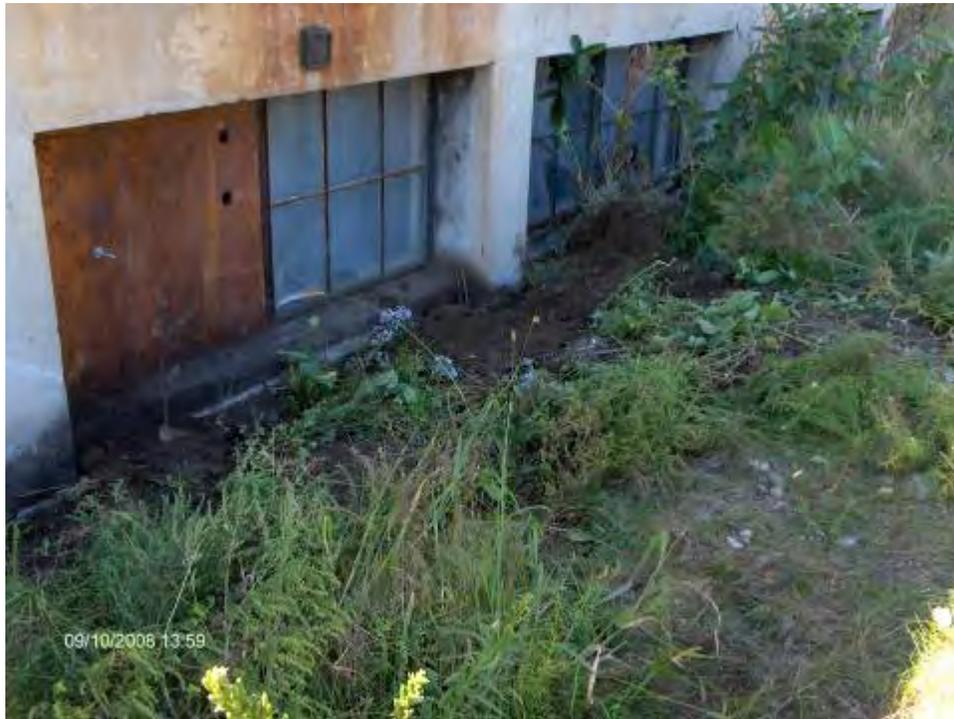
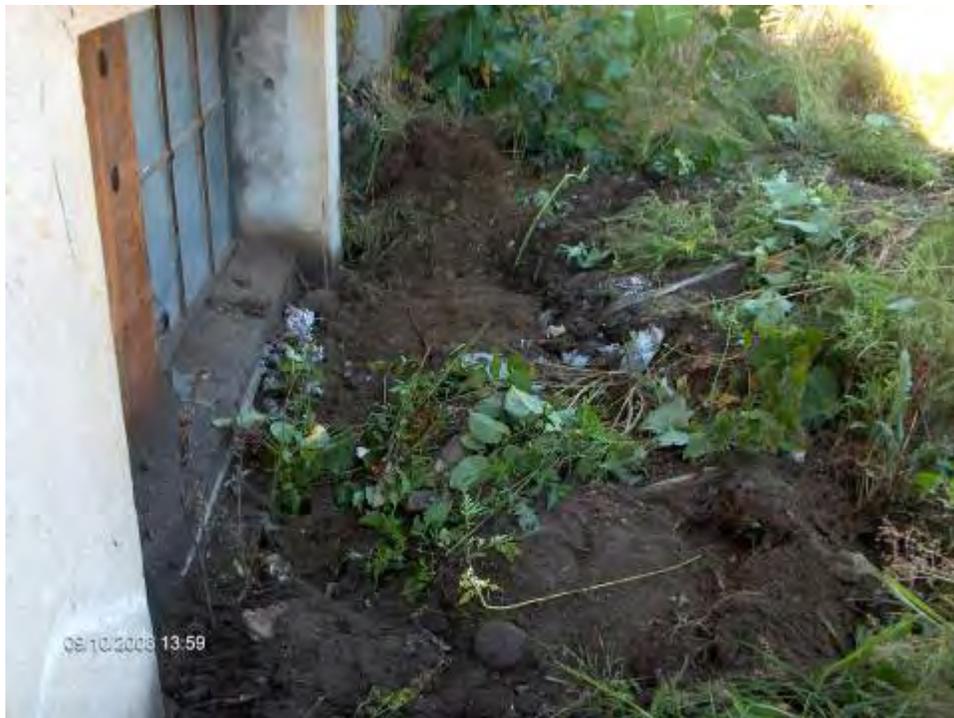
**SCENE:** View of the petroleum-contaminated soil excavation area following backfilling activities. Photograph taken facing northeast.

**SCENE:** View of the petroleum-contaminated soil excavation area following backfilling activities. Photograph taken facing north.

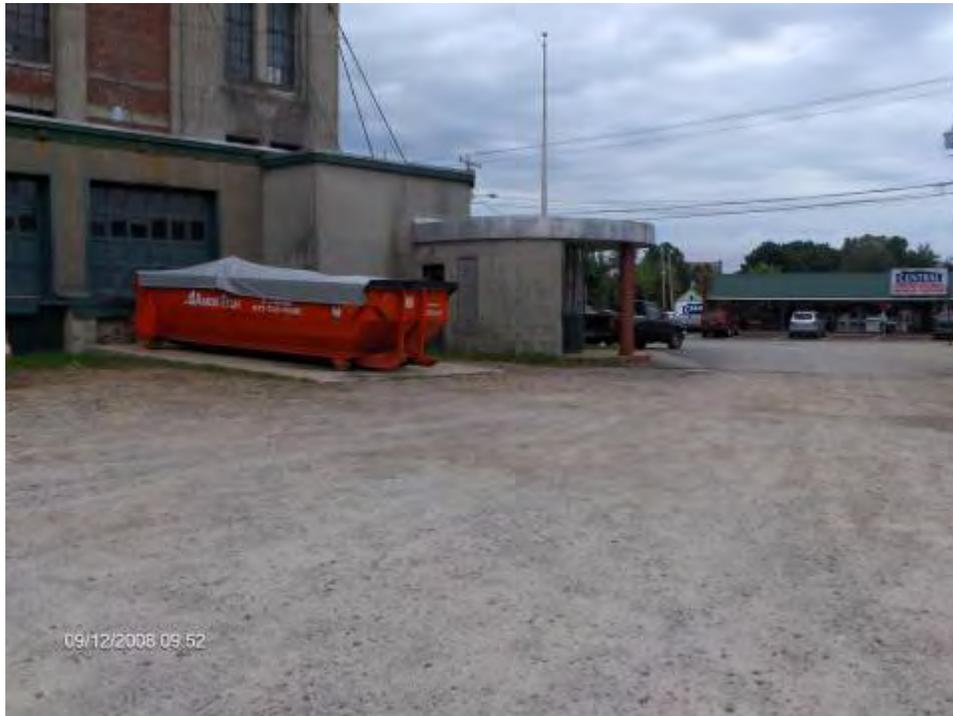
**SCENE:** View of the second roll-off container delivered to the northern portion of the site. The roll-off container was filled with electronic waste gathered from throughout the building. Photograph taken facing southwest.

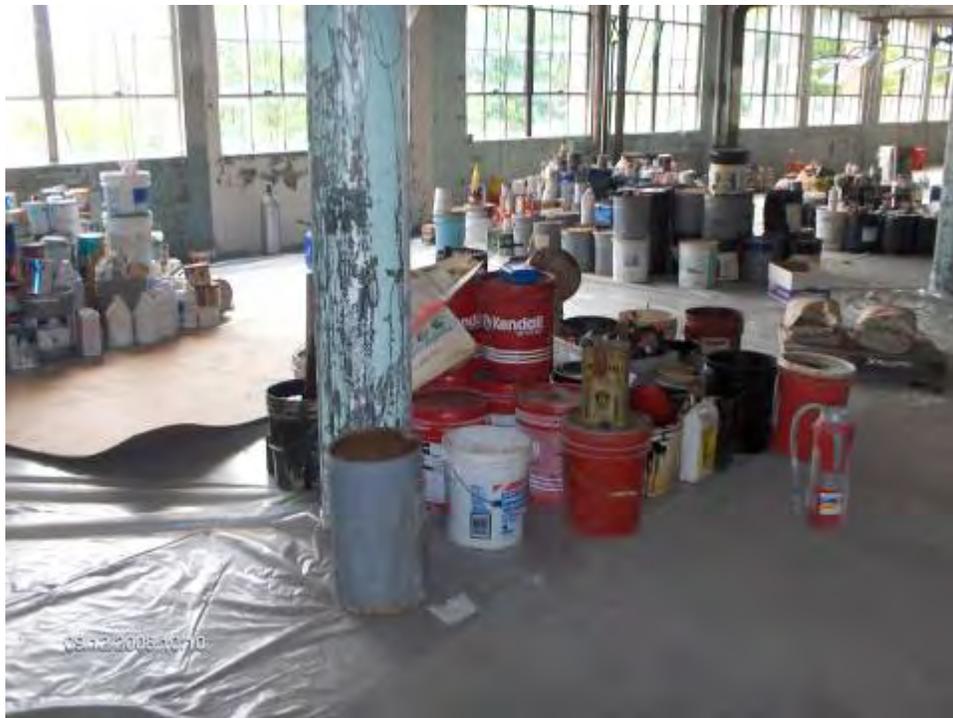
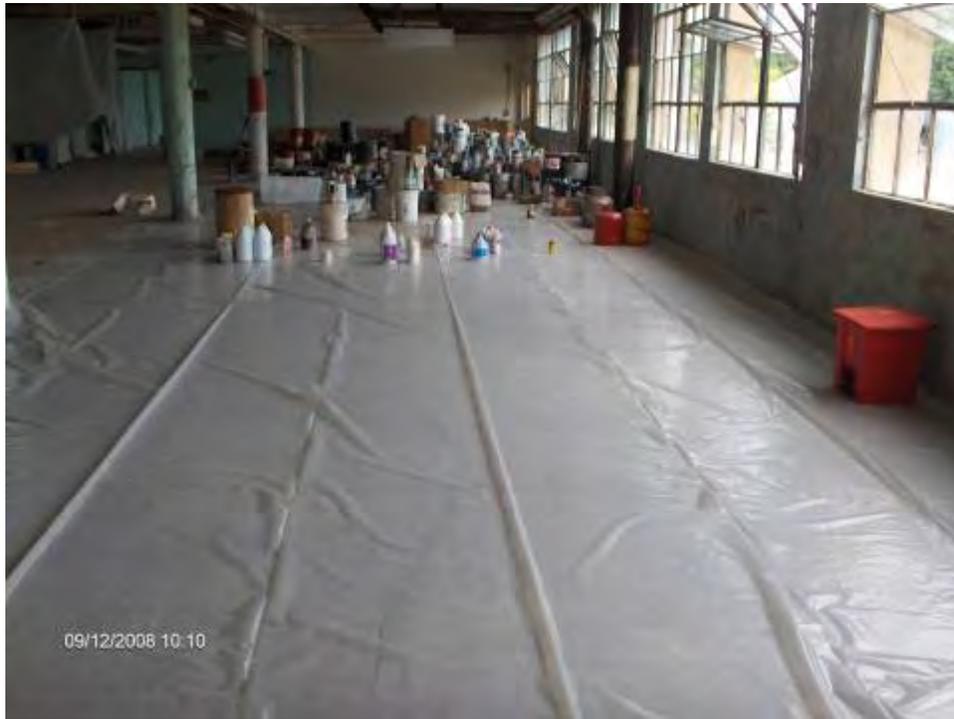
**SCENE:** View of paint waste containers, gathered from the on-site building, segregated and staged on the poly sheeting covering the floor of the waste staging area.

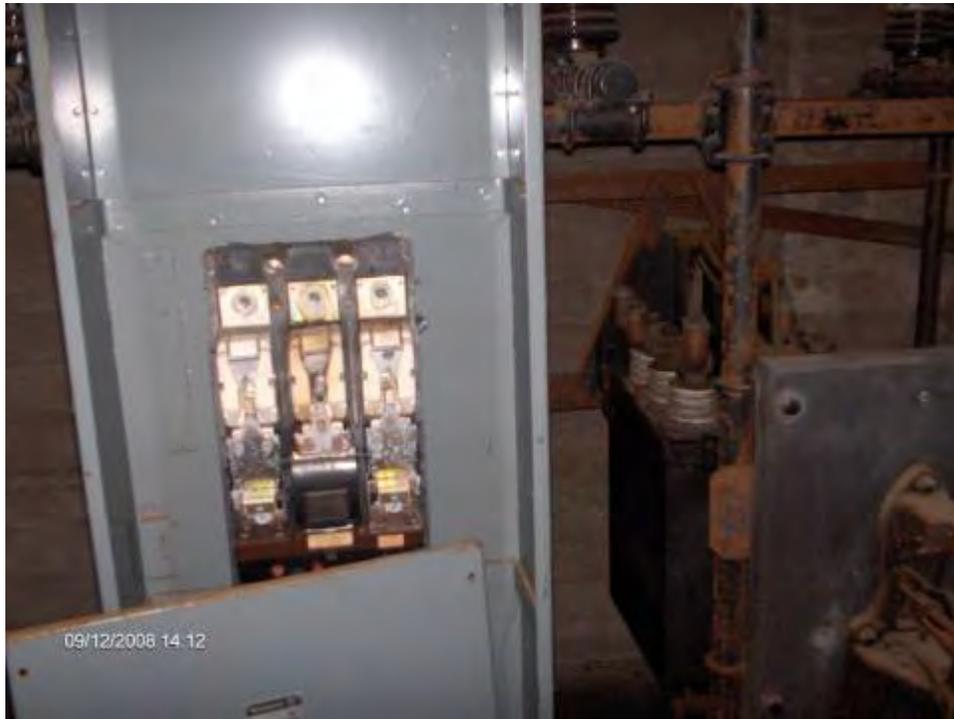
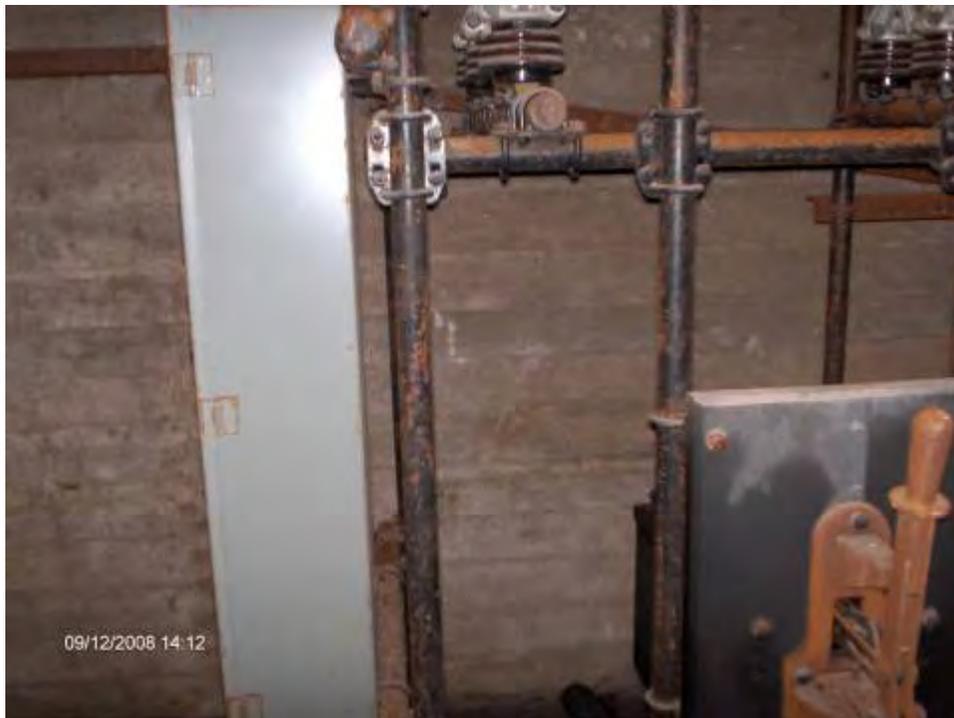
**SCENE:** View of transformers within the electric room located off of a tunnel in the eastern portion of the basement of the on-site building.

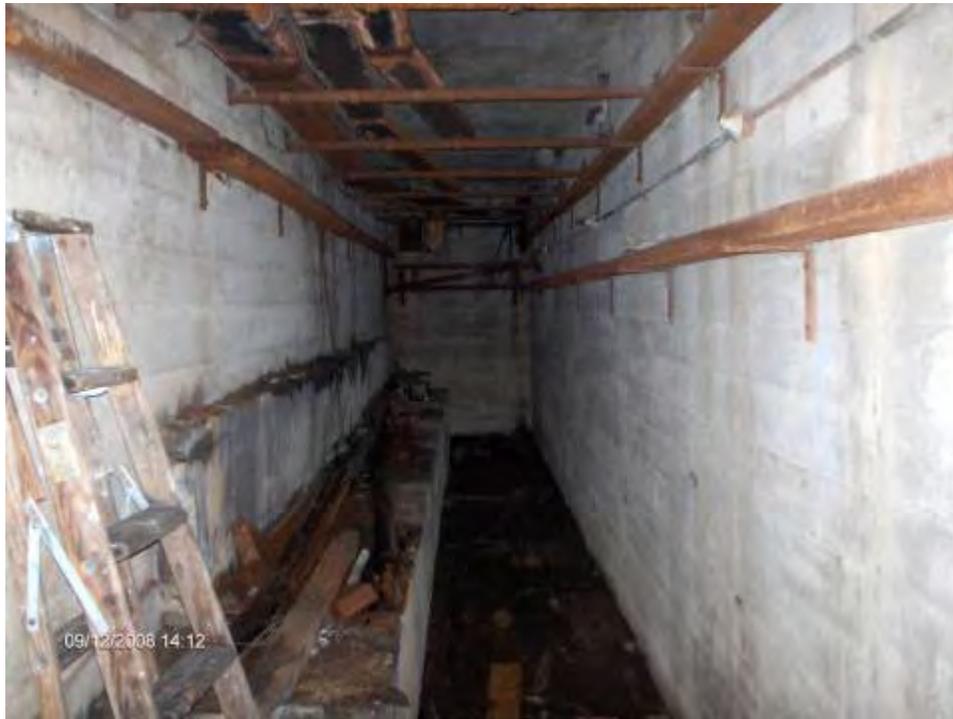
**SCENE:** View of the tunnel within the electric room located off of the tunnel in the eastern portion of the basement of the on-site building.
