**REMOVAL PROGRAM  
AFTER ACTION REPORT  
FOR THE  
STENTON TRUST MILL DRUM SITE  
SANFORD, YORK COUNTY, MAINE  
3 SEPTEMBER 2008 THROUGH 30 SEPTEMBER 2008**

Weston Solutions, Inc.  
Superfund Technical Assessment and Response Team III (START)  
3 Riverside Drive  
Andover, Massachusetts 01810

February 2009

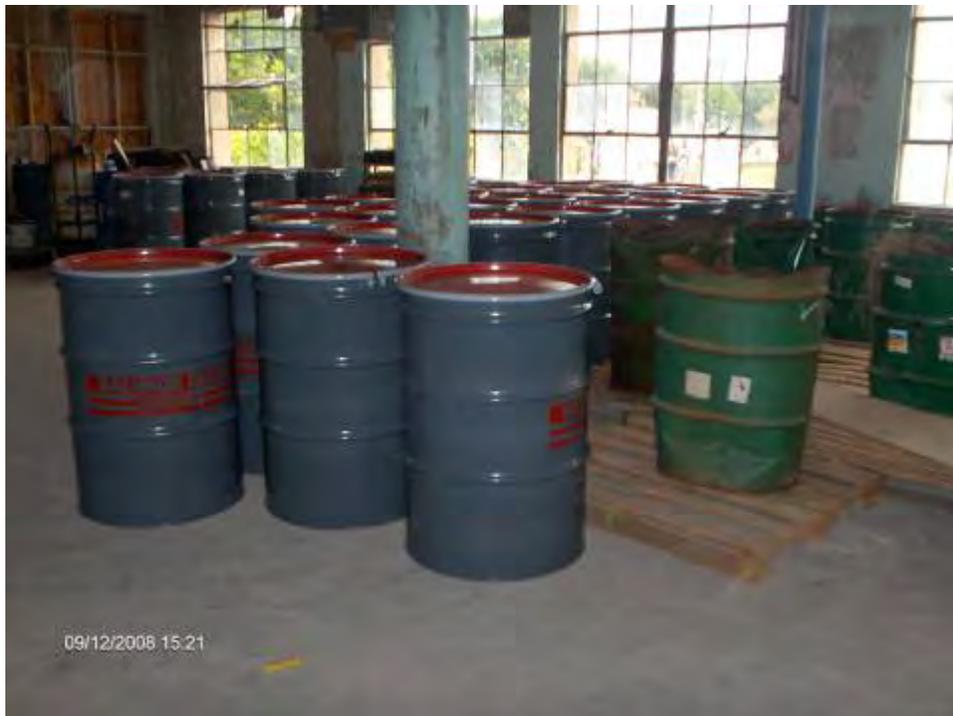
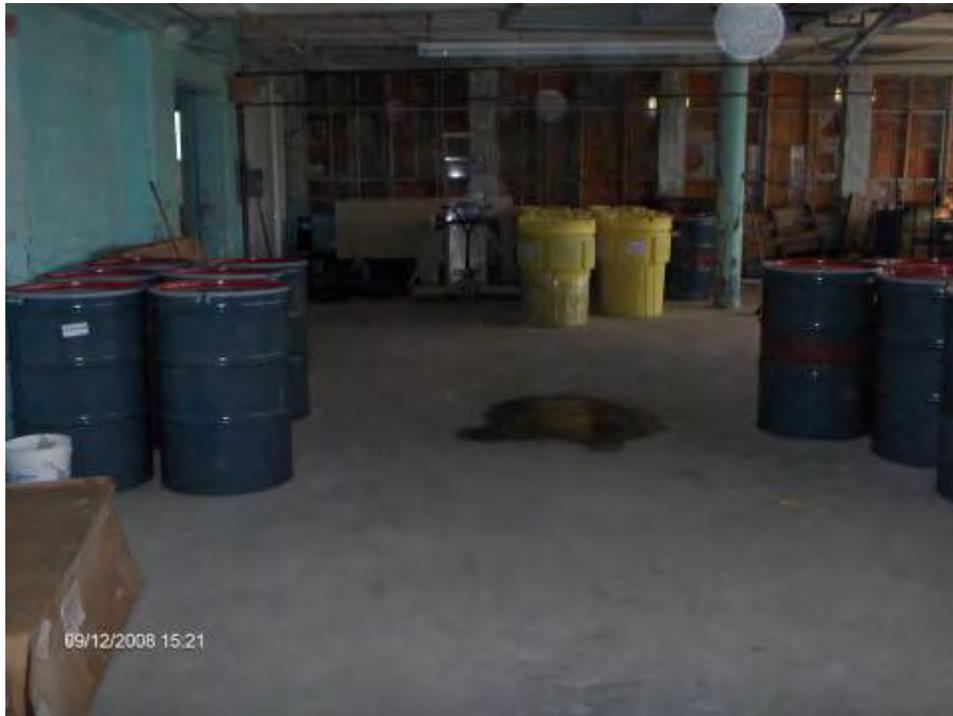
**SCENE:** View of the overpacked drums in the waste staging area, following the completion of all waste collection activities from the on-site building.

**SCENE:** View of the overpacked drums in the waste staging area, following completion of all waste collection activities from the on-site building.

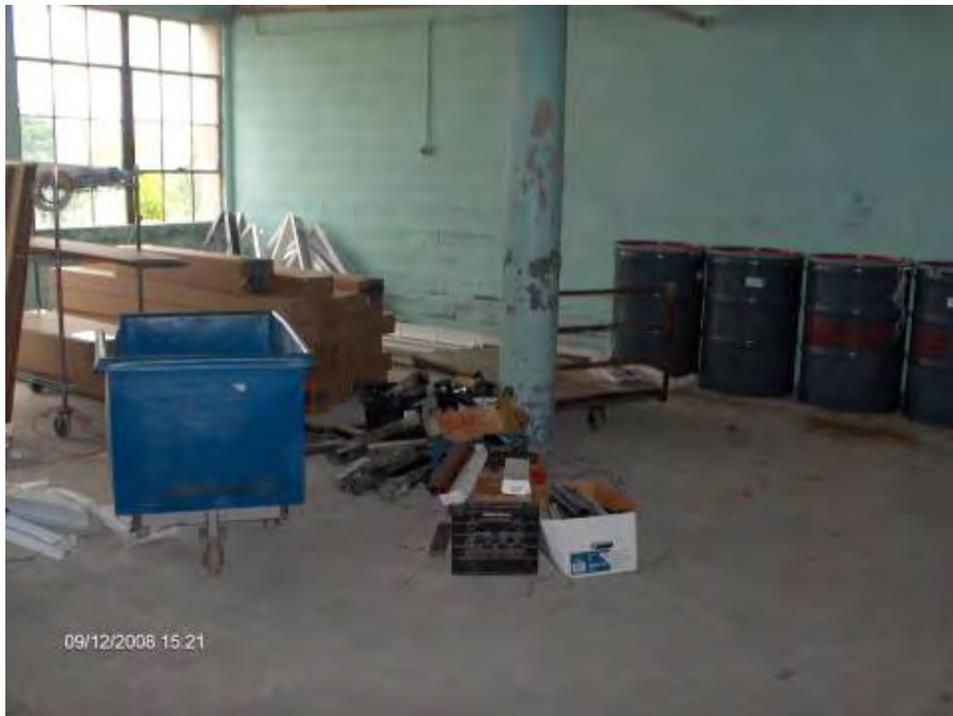
**SCENE:** View of the overpacked drums, fluorescent light bulbs, and light ballasts in the waste staging area, following the completion of all waste collection activities from the on-site building.

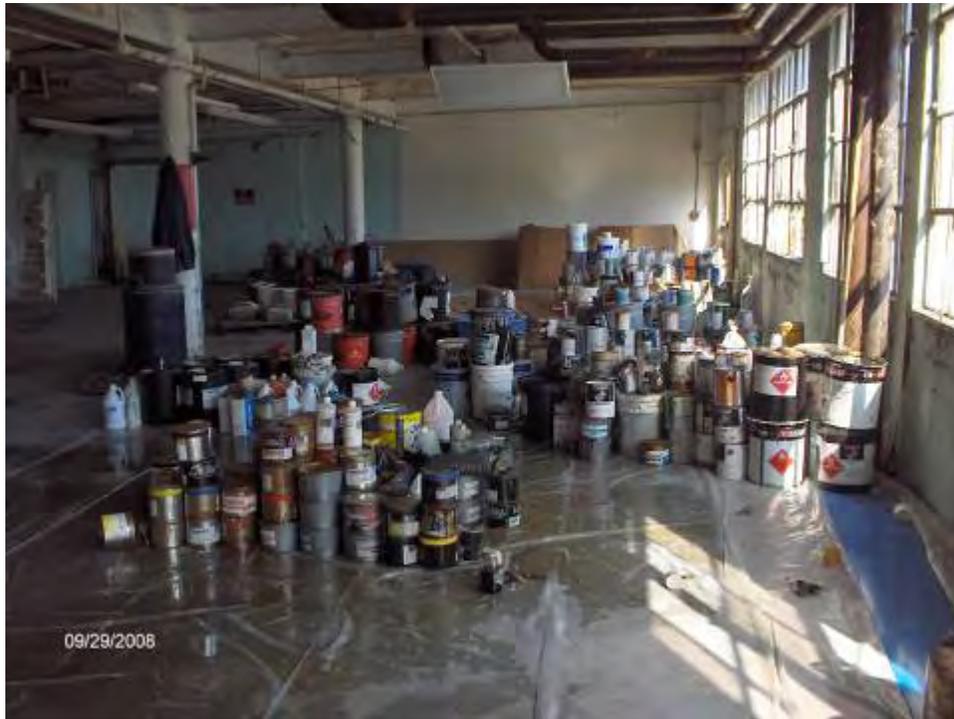
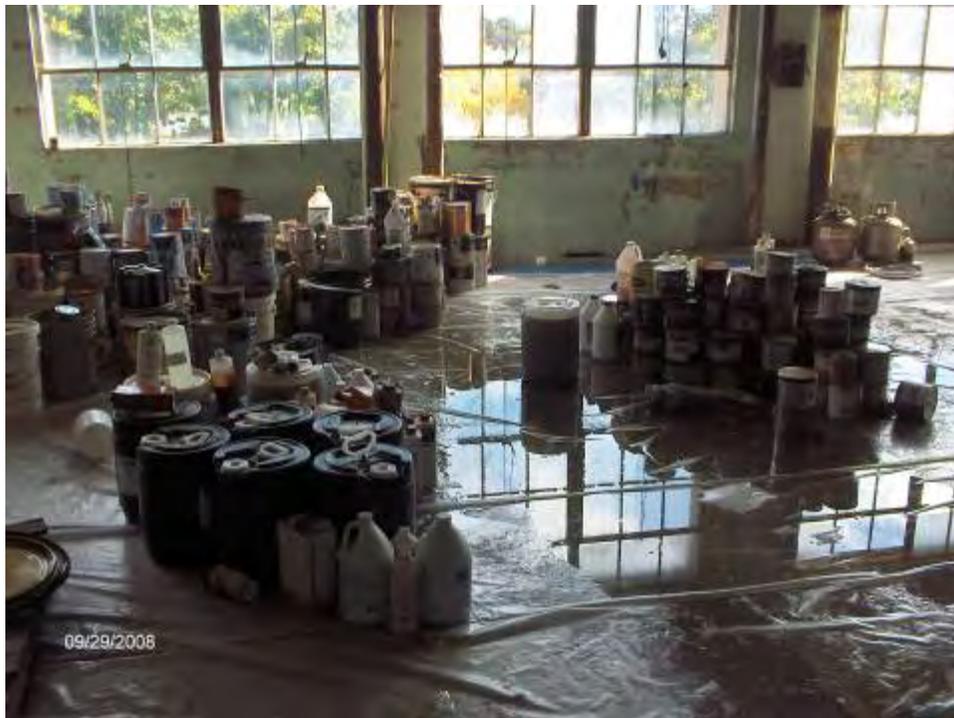
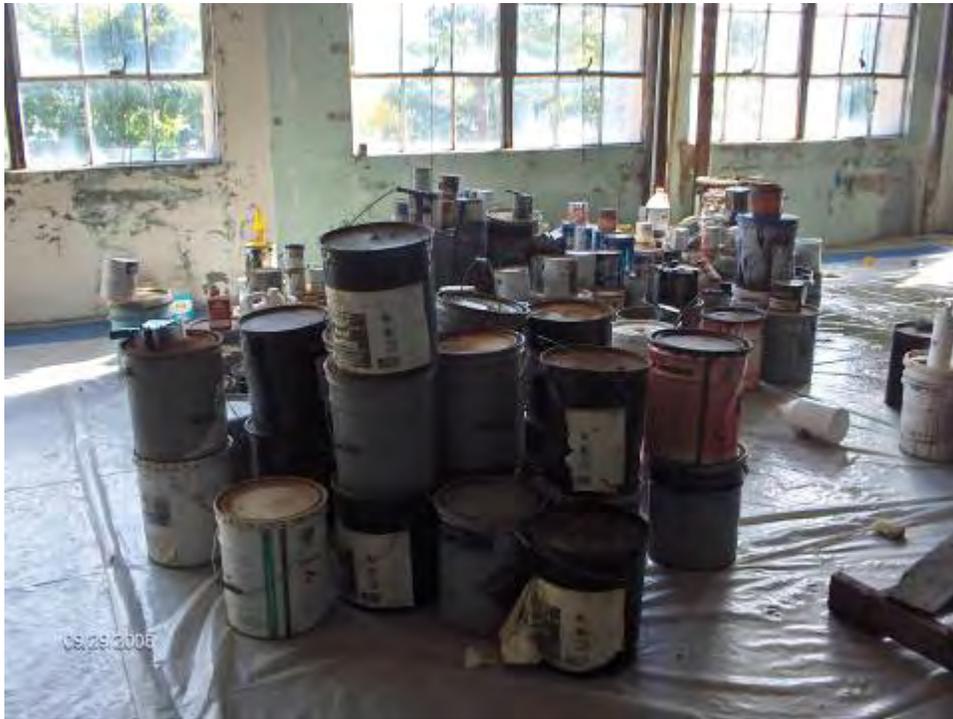
**SCENE:** View of the segregated and staged waste containers located in the waste staging area, prior to load-out activities.

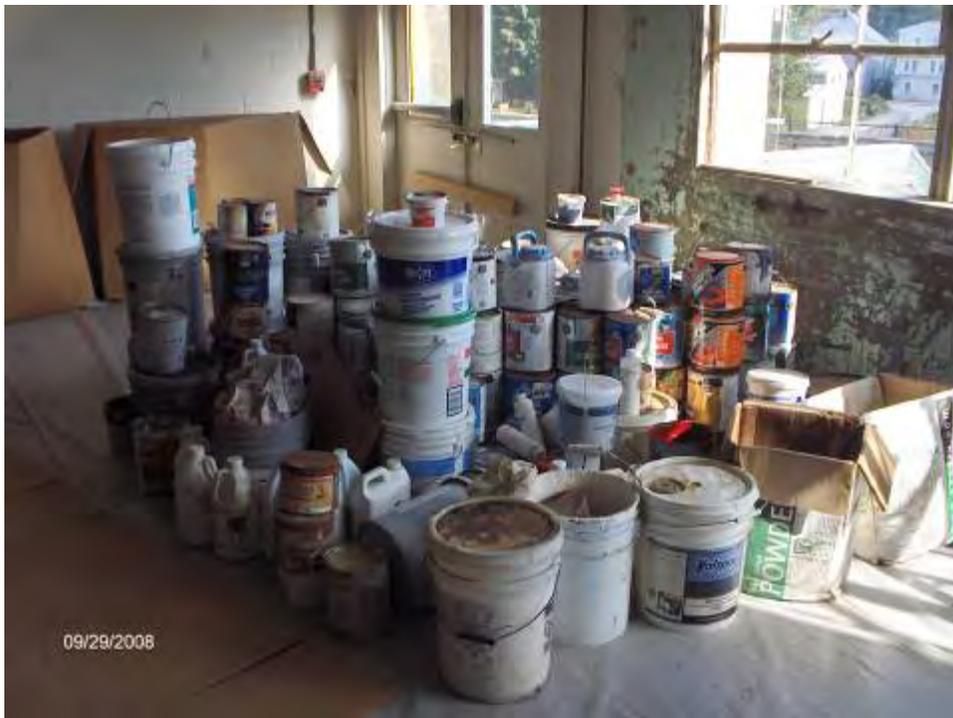
**SCENE:** View of the segregated and staged waste containers of latex paints located in the waste staging area, prior to load-out activities.

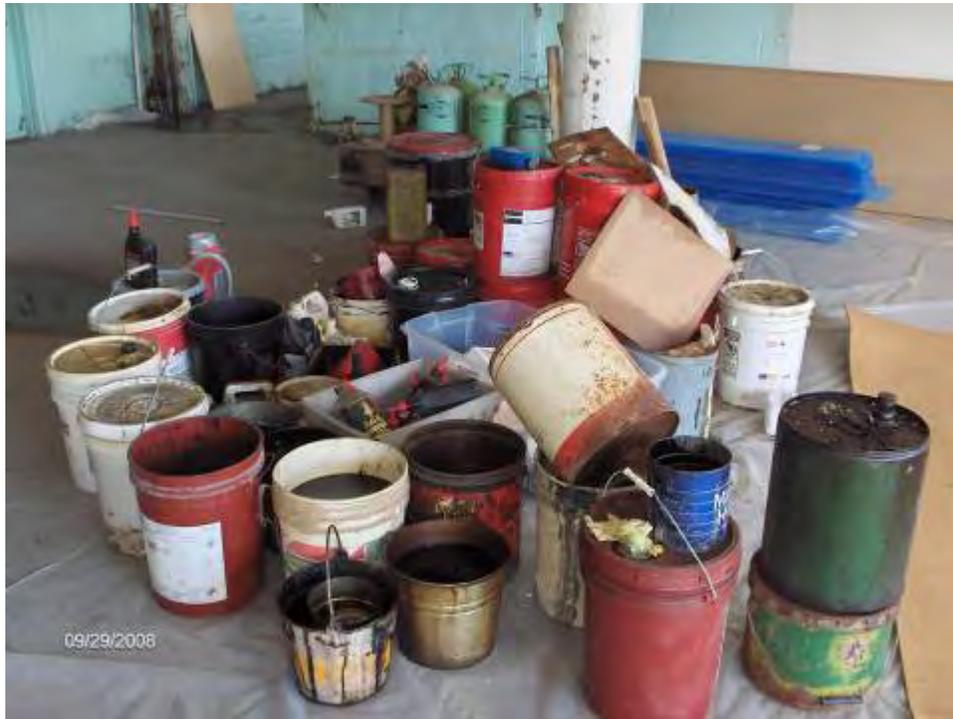
**SCENE:** View of the segregated and staged waste containers of waste oils located in the waste staging area, prior to load-out activities.

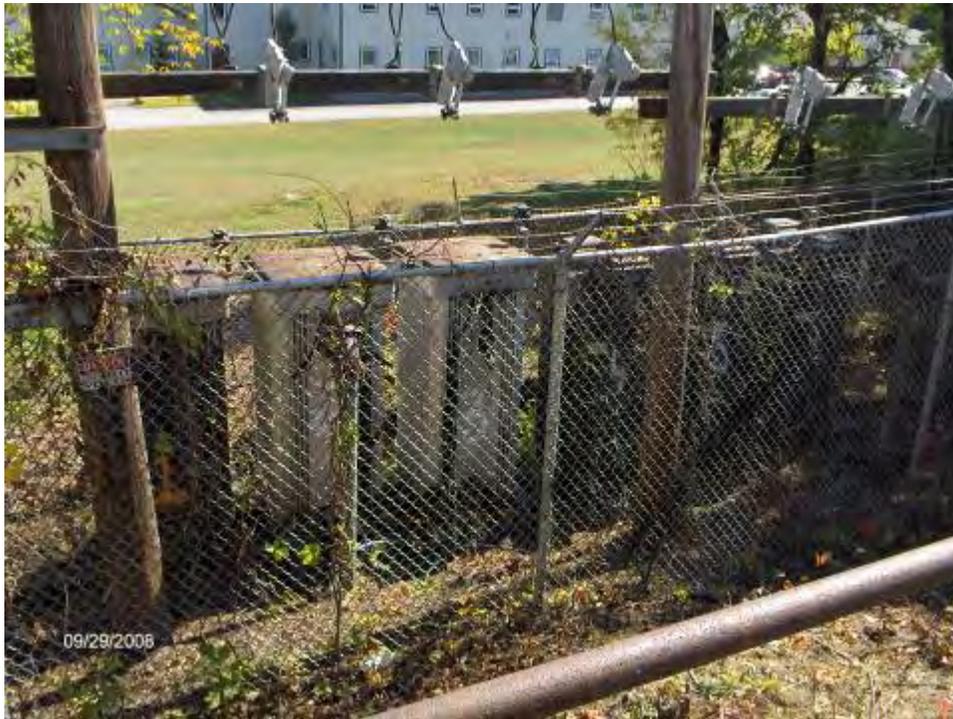
**SCENE:** View of the transformer pad, located east of the on-site building, prior to the removal of the nine transformers. Photograph taken facing southeast.

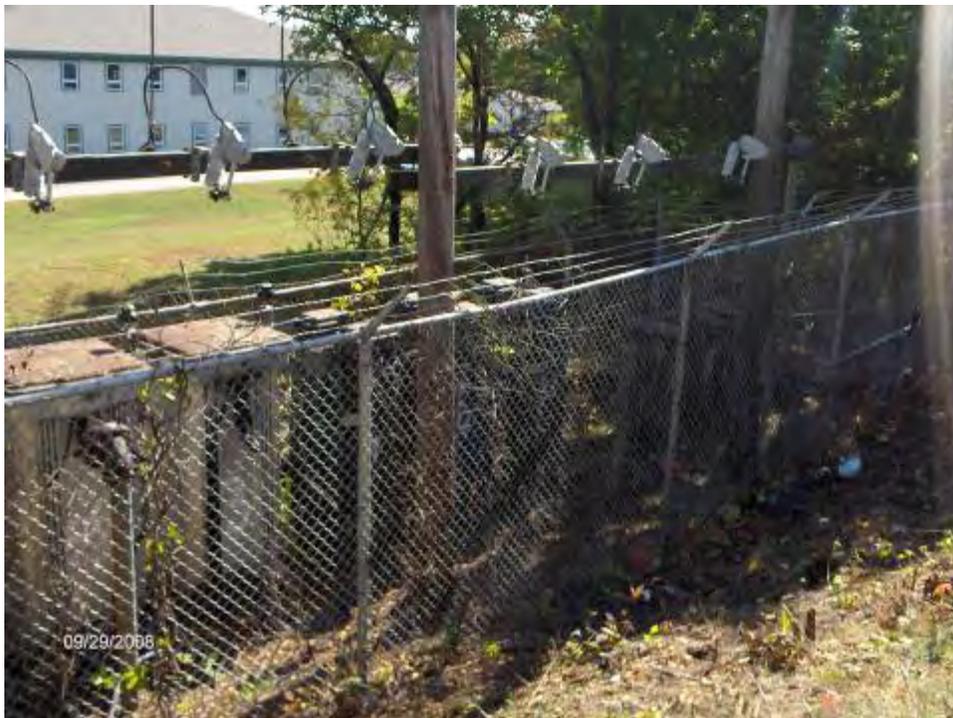
**SCENE:** View of the transformer pad, located east of the on-site building, prior to the removal of the nine transformers. Photograph taken facing southeast.

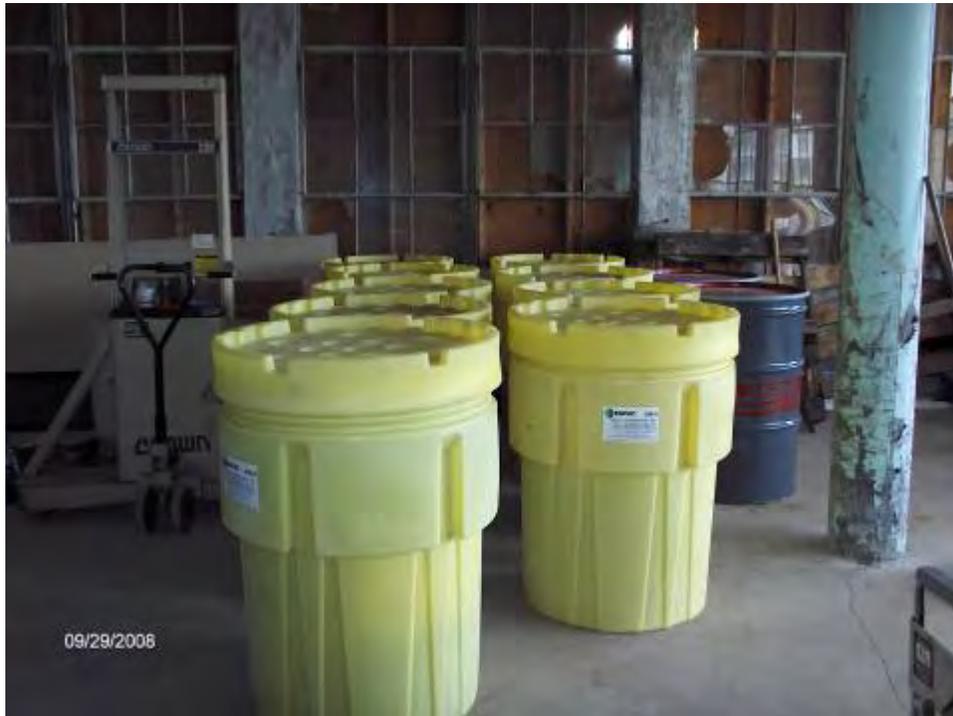
**SCENE:** View of the poly overpack drums staged in the waste staging area, prior to load-out activities.

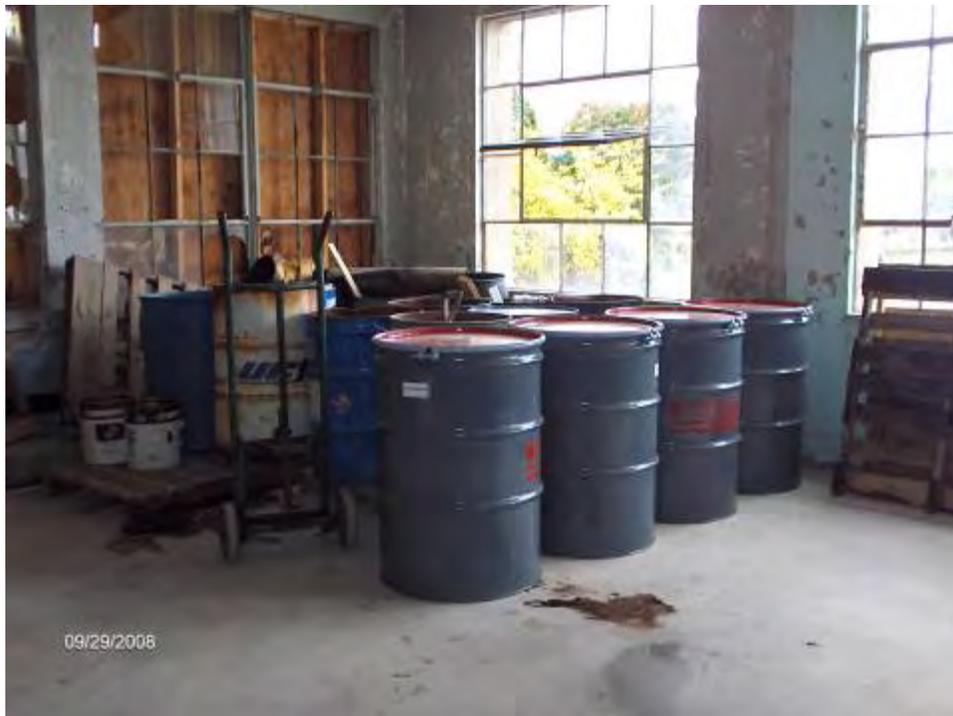
**SCENE:** View of steel overpack drums staged in the waste staging area, prior to load-out activities.

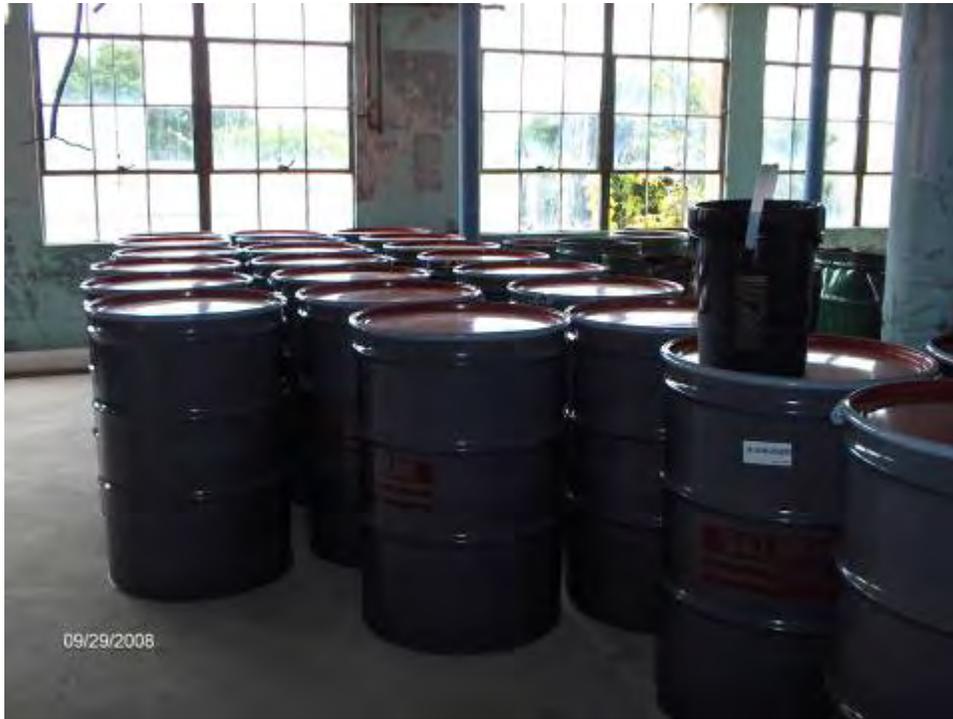
**SCENE:** View of steel overpack drums staged in the waste staging area, prior to load-out activities.

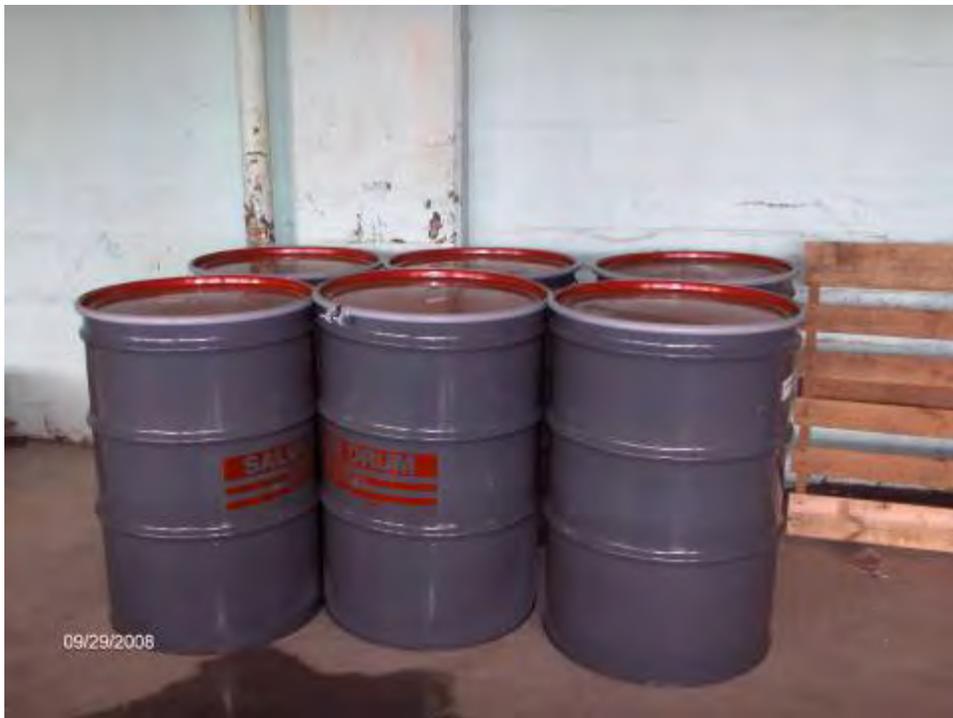
**SCENE:** View of steel overpack drums staged in the waste staging area, prior to load-out activities.

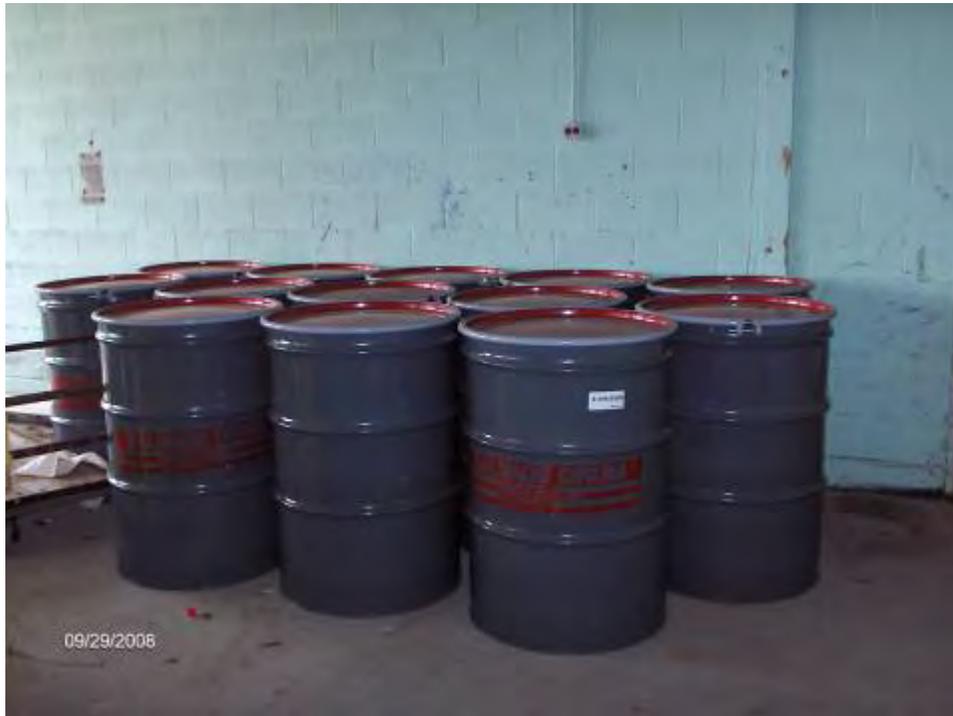
**SCENE:** View of empty (unused) steel overpack drums staged in the waste staging area.

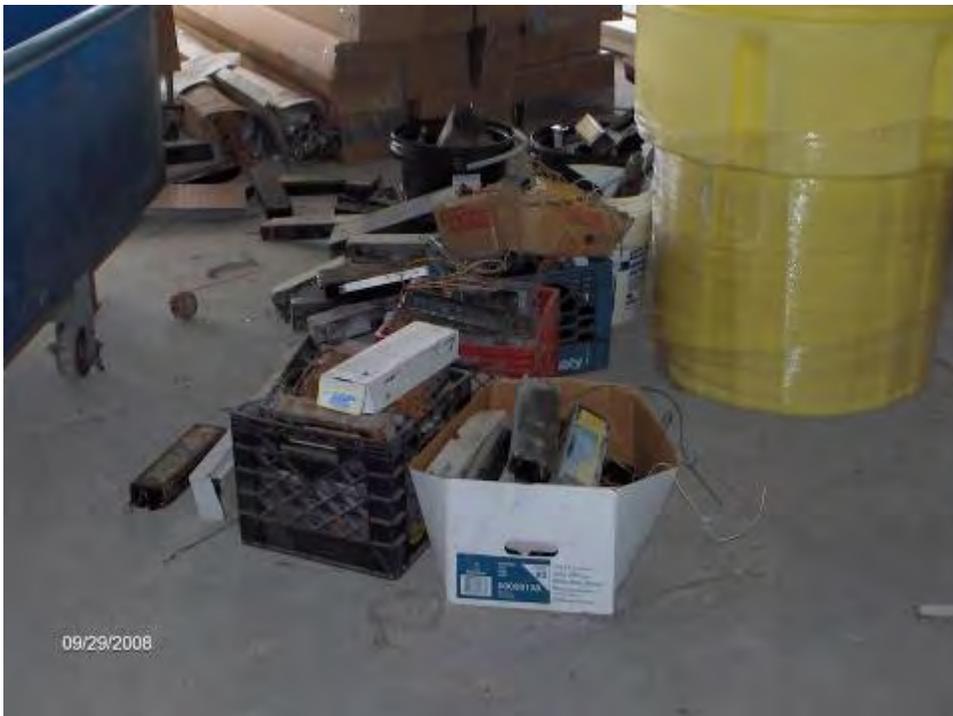
**SCENE:** View of the fluorescent light ballasts staged in the waste staging area, prior to load-out activities.

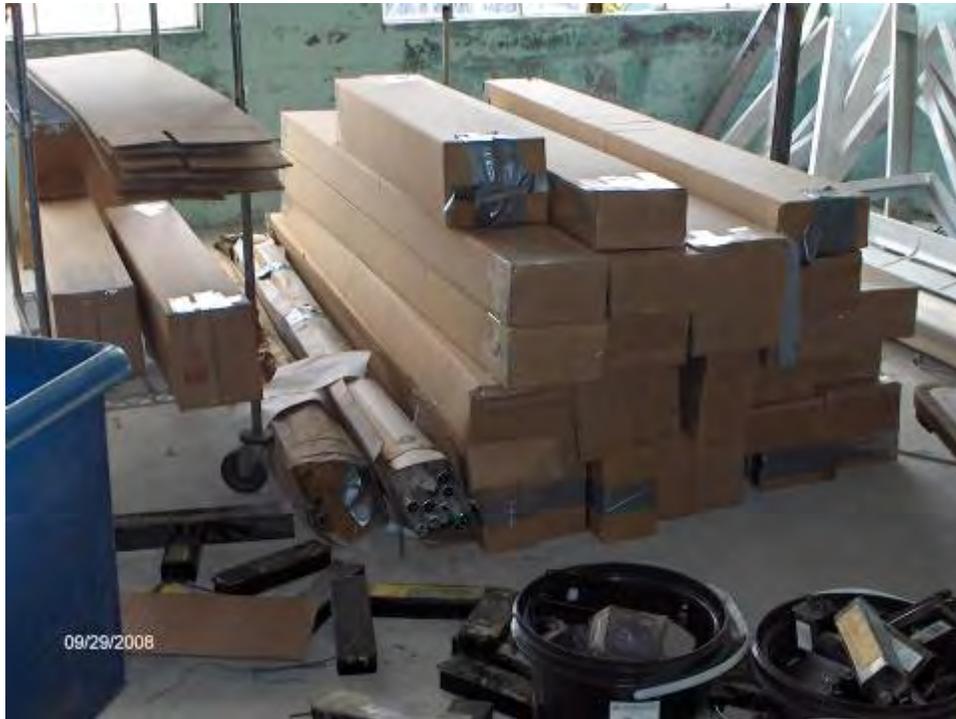
**SCENE:** View of the packaged fluorescent light bulbs and ballasts staged in the waste staging area, prior to load-out activities.

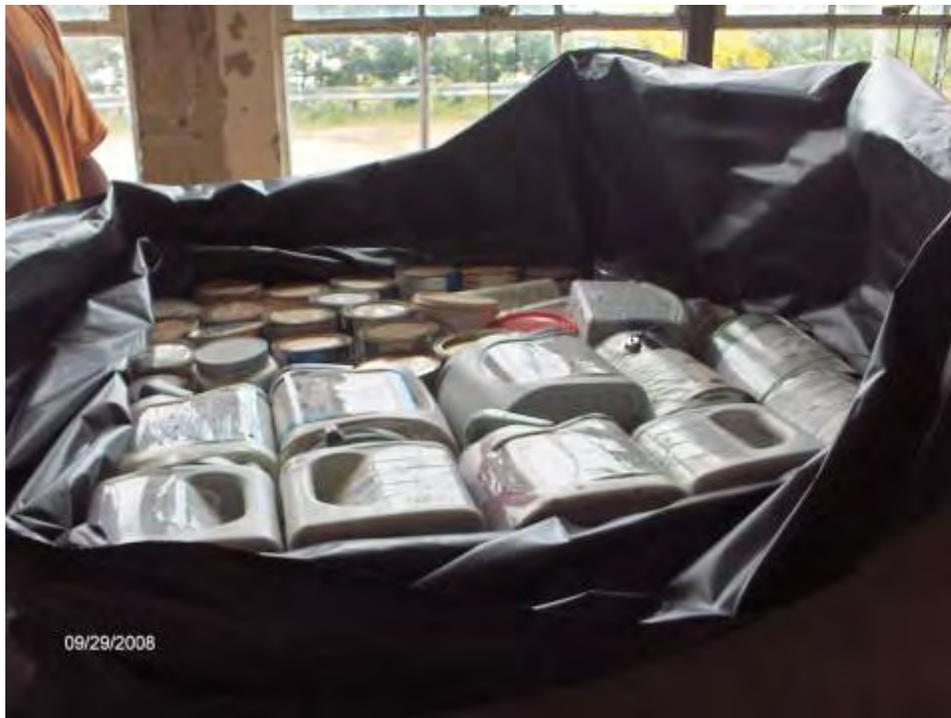
**SCENE:** View of waste containers, from the waste staging area, packed inside of a 1-cubic-yard box in preparation for disposal.

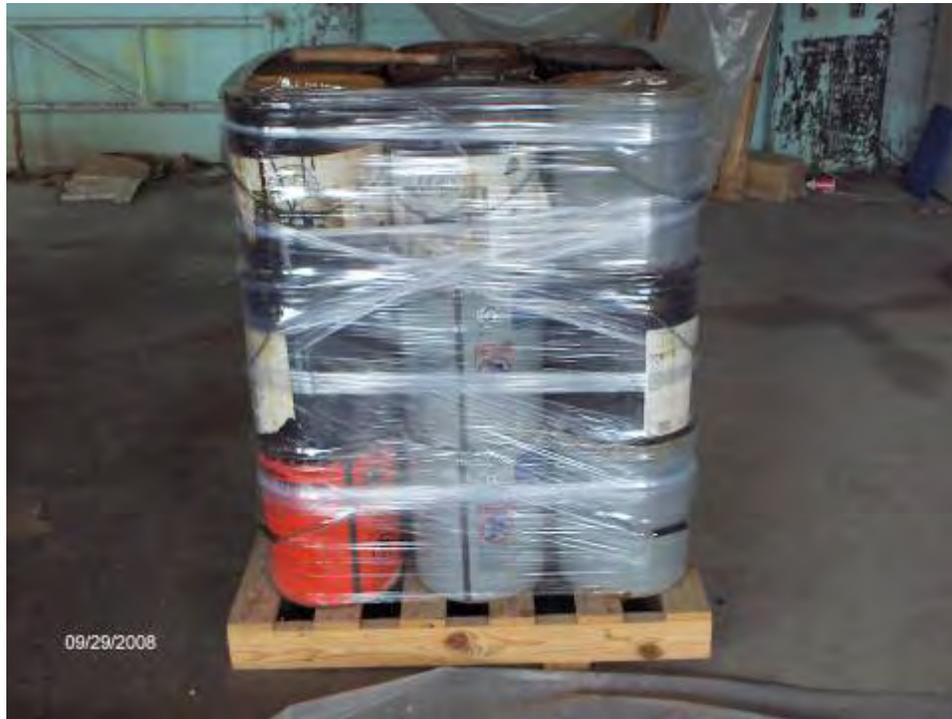
**SCENE:** View of waste containers, from the waste staging area, wrapped on a pallet in preparation for disposal.

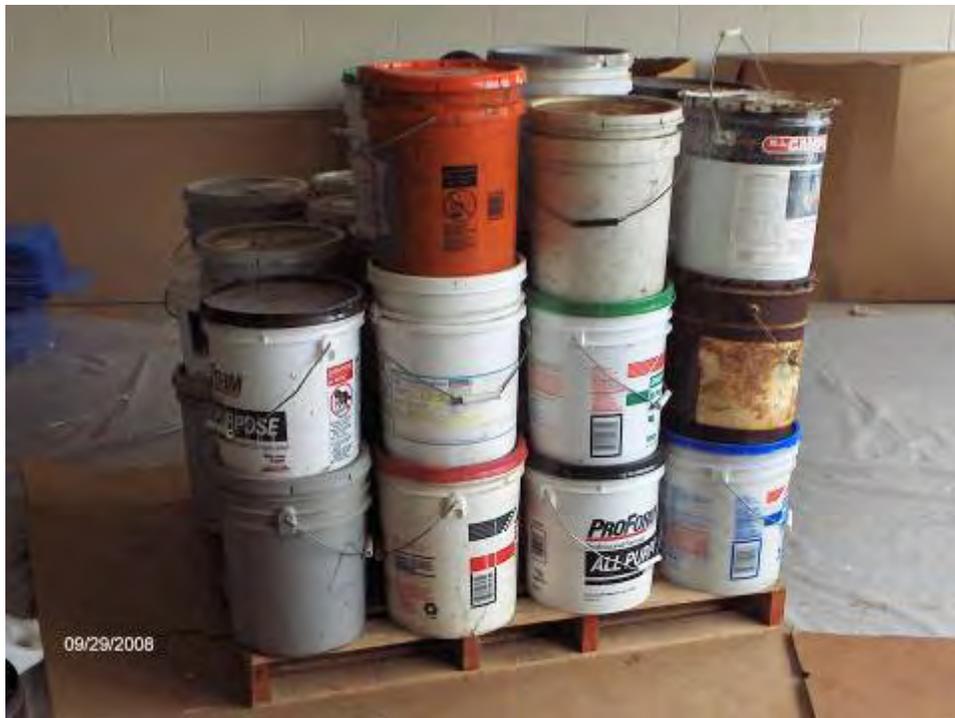
**SCENE:** View of waste containers, from the waste staging area, on a pallet in preparation for disposal.

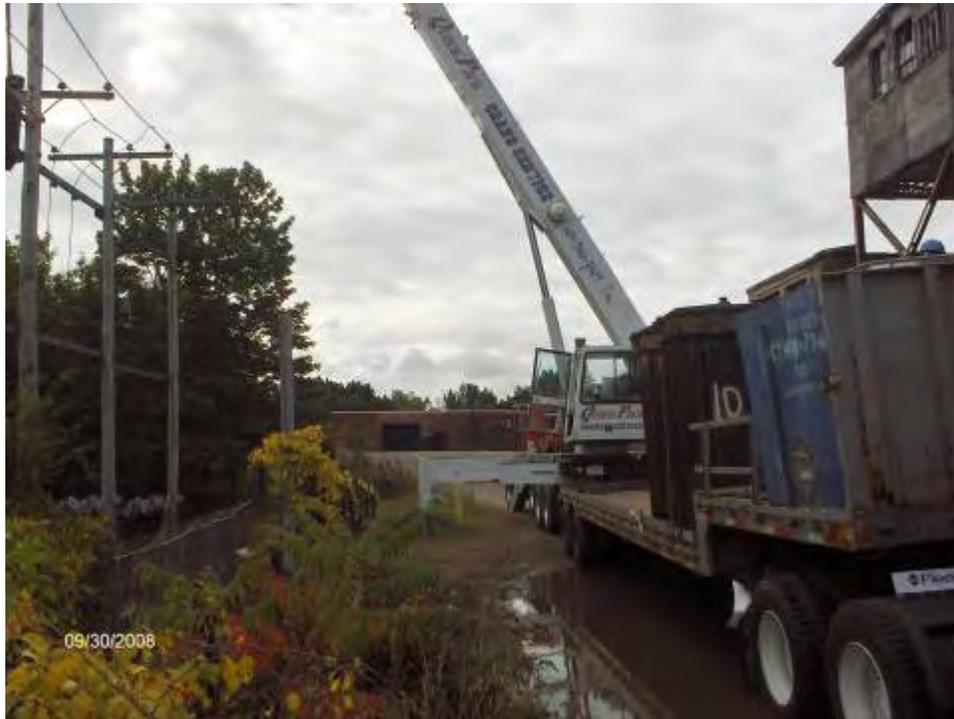
**SCENE:** View of the crane that was used to extract the nine transformers from the transformer pad located east of the on-site building. Photograph taken facing south.

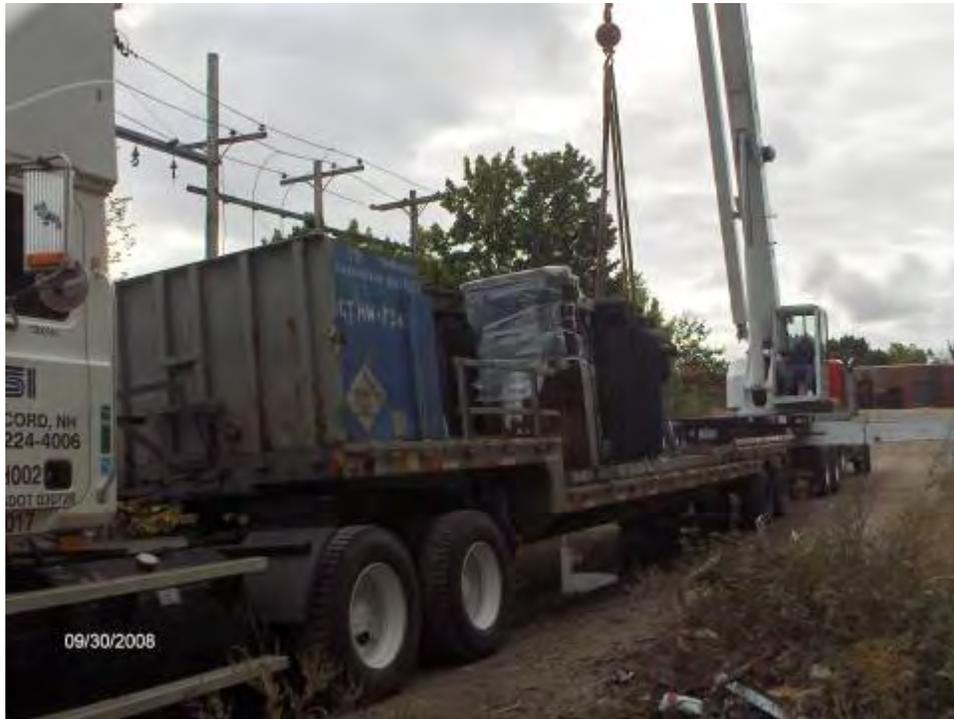
**SCENE:** View of the crane loading a transformer onto a flat-bed trailer after extracting it from the transformer pad located east of the on-site building. Photograph taken facing southeast.

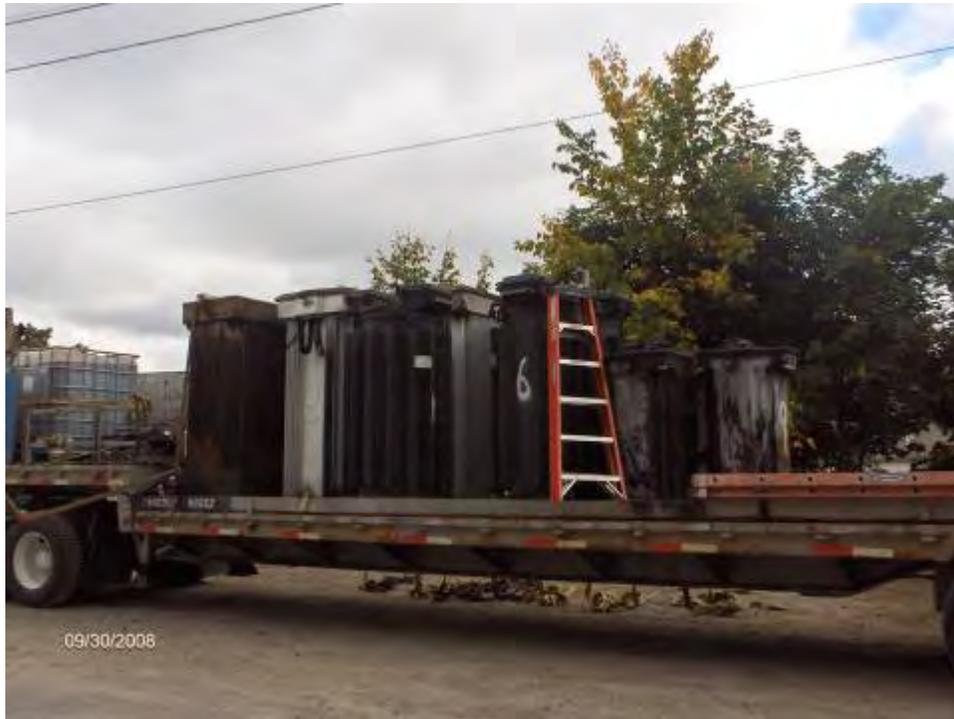
**SCENE:** View of the nine transformers, extracted from the transformer pad located east of the on-site building, loaded on the flat-bed trailer for disposal. Photograph taken facing south.
