September 30, 2009

**Subject: Final Emergency Response Letter Report  
Goodwater Mercury Spill  
Goodwater, Coosa County, Alabama  
EPA Contract No. EP-W-05-054  
TDD No. TTEMI-05-001-0102**

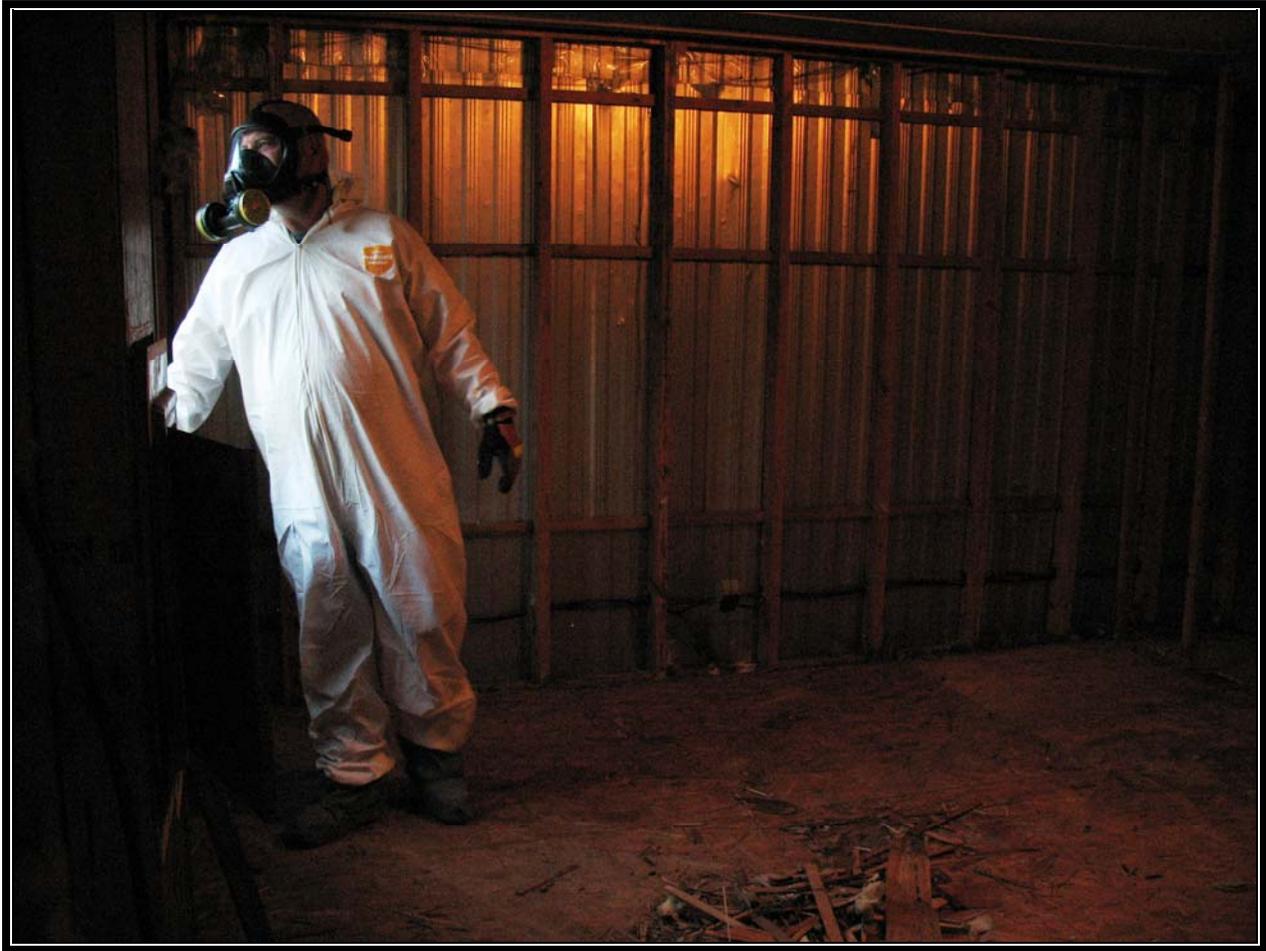
**OFFICIAL PHOTOGRAPH NO. 6  
U.S. ENVIRONMENTAL PROTECTION AGENCY**

**TDD Number:** TTEMI-05-001-0102      **Location:** Goodwater Mercury Spill  
**Orientation:** South      **Date:** June 13, 2009  
**Photographer:** Courtney Roden, Tetra Tech      **Witness:** Charles Berry, Tetra Tech  
**Subject:** WRS's subcontractor, USES, removing structural components from the master bedroom in Level C PPE.
