**REMOVAL PROGRAM
PRELIMINARY ASSESSMENT/
SITE INVESTIGATION REPORT
FOR THE
MARINO PROPERTY
MIDDLETOWN, CONNECTICUT
12 AUGUST 1999**

U.S. Environmental Protection Agency
Region I
Emergency Planning and Response Branch
1 Congress Street, Suite 1100
Boston, MA 02114-2023

Roy F. Weston, Inc. (WESTON®)
Superfund Technical Assessment and Response Team (START)
217 Middlesex Turnpike
Burlington, MA 01803

September 1999

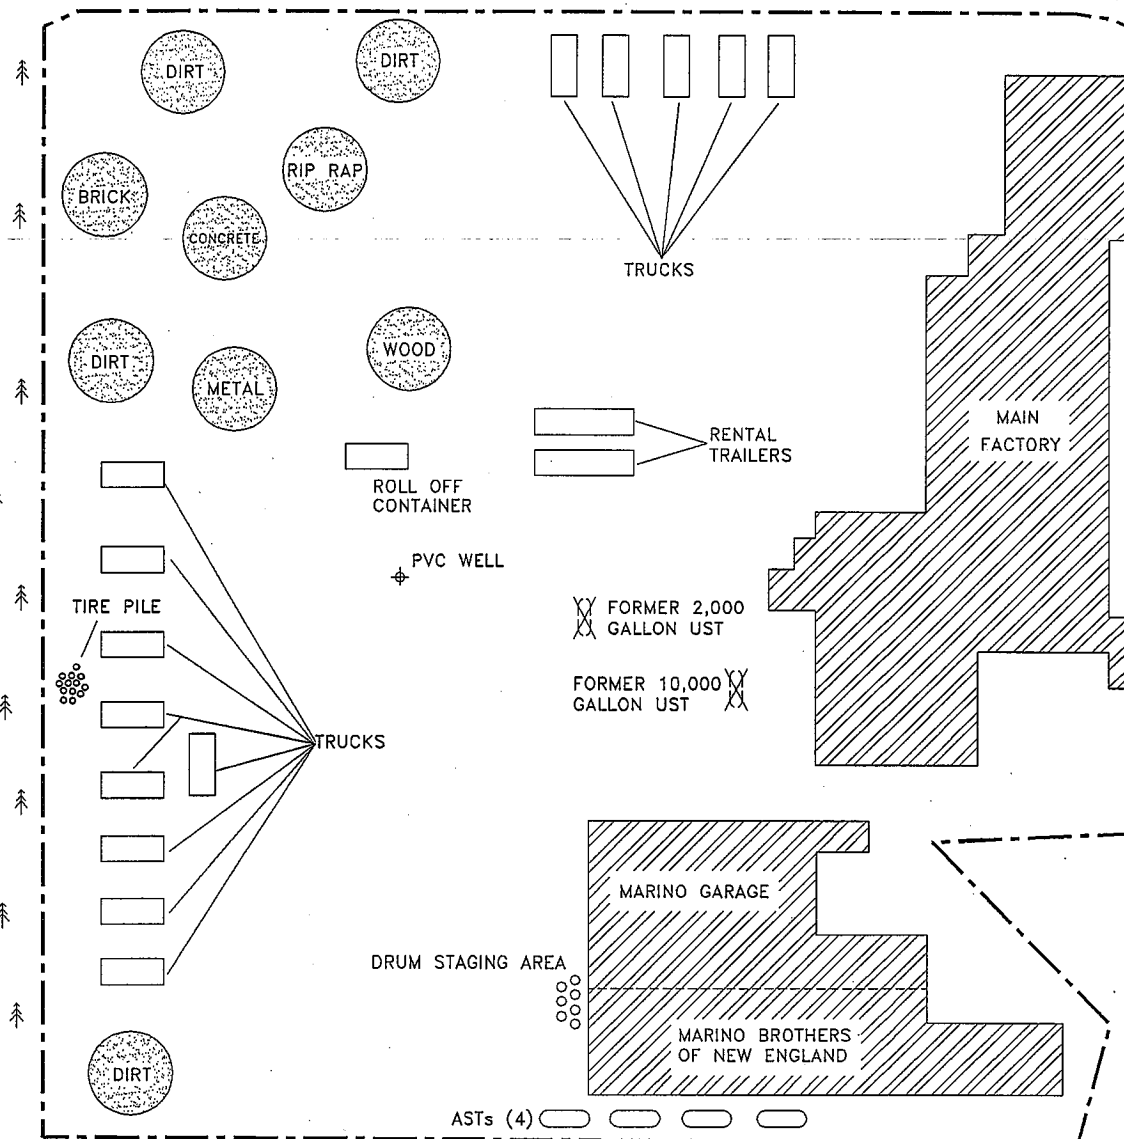
FIGURE 2

(X) Piles:	Piles of soil, brick, concrete, metal debris, wood, and rock are located in the northwest and southwest corners of the property.
(X) Stained Soil:	Uncontained AST containing diesel fuel located adjacent to a red storage box (see Appendix D - Film Roll 03375 Frame Numbers 9 and 10).
() Sheens:	
() Stressed Vegetation:

In addition to piles of wood, concrete, soil, gravel, tires, tree limbs, metal pipes, and bricks on the property, START noted that four aboveground storage tanks, vent and fill pipes for two former underground storage tanks, drums staged alongside the building, and trucks used for storage purposes were on site. CFL Inc., of Manchester, Connecticut, a contractor for the City of Middletown Sewage Treatment Plant Relocation Project, leases a portion of the property to stage office trailers, stockpile clean fill, and store construction supplies.

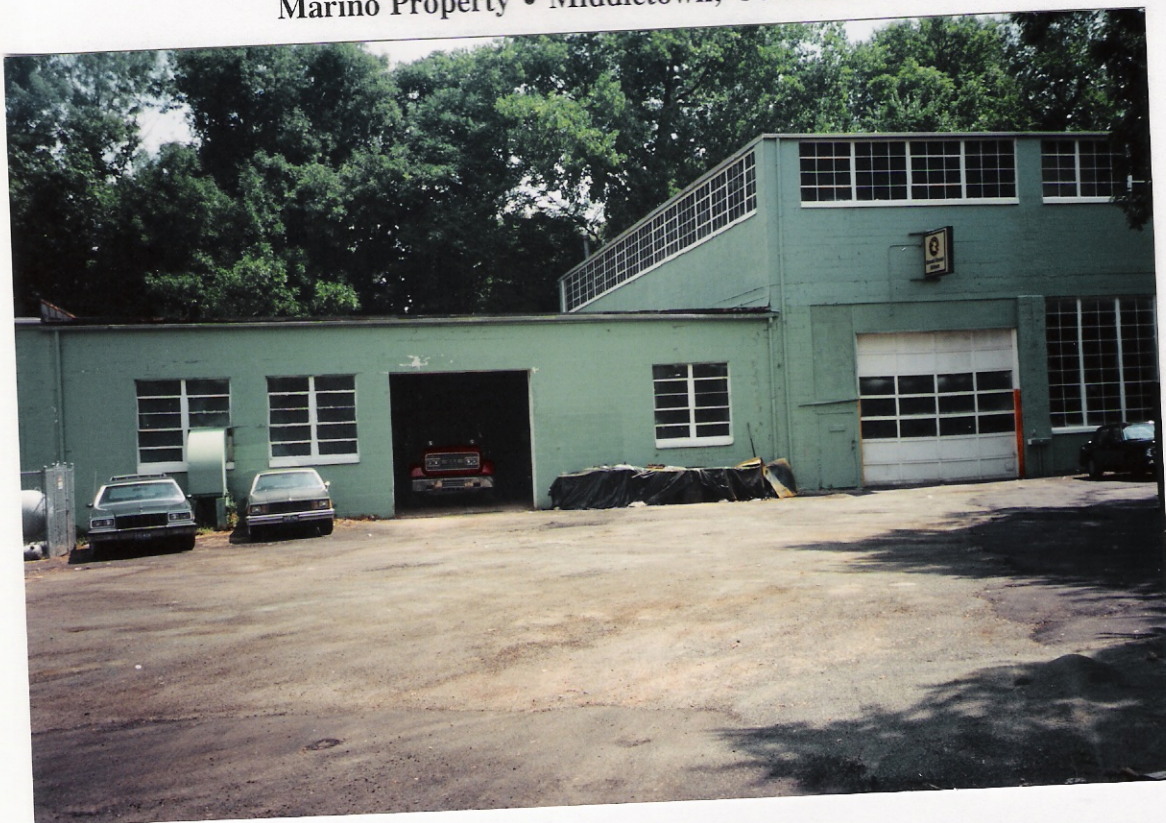
FRAME NUMBER: 8 **DATE:** 27 July 1999

SCENE: View of Detroit Diesel Allison building, facing east.

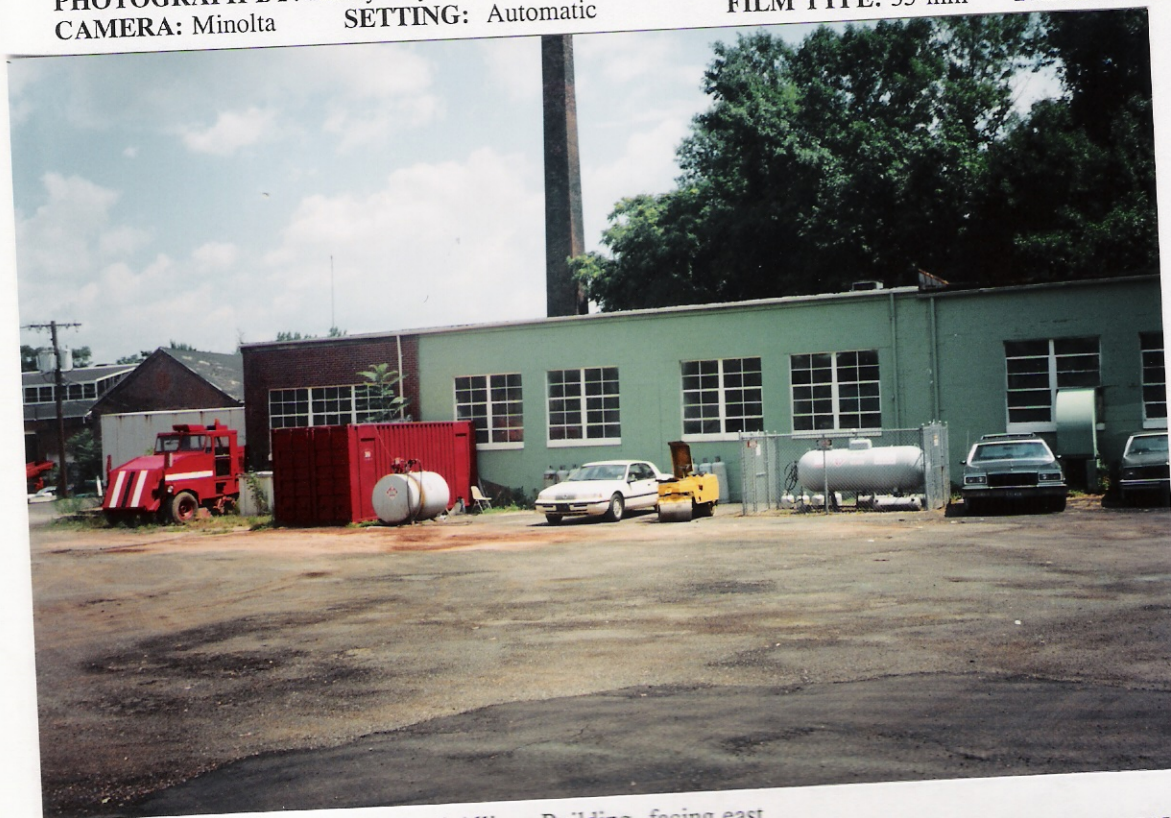
FRAME NUMBER: 9 **DATE:** 27 July 1999

SCENE: View of Detroit Diesel Allison Building, facing east

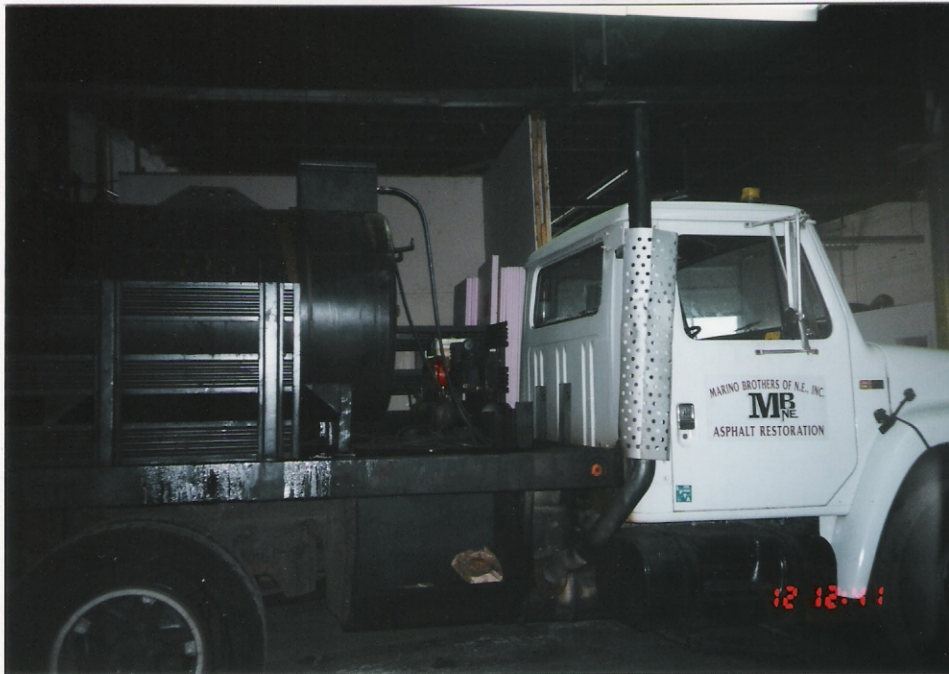
SCENE: View of a Marino Brothers of New England truck waiting to be cleaned, facing north.		
FRAME NUMBER: 4	DATE: 12 August 1999	TIME: 1241
SKY CONDITION: Indoor	PHOTO BY: Julie Geissler	WITNESS(ES): Eric Ackerman
CAMERA: Minolta	SETTING: Automatic	
FILM TYPE: 35 mm	FILM ROLL: BC10023

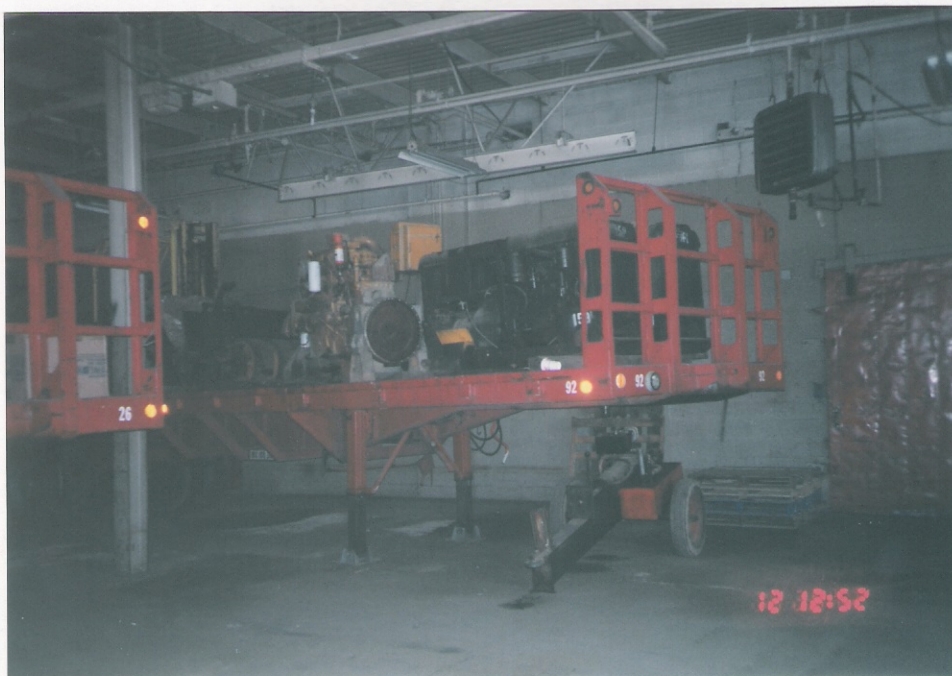
SCENE: SCENE: View of a log splitter and generators in Mr. Sal Marino's garage area, facing west.
FRAME NUMBER: 6
SKY CONDITION: Indoor
CAMERA: Minolta
FILM TYPE: 35 mm
DATE: 12 August 1999
PHOTO BY: Julie Geissler
SETTING: Automatic
FILM ROLL: BC100203
TIME: 1252
WITNESS(ES): Eric Ackerman
