**REMOVAL PROGRAM
PRELIMINARY ASSESSMENT/
SITE INVESTIGATION REPORT
FOR THE
FORMER WATERBURY CLOCK FACTORY
WATERBURY, NEW HAVEN COUNTY, CONNECTICUT
8 JULY 2019, 4 SEPTEMBER 2019, AND
21 THROUGH 24 OCTOBER 2019**

U.S. Environmental Protection Agency
Region I
Emergency Planning and Response Branch
5 Post Office Square, Suite 100
Boston, Massachusetts 02109-3912

Weston Solutions, Inc.
Region I
Superfund Technical Assessment and Response Team
101 Billerica Avenue, Building 5, Suite 103
North Billerica, Massachusetts 01862

December 2019

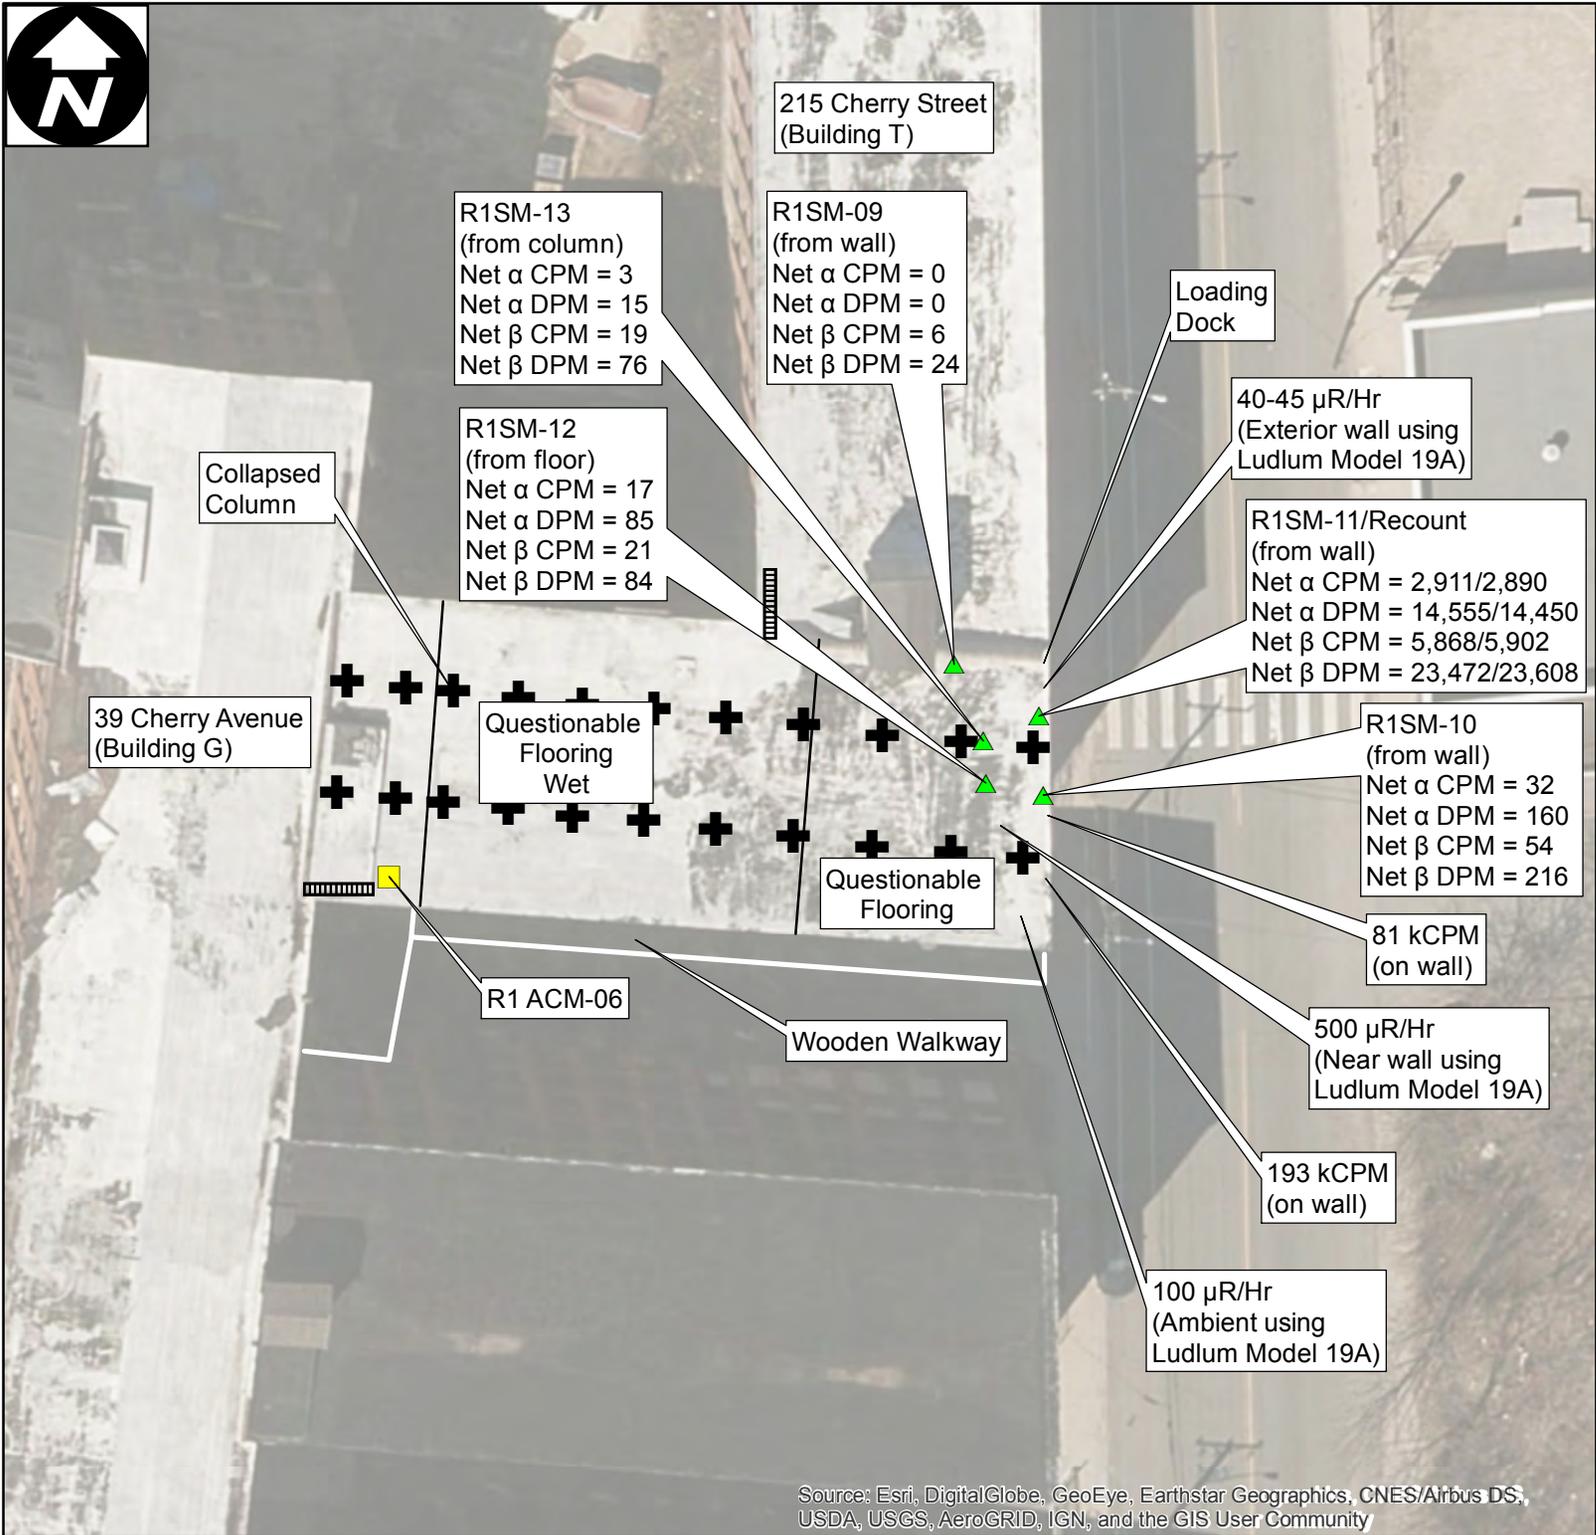
Figure 6
Building R - First Floor
Radiation Readings
and Building Conditions
Former Waterbury Clock Factory
215 Cherry Street
Waterbury, Connecticut

START member Kelly noted a high level of 350 $\mu\text{R/hr}$ on the EPA Ludlum 19A in the vicinity of the interior side of the loading dock (eastern wall) near the location where elevated radiation level measurements had been noted outside the building. EPA NCRFO/RERT member Faller noted that he obtained a reading of 400-450 $\mu\text{R/hr}$ on his radiation unit. START member Kelly noted that Faller had scanned a large area of the wall and floor within this area and obtained the higher result near the base of the wall at floor level. EPA Faller also noted that he had also obtained elevated readings, up to 250 $\mu\text{R/hr}$ on his radiation unit, along an interior hallway wall within the interior of Building 3/R, west of the loading dock area. No PID readings were noted above background within the areas of Building 3/R entered by START.

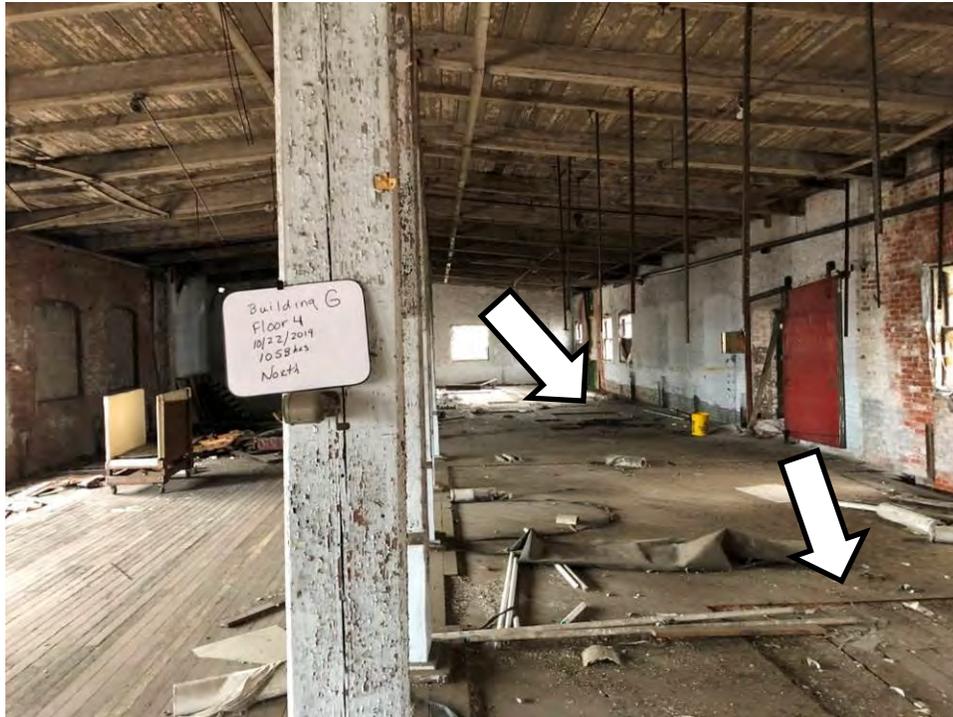
SCENE: View of Building G, Floor 4 with portions of the flooring removed (arrows) that contained elevated Ra-226.
Photograph taken facing north.

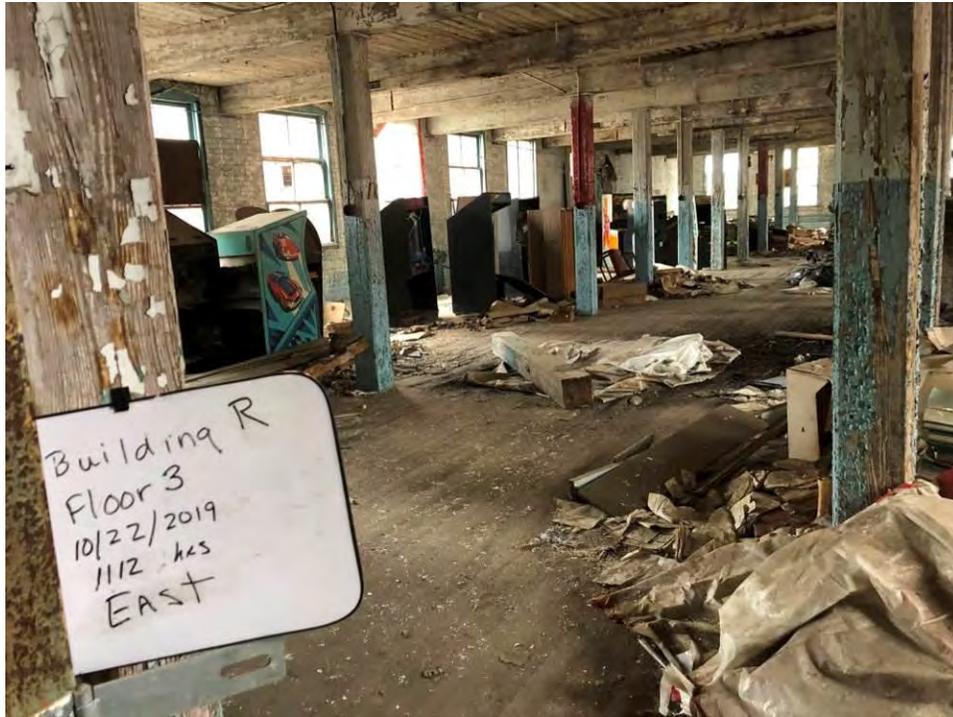
SCENE: View of Building R, Floor 3 with video arcade game carcasses and other debris. Photograph taken facing northeast.

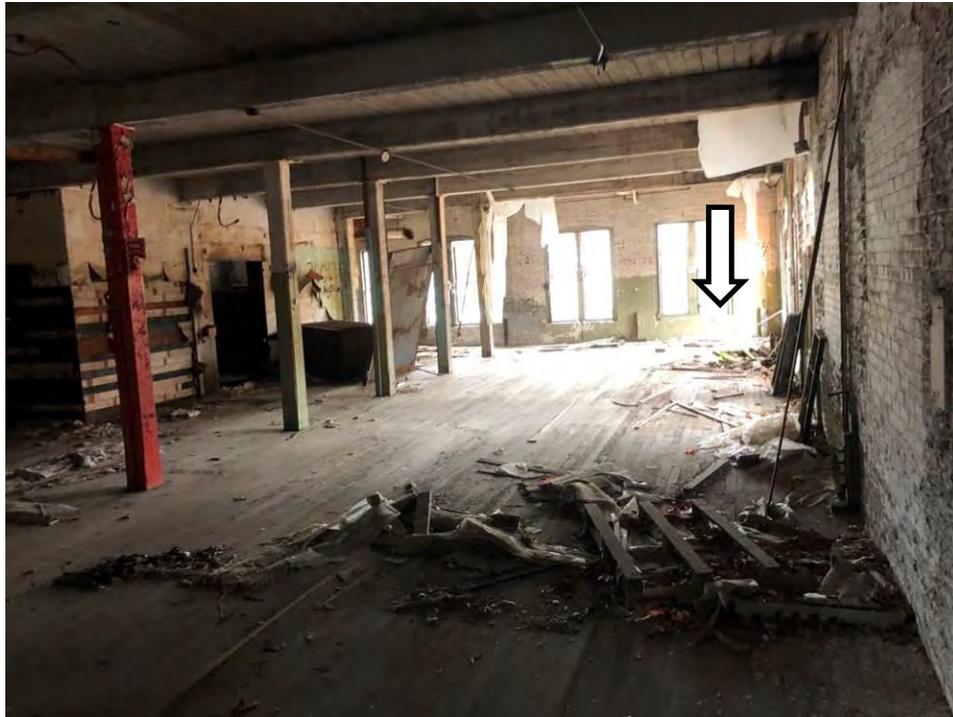
SCENE: View of Building G, Floor 3 with debris and hole in floor (arrow). Photograph taken facing north.

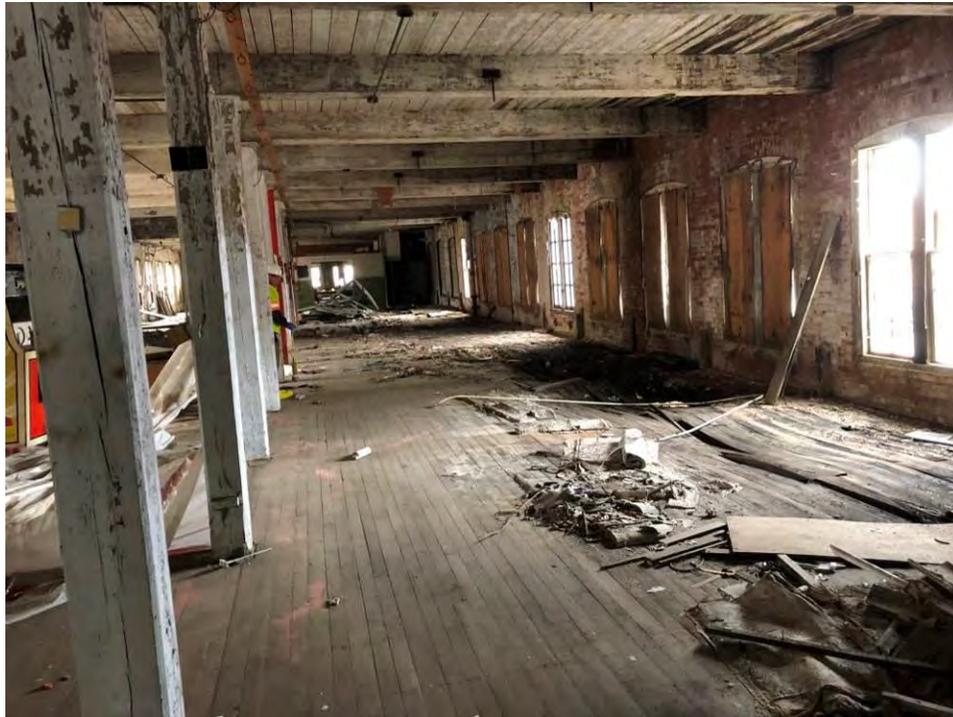
SCENE: View of Building G, Floor 3 with areas of orange paint denoting elevated Ra-226 along the floor near the columns and the warped, structurally compromised flooring. Photograph taken facing southwest.

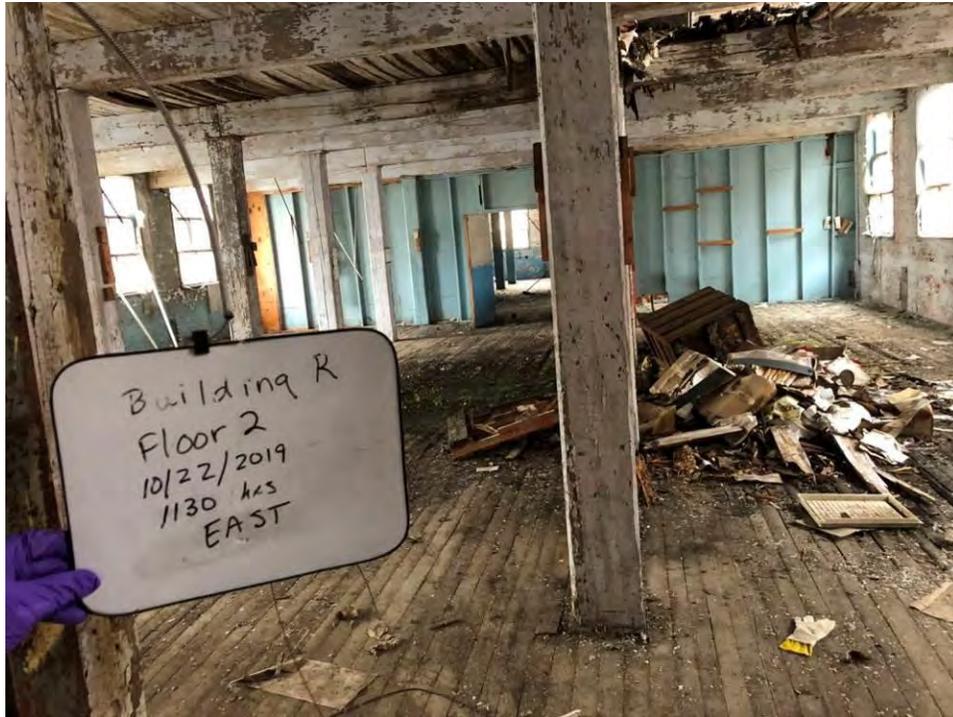
SCENE: View of Building R, Floor 2 with hole in floor above and debris on floor. Photograph taken facing east.

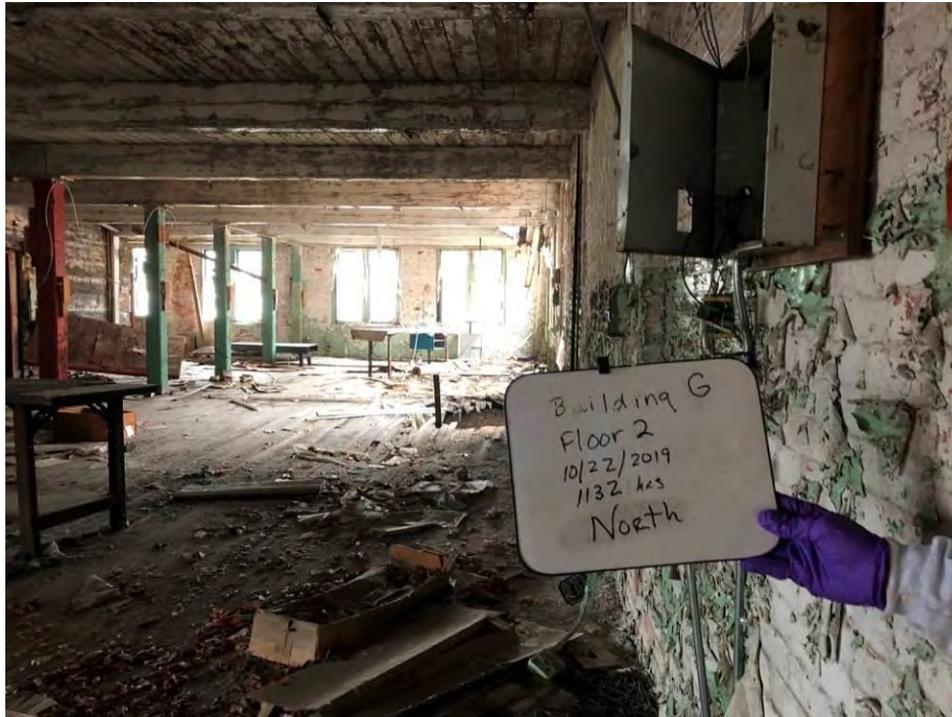
SCENE: View of Building G, Floor 2 with debris and holes in floor. Photograph taken facing north.

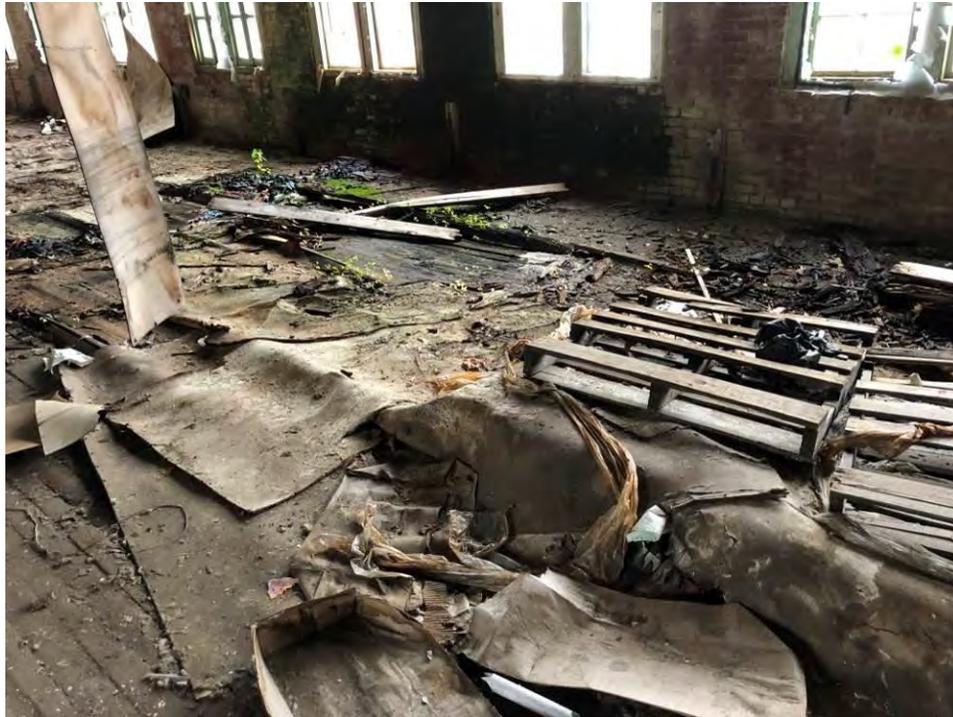
SCENE: View of Building G, Floor 2 with debris and compromised floor. Photograph taken facing west.

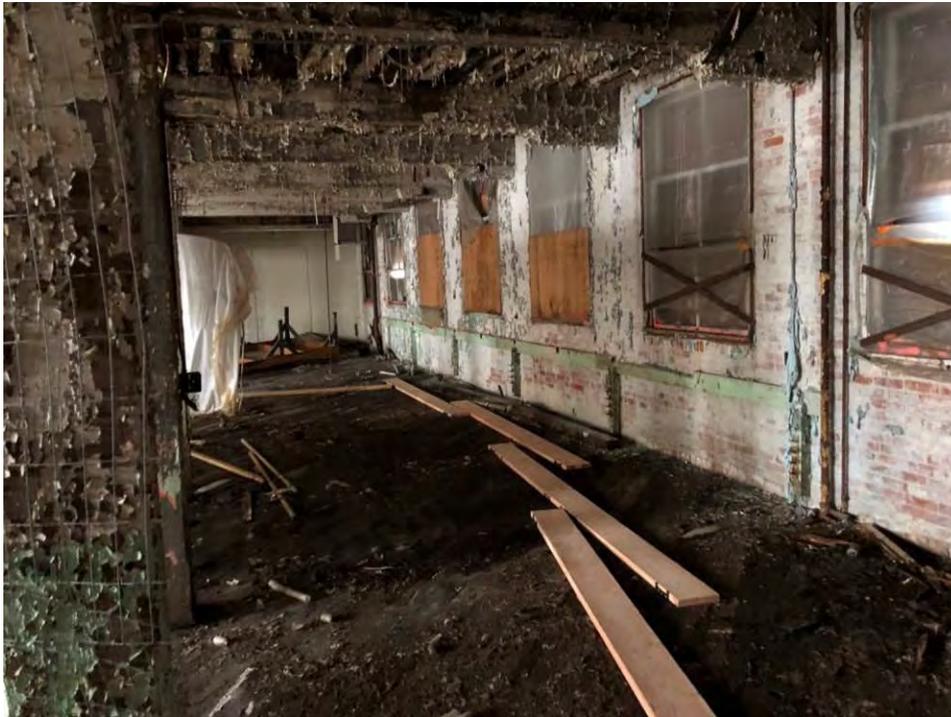
SCENE: View of Building R, Floor 1 with wooden planking used to span beams and cross the compromised floor. Photograph taken facing southeast.

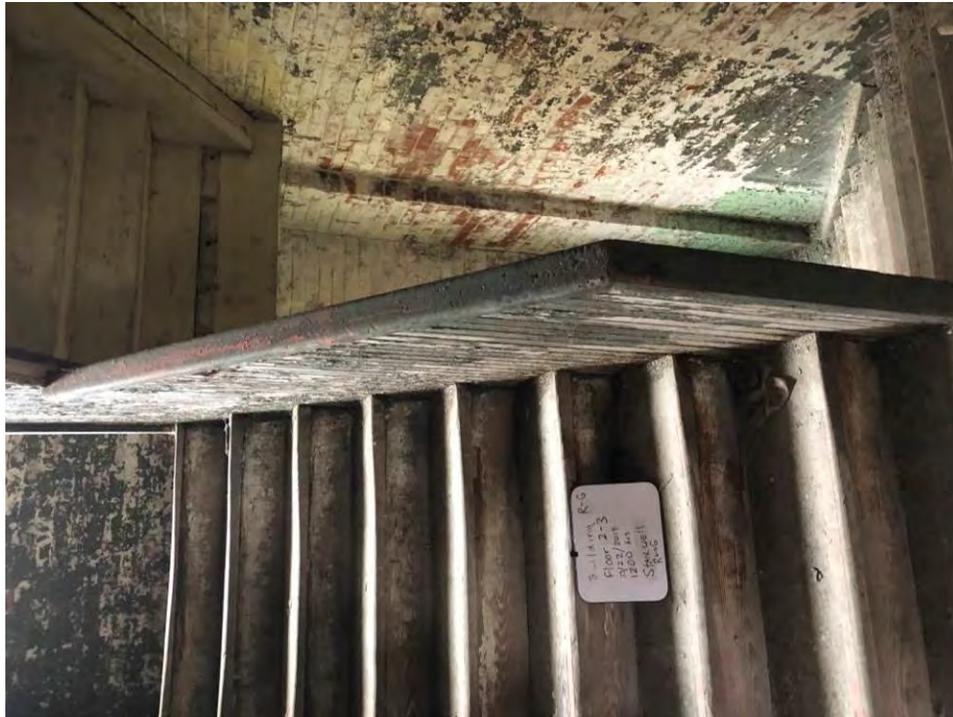
SCENE: View of stairwell between Floor 2 and 3 and between Buildings R and G with orange paint on the handrail denoting elevated Ra-226. Photograph taken facing south.

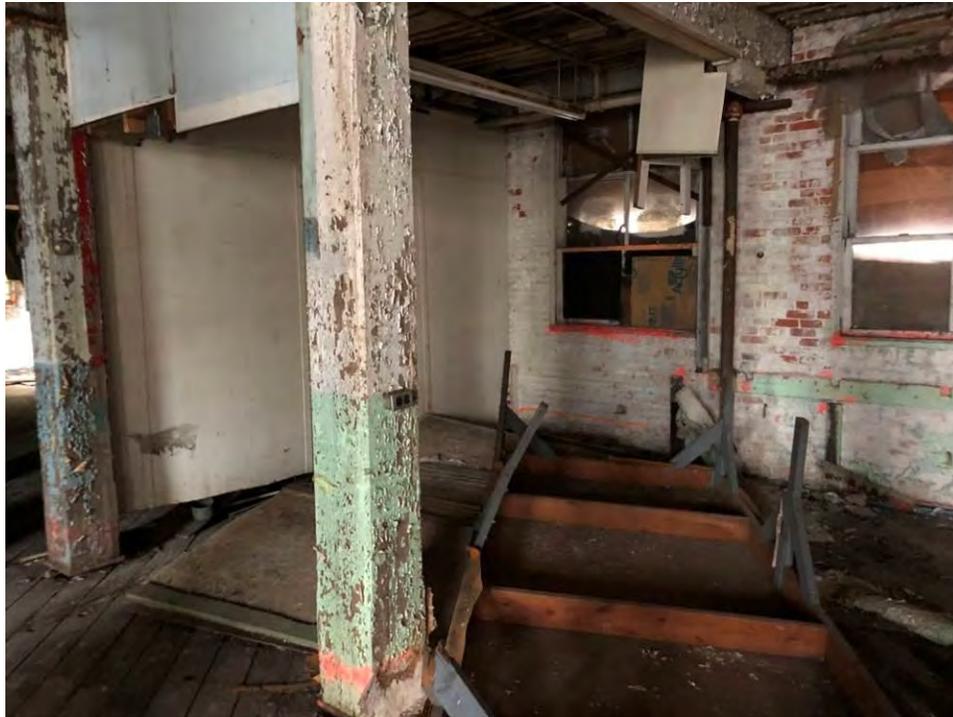
SCENE: View of Building R, Floor 1 with orange paint on columns and windowsills denoting elevated Ra-226. Photograph taken facing southeast.

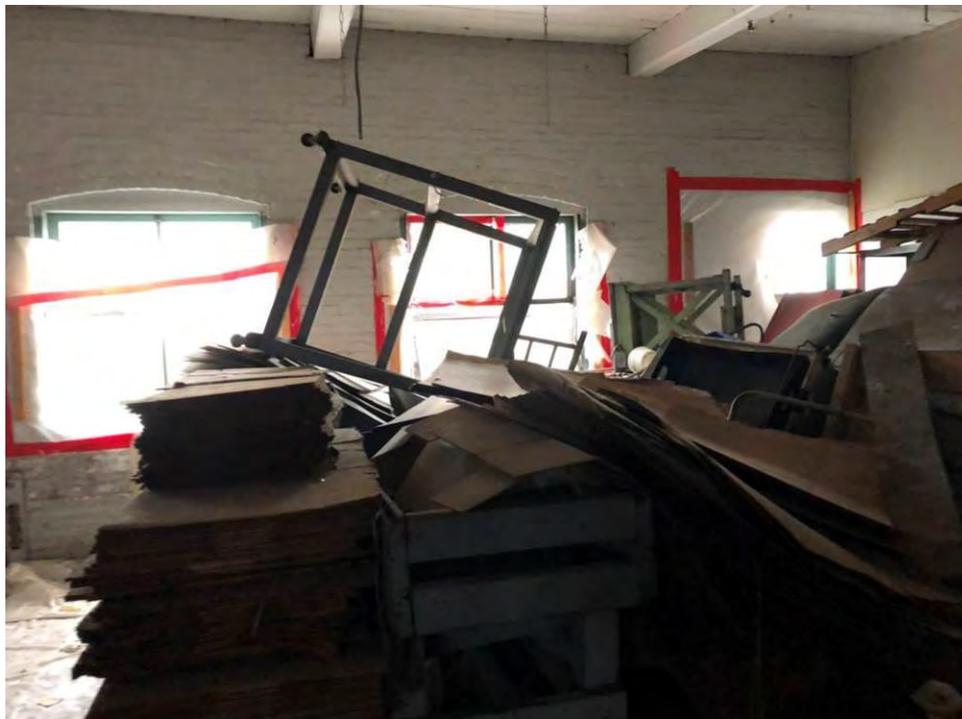
SCENE: View of Building T, Floor 4 with debris (tables/cardboard) in southeastern portion. Photograph taken facing east.

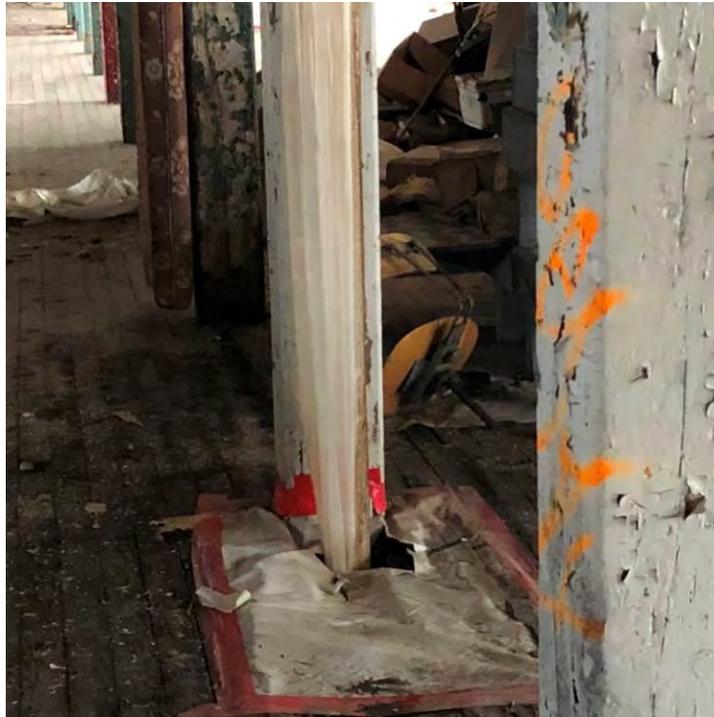
SCENE: View of Building T, Floor 4 with orange paint on column, approximate location of smear sample T4-SM-01. Photograph taken facing northeast.

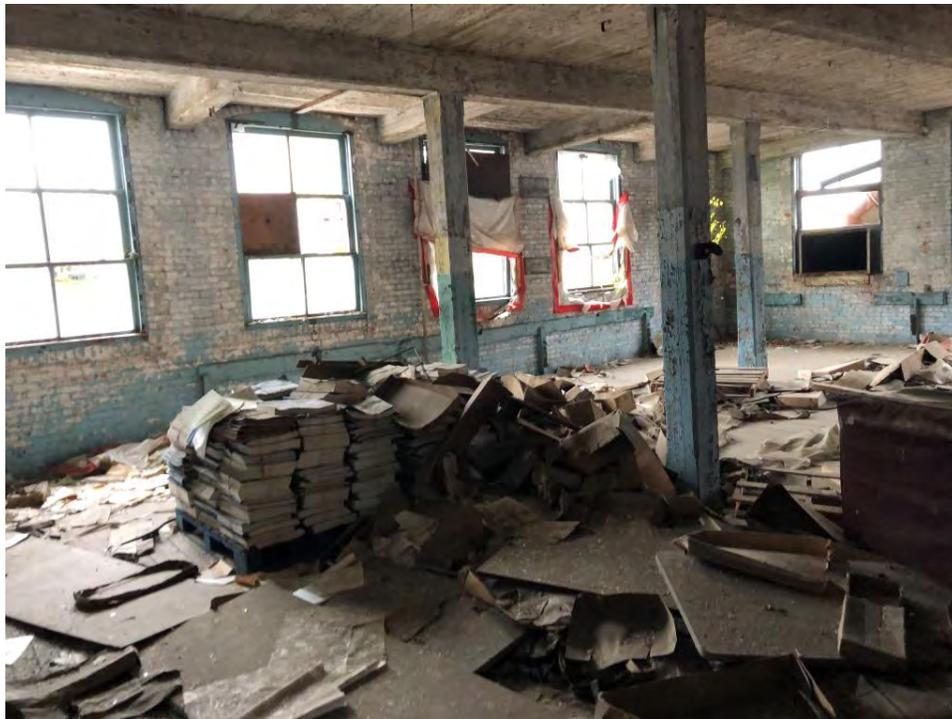
SCENE: View of Building R, Floor 3 with pallet of books in eastern end. Photograph taken facing southeast.

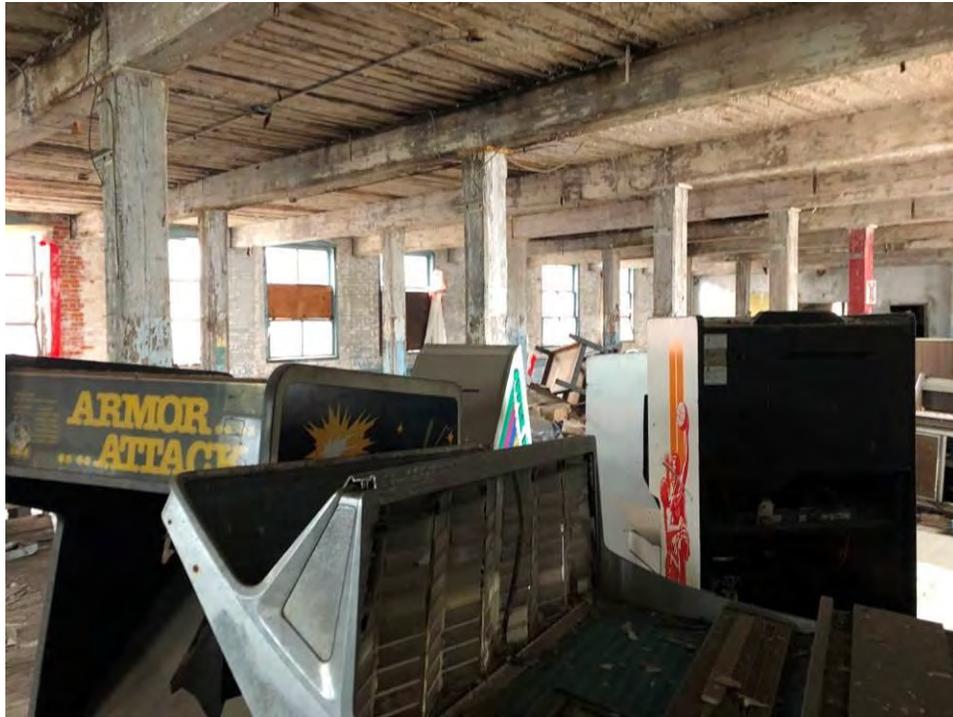
SCENE: View of Building R, Floor 3 with video game carcasses. Photograph taken facing south.

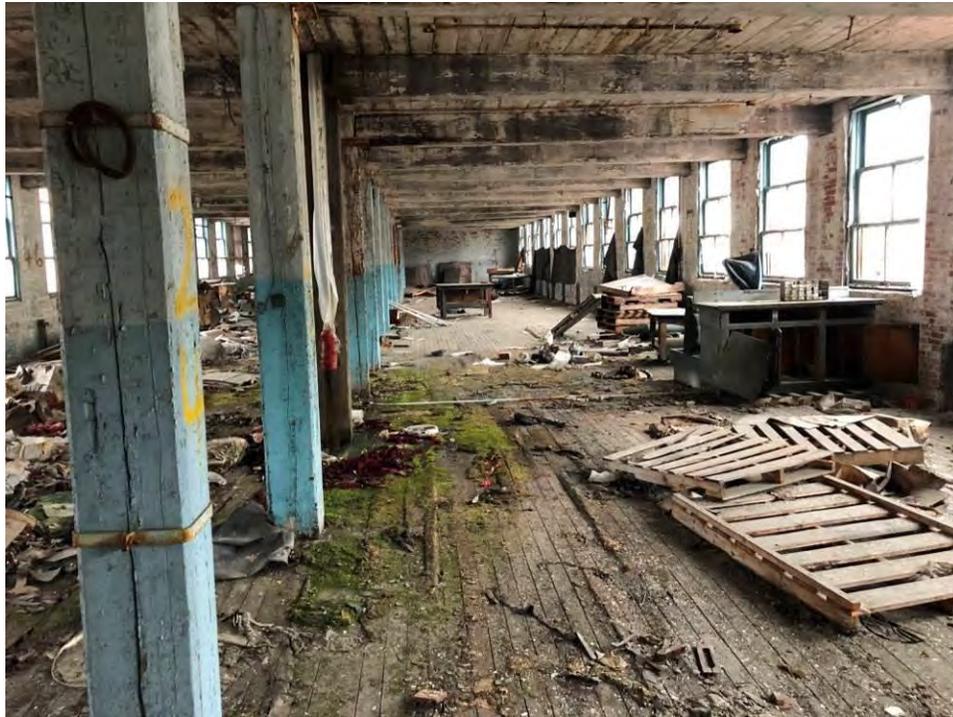
SCENE: View of Building T, Floor 3 with debris including suspected ACM, cardboard and paperwork along with vegetation on the floor. Photograph taken facing north.

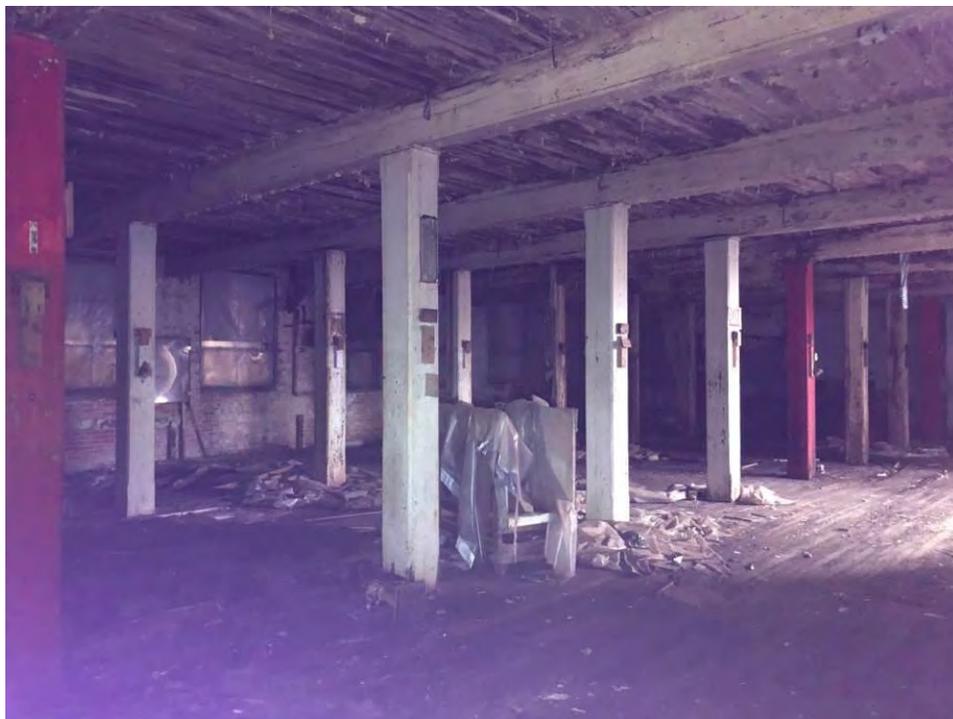
SCENE: View of Building R, Basement with debris. Photograph taken facing south.

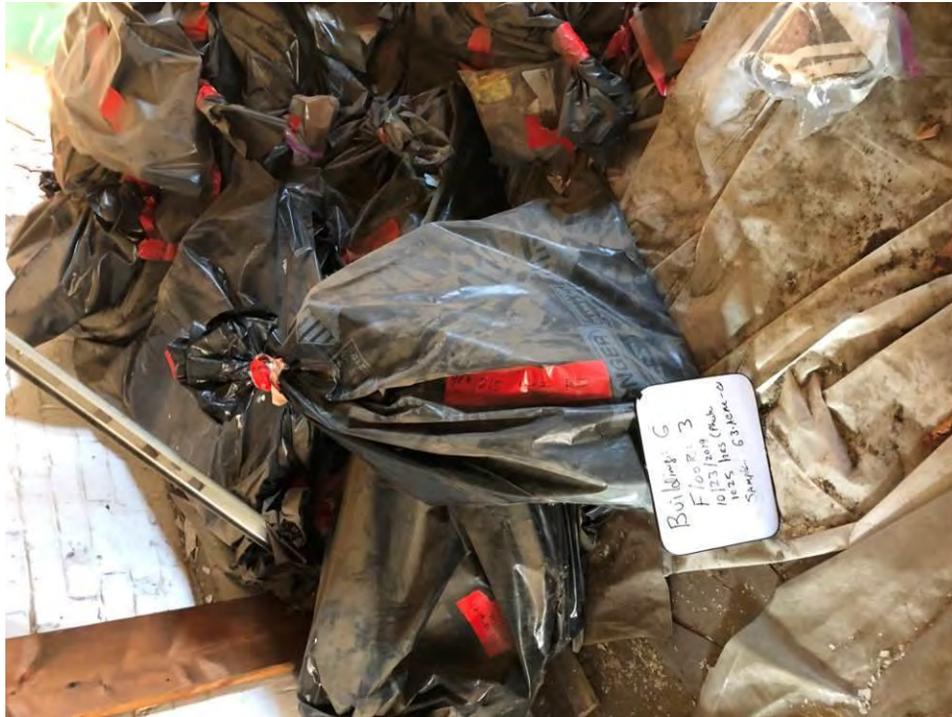
SCENE: View of bulk asbestos sample location G3-ACM-01, collected from the black “asbestos” waste bags of Building G, Floor 3. Photograph taken facing east.

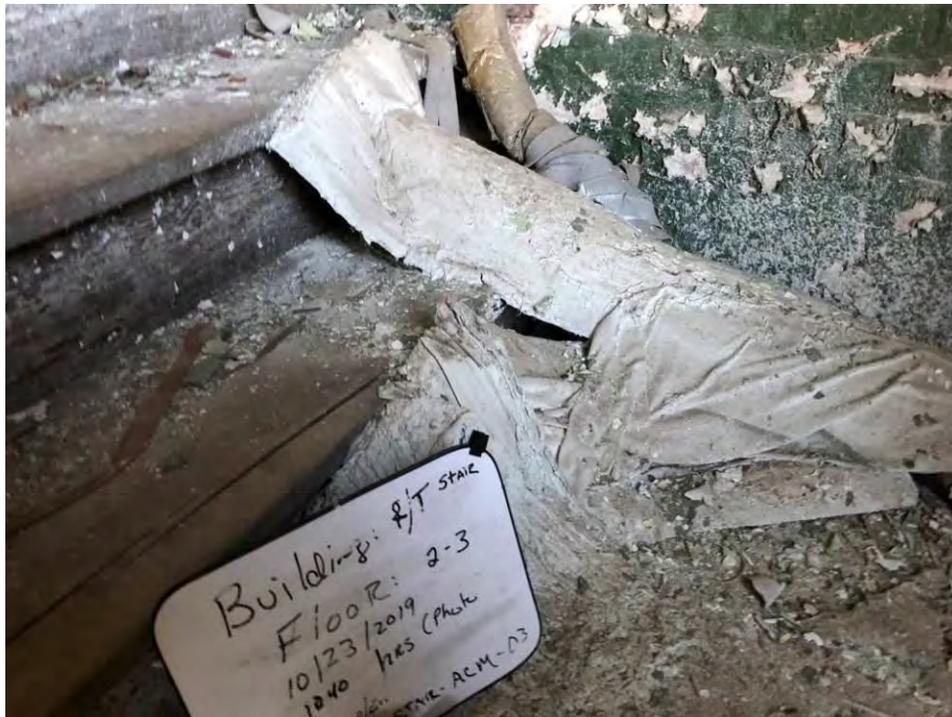
SCENE: View of bulk asbestos sample location RT2-3-ACM-03, collected from pipe wrap in the stairwell between Buildings R and T, between Floors 2 and 3. Photograph taken facing north.

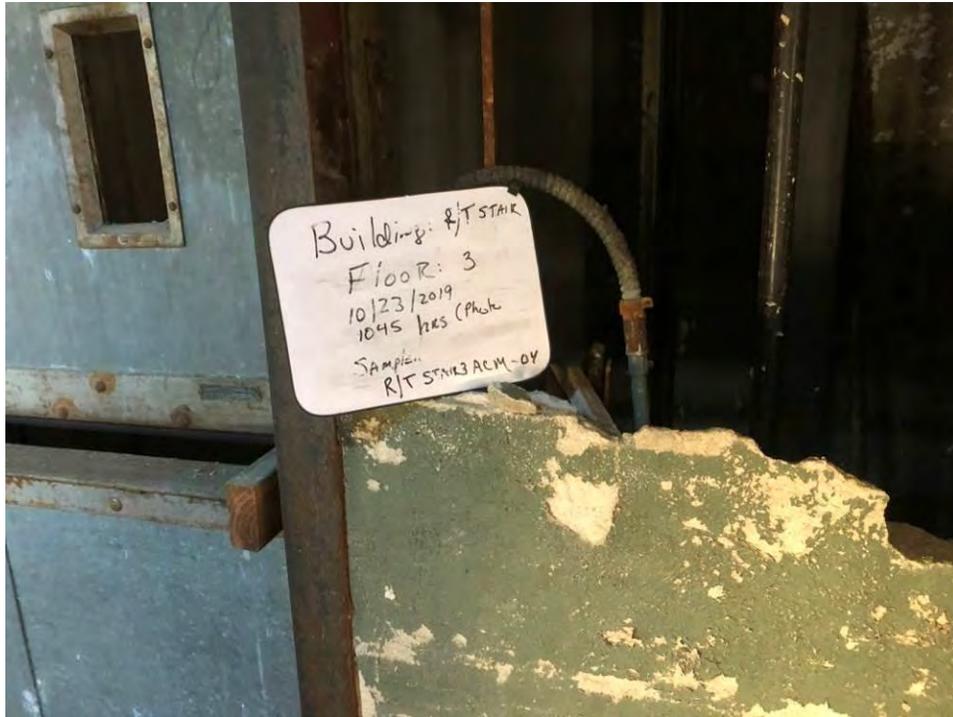
SCENE: View of bulk asbestos sample location RT3-ACM-04, collected from wall between the elevator shaft between Buildings R and T, Floor 3. Photograph taken facing east.

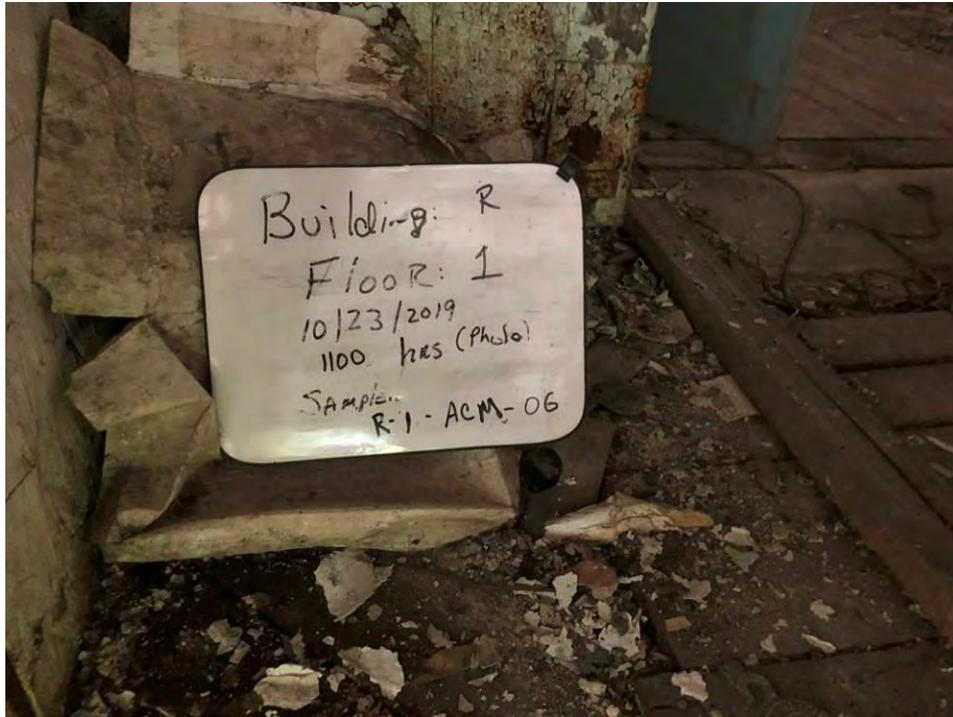
SCENE: View of bulk asbestos sample location R1-ACM-06, collected floor layer in Buildings R, Floor 1. Photograph taken facing east.

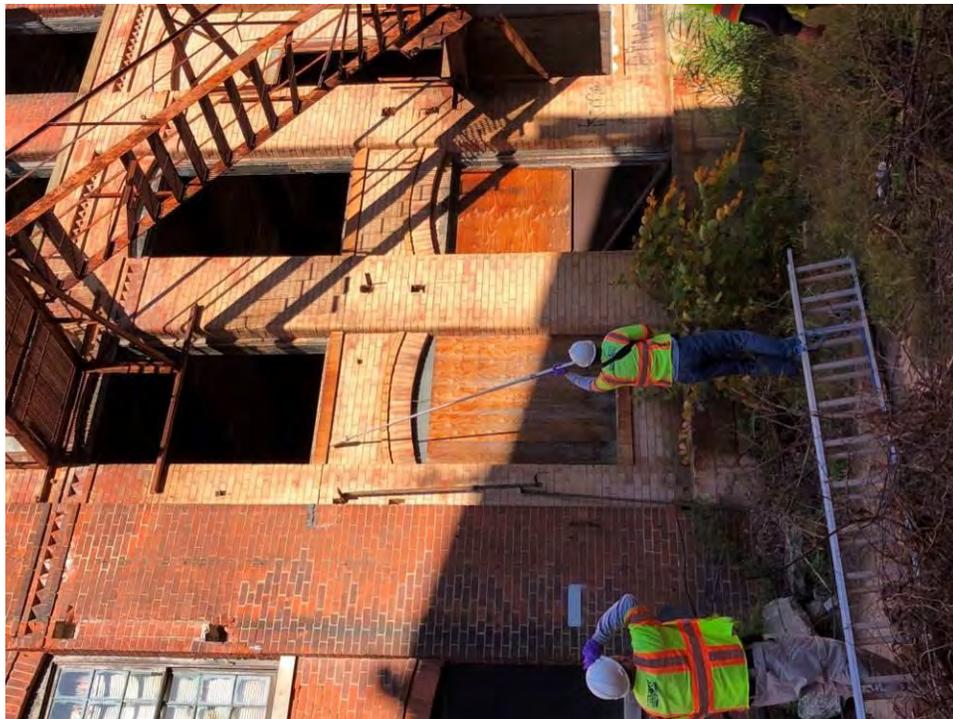
SCENE: View of radiation screening from the southern exterior of Building K. Photograph taken facing north.

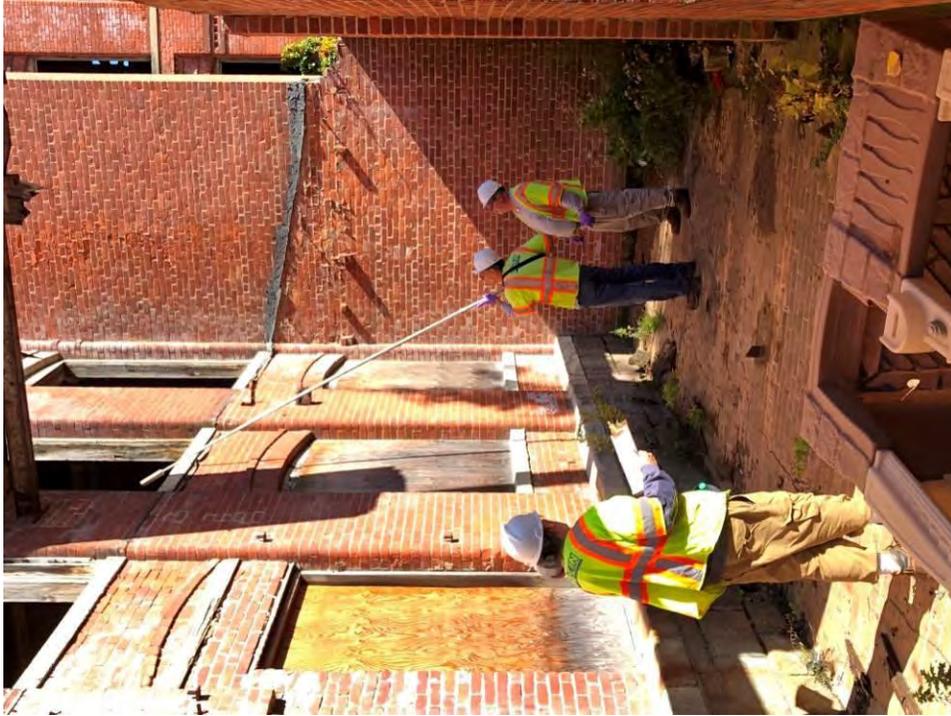
SCENE: View of radiation screening from the southern exterior of Building K. Photograph taken facing northeast.

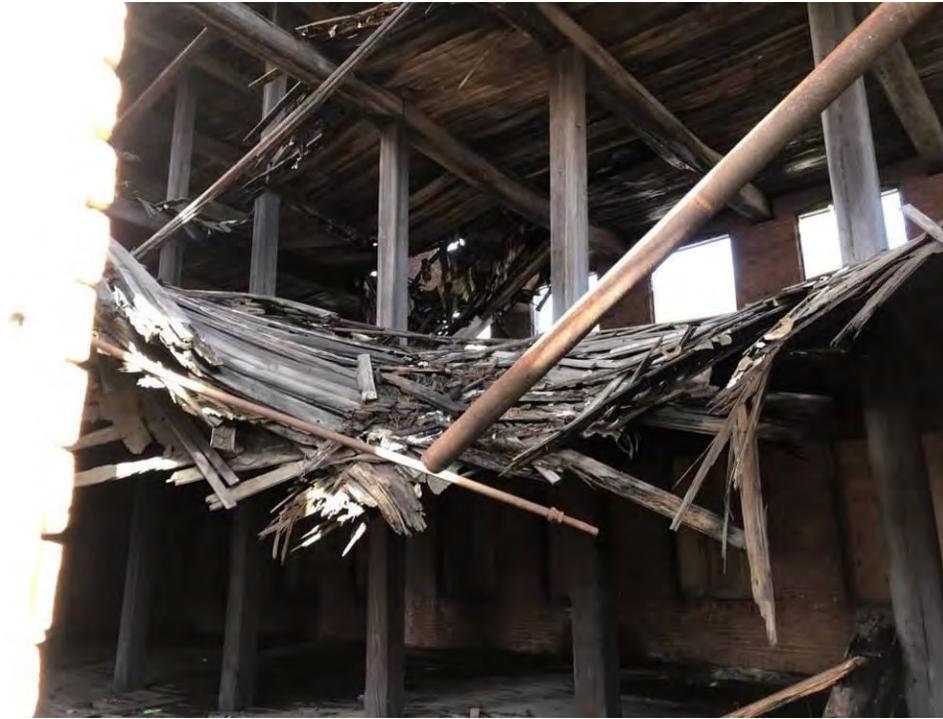
SCENE: View of compromised floors inside the interior of Building L. Photograph taken facing northeast.

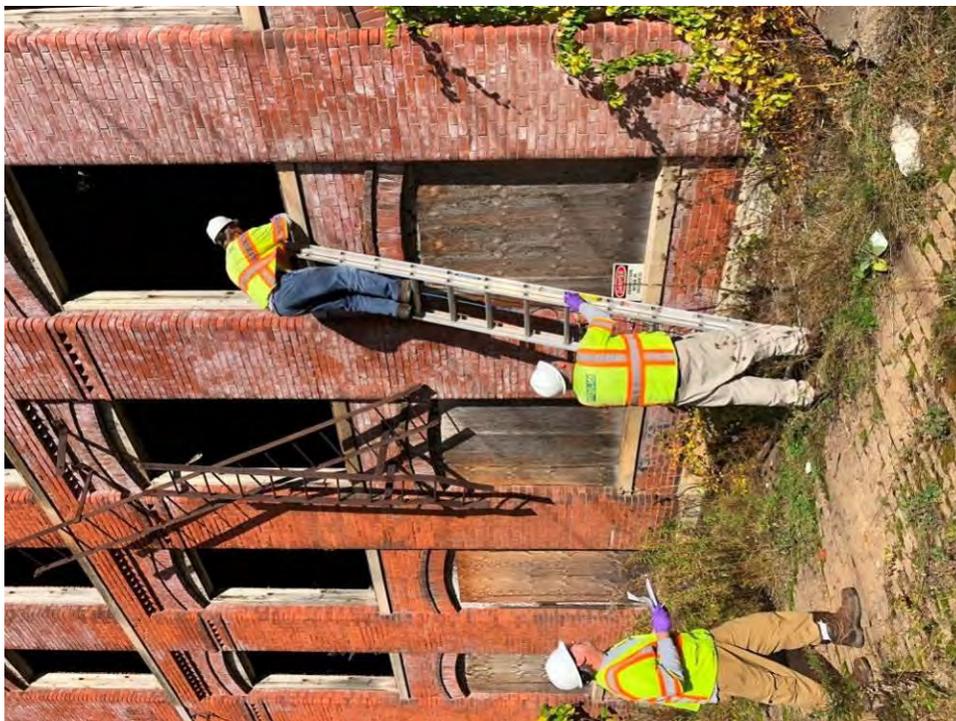
SCENE: View of radiation screening from the western exterior of Building L. Photograph taken facing northeast.

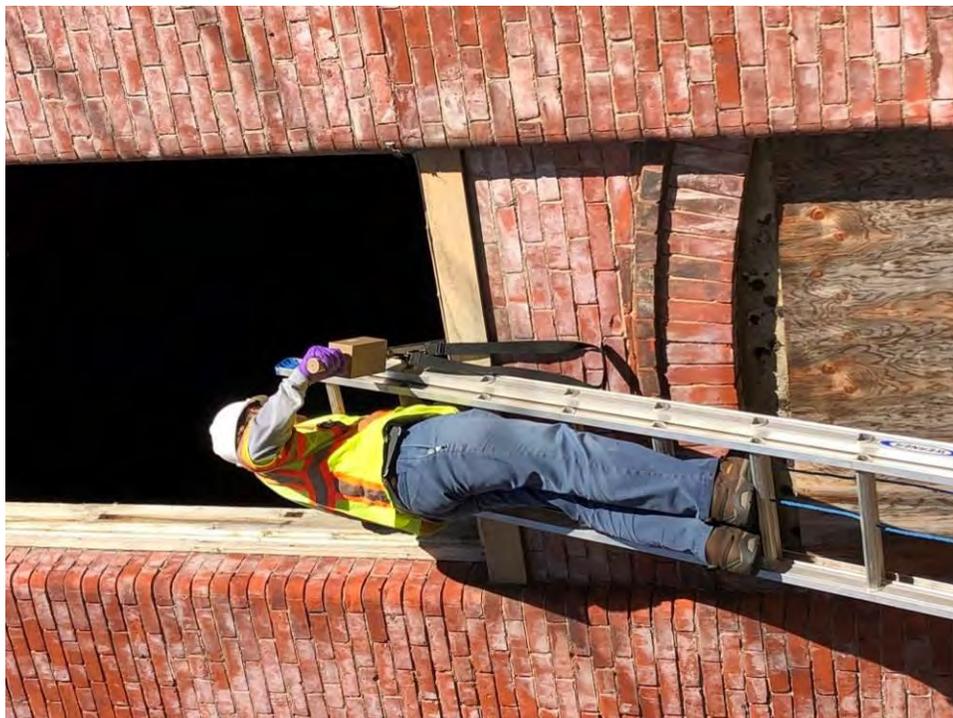
SCENE: View of radiation screening of the western exterior of Building L. Photograph taken facing northeast.

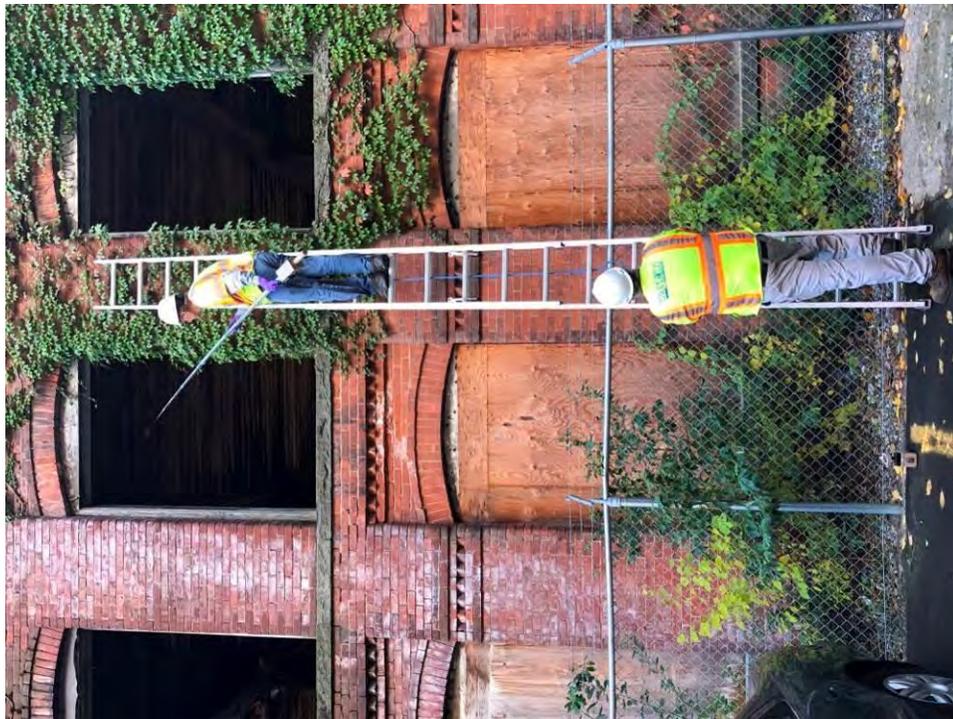
SCENE: View of radiation screening from the northern exterior of Building K. Photograph taken facing south.

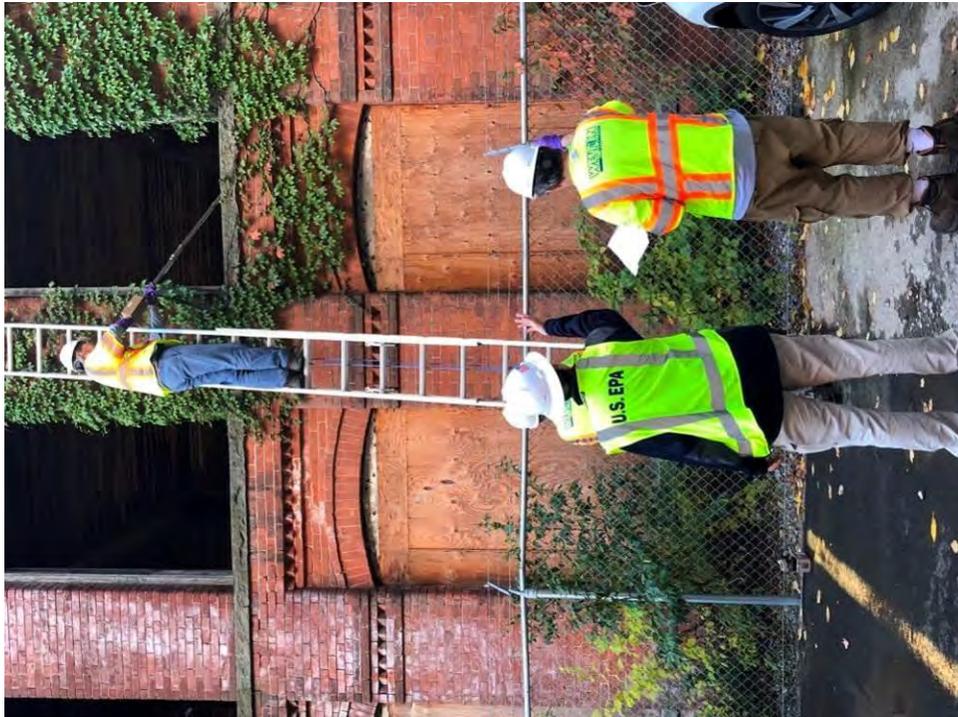
SCENE: View of radiation screening from the northern exterior of Building K. Photograph taken facing west.
