**Subject: Phase II Targeted Brownfields Assessment – Hazardous Materials Survey
Elkem Carbide
Keokuk, Lee County, Iowa
EPA Region 7 START 4, Contract No. EP-S7-13-06, Task Order No. 0002.019.017
Task Monitor: Todd Davis, Site Assessment Manager**

**HAZARDOUS MATERIALS SURVEY
FOR PHASE II TARGETED BROWNFIELDS ASSESSEMENT**

**ELKEM CARBIDE
KEOKUK, IOWA**

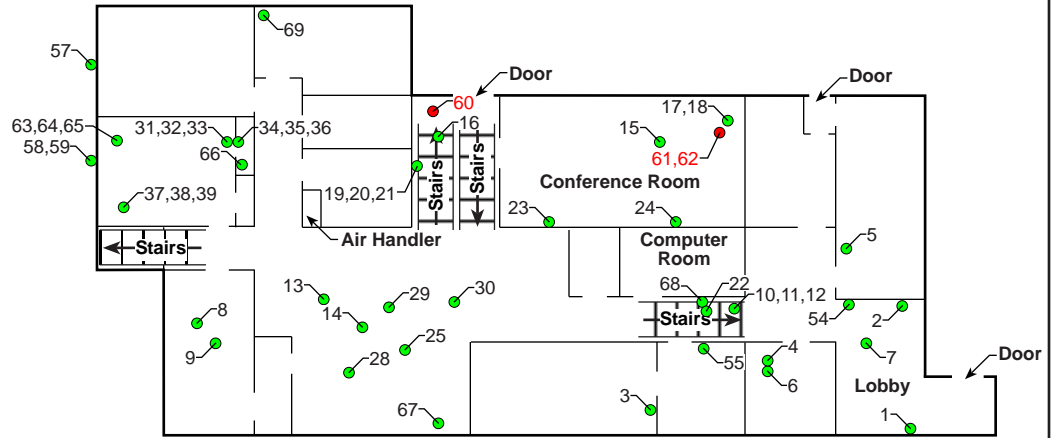
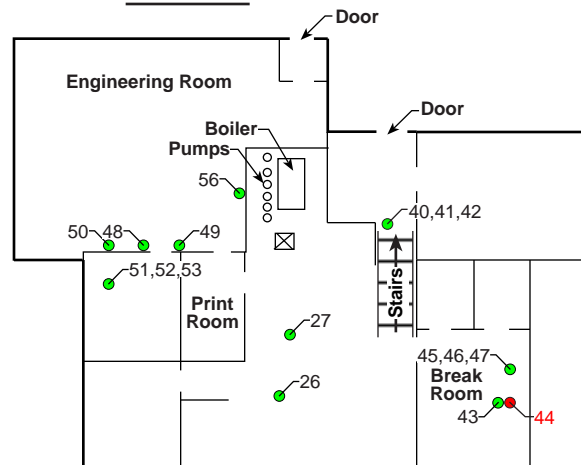
Figure 2a
Asbestos Sample Location Map - Building 1

Note: Refer to Sample Key Table for corresponding sample numbers.

Main Floor

Basement

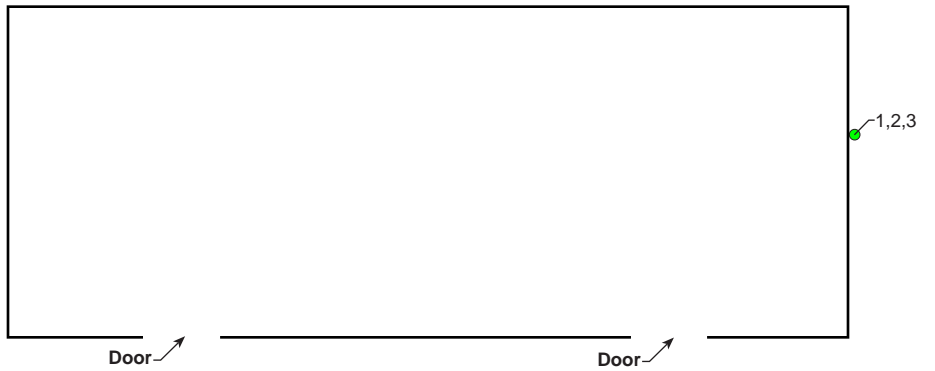
Figure 2b
Asbestos Sample Location Map - Building 2

Sample Key Table	
Key	Sample No.
Asbestos	
1	2-WG-1
2	2-WG-2
3	2-WG-3

Legend

- Non-asbestos Containing Material Sample Location

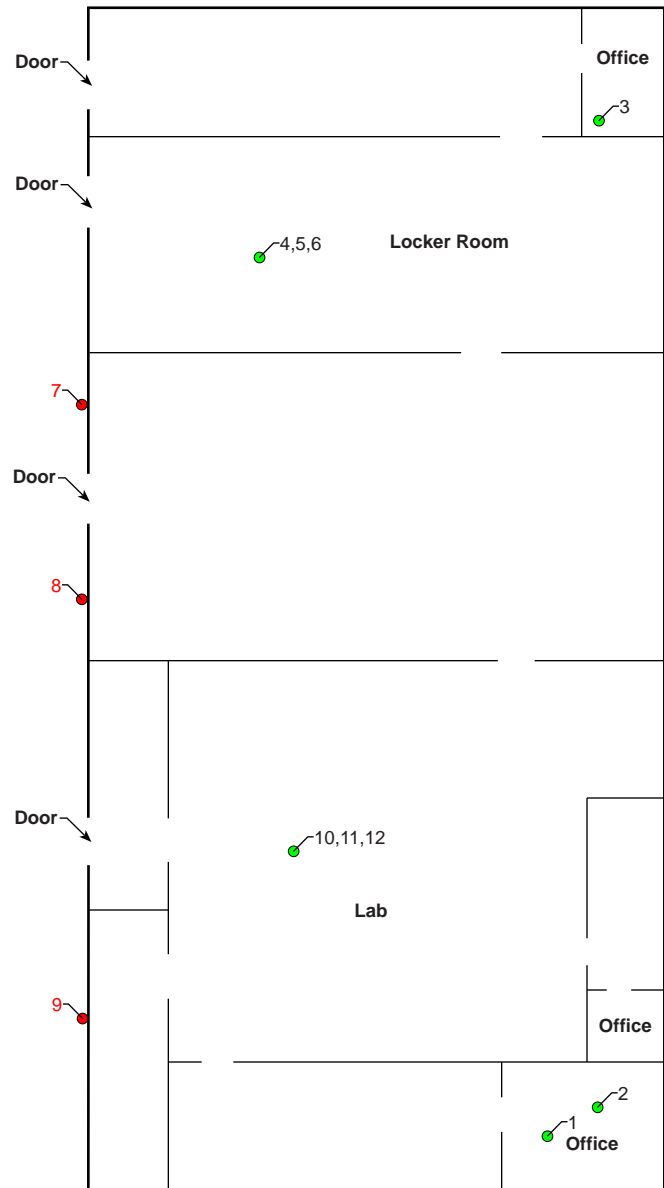
Figure 2c
Asbestos Sample Location Map - Building 3

Sample Key Table	
Key	Sample No.
Asbestos	
1	3-CT-1
2	3-CT-2
3	3-CT-3
4	3-TSI-1
5	3-TSI-2
6	3-TSI-3
7	3-WG-1
8	3-WG-2
9	3-WG-3
10	3-TSI2-1
11	3-TSI2-2
12	3-TSI2-3

Legend

- Asbestos Containing Material Sample Location
- Non-asbestos Containing Material Sample Location

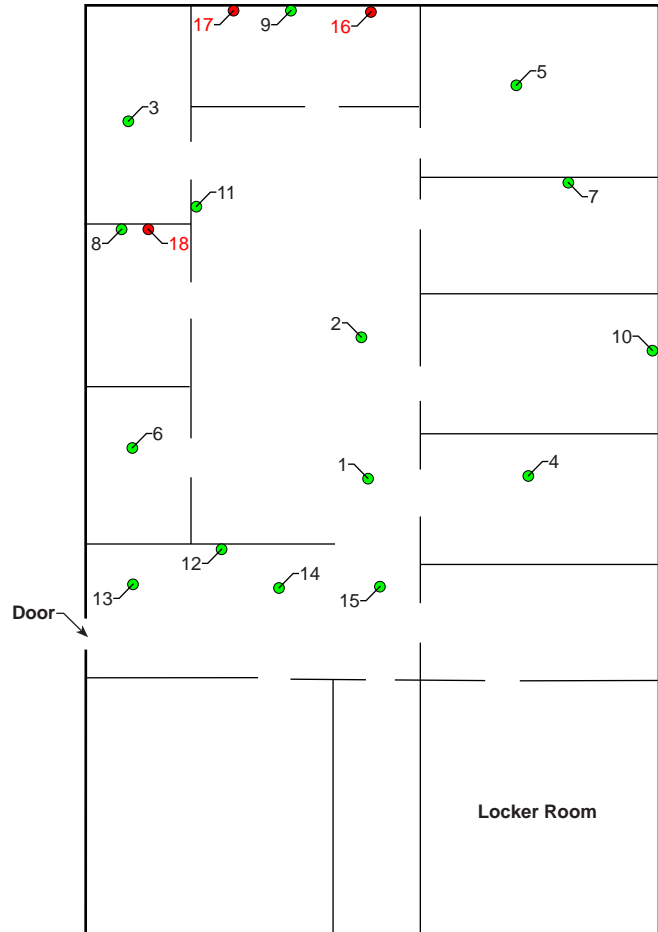
Figure 2d
Asbestos Sample Location Map - Building 4

Sample Key Table

Key	Sample No.
Asbestos	
1	4-FT-1
2	4-FT-2
3	4-FT-3
4	4-CT-1
5	4-CT-2
6	4-CT-3
7	4-DWJC-1
8	4-DWJC-2
9	4-DWJC-3
10	4-CBM-1
11	4-CBM-2
12	4-CBM-3
13	4-FT2-1
14	4-FT2-2
15	4-FT2-3
16	4-WM-1
17	4-WM-2
18	4-WM-3

Legend

- Asbestos Containing Material Sample Location
- Non-asbestos Containing Material Sample Location

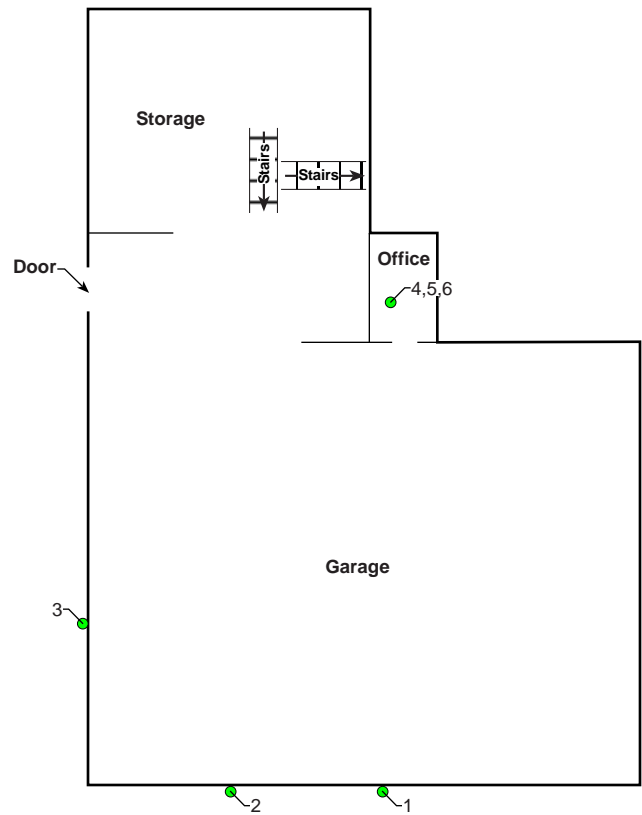
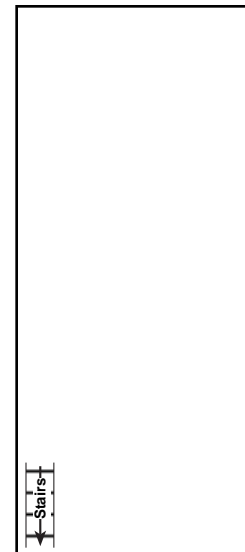
Figure 2e
Asbestos Sample Location Map - Building 6

First Floor

Sample Key Table

Key	Sample No.
Asbestos	
1	6-WG-1
2	6-WG-2
3	6-WG-3
4	6-CT-1
5	6-CT-2
6	6-CT-3

Second Floor

- Non-asbestos Containing Material Sample Location

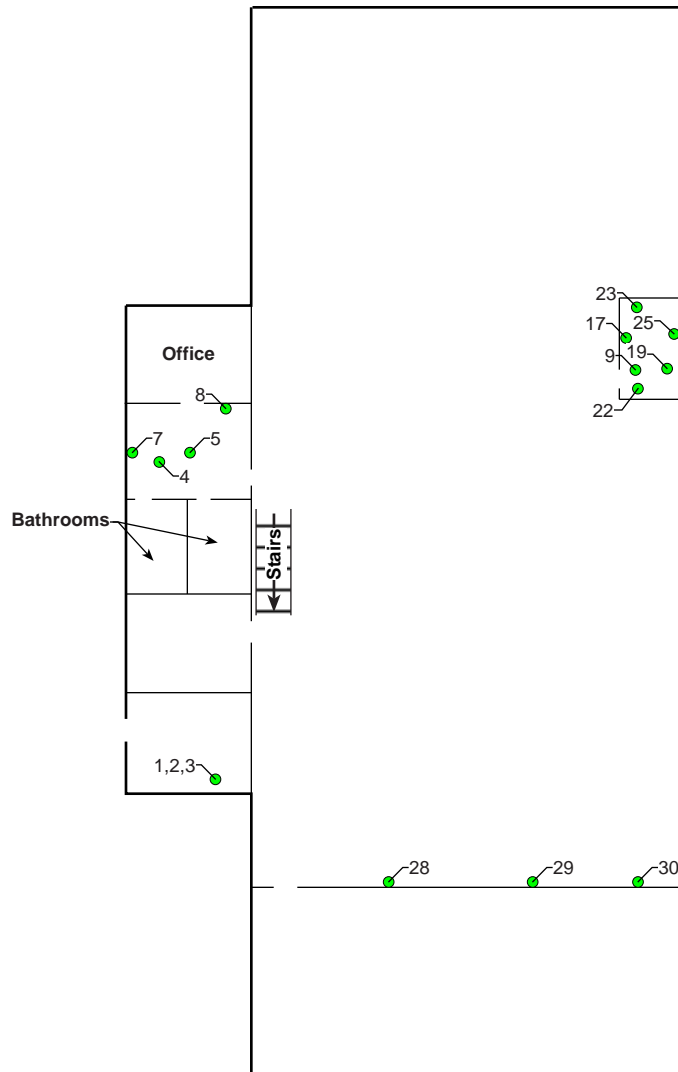
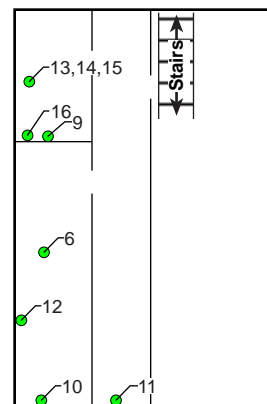
Figure 2f
Asbestos Sample Location Map - Building 8

First Floor

Sample Key Table	
Key	Sample No.
Asbestos	
1	8-TSI-1
2	8-TSI-2
3	8-TSI-3
4	8-CT-1
5	8-CT-2
6	8-CT-3
7	8-CBM-1
8	8-CBM-2
9	8-CBM-3
10	8-WG-1
11	8-WG-2
12	8-WG-3
13	8-CT2-1
14	8-CT2-2
15	8-CT2-3
16	8-DWJC-1
17	8-DWJC-2
18	8-DWJC-3
19	8-FT-1
20	8-FT-2
21	8-FT-3
22	8-CTX-1
23	8-CTX-2
24	8-CTX-3
25	8-CBM2-1
26	8-CBM2-2
27	8-CBM2-3
28	8-VER-1
29	8-VER-2
30	8-VER-3

Second Floor - Office Area

- Non-asbestos Containing Material Sample Location

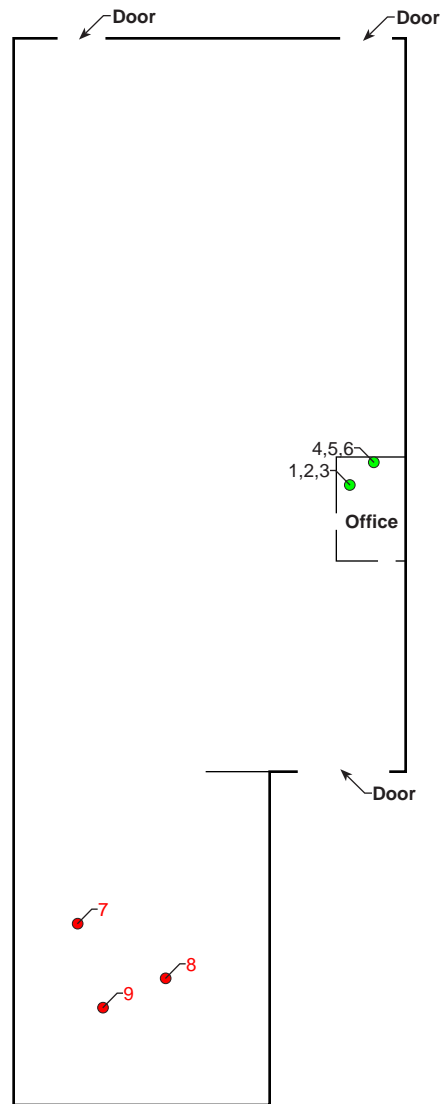
Figure 2g
Asbestos Sample Location Map - Building 9

Sample Key Table	
Key	Sample No.
Asbestos	
1	9-CT-1
2	9-CT-2
3	9-CT-3
4	9-DW-1
5	9-DW-2
6	9-DW-3
7	9-TR-1
8	9-TR-2
9	9-TR-3

Legend

- Asbestos Containing Material Sample Location
- Non-asbestos Containing Material Sample Location
