**MONITORING AND MAINTENANCE PLAN
FOR THE
FIRST BAPTIST CHURCH ASBESTOS SOILS REPOSITORY
OROFINO, IDAHO**

May 2018

**Orofino Asbestos Site
First Baptist Church Asbestos Soils Repository
Monitoring and Maintenance Plan**

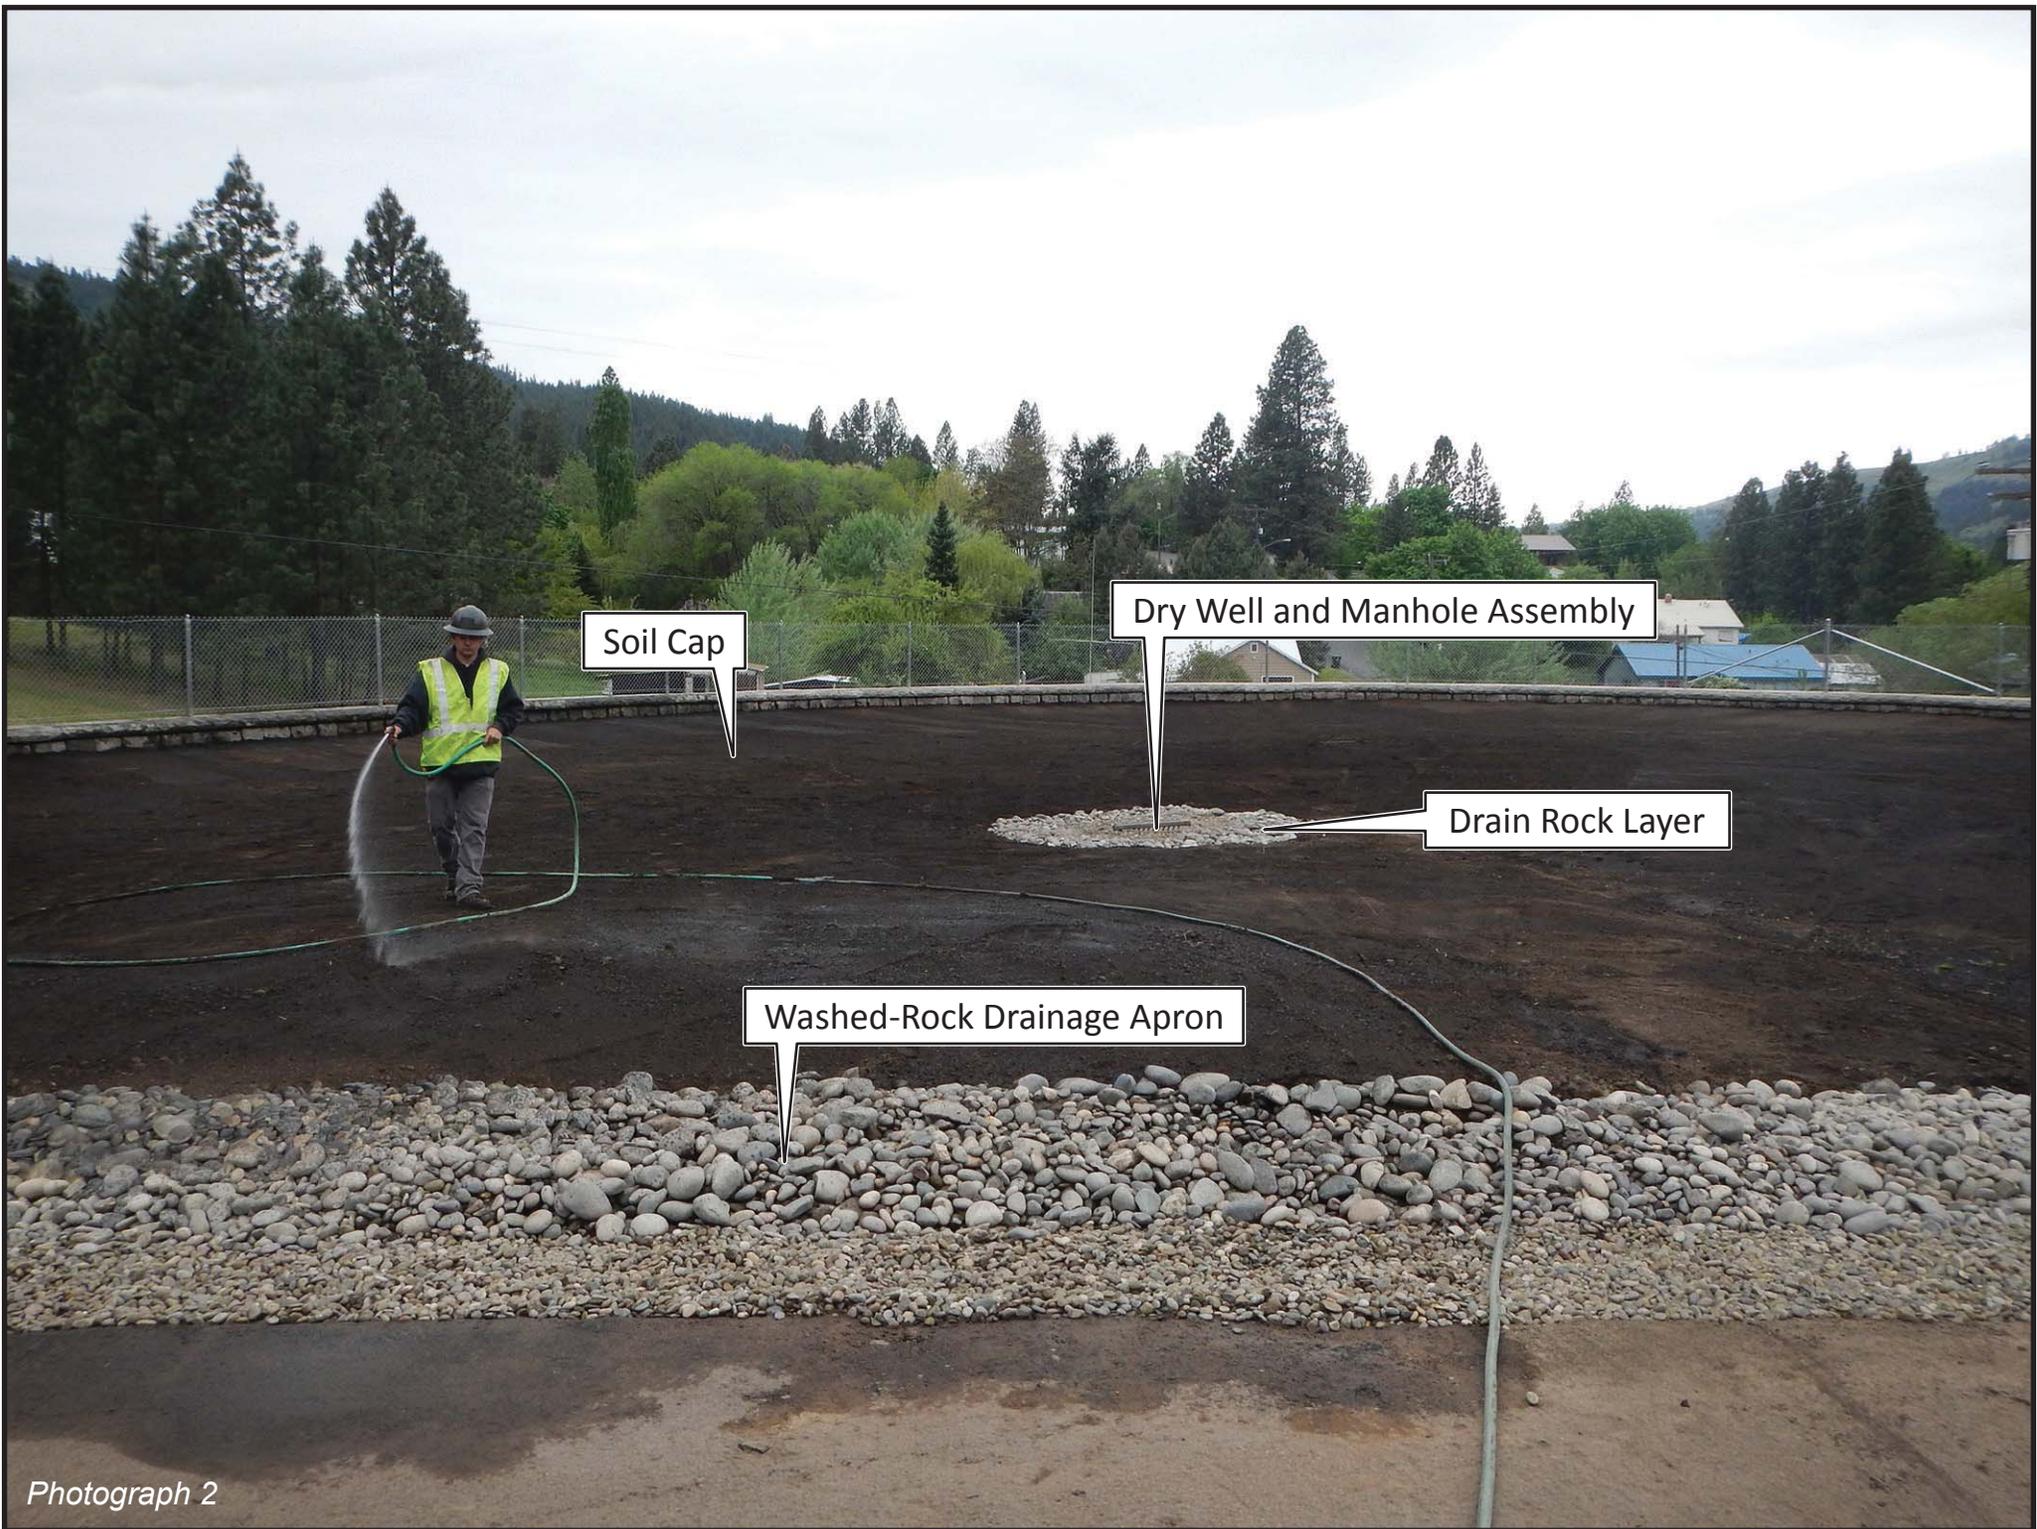
Soil Cap

Dry Well and Manhole Assembly

Washed-Rock Drainage Apron

2. Soil Cap (Dry Retention Basin) (see Section 2.2.2 of the M&M Plan); See Photograph 2 in Attachment 2.							
Erosion	Formation of ruts, rills or gullies on cap ≥ 2 inches deep						
Sparse vegetated areas or stressed vegetation	Bare soil areas ≥ 20 square feet or total vegetation cover $\leq 70\%$						
Deep-rooted vegetation	Presence of trees, shrubs, brush or other woody or deep-rooted plant growth						
Subsidence and differential settlement	Presence of depressions ≥ 5 feet in length and ≥ 2 inches

4. Dry Well and Manhole Assembly (see Section 2.2.4 of the M&M Plan); See Photographs 2 and 3 in Attachment 2.							
Dry well and manhole	Structural changes or damage						
Dry well	Vegetation restricting proper drainage						
Dry well	Accumulation of debris, sediment or other obstructions inside dry well impacting water infiltration; standing water inside dry well (do not enter dry well)						
Manhole cover	Security assembly properly in-place

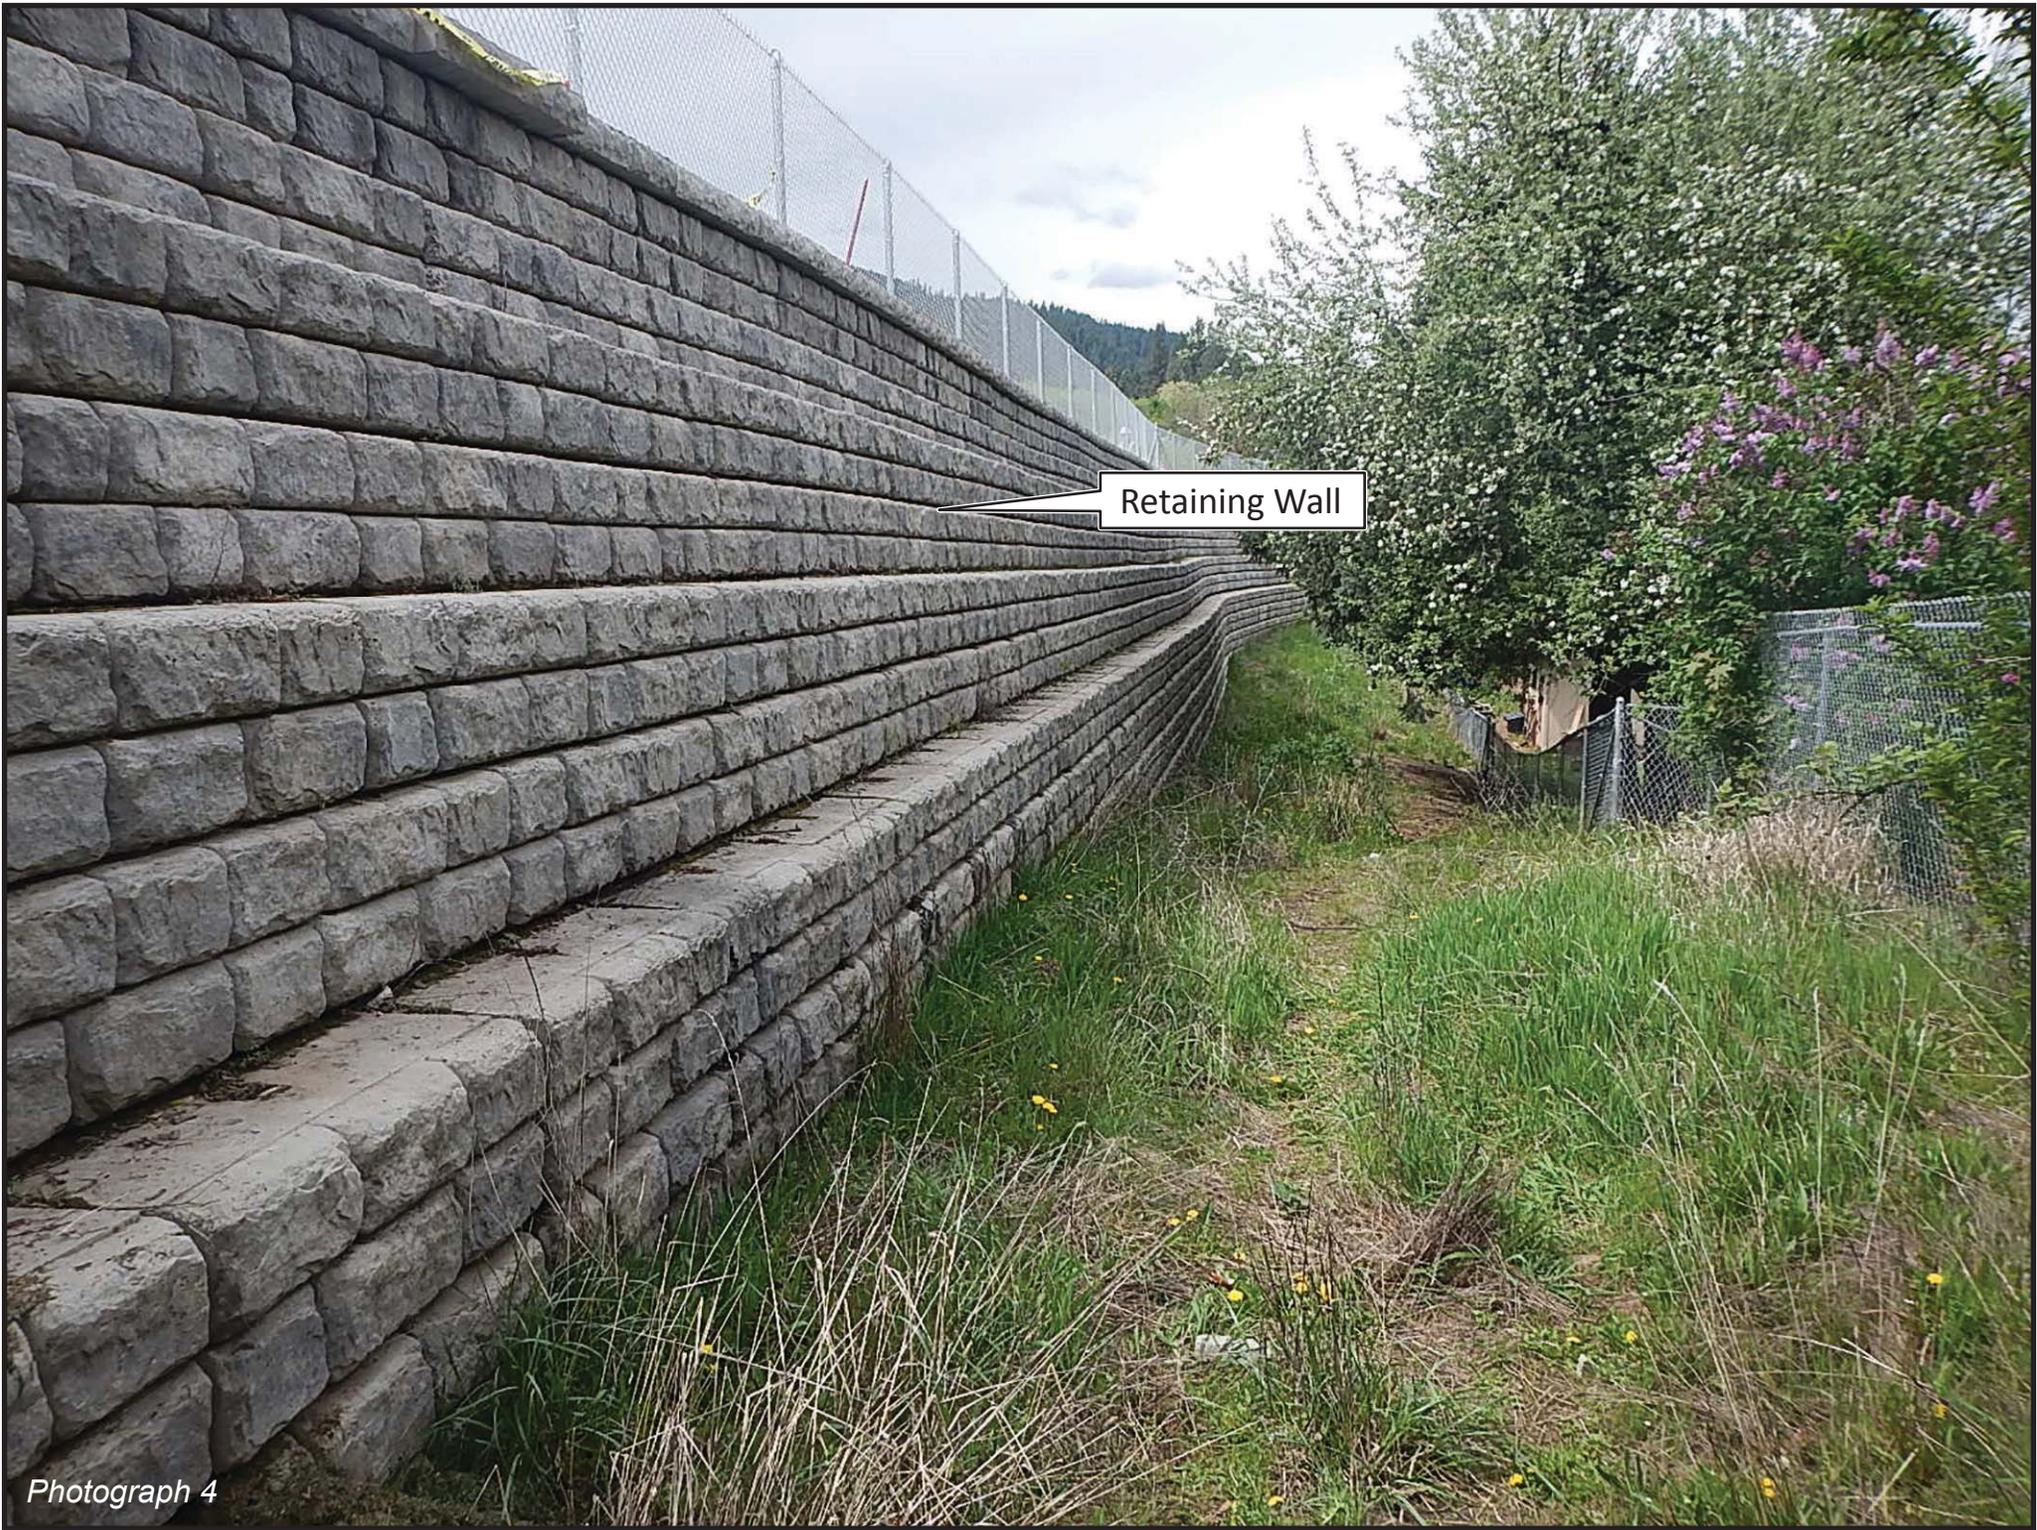
Retaining Wall

5. Retaining Wall (see Section 2.2.5 of the M&M Plan) (15 to 20 minutes); See Photograph 4 in Attachment 2.							
Ramp to base of retaining wall	Erosion, slumping, movement of soil at base.						
Blocks	Material washout from around/between retaining blocks or movement of blocks						
Base of retaining wall	Standing water, saturated soils, or movement of soil at the base of the wall
