**Subject: Trip Report and Data Summary for Asbestos Sampling
Community Laundromat Site, Ava, Missouri
U.S. EPA Region 7 START 3 Contract No. EP-S7-06-01
Task Order No. 0068.000
Task Monitor: Eric Nold, EPA On-Scene Coordinator**

**TRIP REPORT AND DATA SUMMARY
FOR ASBESTOS SAMPLING**

COMMUNITY LAUNDROMAT SITE – AVA, MISSOURI

**Superfund Technical Assessment and Response Team (START) 3
Contract No. EP-S7-06-01, Task Order 0068.000**

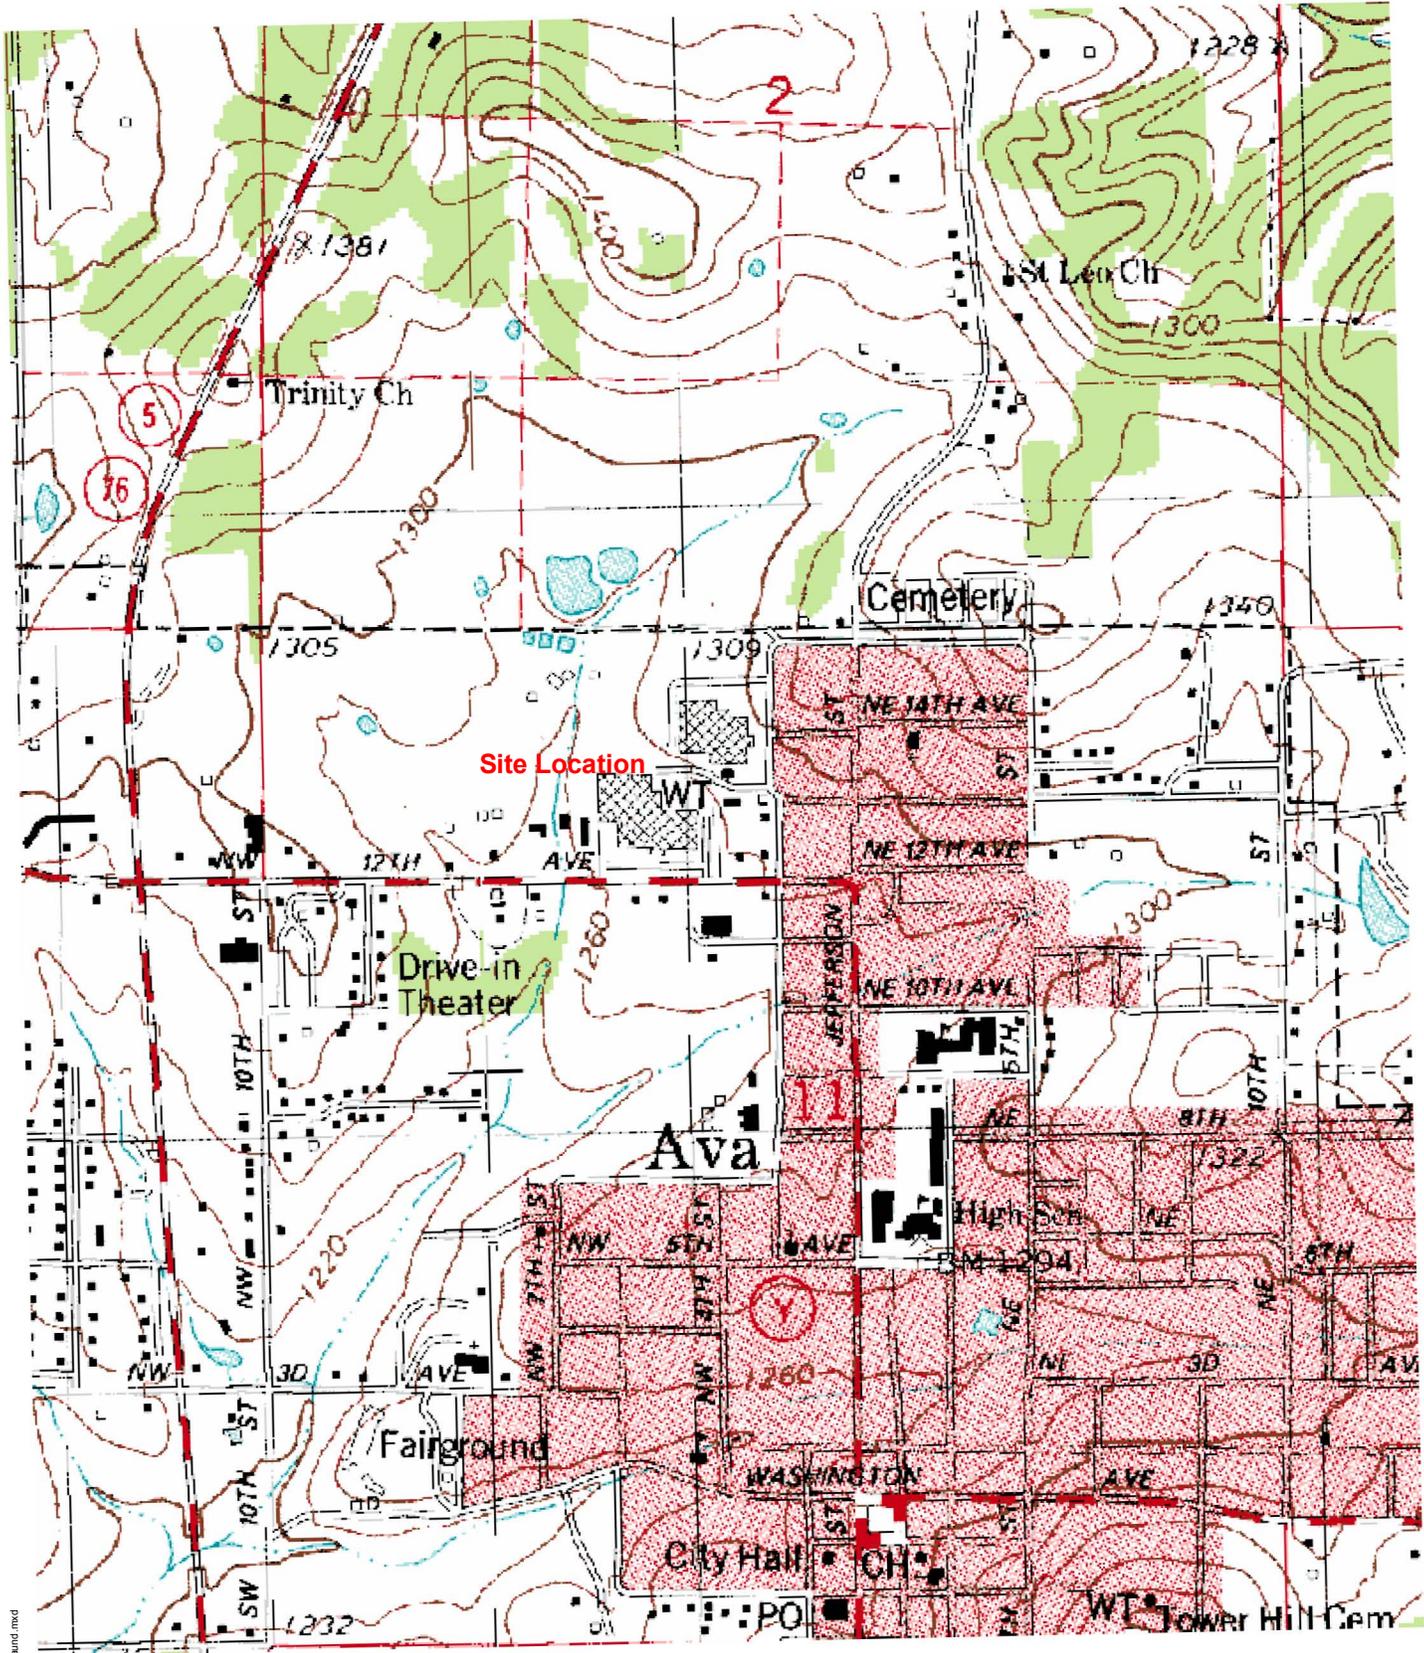
Figure 1
Site Location Map

Community Laundromat
Ava, Missouri

The Community Laundromat site is located at 306 Northwest 12th Avenue in the southeast quarter of the northeast quarter of the northwest quarter of Section 11, Township 26 North, Range 16 West, in Douglas County, Missouri (See Appendix A, Figure 1). The geographic coordinates are 36.9593 degrees (39° 57' 33") north latitude and 92.6614 degrees (92° 39' 41") west longitude, and the Universal Transverse Mercator (UTM) coordinates are 530128 meters east and 4090416 meters north, in Zone 15. The site is in a commercial/residential area in Ava, Missouri. Ava has a population of 3,200 and lies approximately 50 miles southeast of Springfield, Missouri.
