**Subject: Analysis of Brownfields Cleanup Alternatives Report
Oak Street City Hall Site
Poplar Bluff, Butler County, Missouri
EPA Region 7, START 5, Contract No. 68HE0719D0001
Task Order No. 19F0101.005
Task Monitor: Todd Davis, Site Assessment Manager**

ANALYSIS OF BROWNFIELDS CLEANUP ALTERNATIVES REPORT

**OAK STREET CITY HALL SITE
POPLAR BLUFF, MISSOURI**

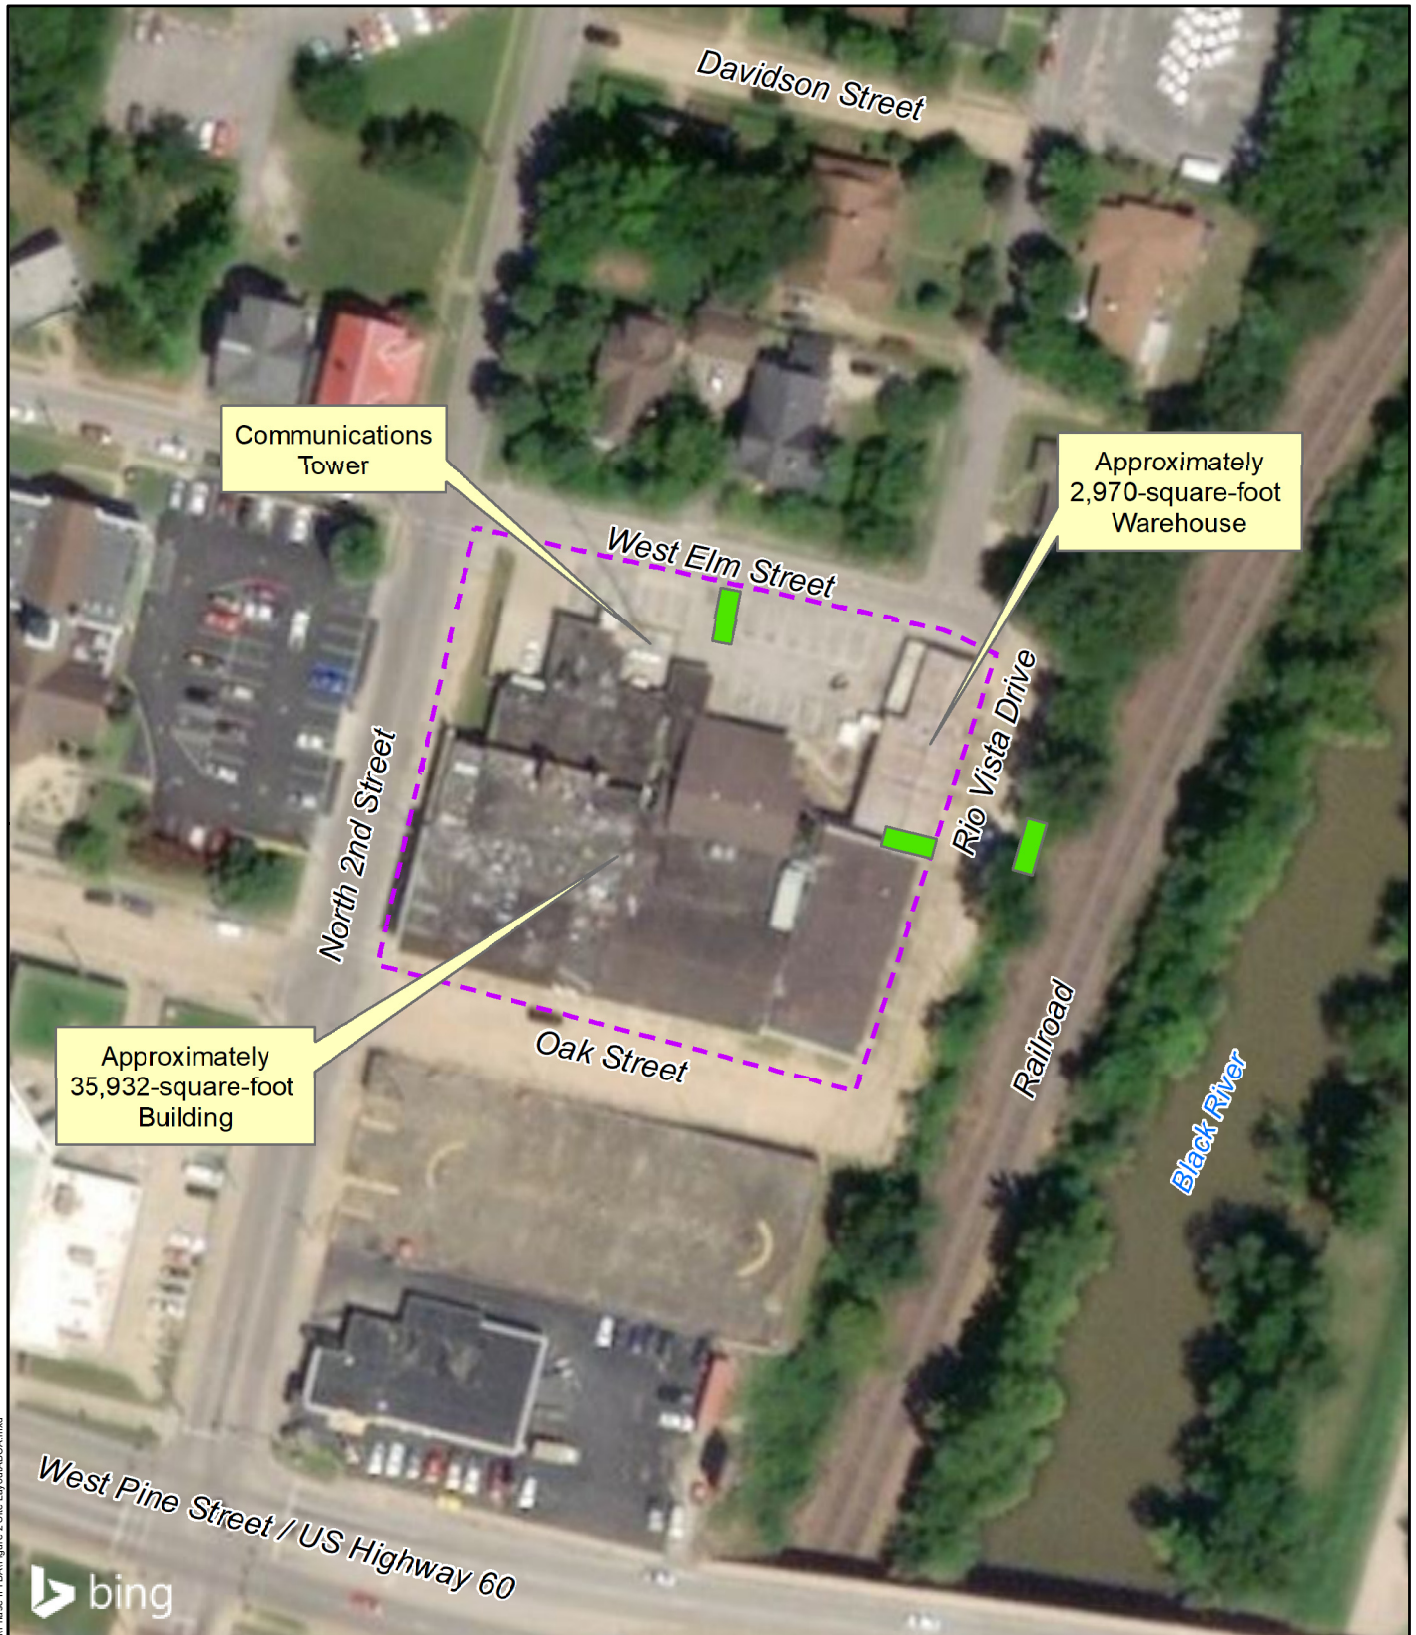
Figure 2
Site Layout Map

- Approximate Site Boundary
- Pad-mounted Transformer Location

The site is in a mixed-use commercial and residential area of Poplar Bluff, encompassing approximately 1.13 acres, and is developed with an approximately 35,932-square-foot former hospital building, a 2,970-square-foot warehouse, a communications tower, and a paved parking area. Figure 2 in Appendix A illustrates the location and boundaries of the site. The site is surrounded by commercial, municipal, and residential properties. The site and vicinity are depicted on the Poplar Bluff, Missouri, U.S. Geological Survey (USGS) 7.5-minute topographic series map (USGS 1979) (see Appendix A, Figure 1). Coordinates at the approximate center of the site are 36.757705 degrees north latitude and 90.391054 degrees west longitude.

Tetra Tech conducted a Phase II TBA in October 2019 to confirm or eliminate the REC identified during the 2018 Phase I ESA by SCS (Tetra Tech 2020a). Samples of surface soil, subsurface soil, and groundwater were submitted for analyses for volatile organic compounds (VOC), semivolatile organic compounds (SVOC), Resource Conservation and Recovery Act (RCRA) metals (not including mercury), total petroleum hydrocarbon (TPH) – gasoline-range organics (GRO), TPH – diesel-range organics (DRO), TPH – oil-range organics (ORO), and PCBs. Sampling results during this Phase II TBA indicated presence of contaminants in both soil and groundwater at the site. Sample locations are depicted on Figure 2 in Appendix A.

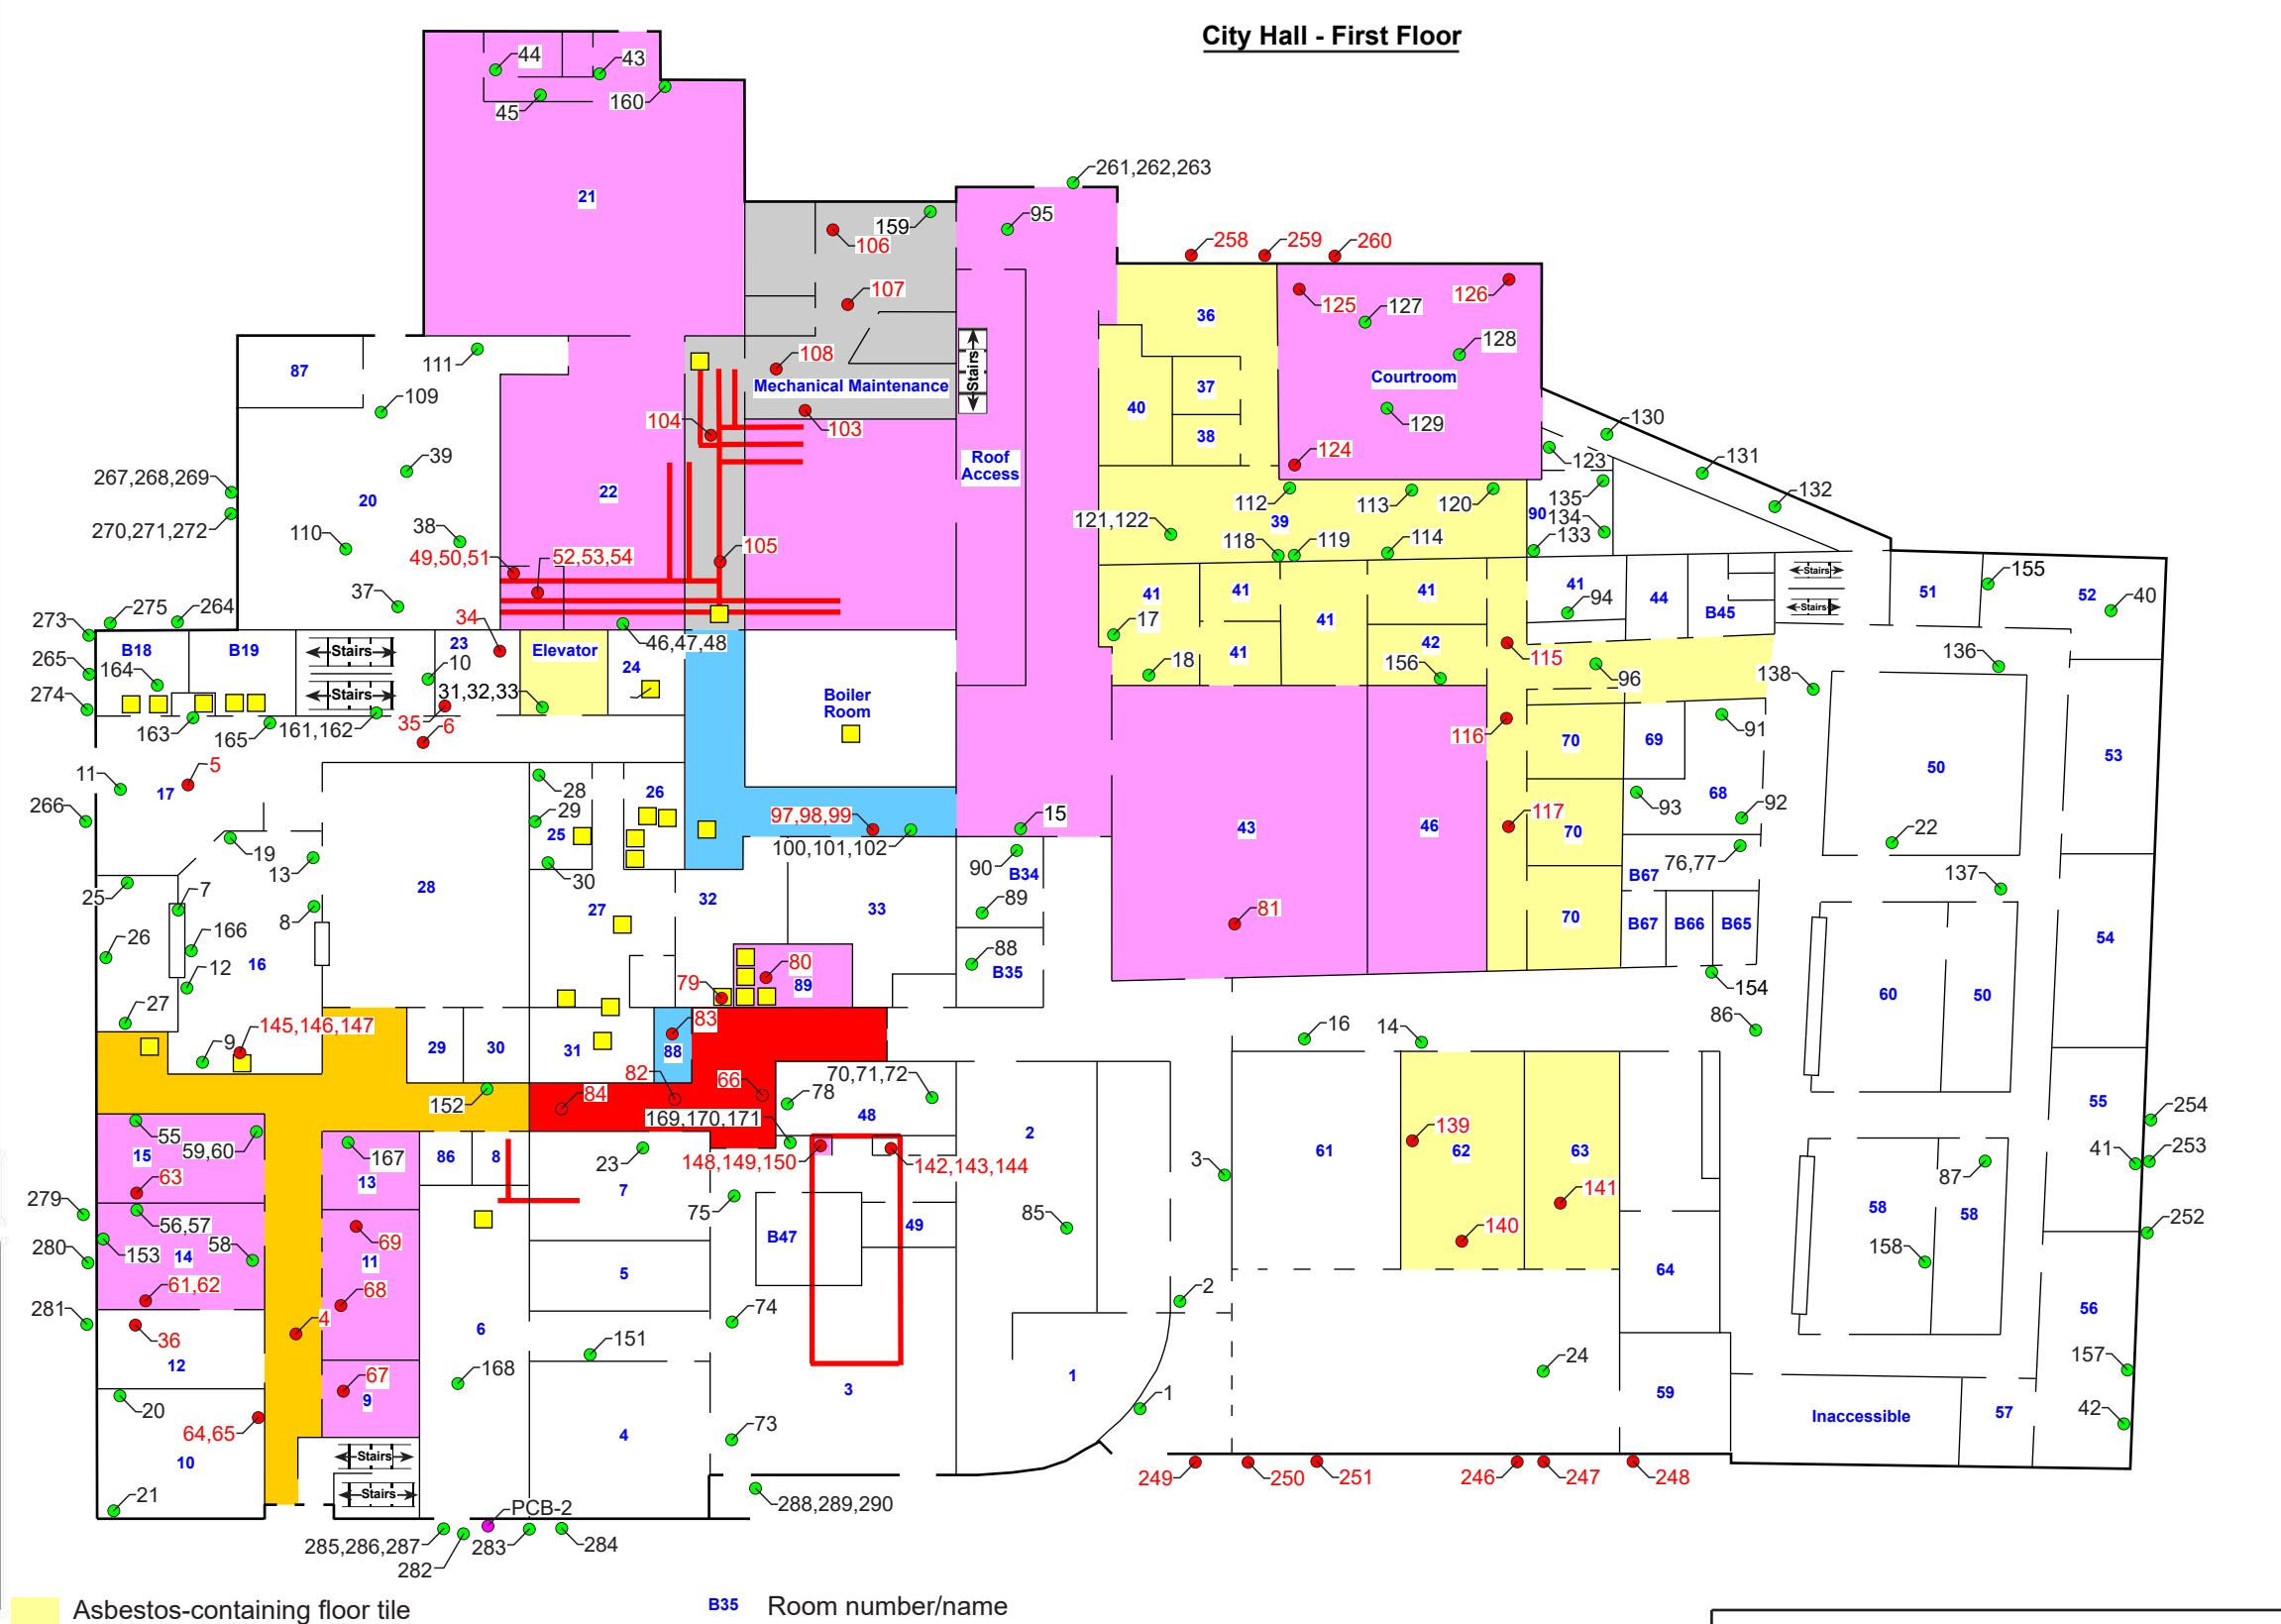
Figure 3A
Asbestos and PCB Sample Location Map

- Asbestos-containing material sample location
- Non-asbestos-containing material sample location
- Polychlorinated biphenyl (PCB) sample location
- Room number/name

- Asbestos-containing ceramic tile mastic
- Asbestos-containing floor tile and linoleum
- Asbestos-containing linoleum
- Asbestos-containing mastic

During the ACM survey, Tetra Tech collected 308 bulk samples of suspect ACM. Collections of samples of building materials accorded with National Emissions Standards for Hazardous Air Pollutants (NESHAP) as adopted by EPA and Asbestos Hazard and Emergency Response Act of 1986 (AHERA) protocols. Upon completion of sampling activities, the bulk samples were sent to Quantem Laboratories (Quantem) in Oklahoma City, Oklahoma. Suspect ACM samples were analyzed per EPA Method 600/R-93/116 via Polarized Light Microscopy (PLM) analysis and, in some cases, 400 Point Count. AHERA defines ACM as any material or product that contains more than 1% asbestos. Figures 3A, 3B, and 3C in Appendix A show ACM sample locations. The ACM survey yielded the following significant findings:

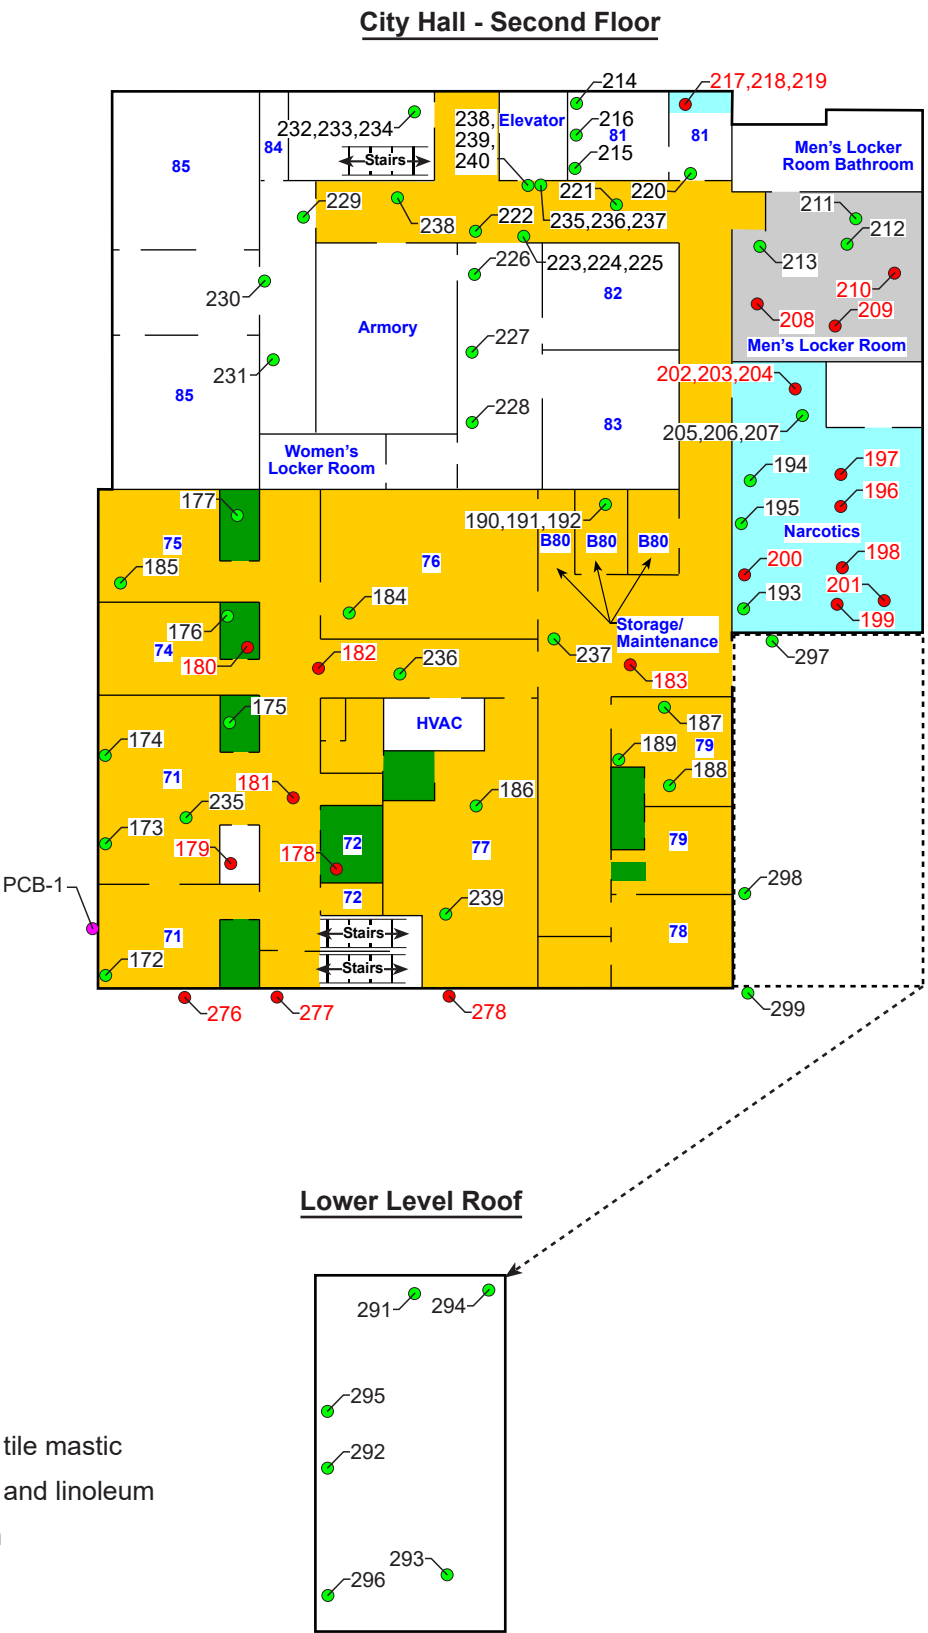
Figure 3B
Asbestos and PCB Sample Location Map

Exterior (All Buildings)	
246	TRAN-1
247	TRAN-2
248	TRAN-3
249	C-1
250	C-2
251	C-3
252	EC-1
253	EC-2
254	EC-3
255	EC1-1
256	EC1-2
257	EC1-3
258	EC2-1
259	EC2-2
260	EC2-3
261	C1-1
262	C1-2
263	C1-3
264	STUCCO-1
265	STUCCO-2
266	STUCCO-3
267	SS-1
268	SS-2
269	SS-3
270	VP-1
271	VP-2
272	VP-3
273	EC3-1
274	EC3-2
275	EC3-3
276	C2-1
277	C2-2
278	C2-3
279	C3-1
280	C3-2
281	C3-3
282	C4-1
283	C4-2
284	C4-3
285	G-1
286	G-2
287	G-3
288	C6-1
289	C6-2
290	C6-3

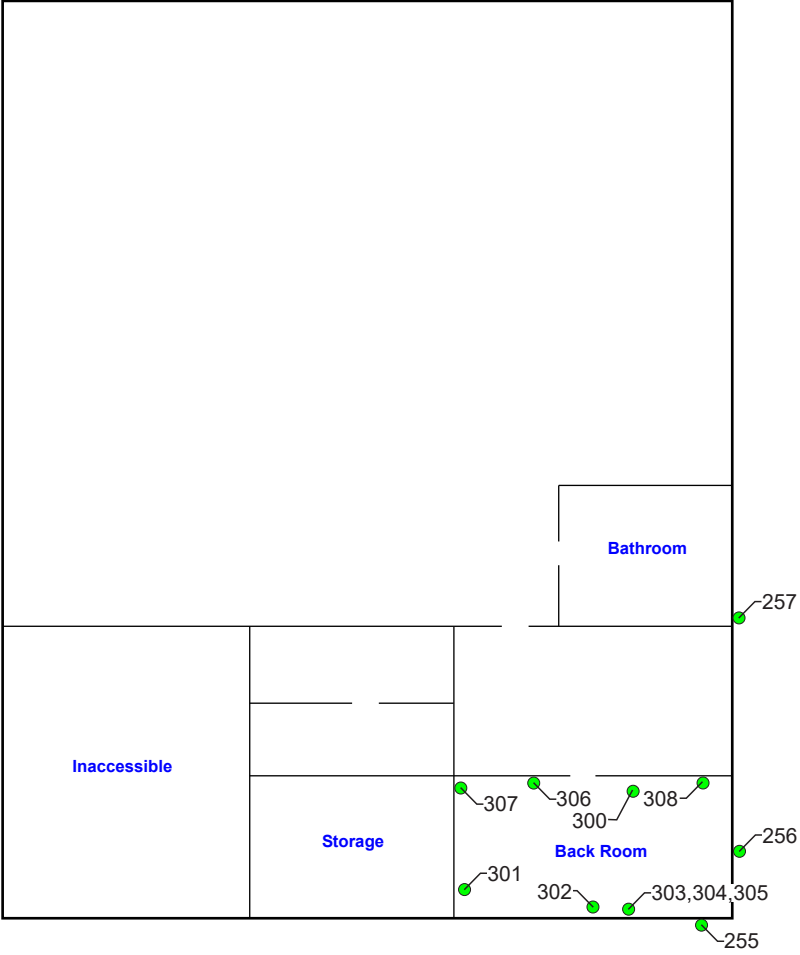
Figure 3C
Asbestos Sample Location Map

- Non-asbestos-containing material sample location
- 72 Room number/name

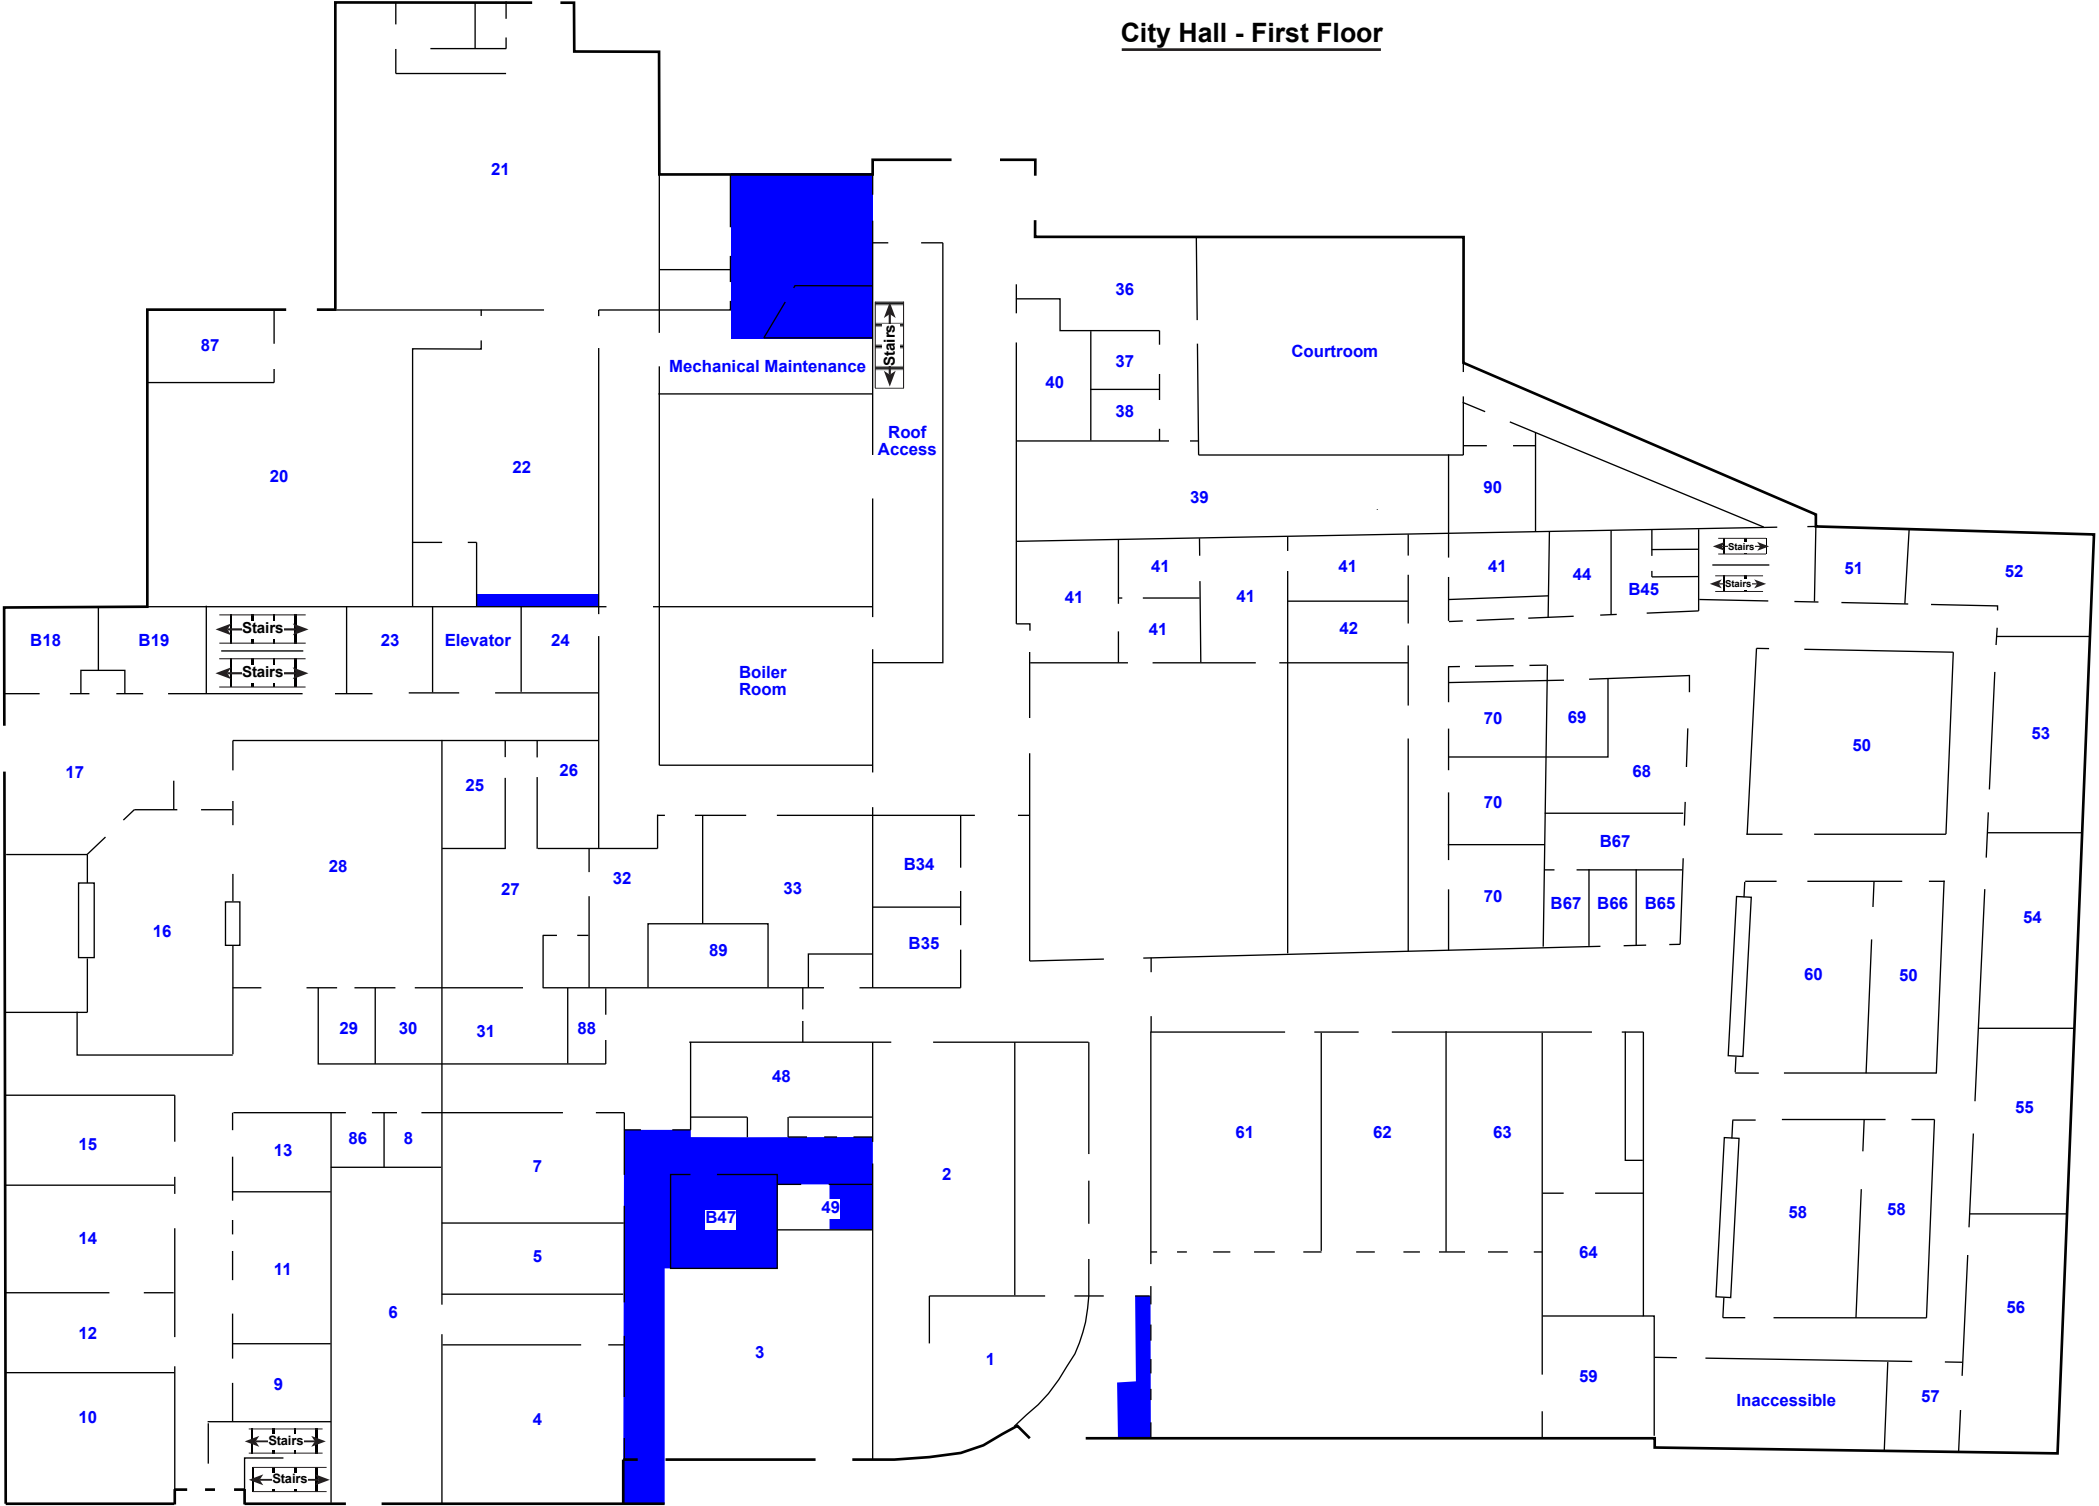
City Hall - First Floor

- Area containing lead-based paint (LBP)
- Room number/name

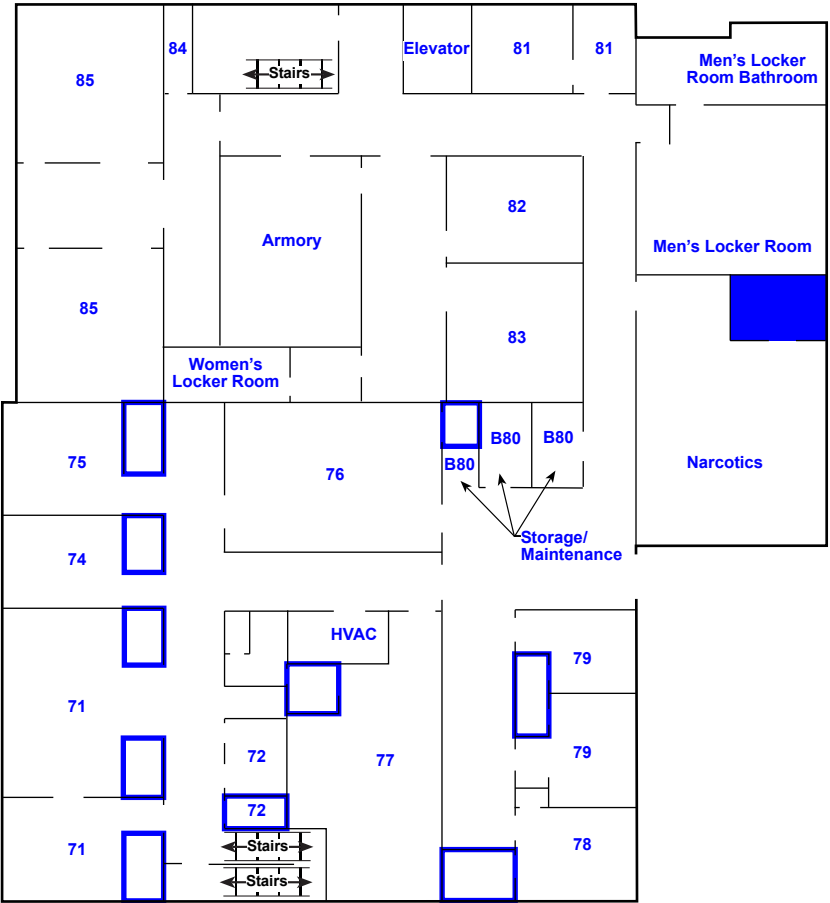
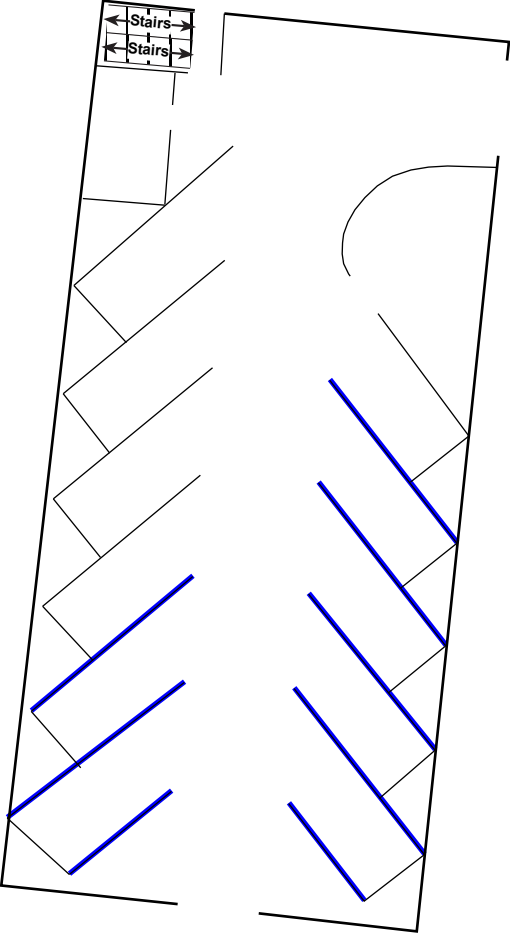
City Hall - Second Floor

- Area containing lead-based paint (LBP)
- 75 Room number/name

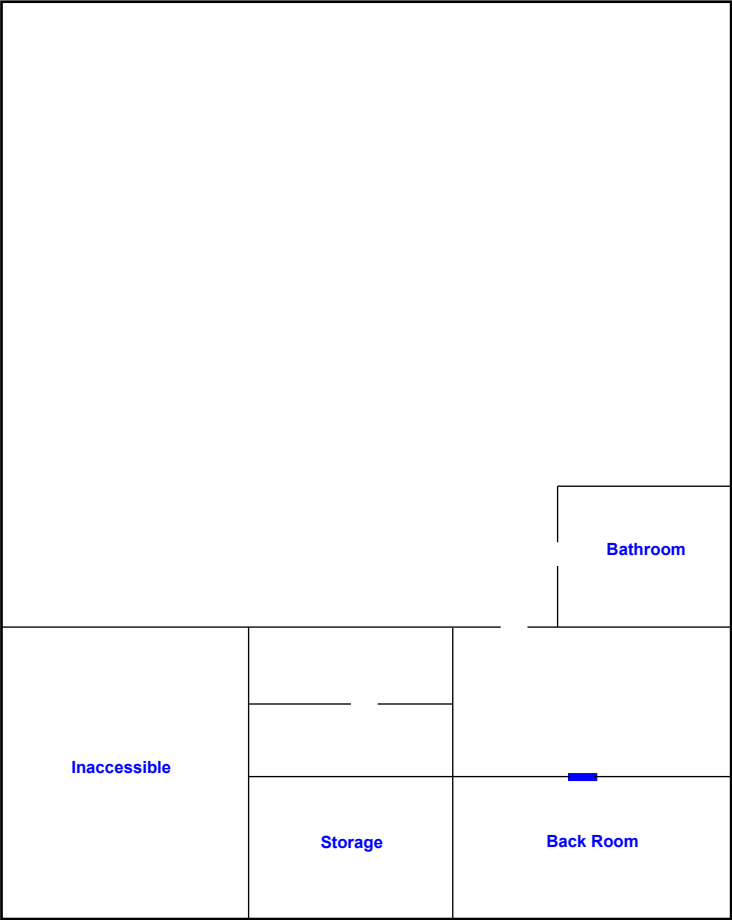
Evidence Building

- Area containing lead-based paint (LBP)
- B35 Room number/name
