**Subject: Analysis of Brownfields Cleanup Alternatives Report
Mead Hansen Building, 408 S. 8th Street, St. Joseph, Buchanan County, Missouri
U.S. EPA Region 7, START 5, Contract No. 68HE0719D0001,
Task Order No. 19F0101.004
Task Monitor: Todd Davis, Site Assessment Manager**

ANALYSIS OF BROWNFIELDS CLEANUP ALTERNATIVES REPORT

**MEAD HANSEN BUILDING
408 S. 8TH STREET
ST. JOSEPH, MISSOURI**

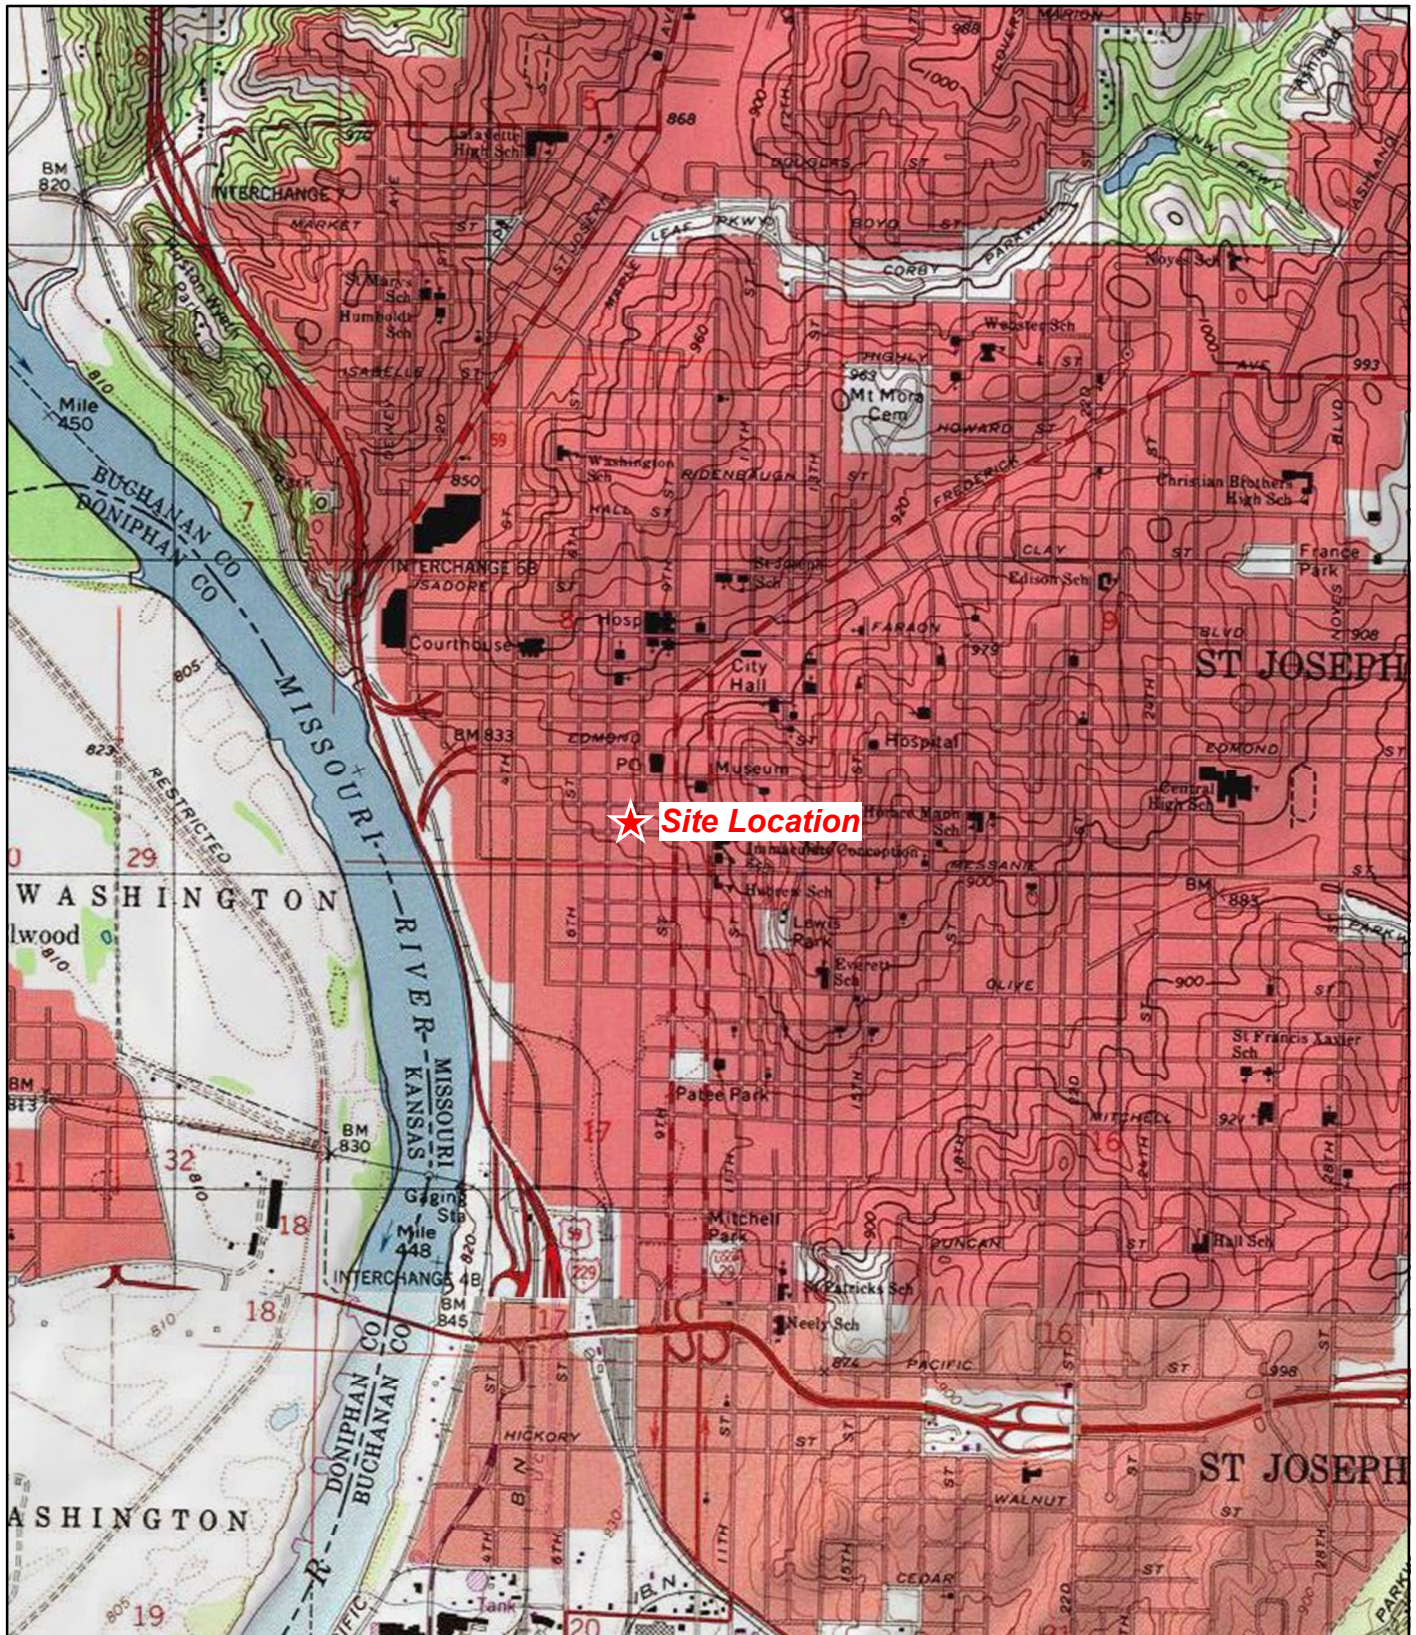
Figure 1
Site Location Map

Mead Hansen Building
408 S 8th Street
St. Joseph, Missouri

The site is included on the St. Joseph North, Missouri, U.S. Geological Survey (USGS) 7.5- minute topographic series map (USGS 1997) (see Appendix A, Figure 1). The site is in the southwest quarter of Section 8, Township 57 North, Range 35 West. Coordinates at the approximate center of the site are 39.7637690 degrees north latitude and 94.8510450 degrees west longitude. The parcel identification number for the subject property is 06-3.0-08-004-003-055.000 (Buchanan County Geographic Information System [GIS] Map Portal 2018).

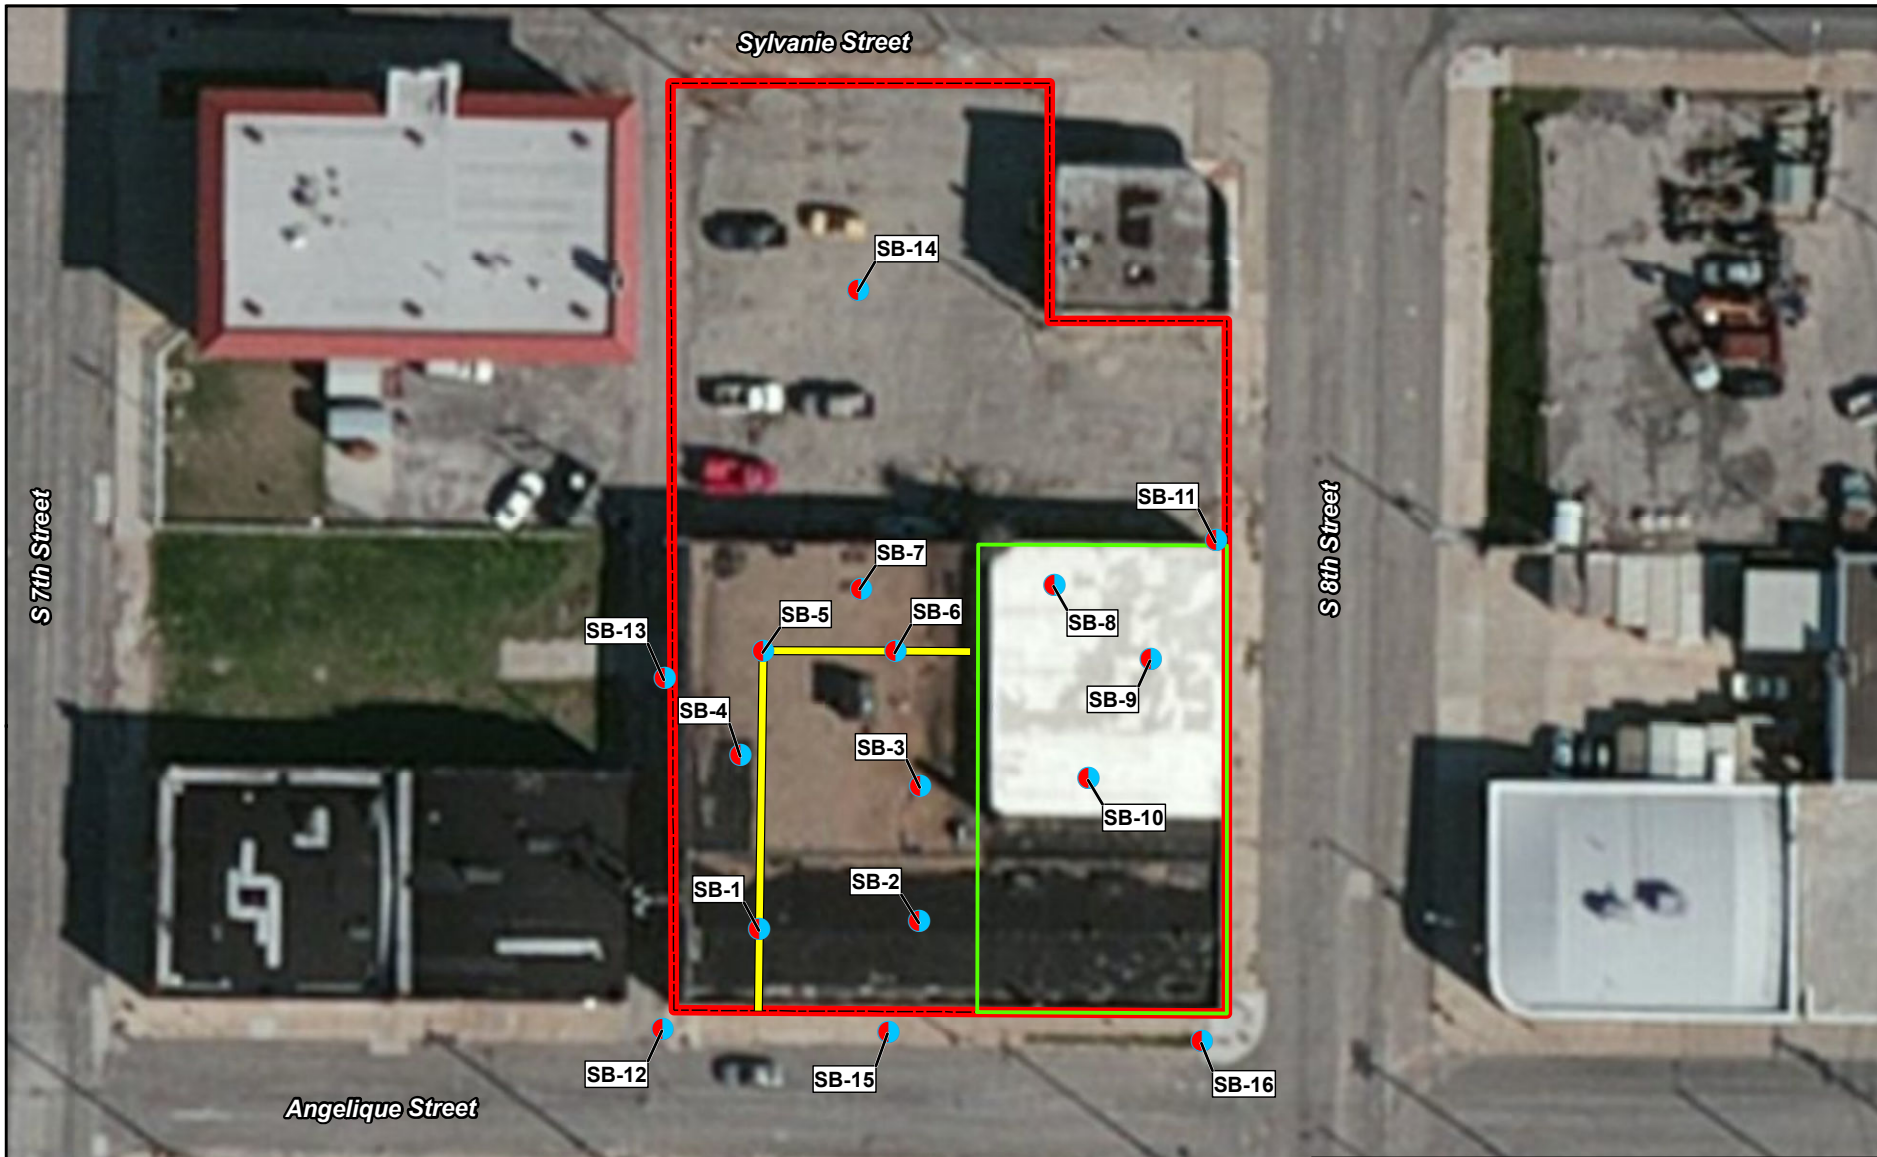
- Legend
- Soil and groundwater sample location
 - Former trench drain
 - Approximate site boundary
 - Basement extent

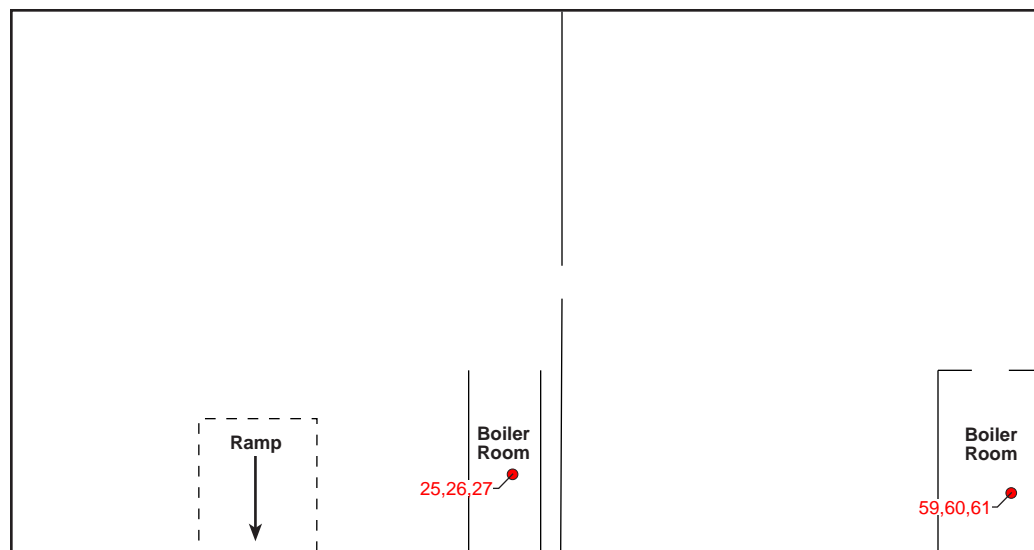
First Floor

Basement

- ACM Sample Location
 - Non-ACM Sample Location
 - Non-ACM and Non-PCB Sample Location
- ACM Asbestos Containing Material
PCB Polychlorinated Biphenyl

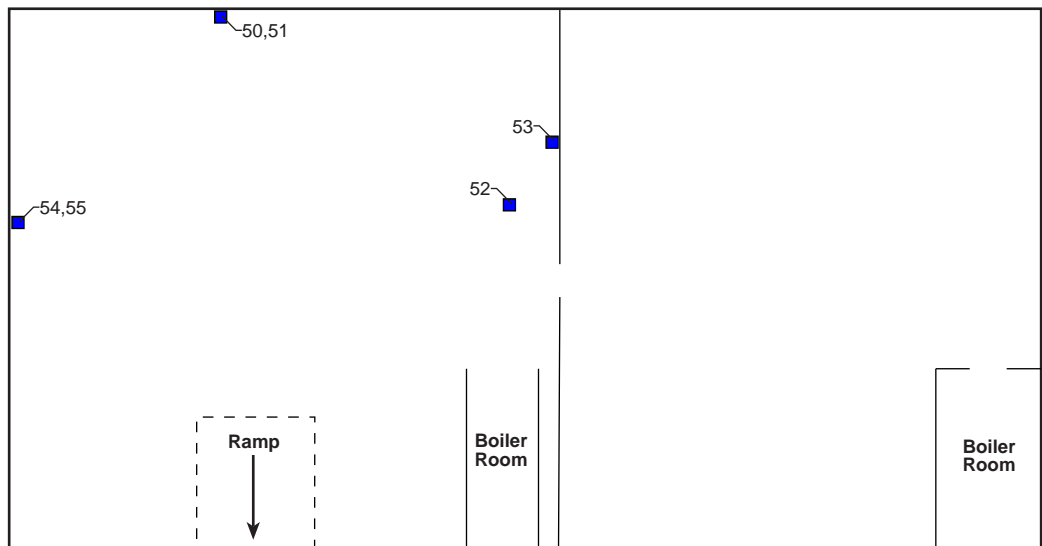
First Floor

Basement

- LBP Containing Material Sample Location
- Non-LBP Containing Material Sample Location
