**Subject: Contract No. 68HERH19D0018; Task Order (TO) No. 68E0719F0190  
Wellsville Firebrick Plant, Wellsville, Montgomery County, Missouri  
Analysis of Brownfields Cleanup Alternatives Report (ABCA)**

# **ANALYSIS OF BROWNFIELDS CLEANUP ALTERNATIVES REPORT**

## **WELLSVILLE FIREBRICK PLANT 1199 HIGHWAY 19, WELLSVILLE, MISSOURI**

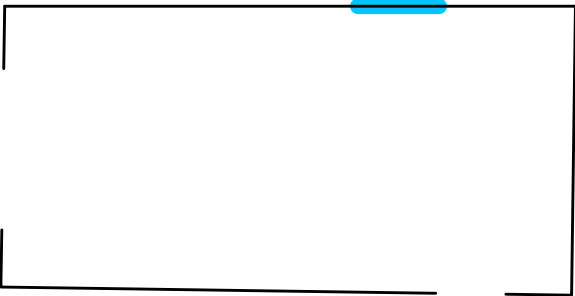
**Figure 7**  
Sample Location Map - Sheds

North Shed

South Shed

South Shed - Roof

- Legend
- Non-ACM sample location
  - PCB sample location
  - Area containing LBP
- ACM Asbestos-containing material  
PCB Polychlorinated biphenyl
