BULKHEAD INSPECTION REPORT

Bonita Peak Mining District Silverton, Colorado

Schnabel Reference #22690010.000
December 15, 2022

**North Wind Site Services
Bonita Peak Mining District – Bulkhead Inspections 2022**

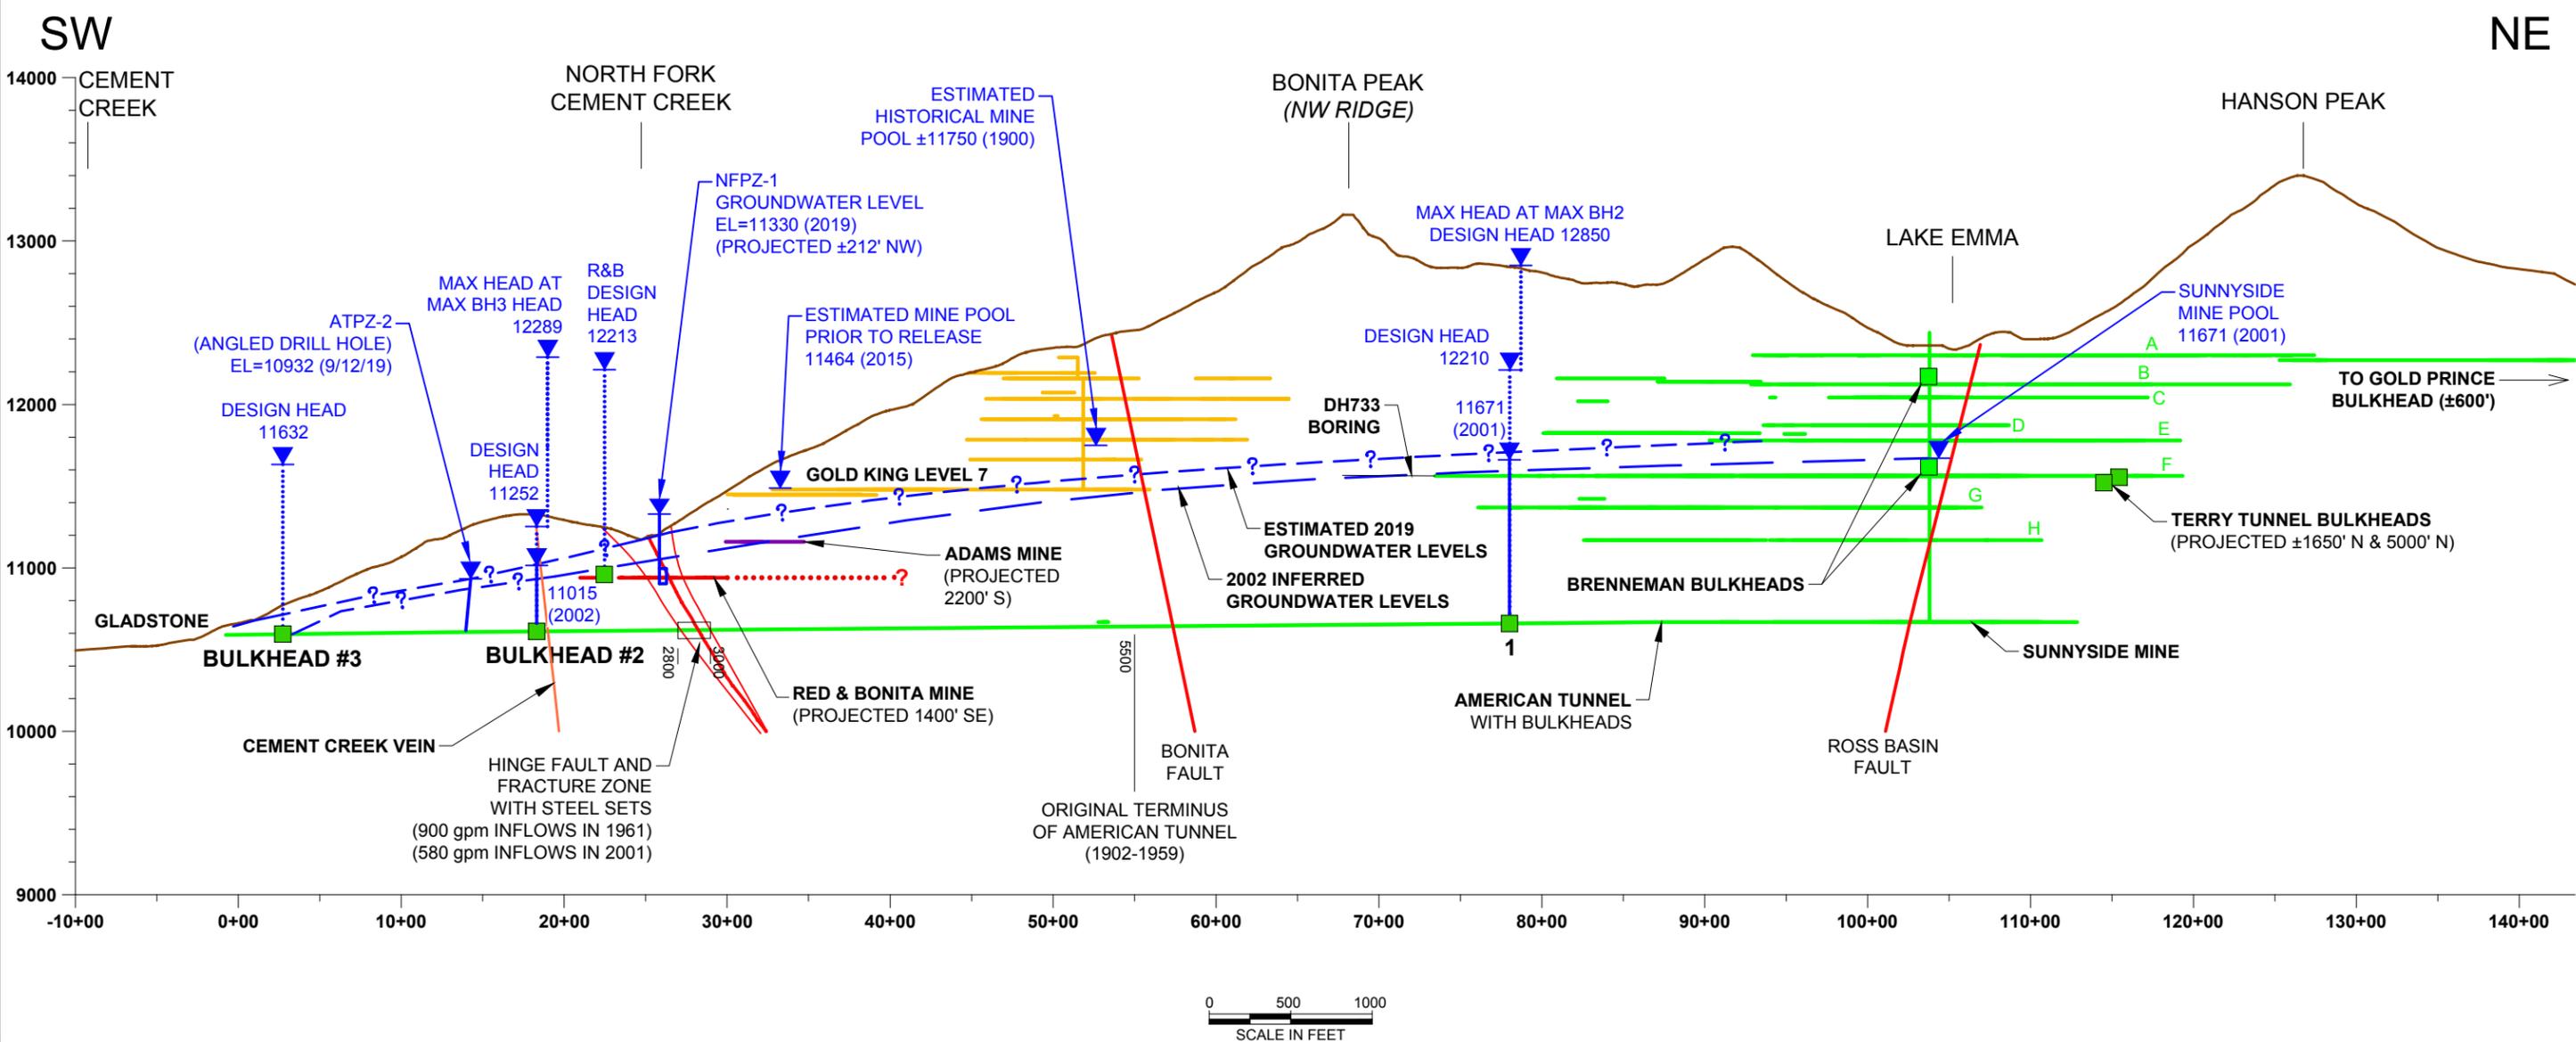
BONITA PEAK MINING DISTRICT BULKHEAD INSPECTIONS	
Bonita Peak Mining District Profile A	
	FIGURE NO. 3
DATE: DECEMBER 2022	SCALE: AS NOTED

1. MINES FROM 3D CAD MODEL USING CDRMS GIS DATA.
2. PROFILE A IS ALONG THE AMERICAN TUNNEL APPROXIMATELY PARALLEL TO THE GOLD KING AND DAVIS VEINS.
3. 1900 ESTIMATED SUNNYSIDE MINE POOL FROM MARKS, 1917.
4. EXISTING GROUND SURFACE FROM USGS DIGITAL ELEVATION MODEL.

Bonita Bulkhead Test Final Report” issued by Deere & Ault (a Schnabel Engineering Company), dated March 10, 2021. A profile of the key mine workings, drainage tunnels, bulkheads and estimated groundwater elevations in the region is shown on **Figure 3**.
