International Paper – Riegelwood Mill

Green Liquor Clarifier Work Plan

September 2007

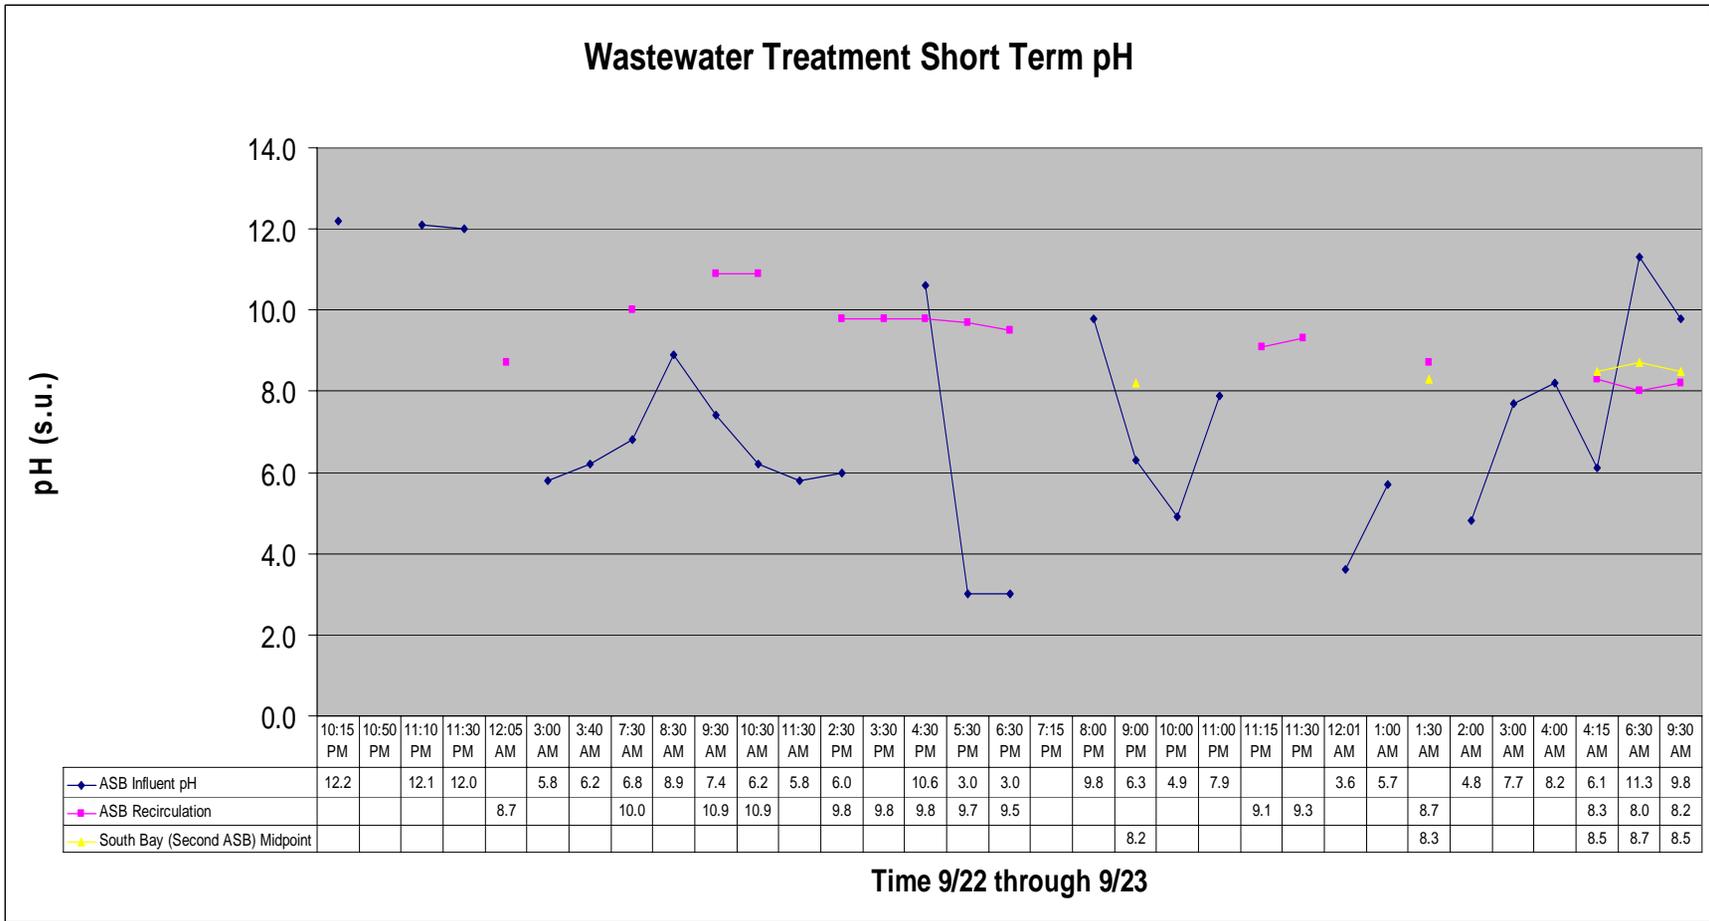
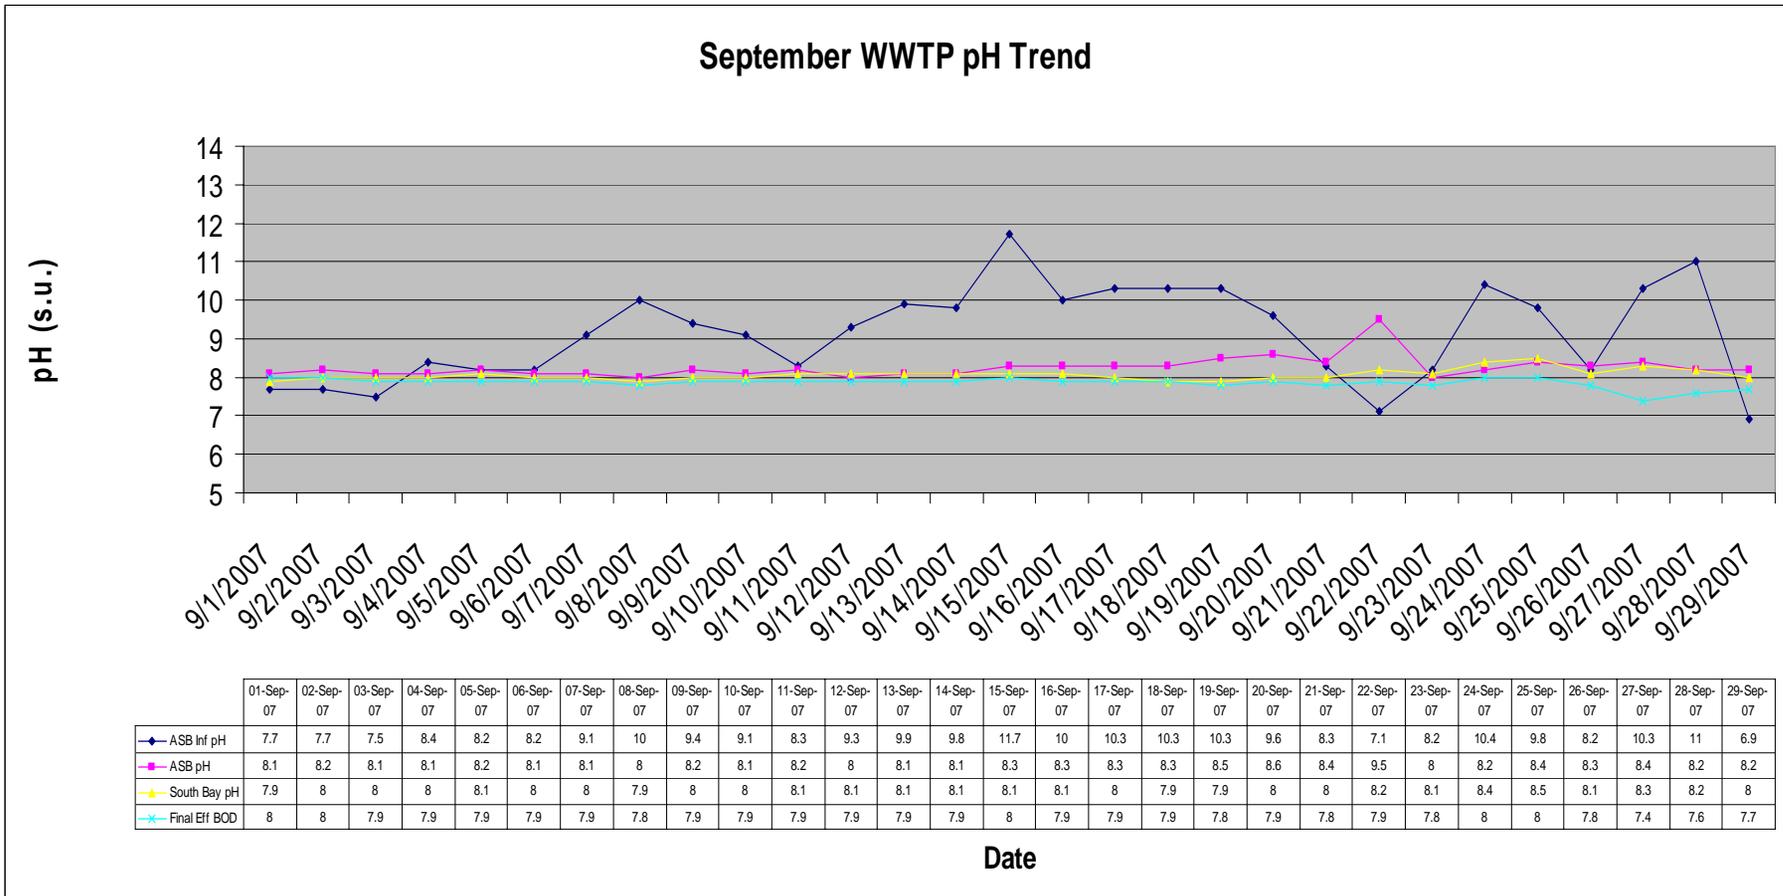
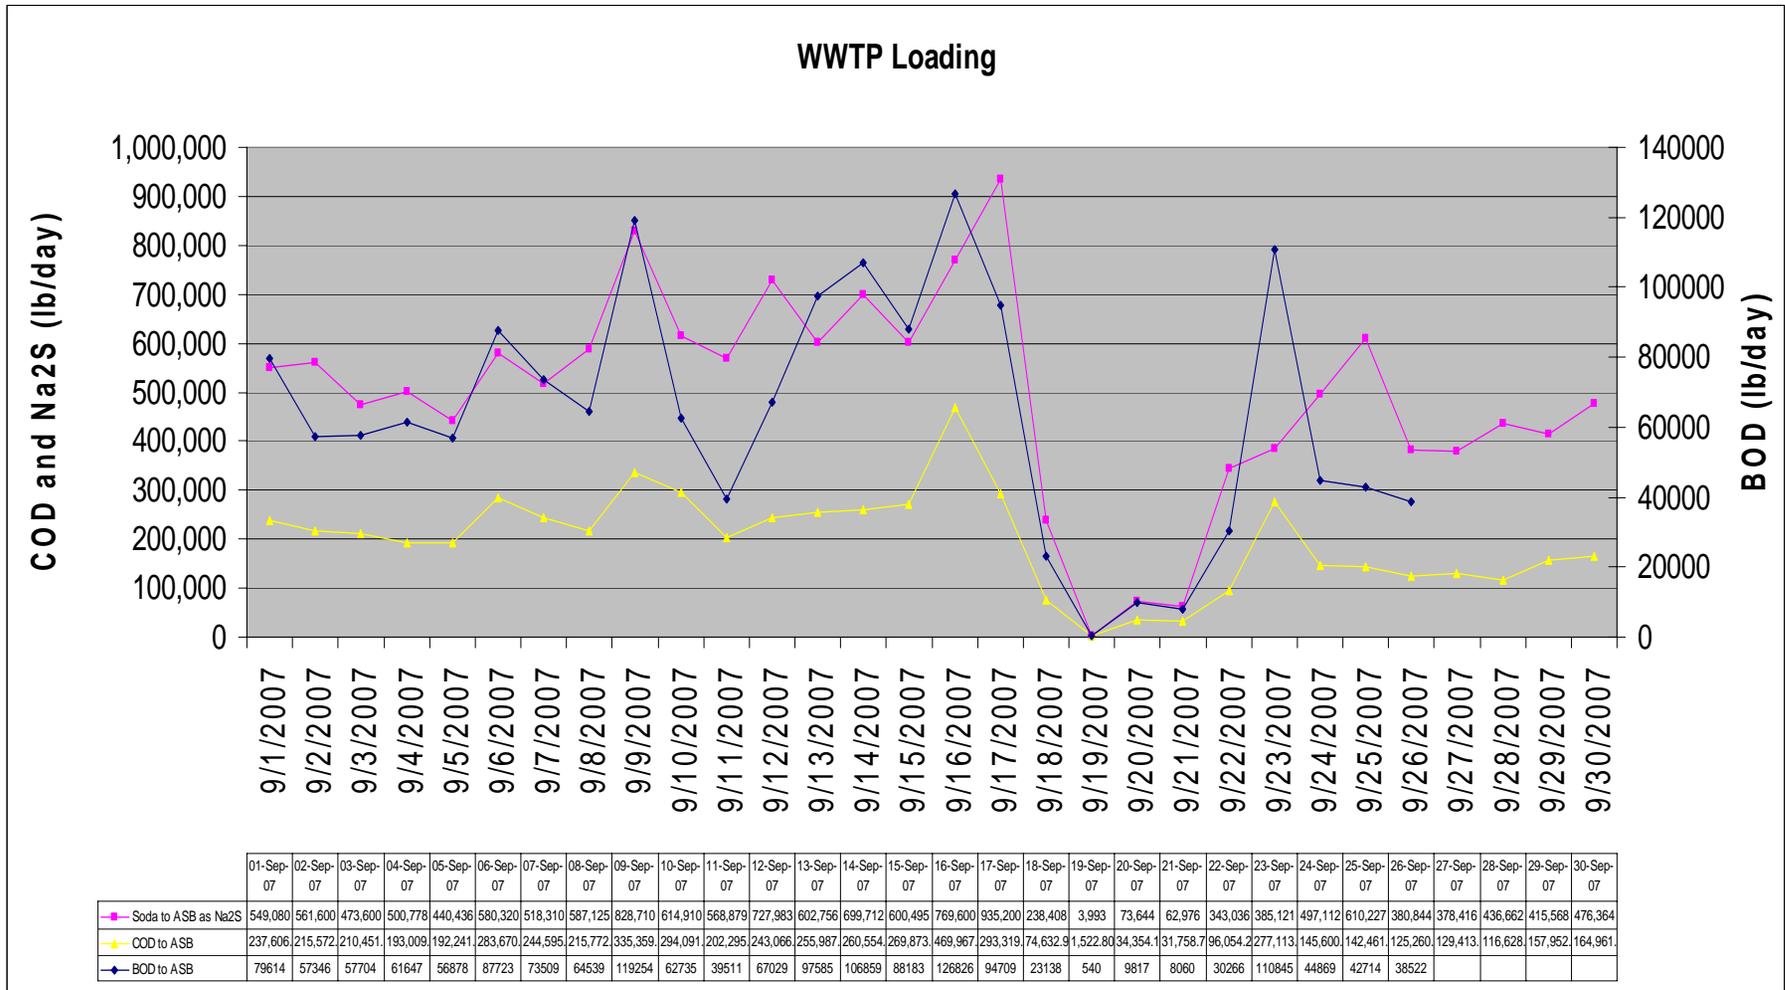
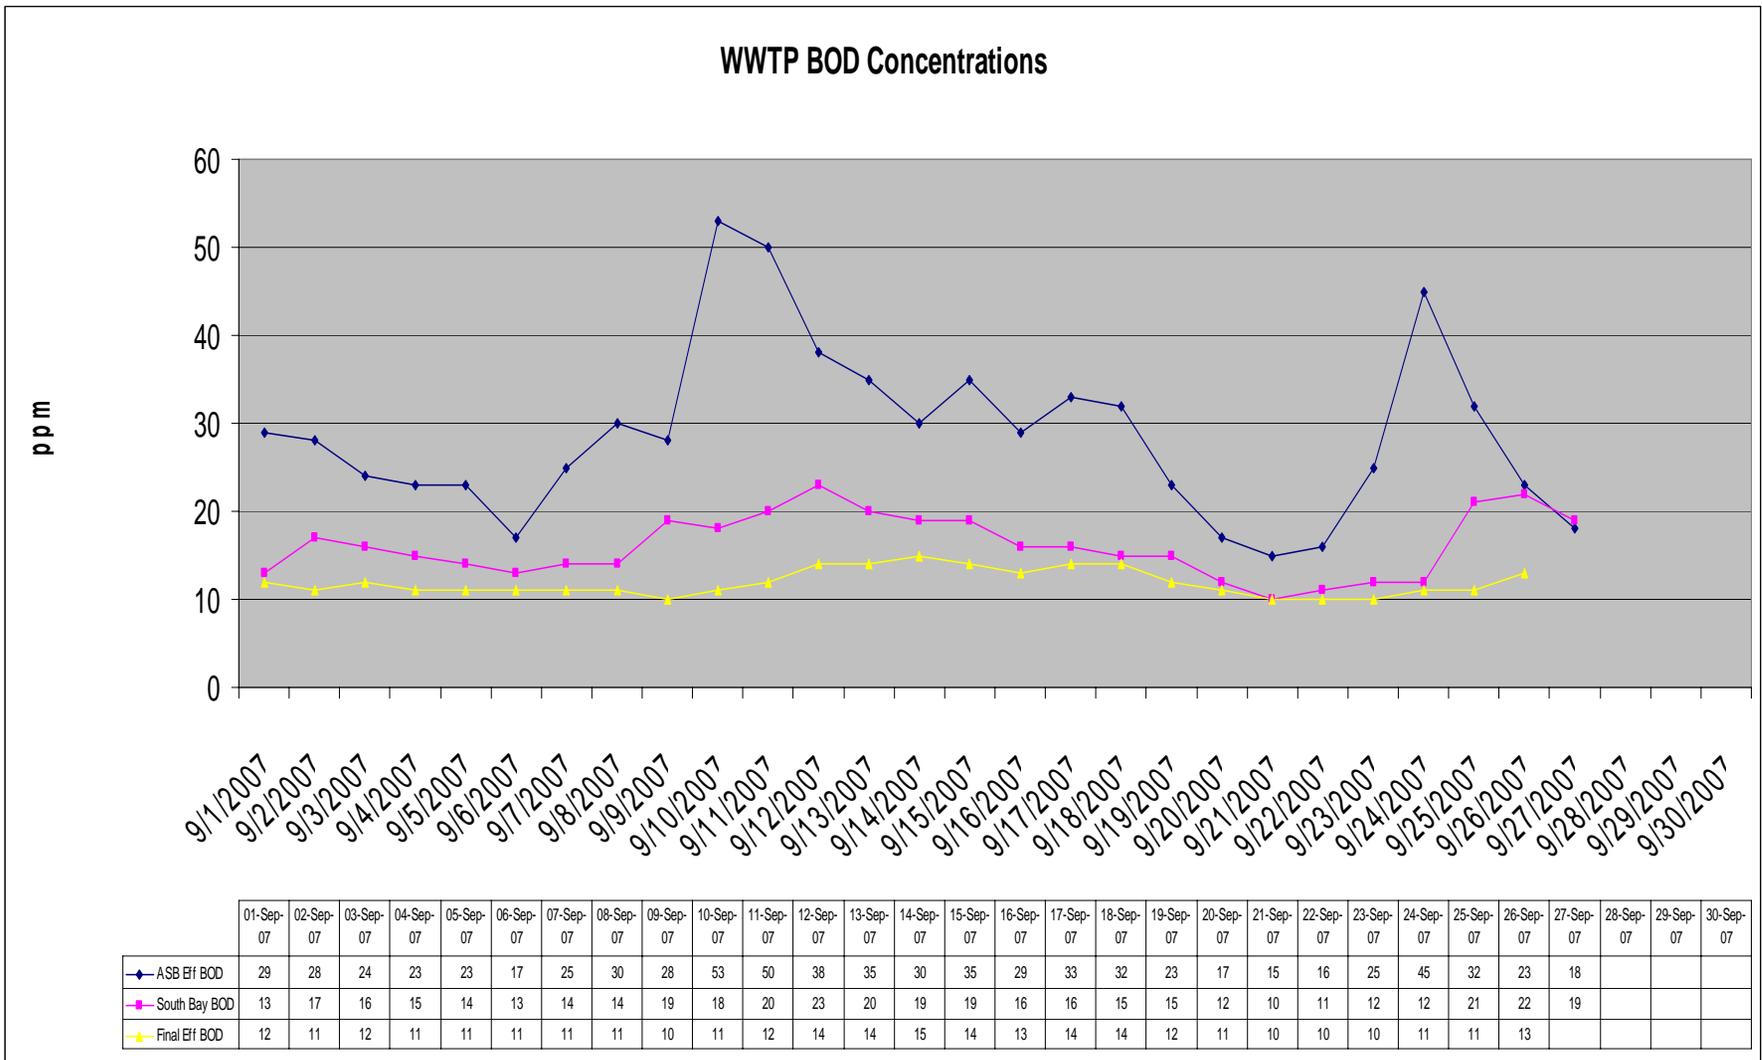
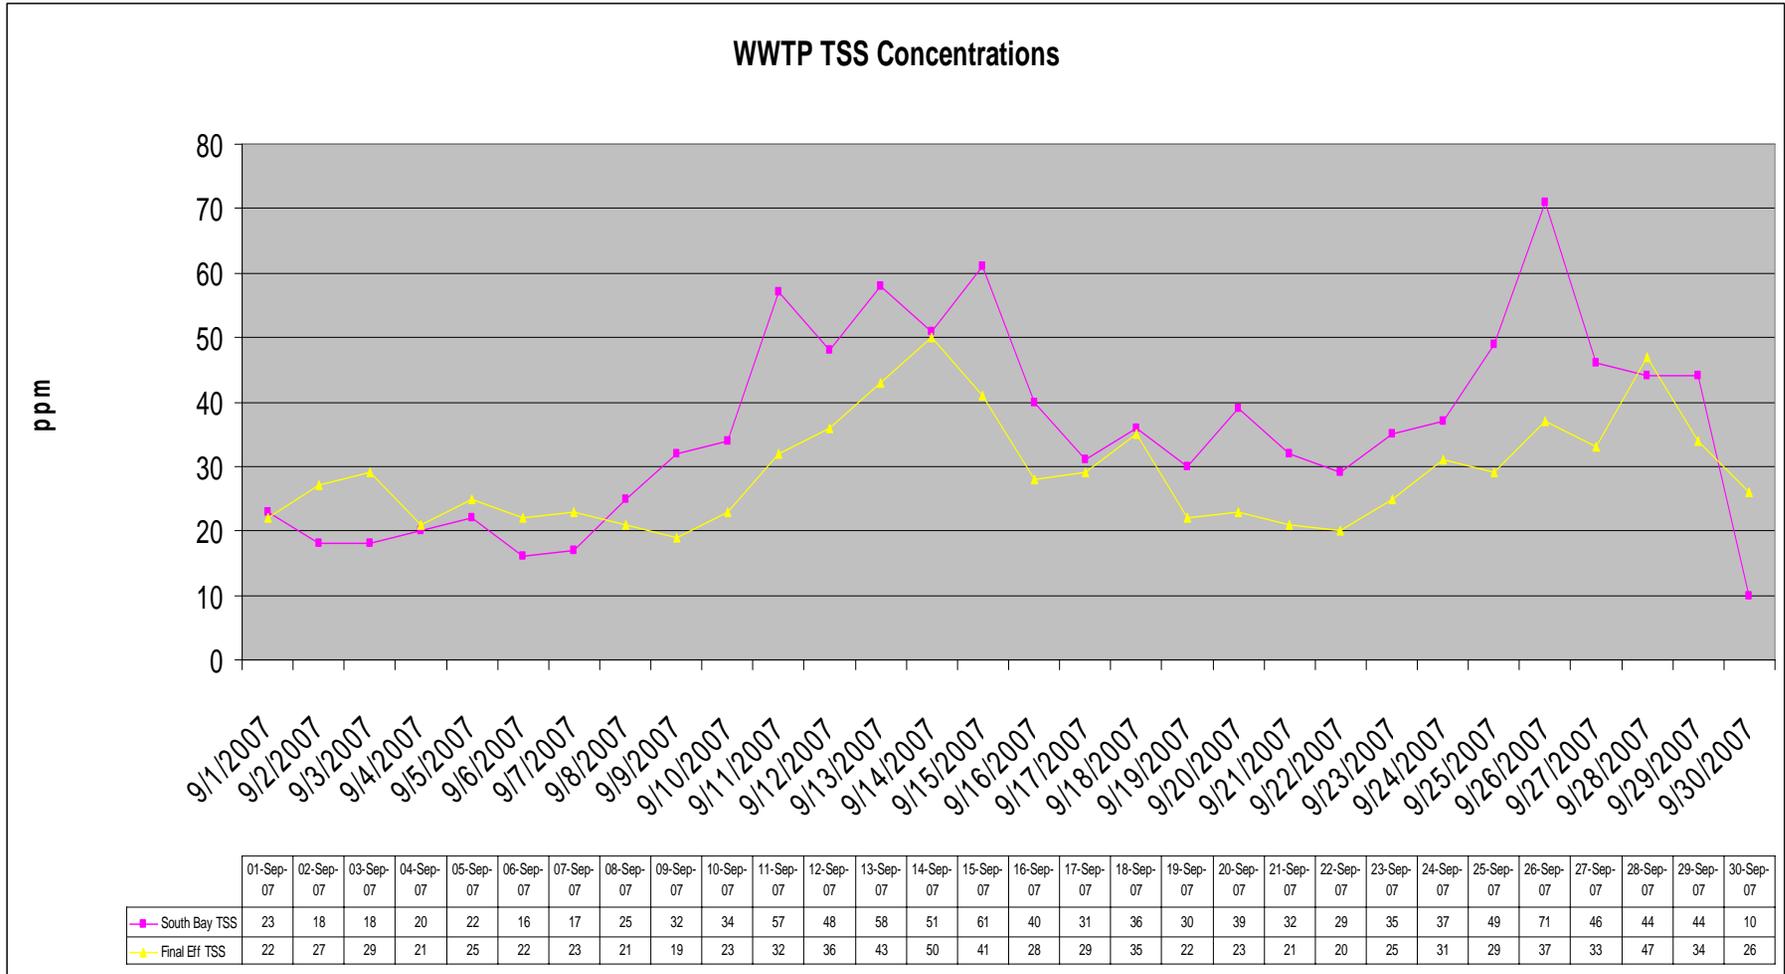
Notably, at the time of the leak, the mill had been down for annual maintenance for several days as is evident from the change in loading to the WTS. The remainder of the charts show the response to the event in terms of total suspended solids (TSS) and biochemical oxygen demand (BOD). These results, although somewhat elevated, did not move beyond their normal range. Since September 26, 2007, no additional extraordinary measures were needed to address the impact of the leak on the system. At this time, no NPDES effluent limits have been exceeded, the system has returned to normal and no exceedances are expected.

Below are the steps taken followed by trends showing the impacts on the treatment system. It should be noted that the wastewater treatment system at the IP Riegelwood facility is a very large biological treatment system, with seven days of total retention time, typically treating nearly 40 million gallons of influent per day.
