**United States Environmental Protection Agency
Region 2
Emergency Remedial Response Division
Response and Prevention Branch – Preparedness Team
Edison, NJ**

**AFTER-ACTION REPORT
for the
Lawrence Aviation Industries
Cleanout Operations
Barnum Avenue Culvert, Old Mill Creek
Village of Port Jefferson, NY**

Date Generated : May 28, 2010

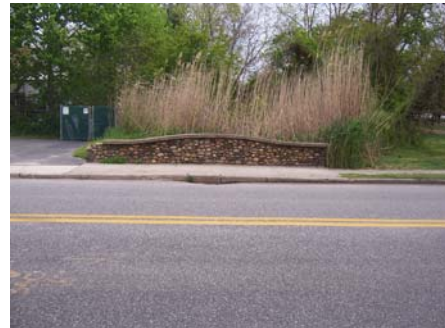
East side view of Barnum Avenue Bridge prior to work performed by EPA.

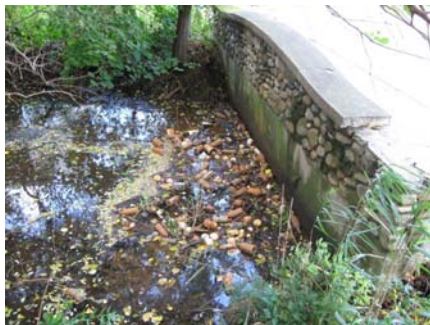
View of debris prior to Old Mill Creek cleaning.

Removal of vegetation was necessary to allow for the staging and operating radius of a long-reach excavator. This large piece of equipment was primarily utilized for the removal of sediments and debris from Old Mill Creek west of Barnum Bridge. Power,

Personnel utilized a variety of heavy equipment for the removal of sediments, vegetative debris, and waste. A bobcat, backhoe, and long-reach excavator allowed for digging in the Creek, transporting material to filtration boxes, and restoration of grade. Approximately 120 yd² of sediment was removed from the Old Mill Creek in the vicinity of Barnum Avenue Bridge. This material was sent to Brookhaven Town Landfill in Brookhaven, NY.

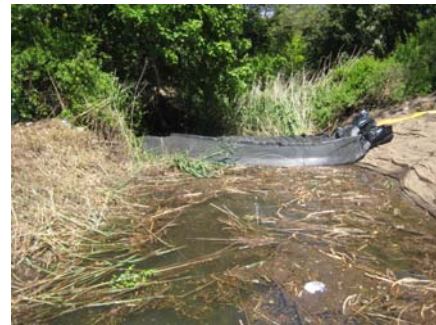
A culvert box measuring 4'X8'X30' is located under Barnum Avenue to allow waters of the Old Mill Creek to move from the west side to the east side of Barnum Avenue. This culvert was found to be functioning poorly, at best. Sediments and debris were removed from this culvert in a unique and instrumental manner. One aqua dam was placed up-gradient in the Creek, approximately forty feet (40') to the west of Barnum Avenue. Another aqua dam was placed down-gradient in the Creek, approximately thirty-five feet (35') west of

Aqua dams were placed in Old Mill Creek to re-route water from west to east overland through pipes.

Barnum Avenue. Two 600 gallons-per-minute pumps were used to move water across Barnum Avenue in six-inch (6") flexible pipes. The water was then returned to the Creek downstream of the Barnum Bridge. This allowed for a minimal amount of water to be in the area of the culvert, so that debris and sediments could be removed from it.

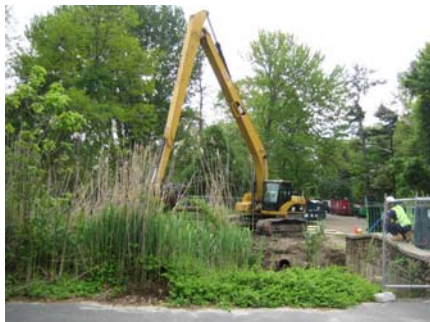
Heavy equipment was utilized for excavating sediment and debris.

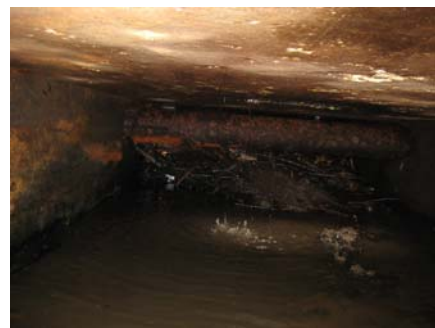
During the damming activities, an inspection of the culvert was conducted. It was found that a twelve-inch (12") ductile cast-iron, active water main extends from north to south in the culvert. Sediment and debris has closed the passage below the pipe, leaving a gap approximately two to four inches (2-4") above the pipe for water flow. This pipe was found to have no supports, no protection from freezing, and is not sleeved. The pipe is acting as an artificial dam, adding stress to the structural integrity of the water main. Sediment was removed from the east side of the water main, along with a vast amount of debris. A limited quantity of sediment and debris was also removed from the west side of the culvert. EPA crews removed as much material as possible without impacting the exposed water line and without producing any additional safety concerns. Personnel were not

Available documentation for the construction and engineering of Barnum Avenue Bridge is limited due to its early period of construction. It had been previously thought that the passageway located under the Bridge to allow water flow was an open box culvert. As work progressed in the removal of sediments, it was learned that a twelve-inch (12") cast-iron water main runs through the culvert. Sediment and debris has clogged the bottom portion of the pipe and will continue to do so unless the pipe is removed. Water is allowed to flow but only between the pipe and the top of the culvert. It is unknown as to the age and structural integrity of the pipe. As such, EPA removed as much material as safely as possible. EPA notified the Village of Port Jefferson, who contacted the Suffolk County Water Authority to initiate emergency protocols in the eventual replacement and removal of the water main.

A water main was discovered in the culvert under Barnum Avenue.

It is predicted that poor water flow along Old Mill Creek may be related to the presence of a 12" water main located in the culvert. The pipe is acting as an artificial dam, holding back debris and allowing the culvert to be clogged. Until the pipe is removed, water flow will be restricted and continued maintenance of the culvert and Creek will be necessary.

allowed to crawl inside the culvert due to the proximity of the water main. Suffolk County Water Authority was contacted by the Village and EPA.
