# EPA Conducting Cleanup At Abandoned Plant

## Pickens Plating Inc.

Albion, Michigan

October 2010

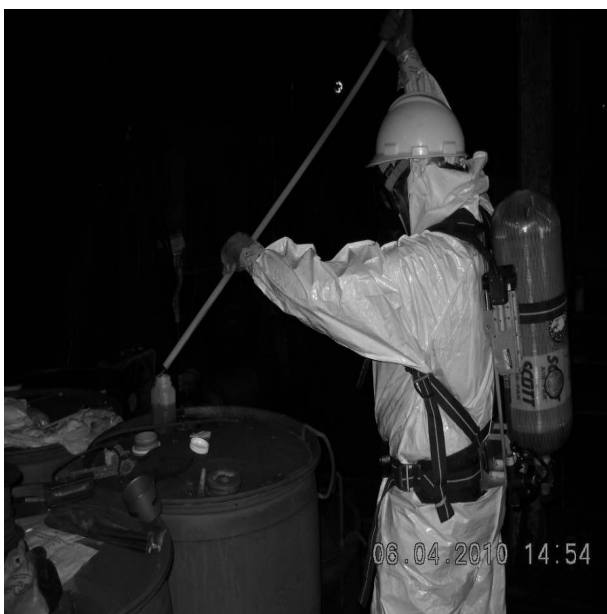
*An environmental worker dressed in a hazard-materials suit takes a sample from a barrel in the abandoned Pickens Plating facility in Albion, Mich. Dozens of drums, vats and containers holding toxic materials were found in the former zinc electroplating plant.*

a 55-gallon drum containing chromium at concentrations 1,000 times higher than levels considered toxic to humans, hydrofluoric and nitric acids with hazardous pH levels and plating chemicals sitting in 41 open vats.

Cleanup workers will first be identifying, consolidating and repackaging hazardous materials on-site. The consolidated materials will then be removed and disposed of at an approved off-site location.

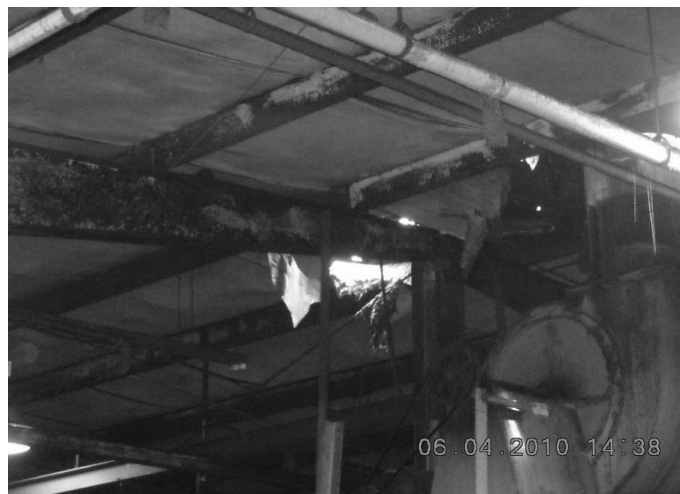
The building floors were also in poor condition showing signs of numerous spills, staining and waste accumulation from years of poor housekeeping. Inspectors found several holes in the roof that could allow precipitation to either corrode drums and cause leaking or react with open acid vats and release dangerous fumes.

*A leaky roof on the Pickens Plating building could allow rain to reach open acid vats and cause a chemical reaction that would release dangerous fumes.*

Additional site activities will include adding security and setting up air monitoring both inside the Pickens building and around the site perimeter. There will also be building decontamination and dismantling of some structures as needed to help the cleanup work progress.
