Subject: Removal Report  
Barker Chemical Company  
TDD No: TNA-05-001-0012  
EPA Contract No: EP-W-05-053 (START 3)

# **REMOVAL REPORT**

**Barker Chemical Company Site  
Inglis, Levy County, Florida  
TDD No.: TNA-05-001-0012  
Contract No.: EP-W-05-053**

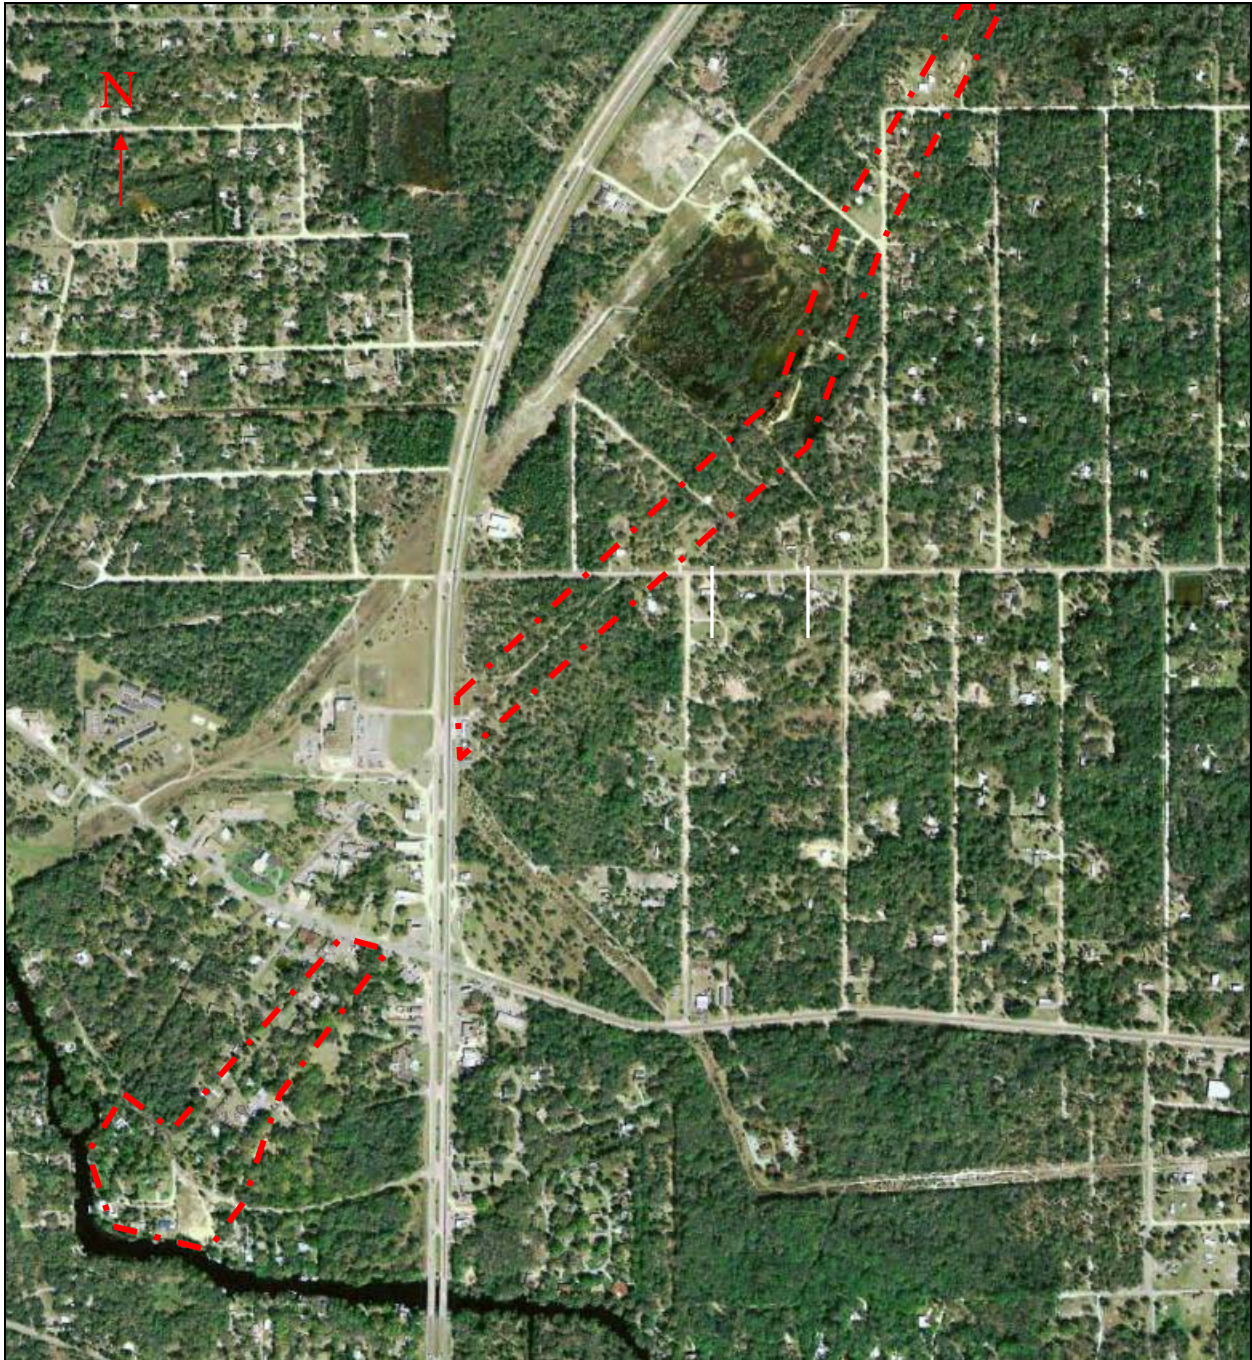
**FIGURE 1**

--- Removal Area

**Aerial Map**

The entire site is comprised of 161 mixed-use parcels that cover approximately 300-acres in the City and unincorporated areas of Inglis, Levy County, Florida. This phase of the Barker Chemical Company Site Removal covers approximately 140-acres of mixed use properties bounded by the Withlacoochee River on the south, County Road 40 to the north-northeast, U.S. Highway 19 to the east, and extends just past the Inglis City limits. The majority of the parcels comprising the site are utilized or zoned for residential use (see Appendix A, Figure 1).

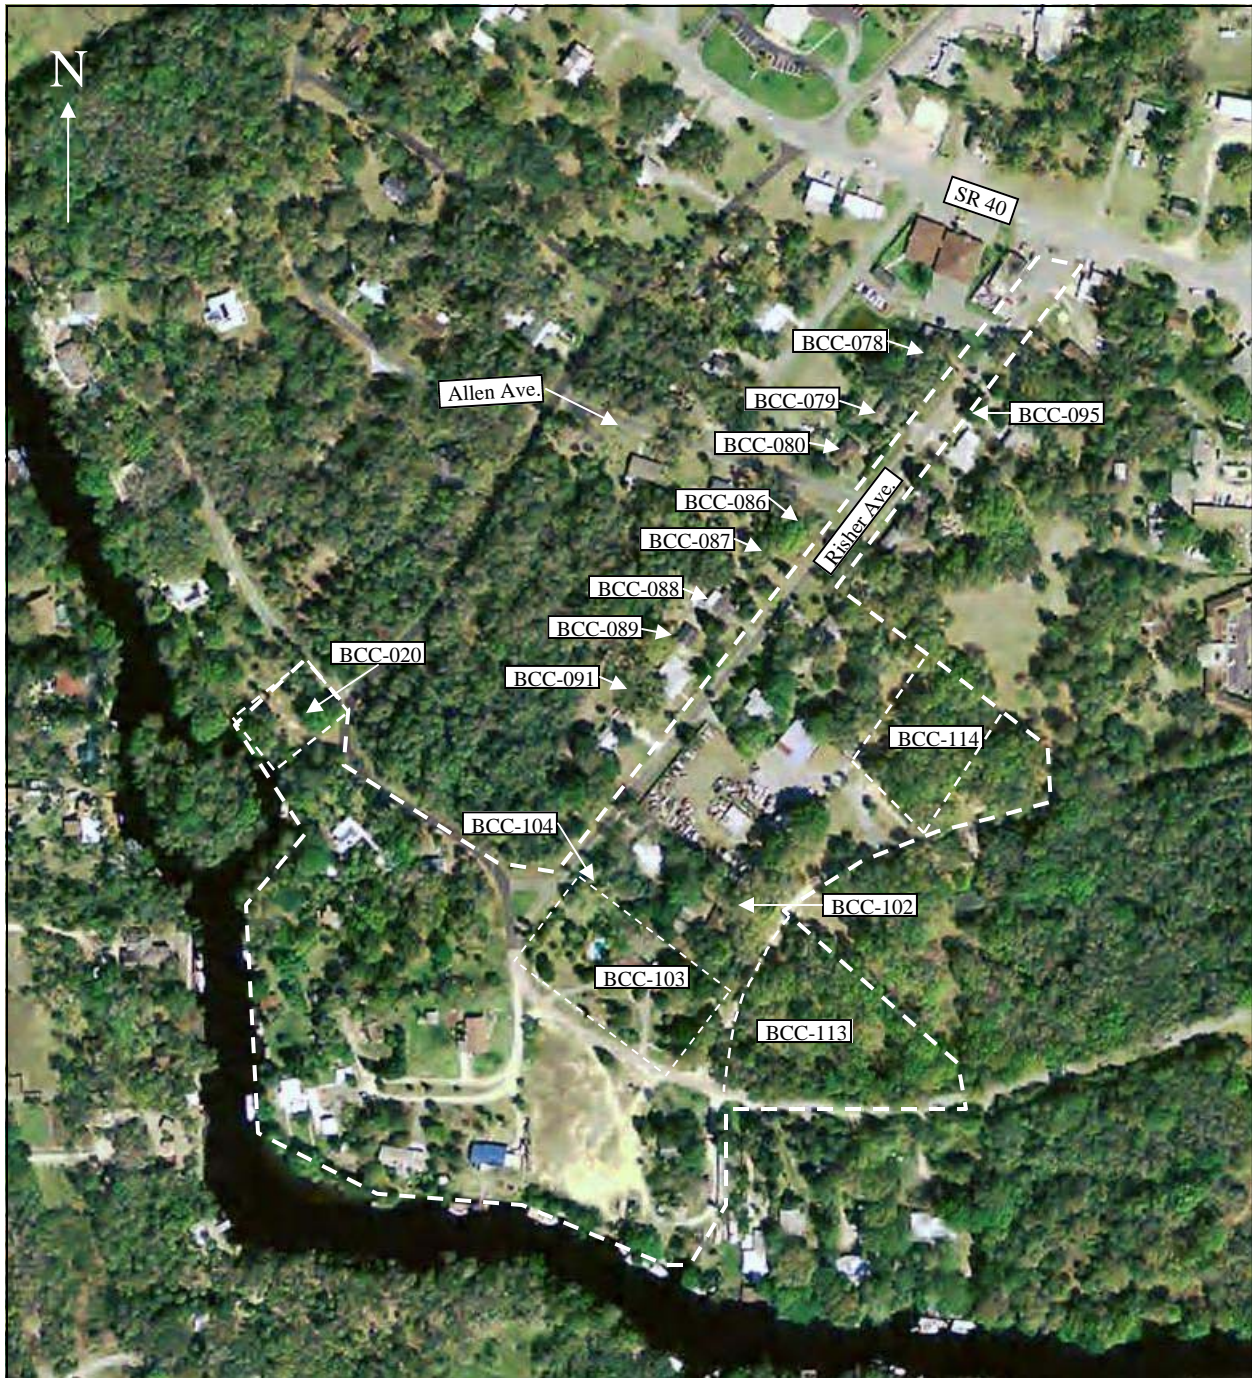
Barker Chemical Company Site FL 0001275627 Inglis, Levy County, Florida	
FIGURE 2 Garden Mall Court Parcel Map

<u>Legend</u>	
-----	Boundary

The site was divided into two sections. The Garden Mall Court section contained the location of the former Barker facility and lies adjacent to the Withlacoochee River within the city limits of Inglis (see Appendix A, Figure 2). The second section was the Former Inglis Road (FIR) and describes a defunct road which originated at the former facility and extended northeast from the site. The FIR has since been

Once ERRS had sufficiently excavated the parcel, START analyzed the excavation floor with the XRF and collected confirmation soil samples for CLP laboratory analysis. The parcels and right of ways listed in this section are BCC 020, 102, 103, 104, 113, 114, and ROW's 78, 79, 80, 86, 87, 88, 89, 90, 91, and 95. Post removal analysis revealed arsenic values ranging from non-detect to 130 mg/kg and lead values ranging from non-detect to 430 mg/kg. The highest values occurred at parcels BCC 020 and BCC 113. In both instances, the results were attained at -2.0 feet bgs (see Appendix A, Figure 2 and Appendix E) (Ref. 10).

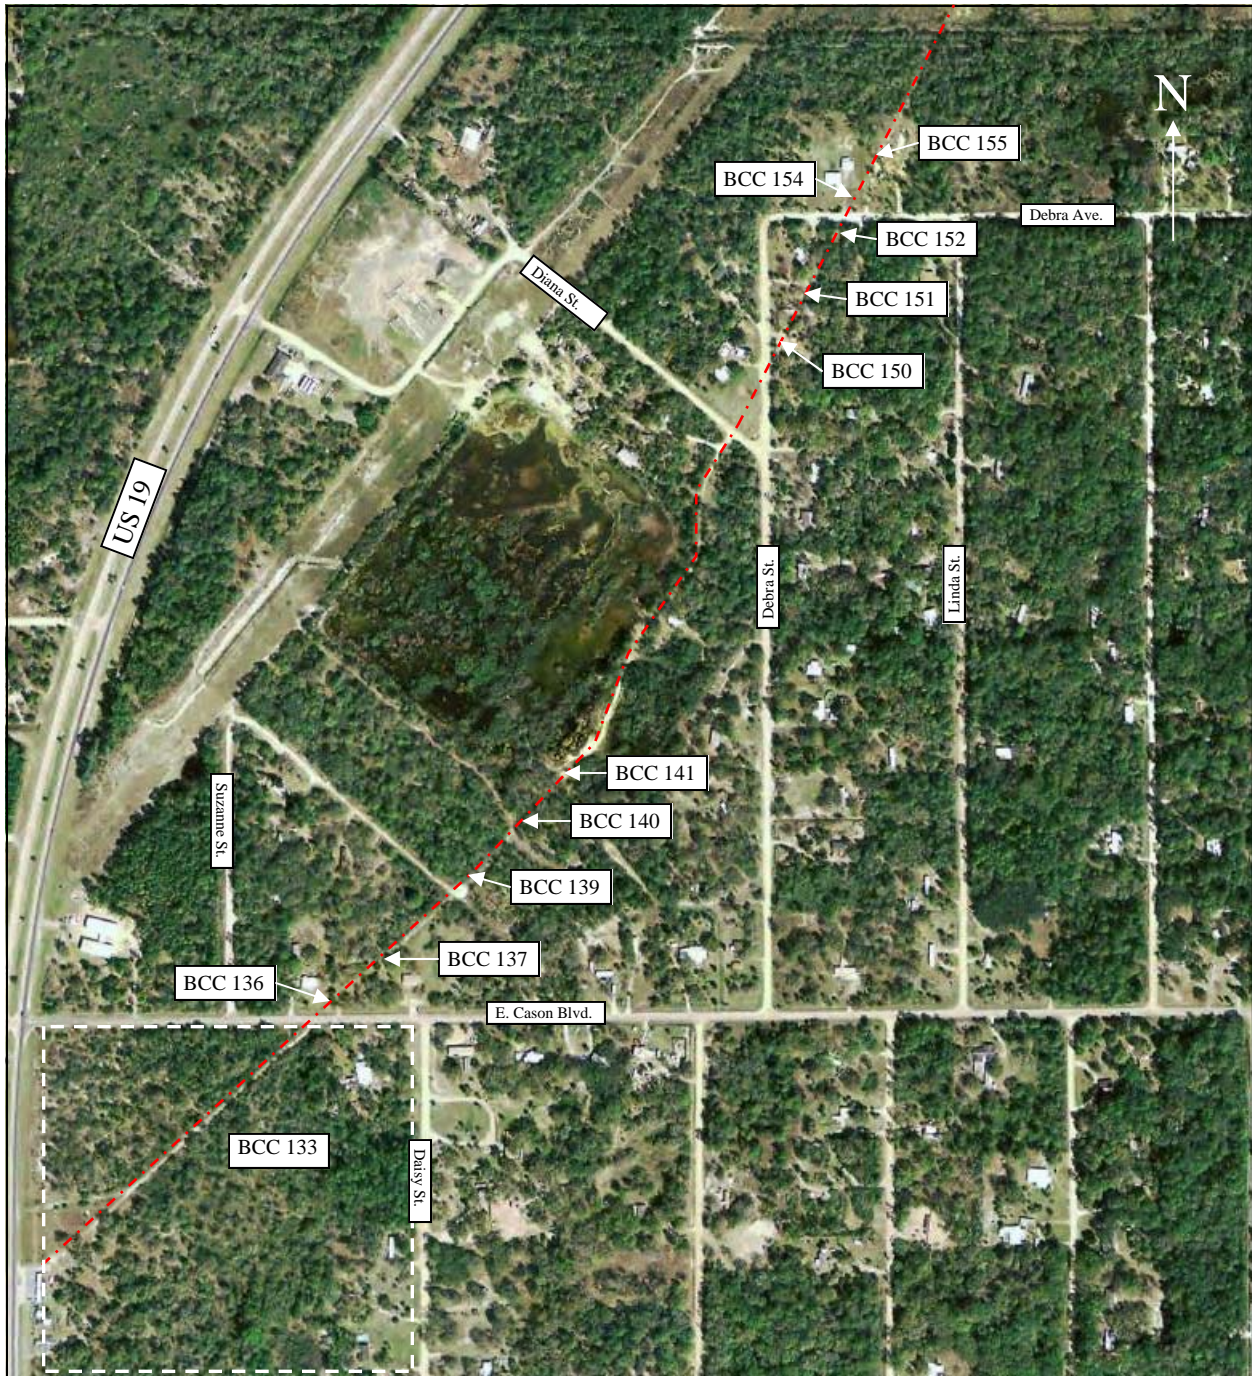
**FIGURE 3**

- - - - - Former Inglis Road
- - - - - Parcel Boundary

**Former Inglis Road Parcel Map**

platted and developed with residential and commercial properties (see Appendix A, Figure 3). Earlier site assessments by EPA and FDEP revealed arsenic and lead levels in excess of their respective action guidelines, resulting in these areas being listed as time critical due to the residences located on or adjacent to them. Access agreements were obtained from the property owners and utilities were marked prior to any parcel investigations or remediation.

The parcels which occurred along this former road are identified as BCC 133, 136, 137, 139, 140, 141, 150, 151, 152, 154, and 155. The XRF was used to analyze the excavation floor with confirmation soil samples collected and analyzed by a CLP laboratory. Post removal analysis revealed arsenic values ranging from non-detect to 23 mg/kg and lead values ranging from non-detect to 296 mg/kg. The highest values occurred at parcel BCC 133 and were attained at -2.0 feet bgs (see Appendix A, Figure 3 and Appendix E) (Ref. 10).
