## Diaz Intermediates Corp., Removal Daily Progress Report 20 September 2011

Site Name	Diaz Intermediates Corp. Removal
SSID No. / CERCLIS No.	A6C4 / ARR000005843
Site Location	301 Wyanoke Drive, West Memphis, Crittenden County, Arkansas Latitude 35.107083°North / Longitude 90.193000°West
EPA On-Scene Coordinator	Adam Adams (cell # 214.202.6952)
ADEQ Field Team Leader	Michael Gates (cell # 501.813.6457)
Work Activity	Removal

A. Photographs (103\_3388, 103\_3390, 103\_3391, 103\_3395)

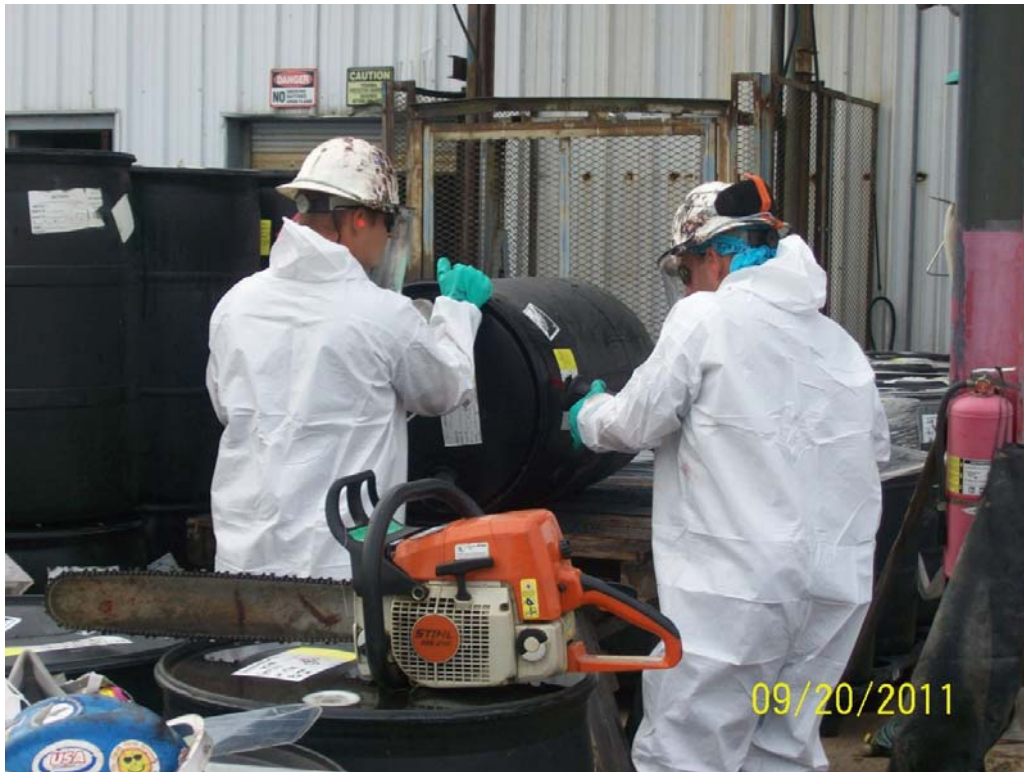
Resizing emptied drums for disposal shipment (Photo# 103\_3388).

- Two hundred and three (203) 55-gallon drums previously emptied of their hazardous substances were cut into smaller pieces and decontaminated to "RCRA empty" status. Total decontaminated drums to date: 300.

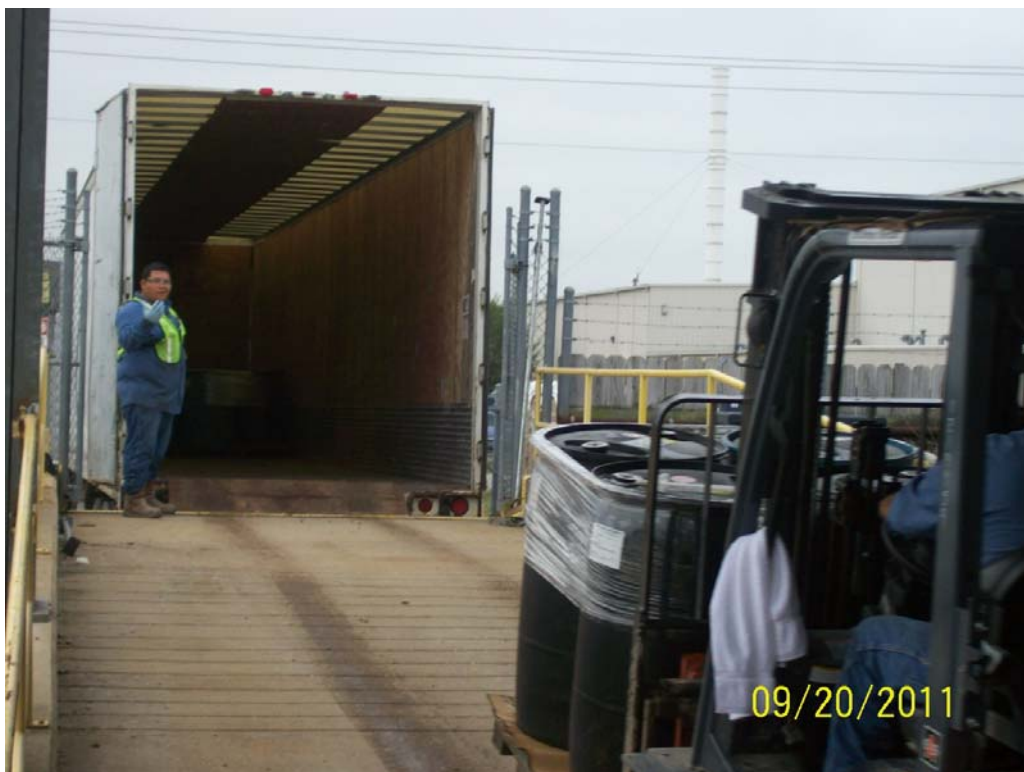
Loading of drums for transport to a disposal facility (Photo# 103\_3390).

- Sixty nine (69) pallets, with four (4) 55-gallon poly drums per pallet, were shipped off-Site for disposal (*See Attachment B*).
- Sixteen (16) pallets, with four (4) 55-gallon poly drums per pallet, were labeled and shrink-wrapped in preparation for disposal shipment.

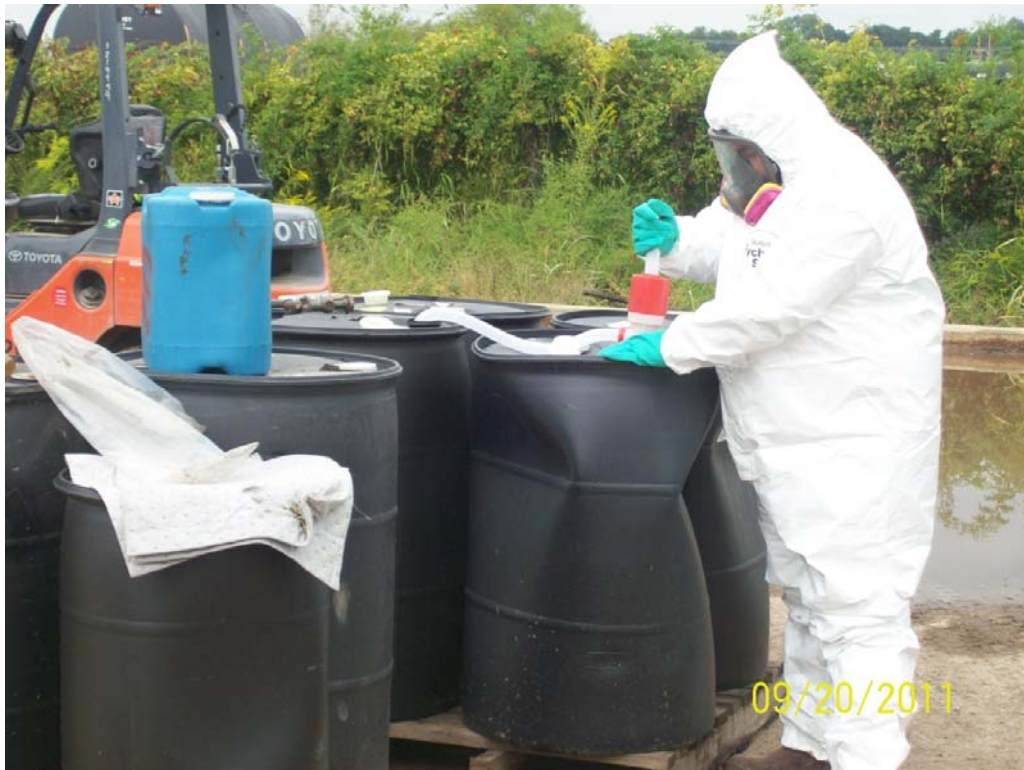
Drum consolidation (Photo# 103\_3391).

- Four (4) partially full 55-gallon drums containing diazene-42 were consolidated into two (2) 55-gallon poly drums.
- Two (2) partially full 55-gallon drums containing bromopyridine were consolidated into one (1) 55-gallon poly drum.

- Two (2) partially full 55-gallon drums containing n-propylbromide were consolidated into one (1) 55-gallon poly drum.
- One (1) partially full 55-gallon drum containing bromophenol was consolidated into an existing bromophenol 55-gallon poly drum.

- One (1) partially full 55-gallon drum containing bromofluorobenzene was consolidated into an existing bromofluorobenzene 55-gallon poly drum.

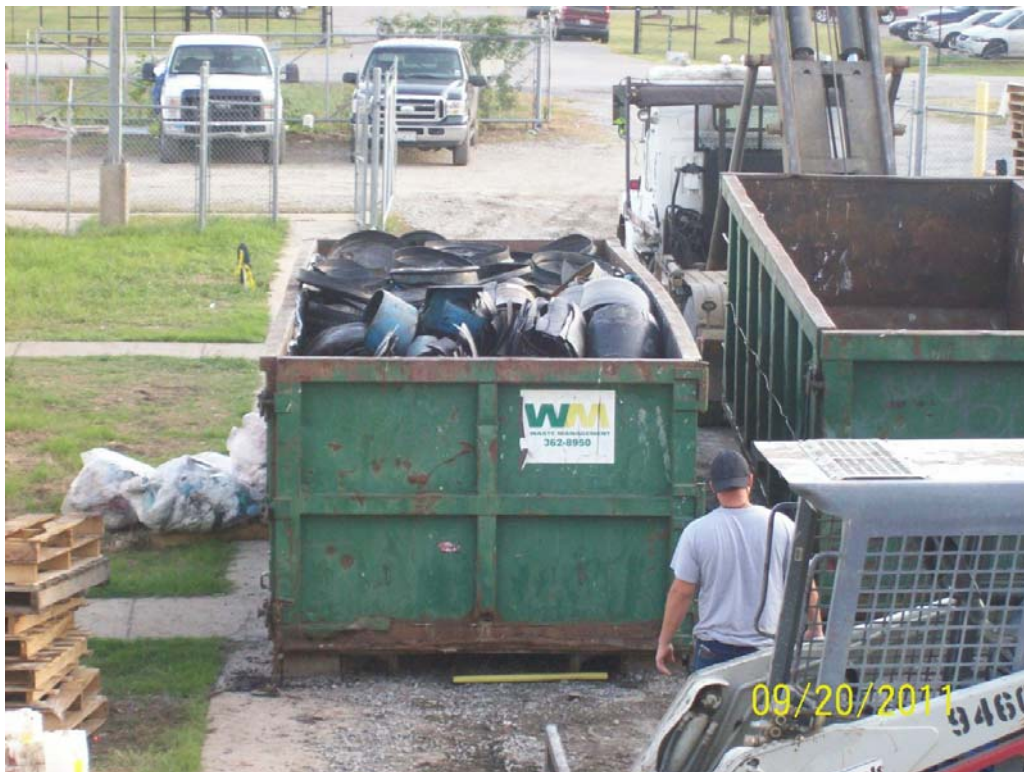
RCRA empty drum pieces ready for transport (Photo# 103\_3395).
