**Subject: Oil Pollution Act (OPA) Emergency Response Action Report
Kinder Morgan Pipeline Release
Tampa, Hillsborough County, Florida
EPA Contract No. 68-W-00-120
TTD No. TTEMI-05-002-0018**

KINDER MORGAN
PIPELINE RELEASE
TAMPA,
HILLSBOROUGH COUNTY,
FLORIDA
TDD: TTEMI-05-002-0018

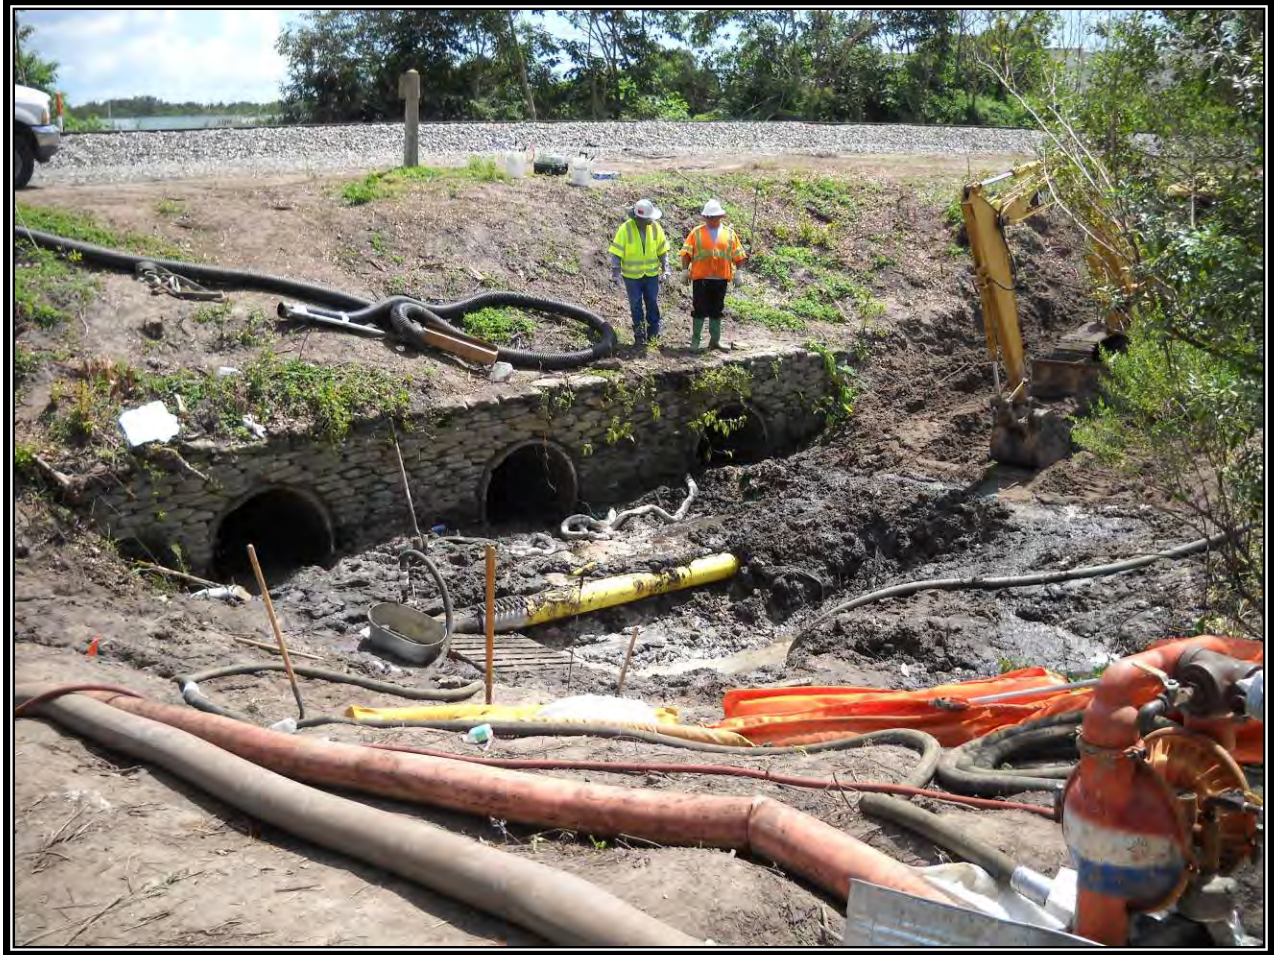
OFFICIAL PHOTOGRAPH NO. 1
U.S. ENVIRONMENTAL PROTECTION AGENCY

| Subject: | Repairs to 10-inch jet fuel pipeline along East Broadway Street. The break in the line was clamped closed with a sleeve and the pipeline was tapped so fuel could be evacuated as necessary for further repairs. | | |

completed and on July 26, 2011 returned to service. Preliminary review of the pipeline showed the damage to be caused from mechanical impact (digging operations) by an undetermined Third Party.

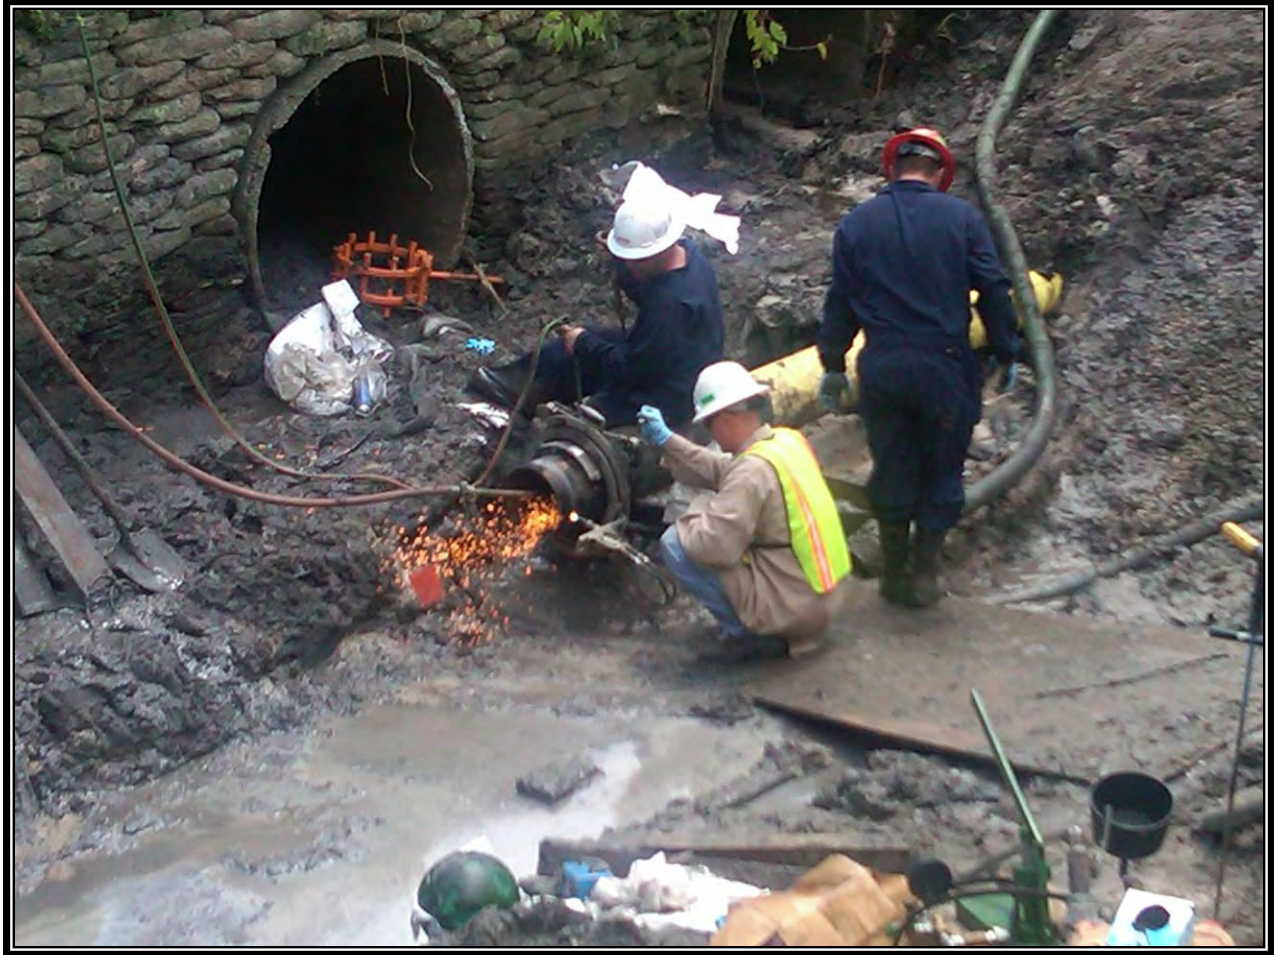
OFFICIAL PHOTOGRAPH NO. 2
U.S. ENVIRONMENTAL PROTECTION AGENCY

Subject: Repairs to 10-inch jet fuel pipeline along East Broadway Street. Workers prepare the ends of the pipeline to receive a new connecting section of pipe.

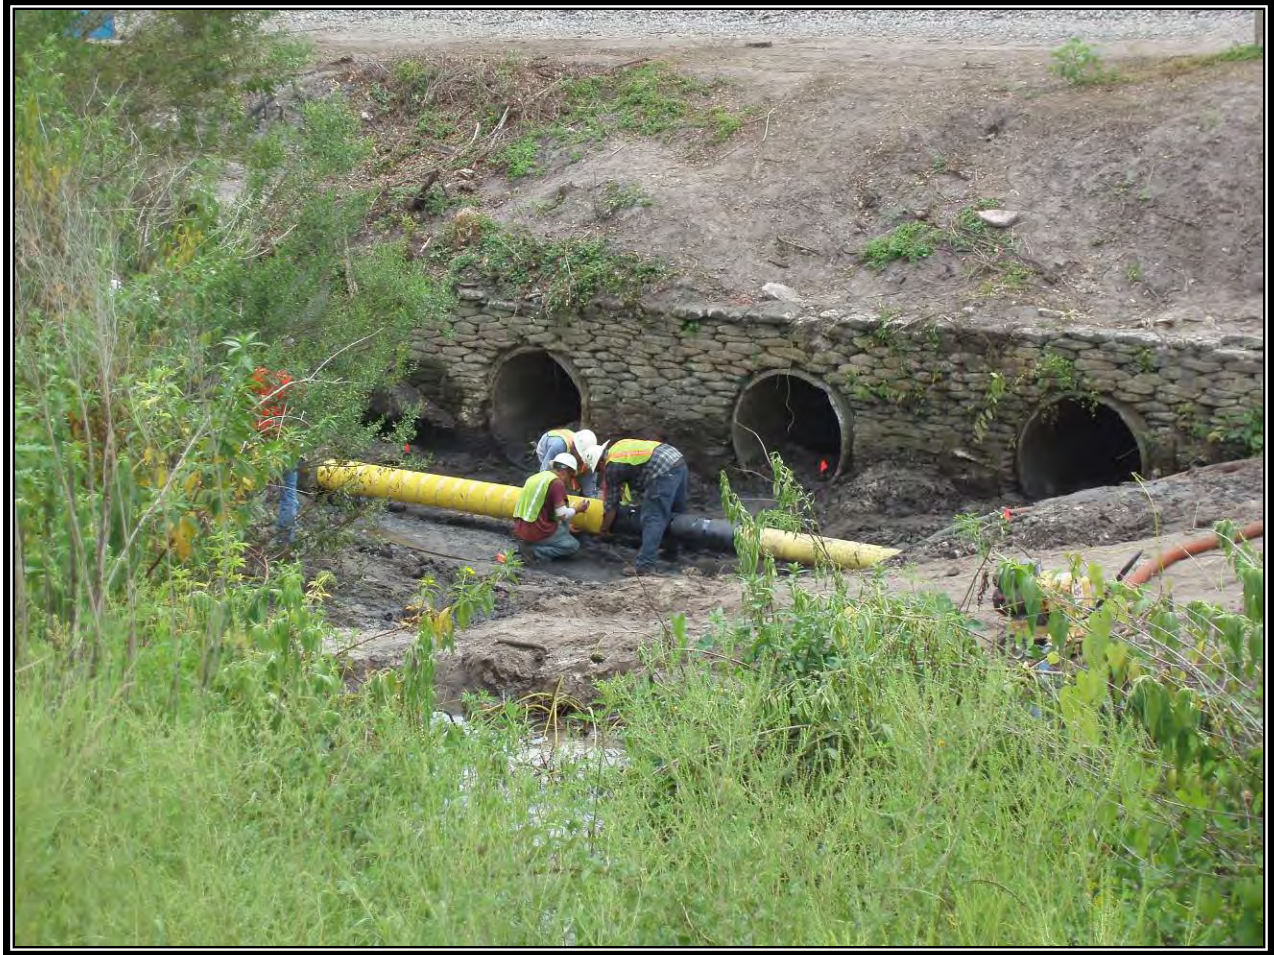
OFFICIAL PHOTOGRAPH NO. 3
U.S. ENVIRONMENTAL PROTECTION AGENCY

| Subject: | Repairs to 10-inch jet fuel pipeline along East Broadway Street. Workers are wrapping the pipeline with highly visible material. | | |

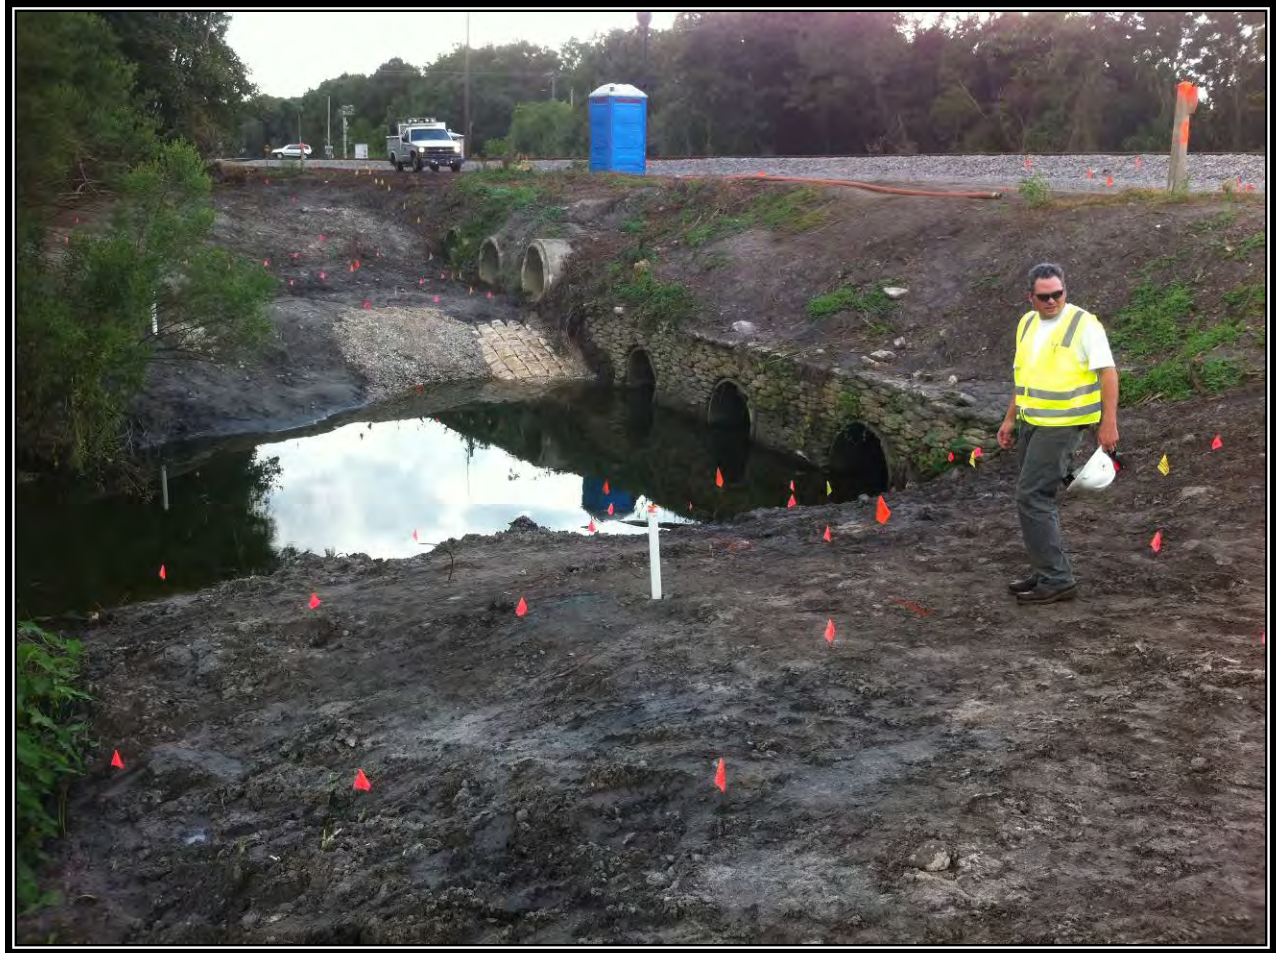
OFFICIAL PHOTOGRAPH NO. 4
U.S. ENVIRONMENTAL PROTECTION AGENCY

Subject: Repairs to 10-inch jet fuel pipeline along East Broadway Street after backfill. Orange flags indicate proposed soil sample locations for environmental impact assessment.

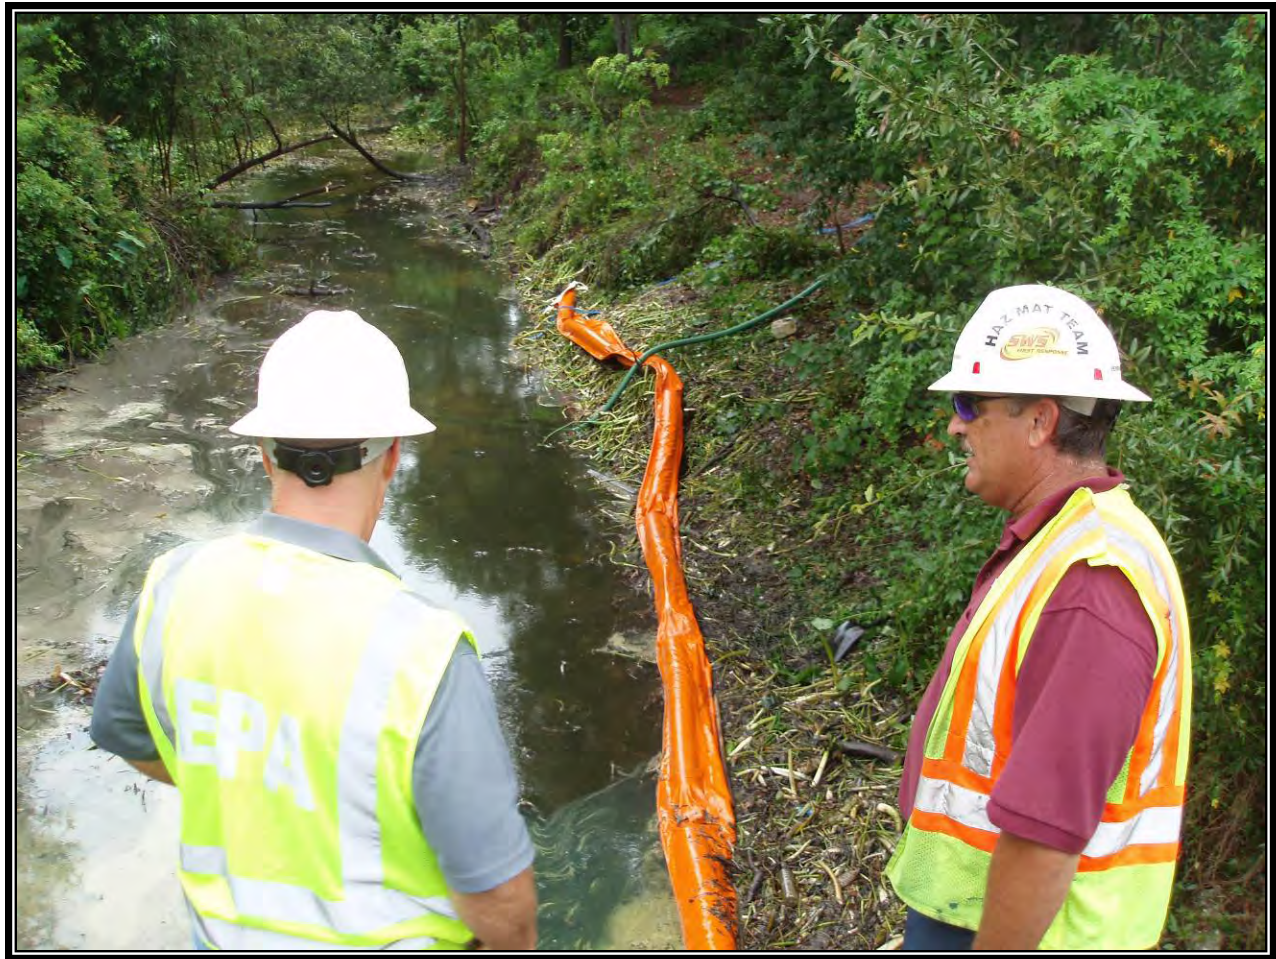
OFFICIAL PHOTOGRAPH NO. 5
U.S. ENVIRONMENTAL PROTECTION AGENCY

Subject: A large section of vegetative overgrowth was cleared from Mango Channel that released a heavy layer of jet fuel for recovery.

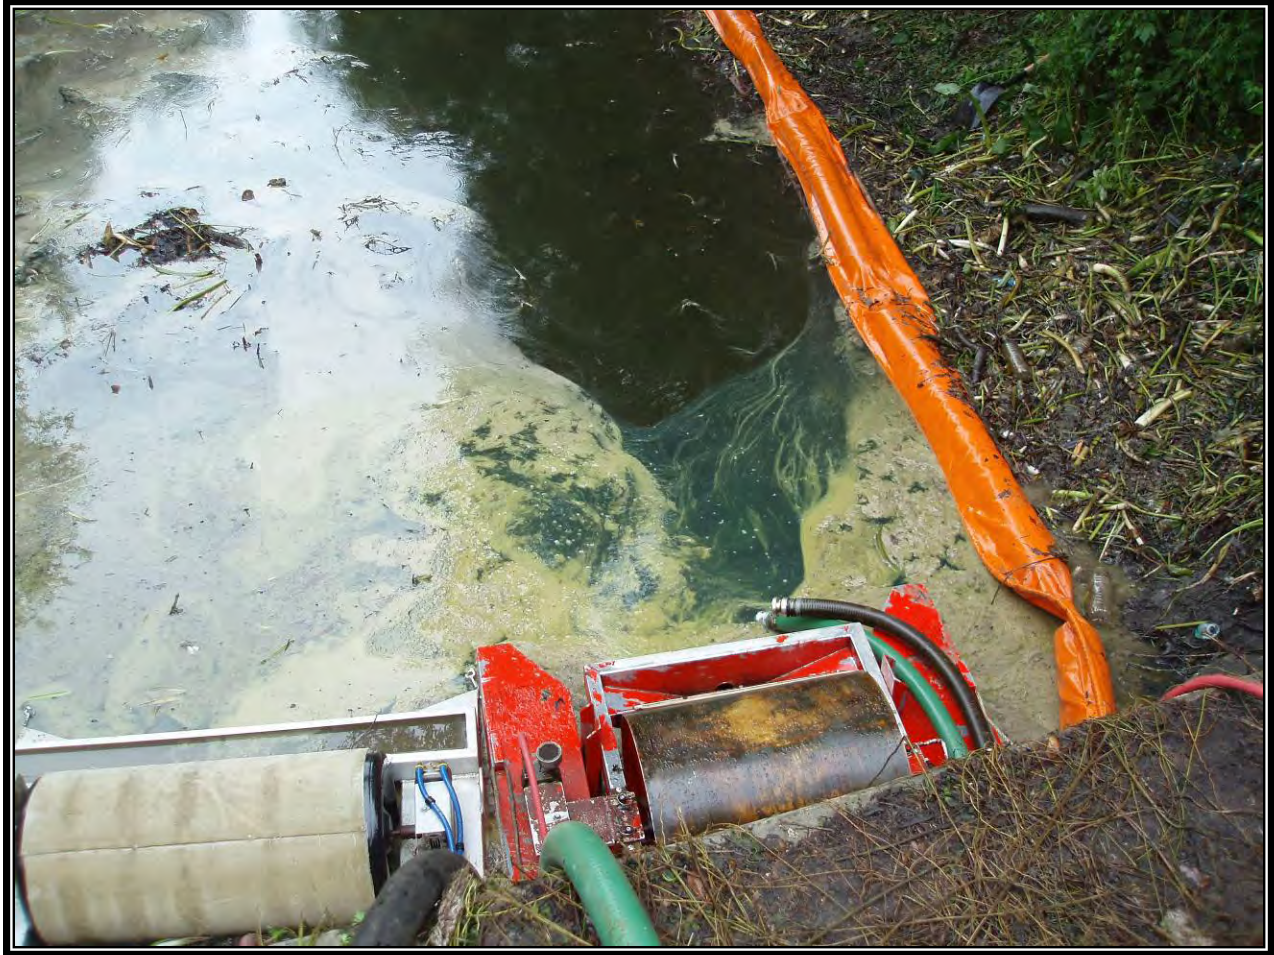
OFFICIAL PHOTOGRAPH NO. 6
U.S. ENVIRONMENTAL PROTECTION AGENCY

Subject: A large section of vegetative overgrowth was cleared from Mango Channel that released a heavy layer of jet fuel for recovery. Two different types of drum skimmers were utilized during recovery efforts.

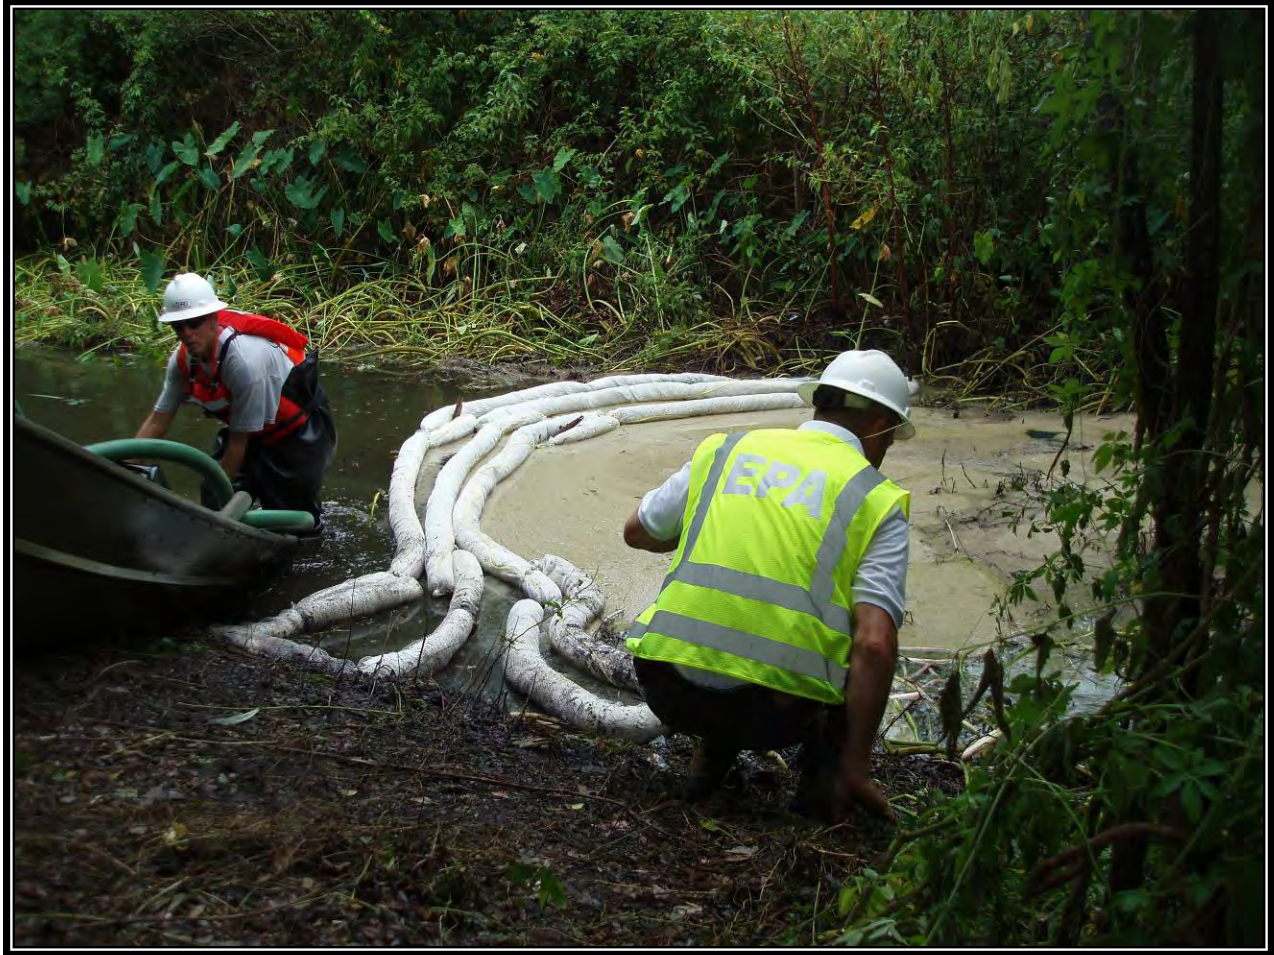
OFFICIAL PHOTOGRAPH NO. 7
U.S. ENVIRONMENTAL PROTECTION AGENCY

Subject: A large section of vegetative overgrowth was cleared from Mango Channel that released a heavy layer of jet fuel for recovery. An emulsified layer of fuel is captured by layered sock boom.

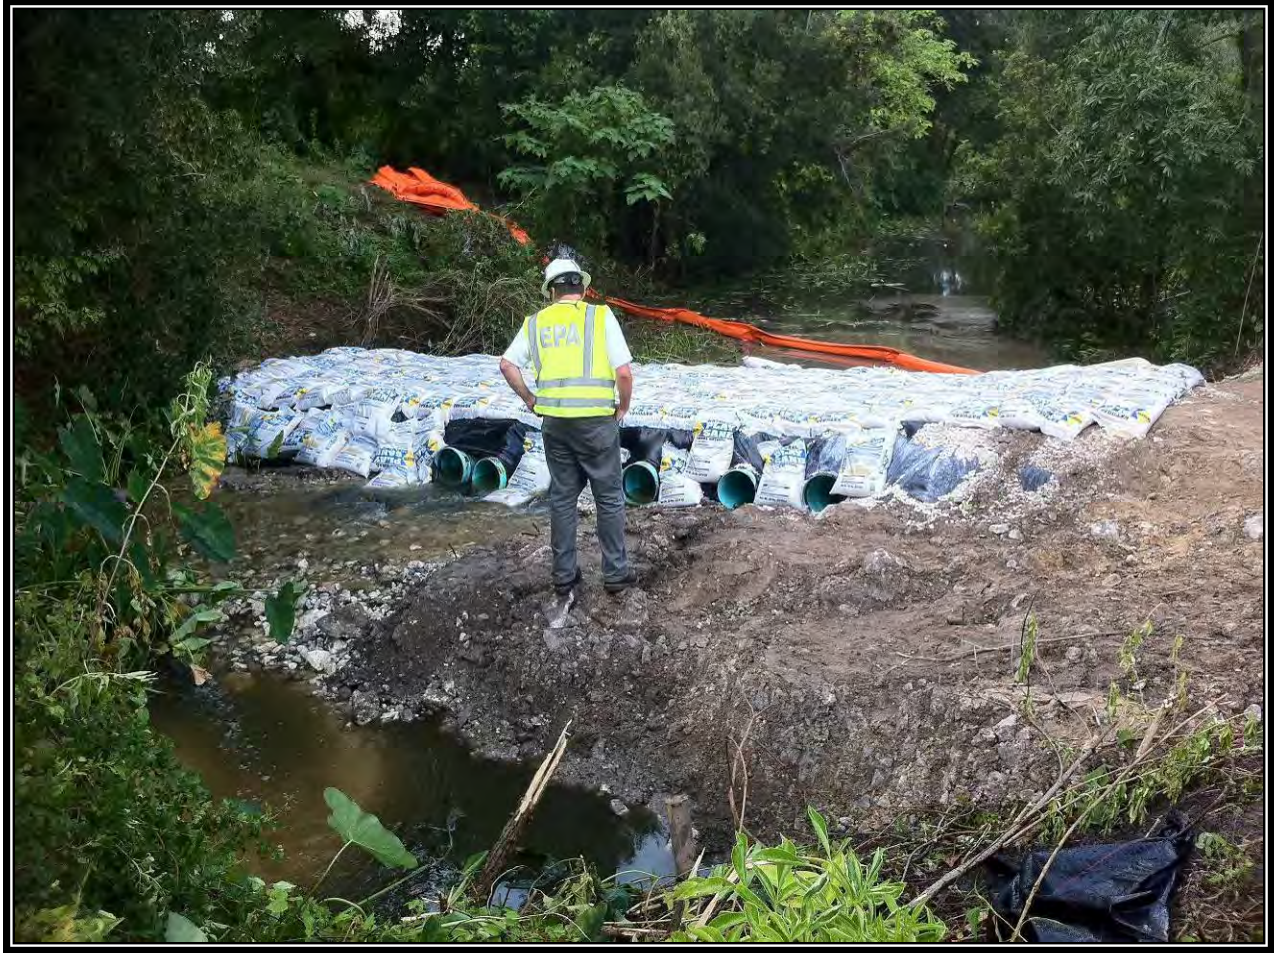
**OFFICIAL PHOTOGRAPH NO. 8
U.S. ENVIRONMENTAL PROTECTION AGENCY**

Subject: EPA inspected an earthen underflow dam constructed by Kinder Morgan.

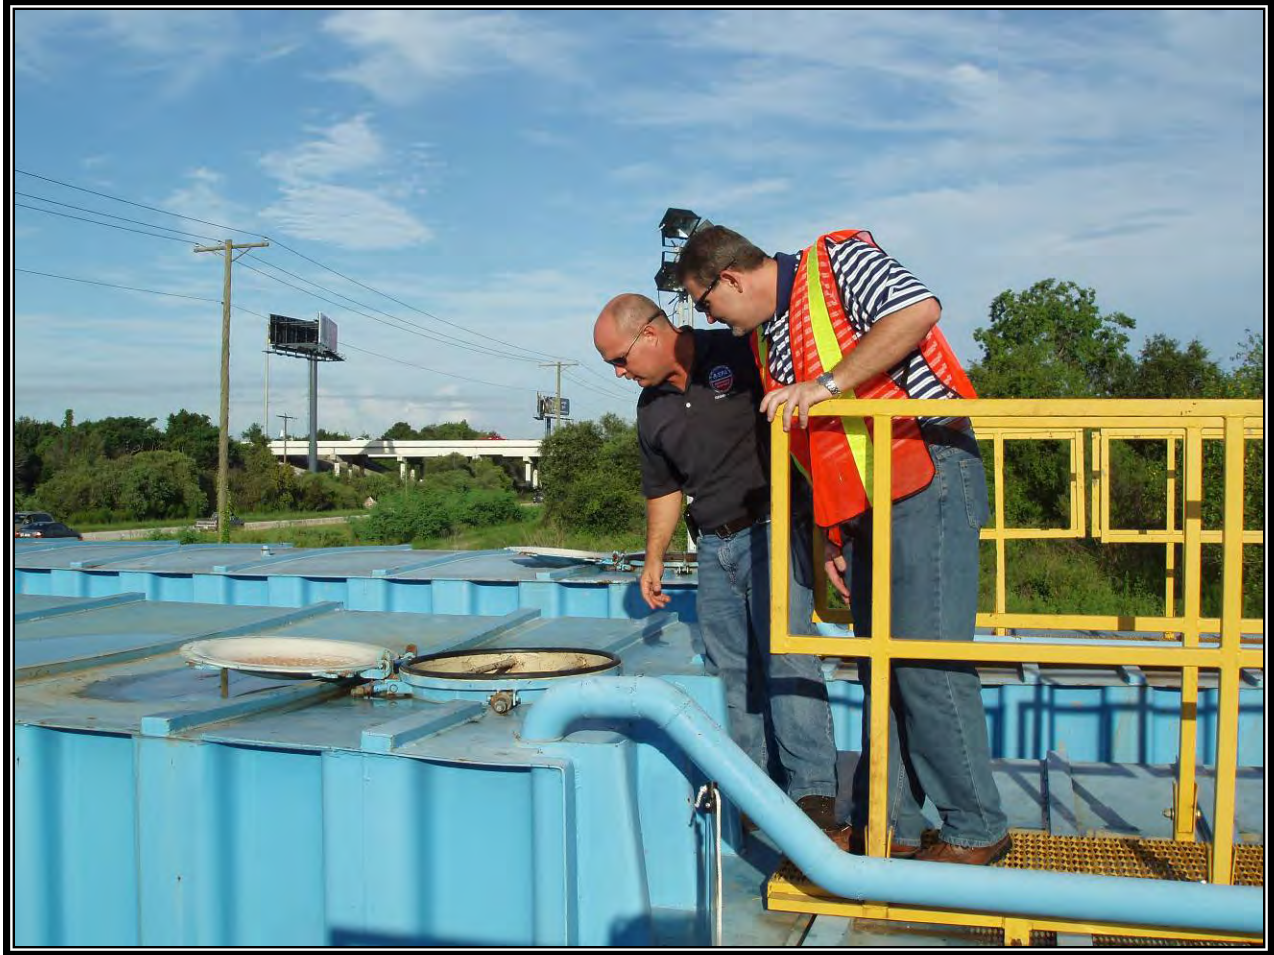
**OFFICIAL PHOTOGRAPH NO. 9
U.S. ENVIRONMENTAL PROTECTION AGENCY**

| Subject: | EPA and Kinder Morgan unified command inspected the temporary recovery tanks. | | |

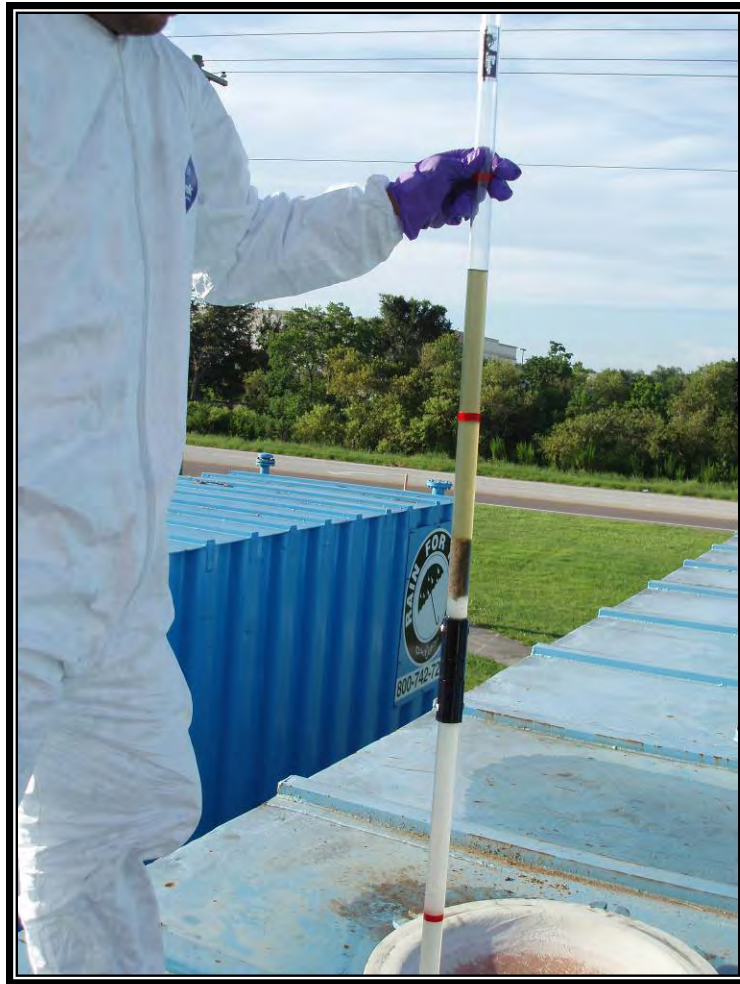
OFFICIAL PHOTOGRAPH NO. 10
U.S. ENVIRONMENTAL PROTECTION AGENCY

Subject: The recovery tanks were measured to see how much fuel to water ratio was recovered.
The tanks ranged from 2 % to 23% fuel.

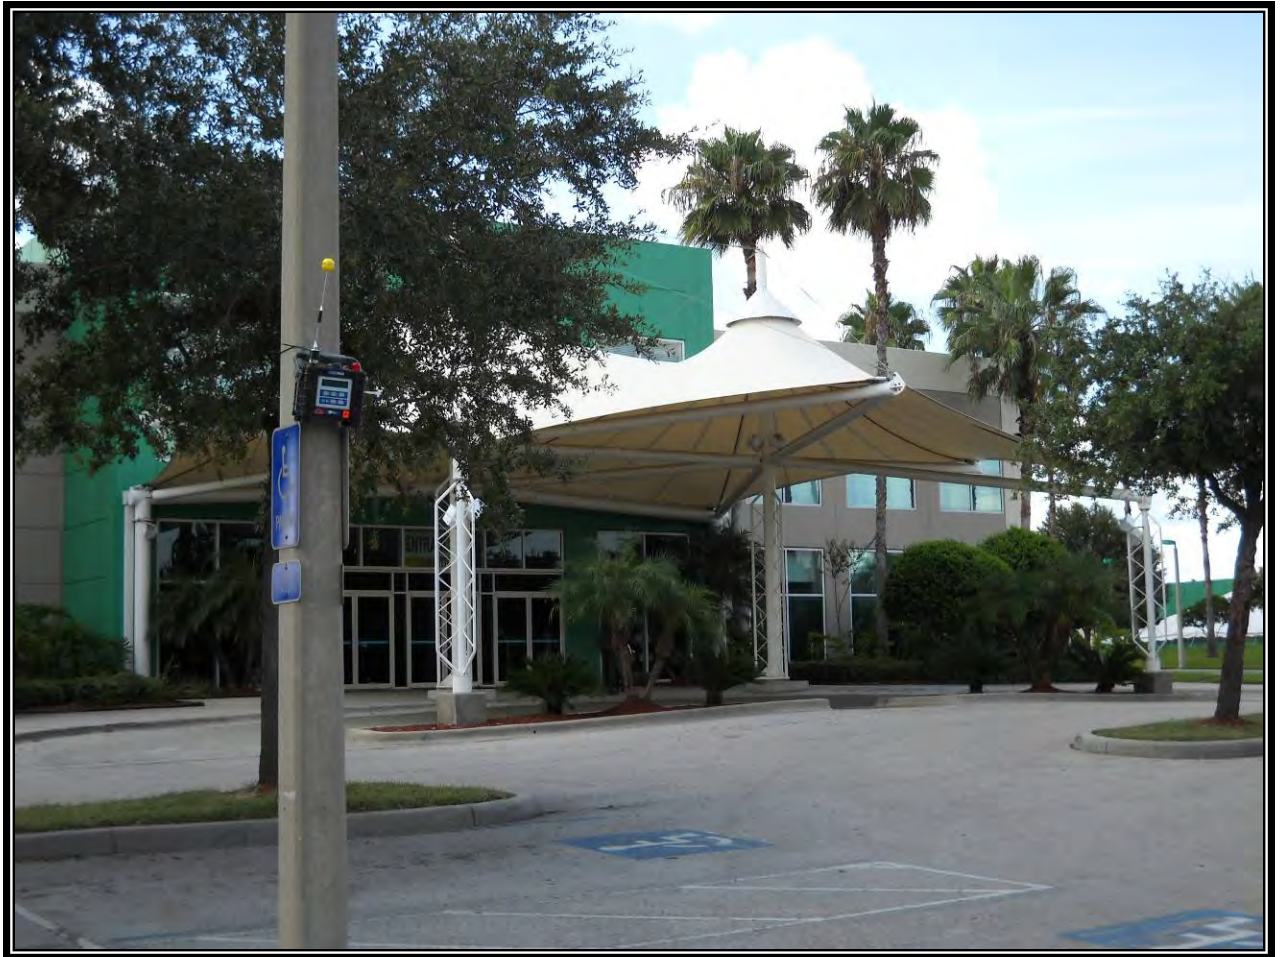
OFFICIAL PHOTOGRAPH NO. 11
U.S. ENVIRONMENTAL PROTECTION AGENCY

| Subject: | Tetra Tech performed air monitoring for volatile organic compounds at the Revival Ministries International located west of the release. | | |

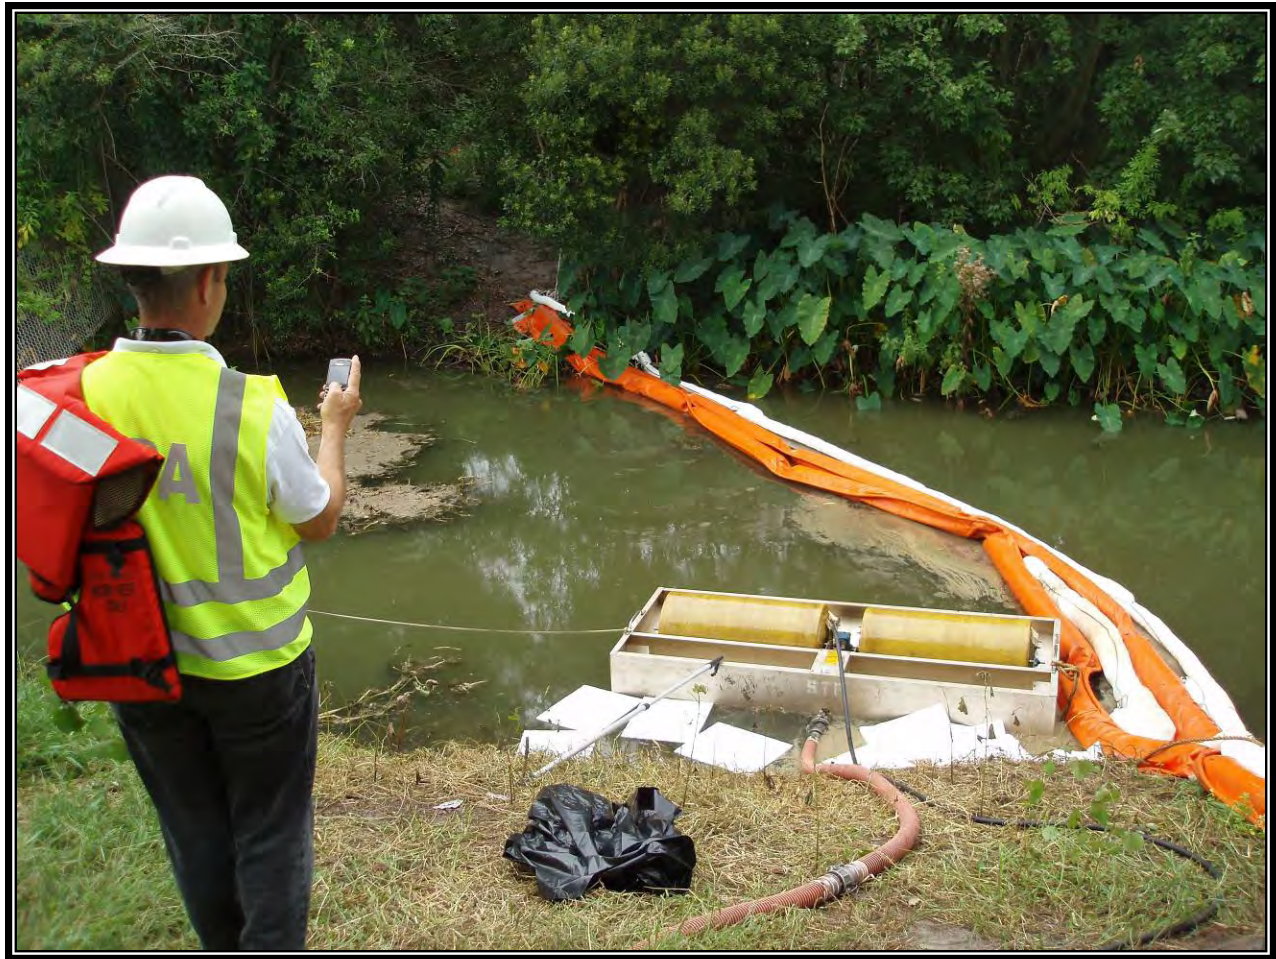
OFFICIAL PHOTOGRAPH NO. 13
U.S. ENVIRONMENTAL PROTECTION AGENCY

Subject: EPA observed a drum skimmer recovering fuel that was flushed downstream.

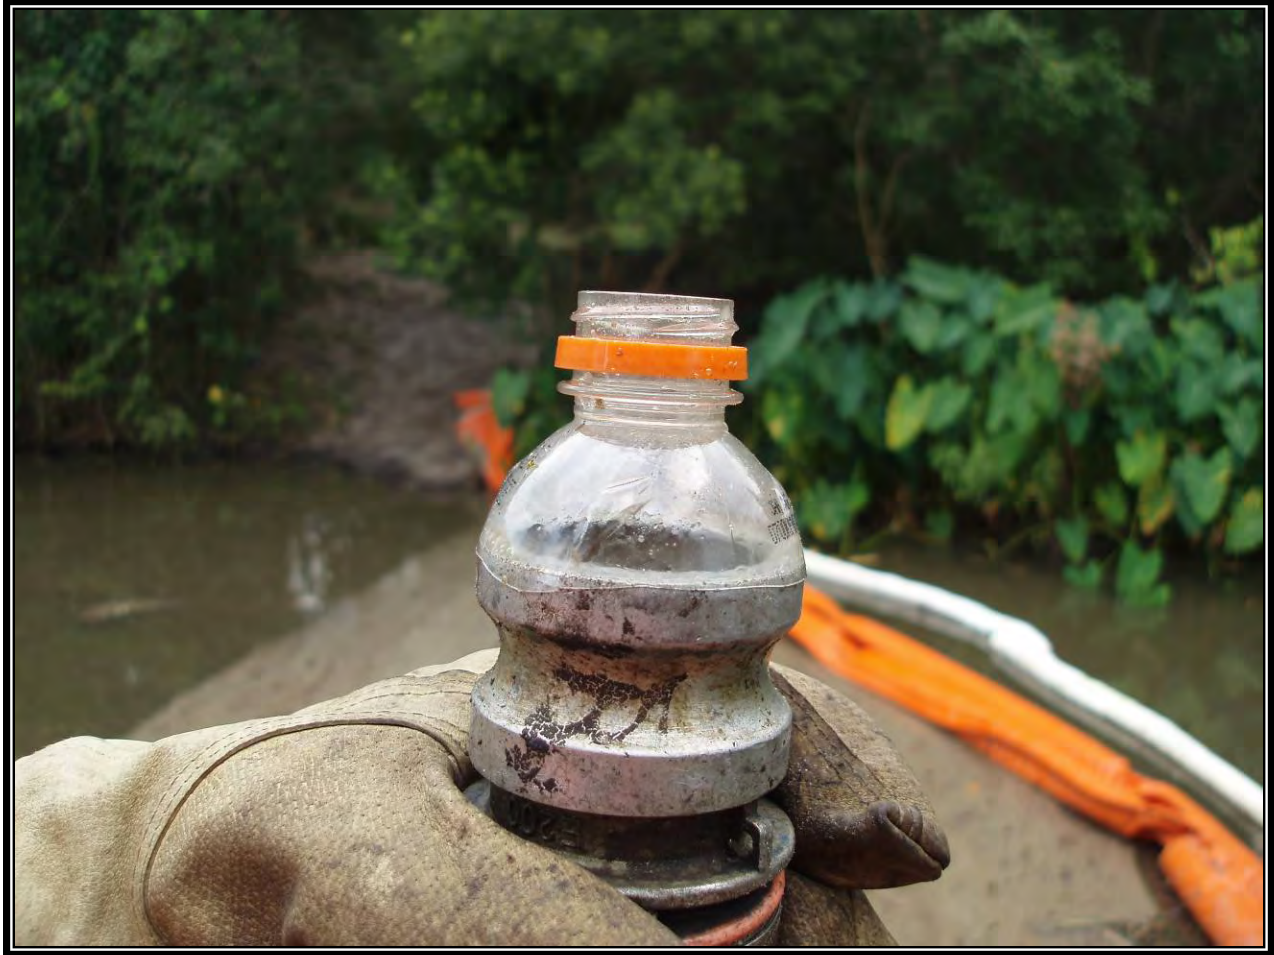
OFFICIAL PHOTOGRAPH NO. 14
U.S. ENVIRONMENTAL PROTECTION AGENCY

Subject: A drink bottle top was used as a reducer to improve the fuel recovery efficiency through the hose.

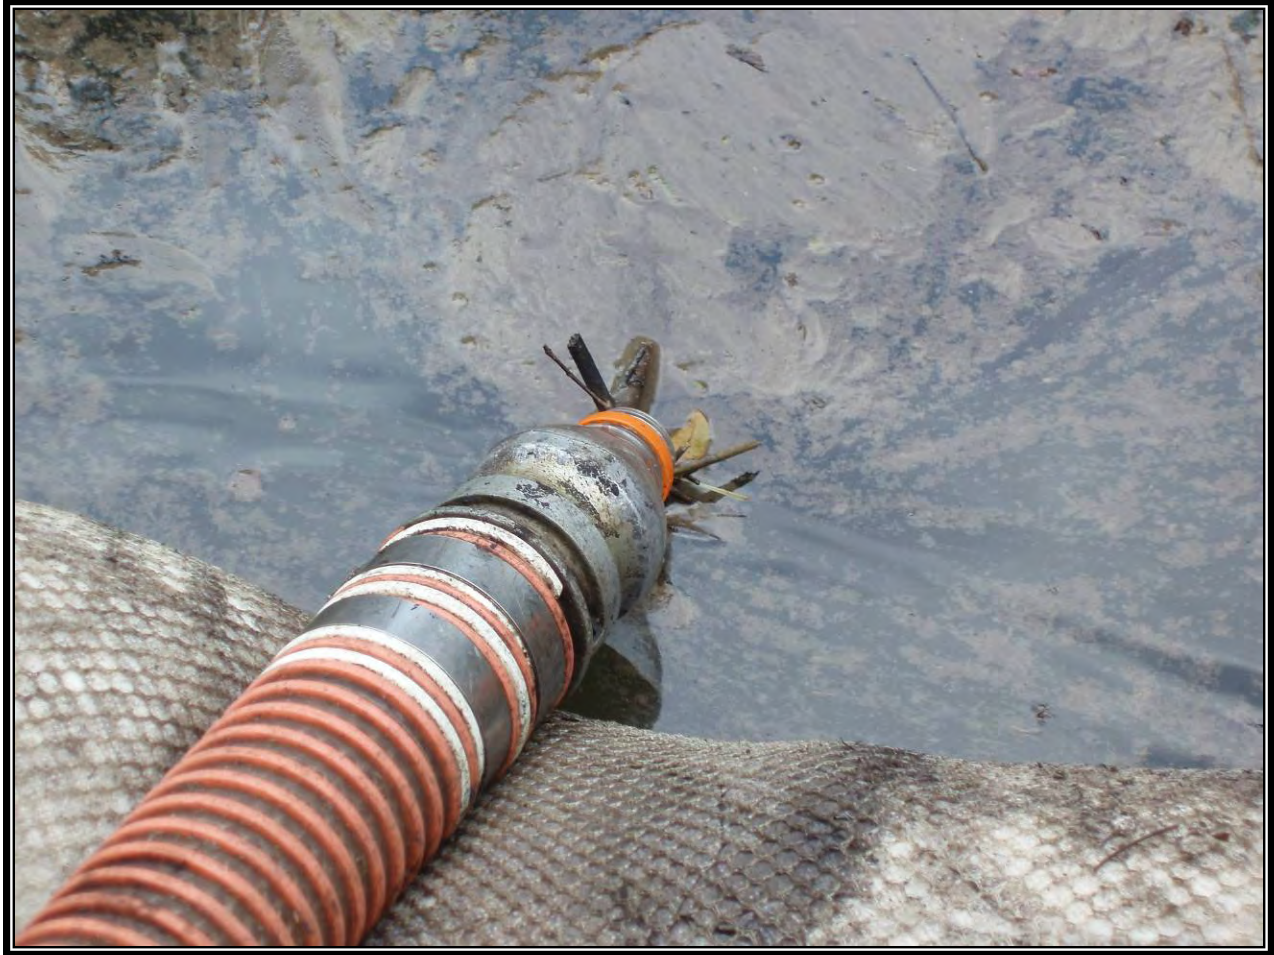
OFFICIAL PHOTOGRAPH NO. 15
U.S. ENVIRONMENTAL PROTECTION AGENCY

Subject: A drink bottle top was used as a reducer to improve the fuel recovery efficiency through the hose.

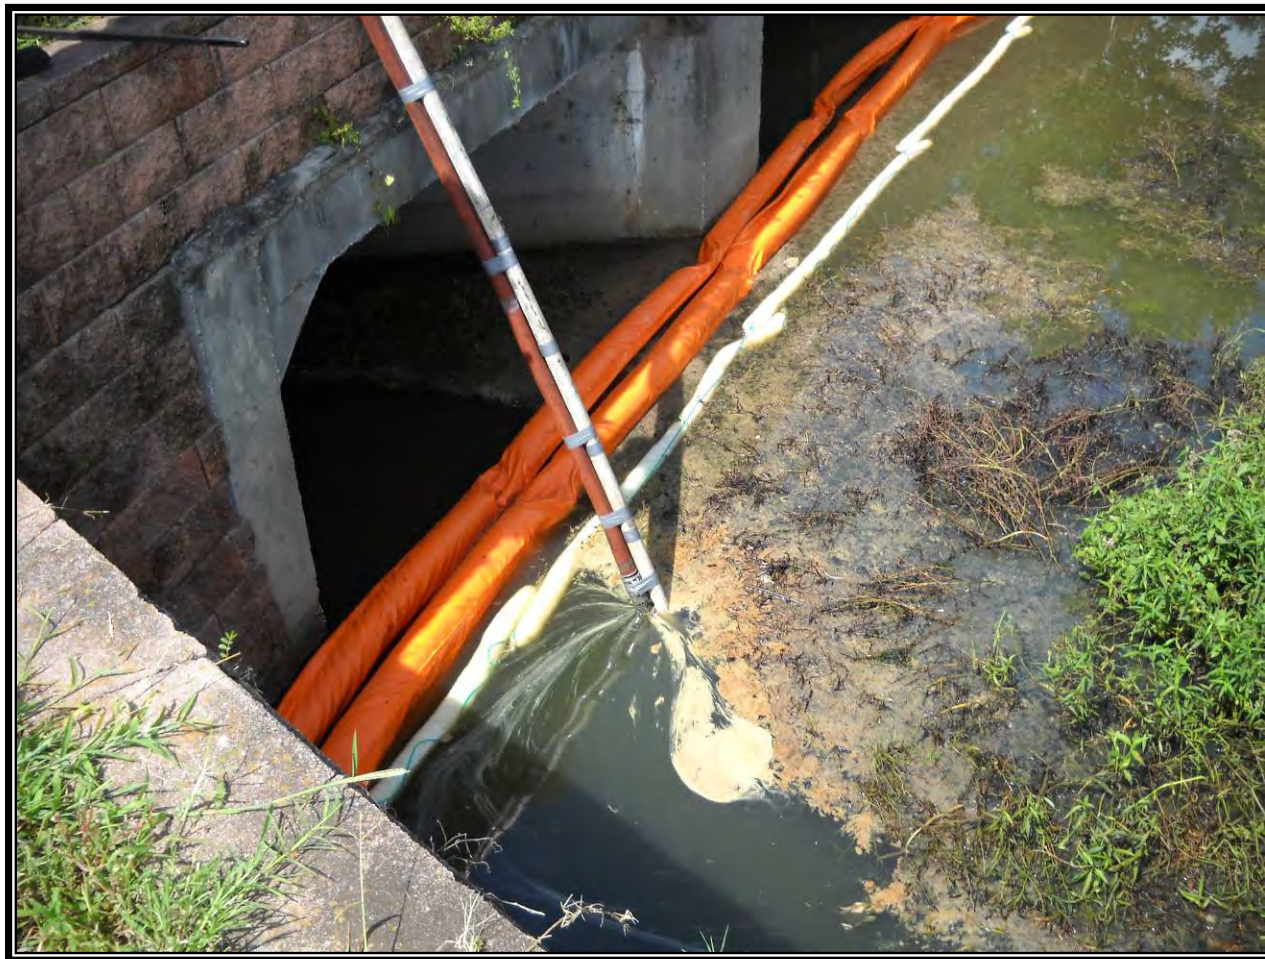
OFFICIAL PHOTOGRAPH NO. 16
U.S. ENVIRONMENTAL PROTECTION AGENCY

Subject: Rigid pipe was attached to flexible recovery hose to allow ease of positioning during fuel recovery efforts.

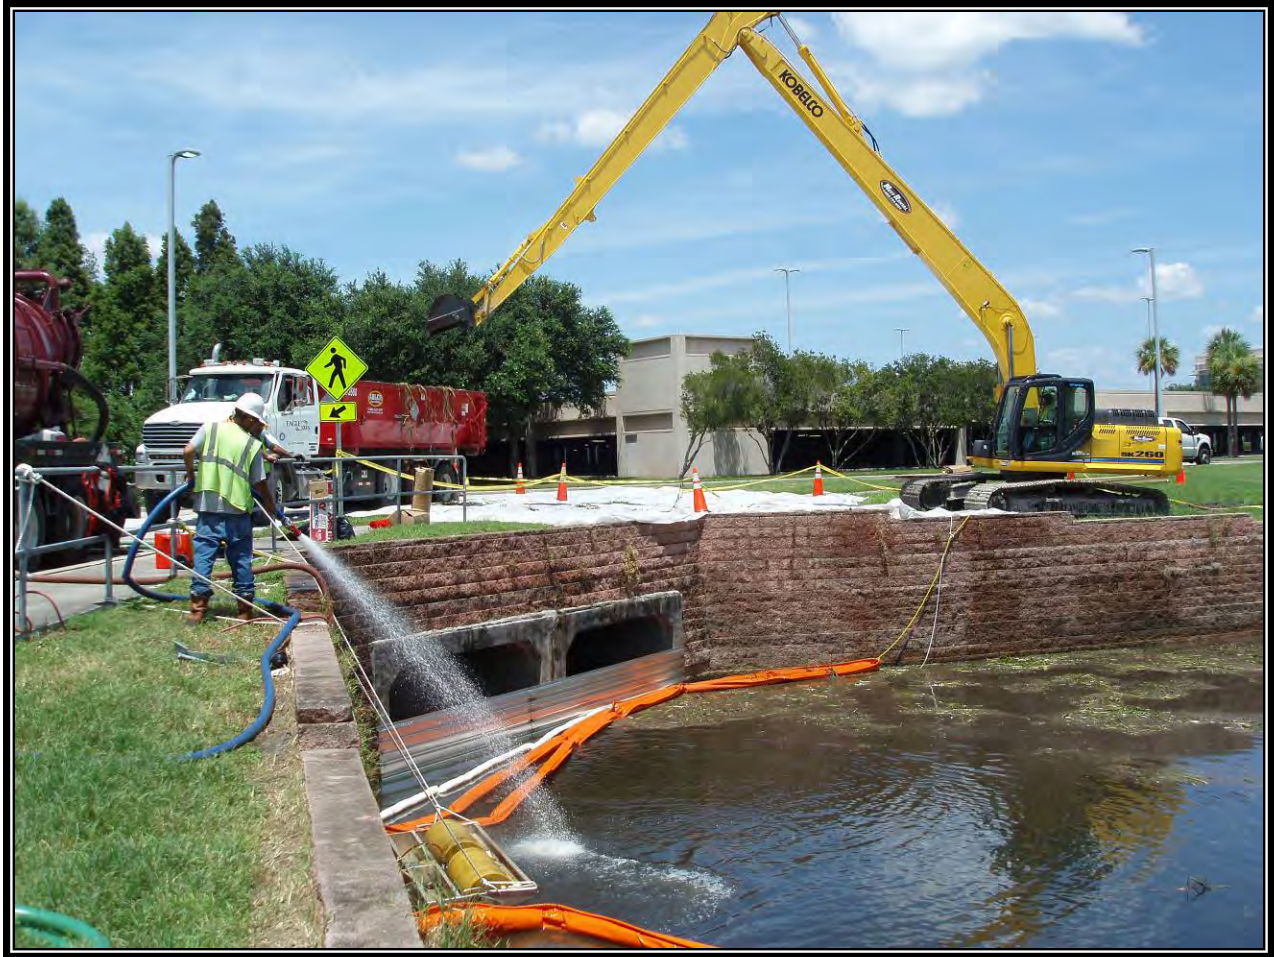
OFFICIAL PHOTOGRAPH NO. 17
U.S. ENVIRONMENTAL PROTECTION AGENCY

Subject: Long-reach excavators were utilized to scoop oiled vegetation in the wetlands area near the CitiGroup buildings. Custom holes were cut in the bucket to allow the solid matter to be strained of liquid.

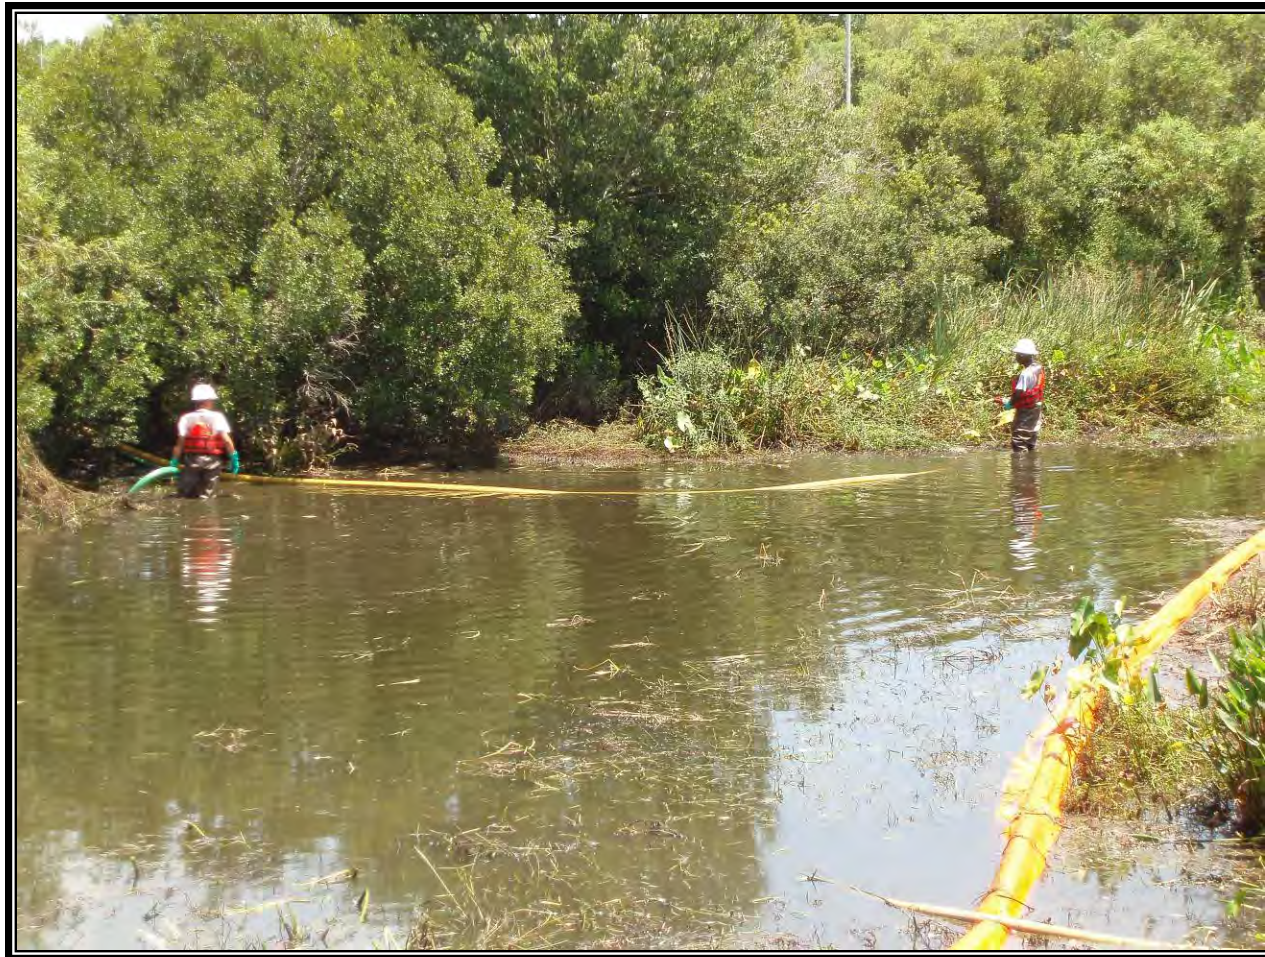
OFFICIAL PHOTOGRAPH NO. 18
U.S. ENVIRONMENTAL PROTECTION AGENCY

Subject: Workers waded out into the wetlands to effectively recover the fuel and emulsified fuel contained in the boom.

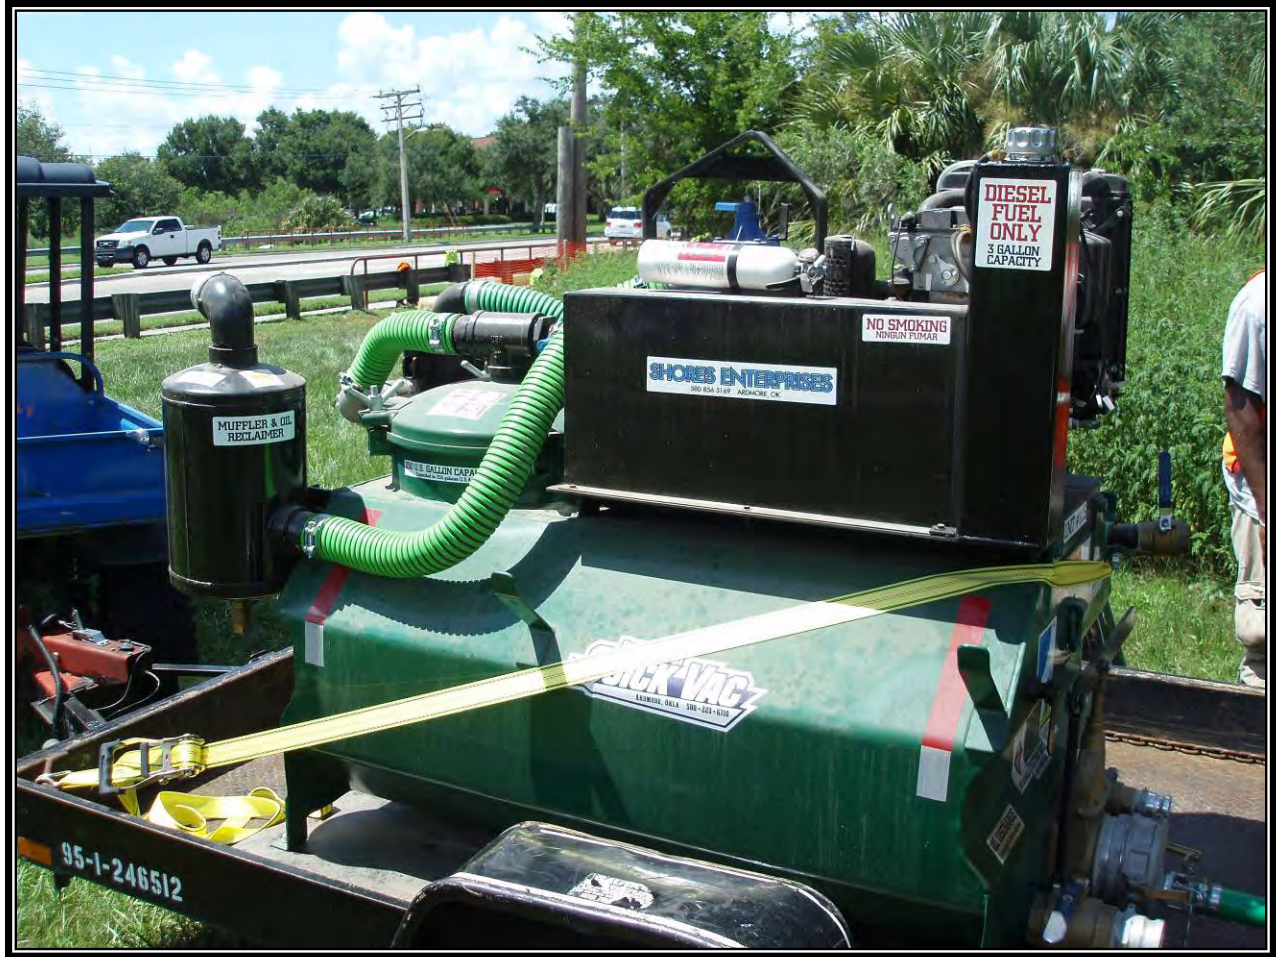
OFFICIAL PHOTOGRAPH NO. 19
U.S. ENVIRONMENTAL PROTECTION AGENCY

Subject: Small 250 gallon capacity vacuum units mounted on trailers allowed recovery crews the ability to keep multiple containment points along the Mango Channel cleaned and maintained.
