**Subject: Oil Pollution Act (OPA) Emergency Response Action Report
Kinder Morgan Pipeline Release
Tampa, Hillsborough County, Florida
EPA Contract No. 68-W-00-120
TTD No. TTEMI-05-002-0018**

KINDER MORGAN
PIPELINE RELEASE
TAMPA,
HILLSBOROUGH COUNTY,
FLORIDA
TDD: TTEMI-05-002-0018

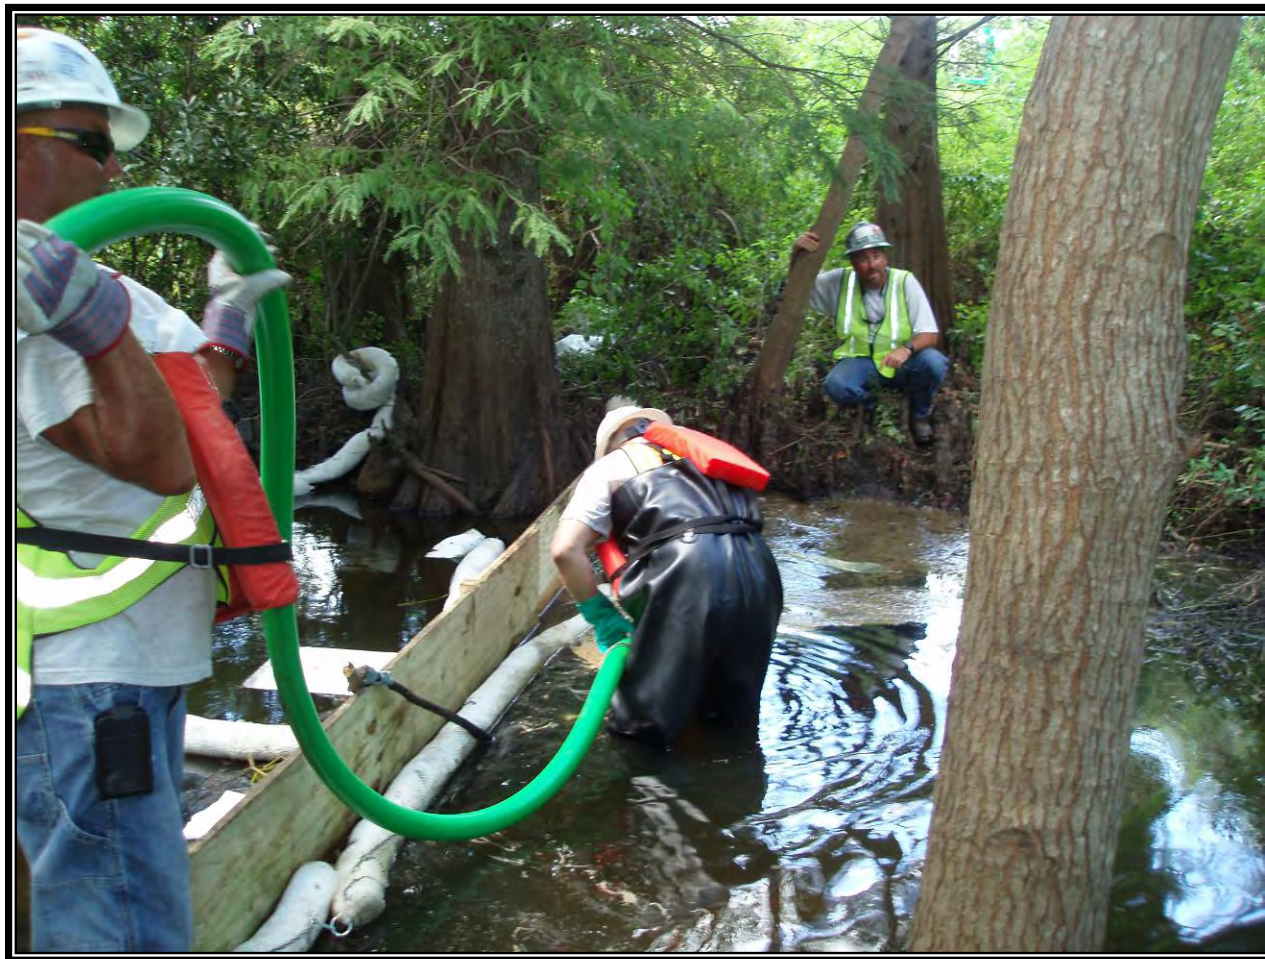
OFFICIAL PHOTOGRAPH NO. 20
U.S. ENVIRONMENTAL PROTECTION AGENCY

Subject: Using the portable vacuum units, workers waded into the channel to capture the fuel that collected behind the wooden underflow dam.

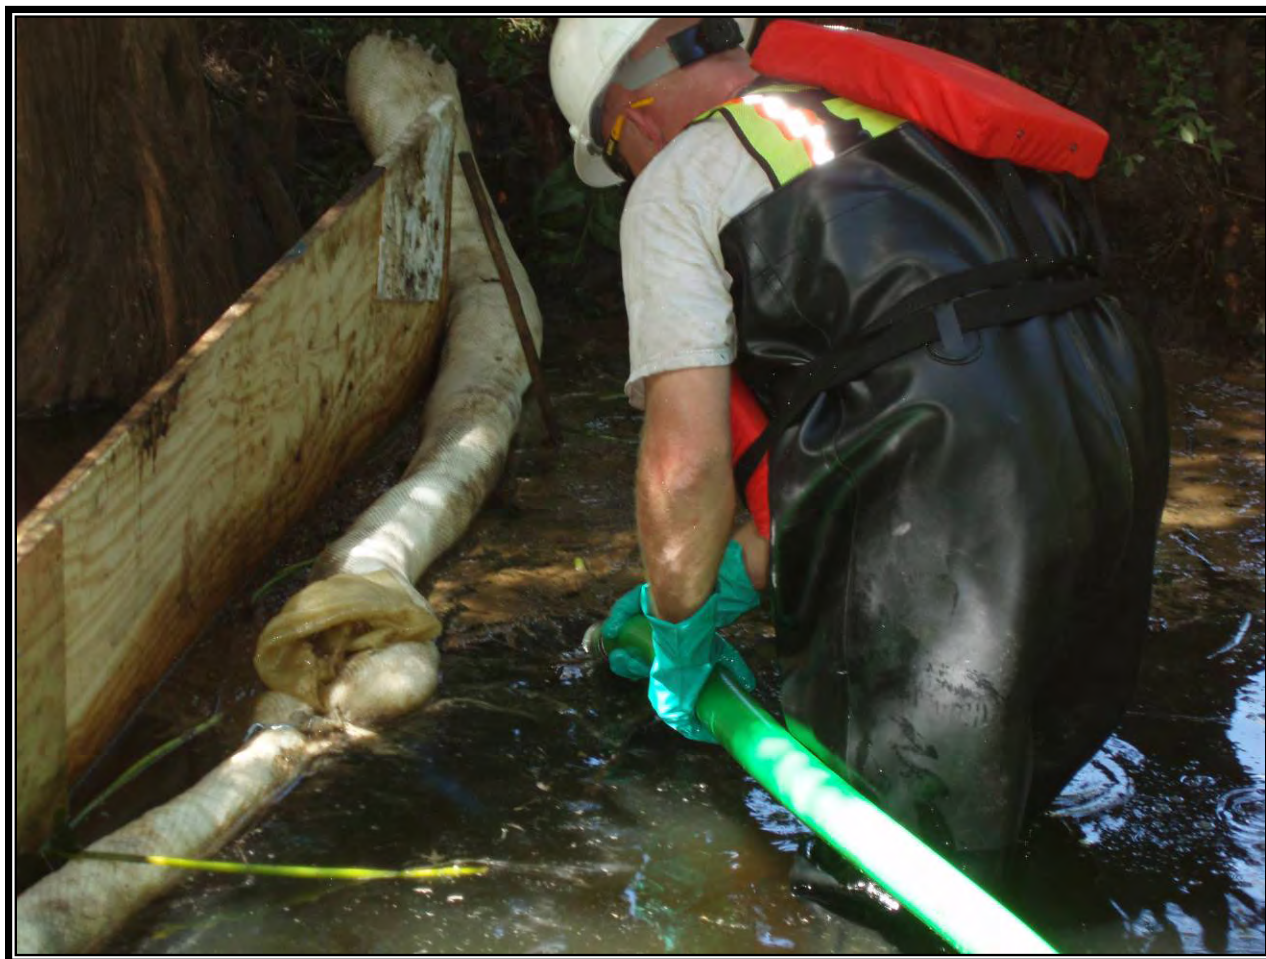
OFFICIAL PHOTOGRAPH NO. 21
U.S. ENVIRONMENTAL PROTECTION AGENCY

Subject: Using the portable vacuum units, workers waded into the channel to capture the fuel that collected behind the wooden underflow dam.

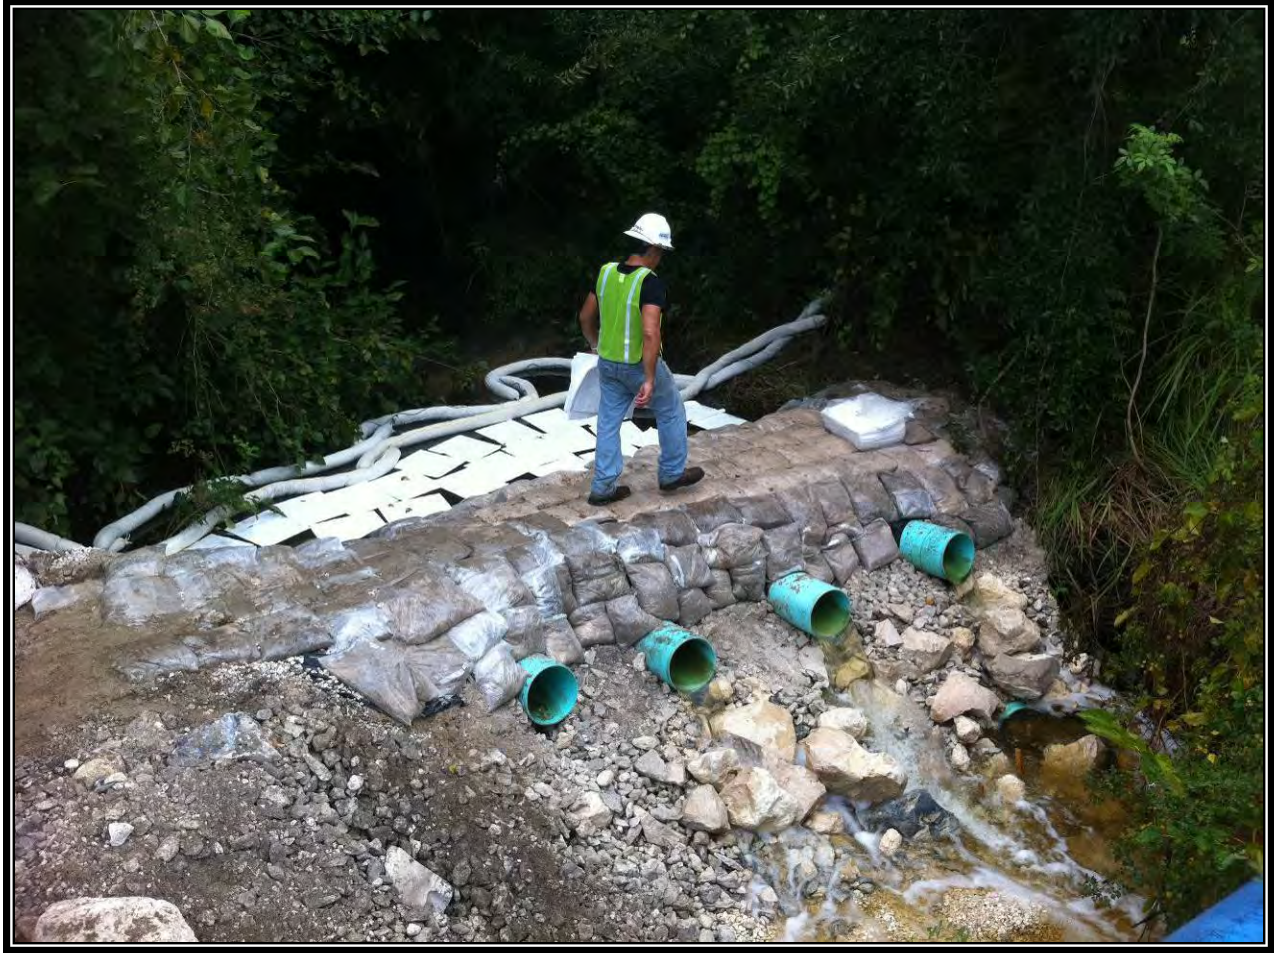
OFFICIAL PHOTOGRAPH NO. 25
U.S. ENVIRONMENTAL PROTECTION AGENCY

Subject: Earthen underflow dam constructed at Riga Boulevard to retain fuel and sheen and protect the downstream channel.

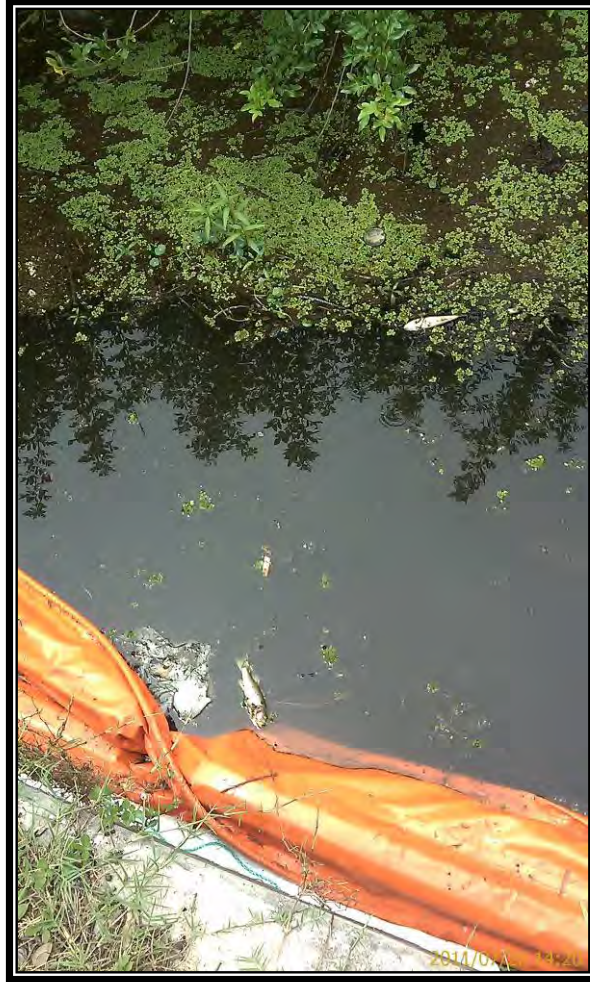
OFFICIAL PHOTOGRAPH NO. 28
U.S. ENVIRONMENTAL PROTECTION AGENCY

| Subject: | By July 26, 2011, 456 fish and 12 crustaceans, amphibians, and reptiles were found dead and collected by Kinder Morgan’s contractor URS. | | |

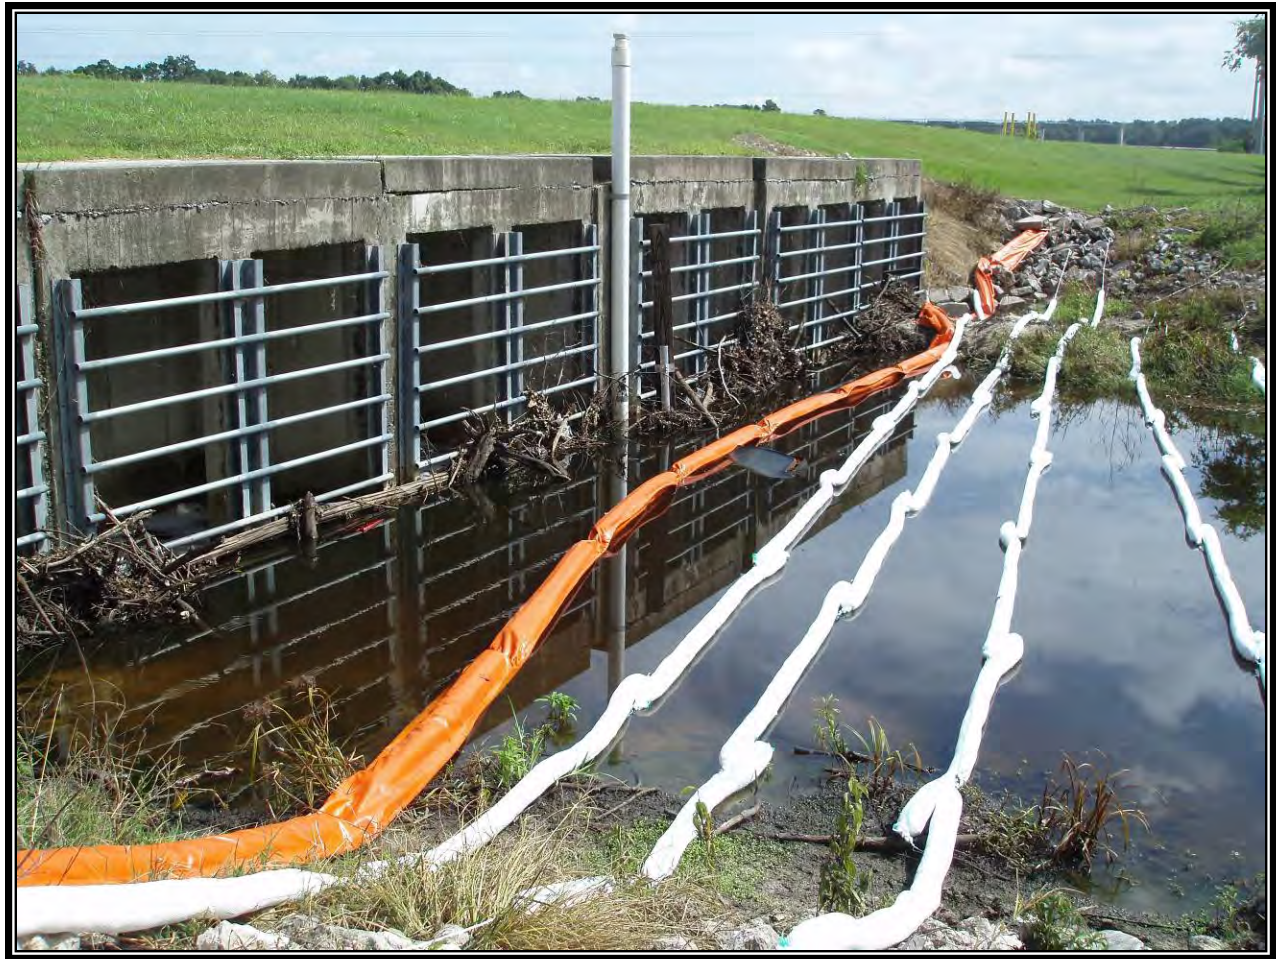
OFFICIAL PHOTOGRAPH NO. 29
U.S. ENVIRONMENTAL PROTECTION AGENCY

Subject: The end of Mango Channel before it enters the Tampa bypass canal; a drinking water intake for the City of Tampa, Florida.
