Daily Progress Report

Aliceville, AL Derailment Response Alabama & Gulf Coast November 25, 2013

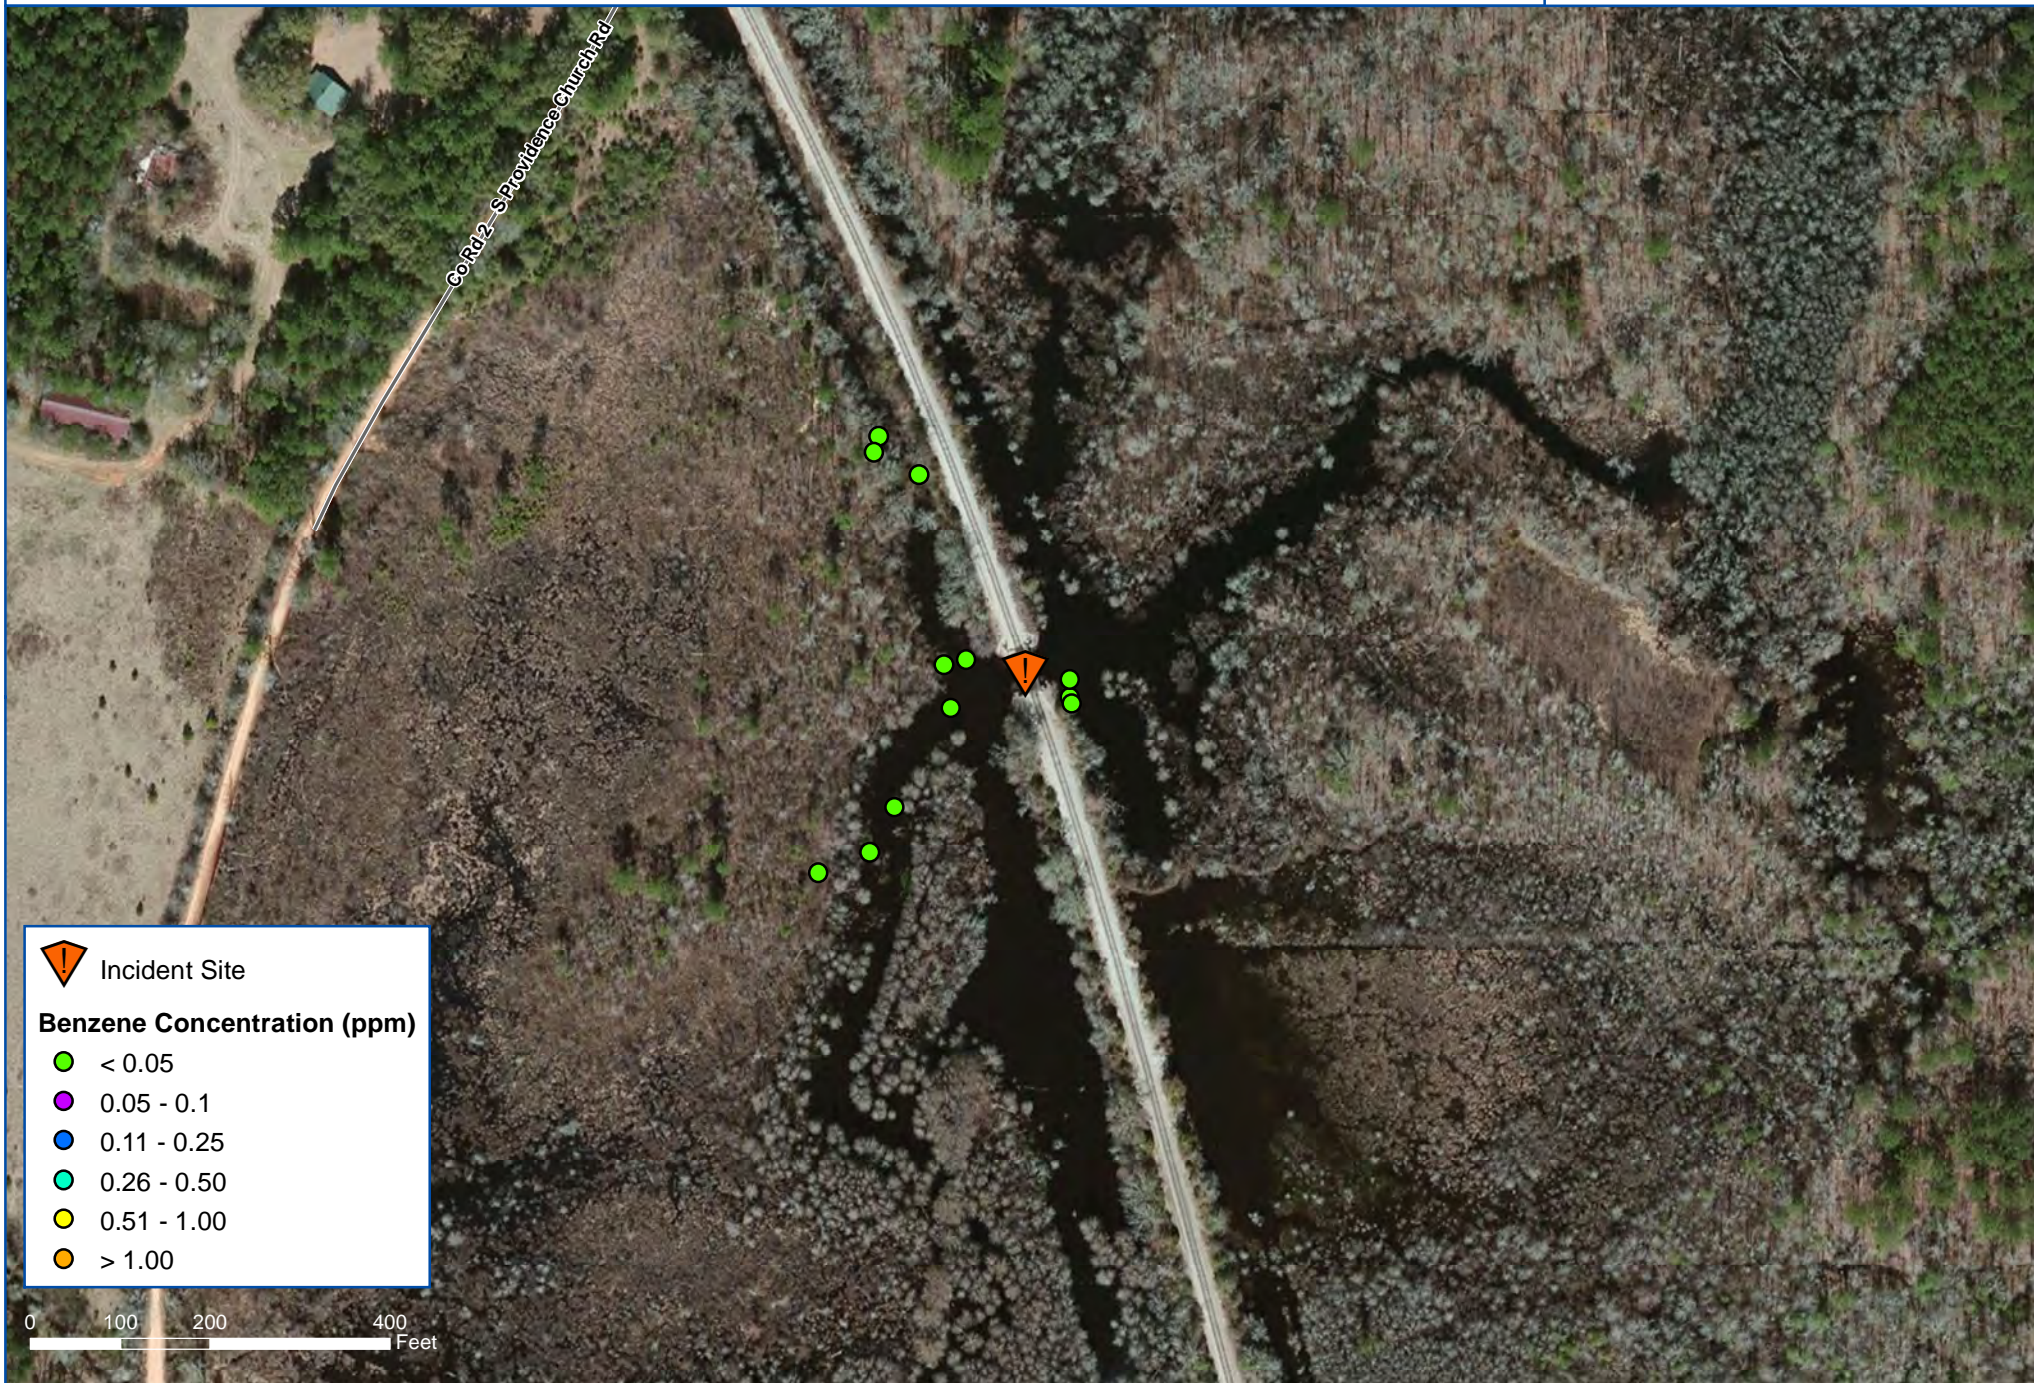
Manually-Logged Real-Time Benzene Concentrations

Location Category	Analyte	Number of Readings	Number of Detections	Average of Detects	Maximum Concentration
Work Area	Benzene	15	0	N/A	< 0.05 ppm
	VOC	56	3	0.9 ppm	1.3 ppm
