**Subject: Removal Action Letter Report
Tamarack Stamp Mill
Osceola Township, Houghton County, Michigan
Technical Direction Document No. TO-01-14-05-1039
OTIE Contract No. EP-S5-10-10**

**APPENDIX A
PHOTOGRAPHIC LOG**

**AIR MONITORING AND CONTINGENCY PLAN
TAMARACK STAMP MILL RV SITE
OSCEOLA TOWNSHIP, HOUGHTON COUNTY, MI**

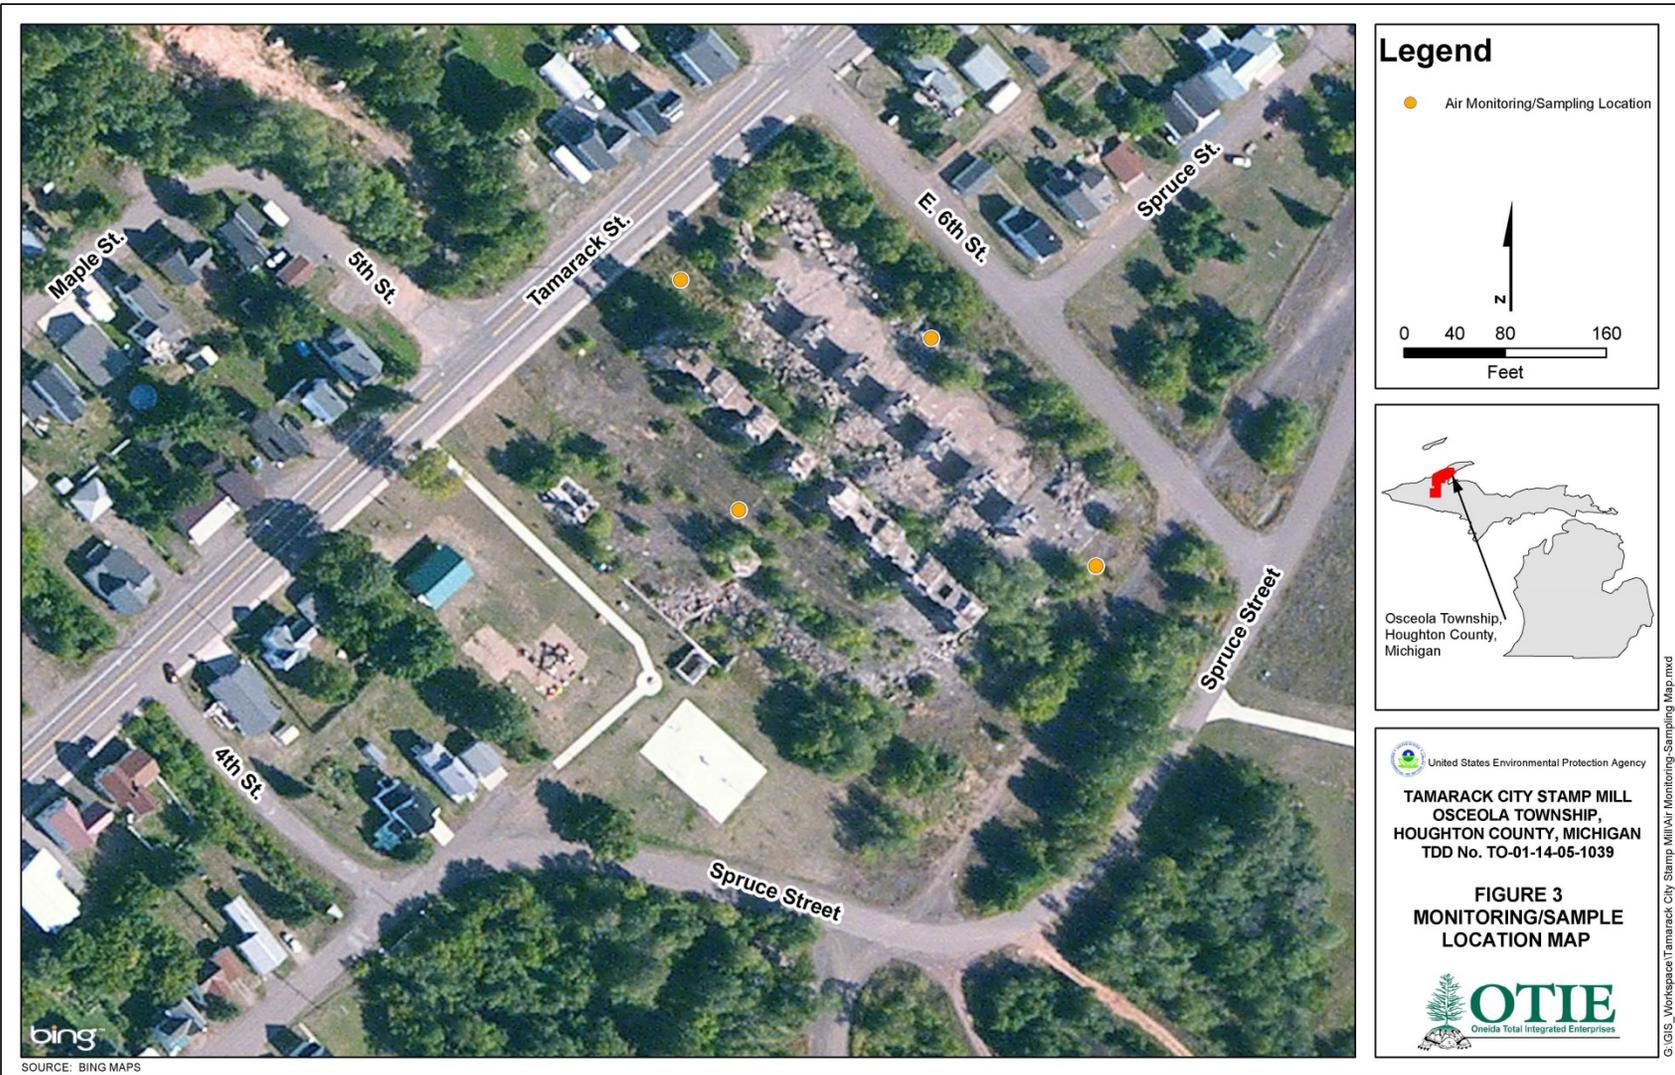
START prepared an air monitoring and sampling plan to address monitoring requirements for fugitive dust and sampling requirements for asbestos in air. START conducted air monitoring for asbestos and particulate monitoring for fugitive dust during all phases of the removal action. Prior to the initiation of removal activities, START collected background samples to quantify “background” levels of airborne asbestos. Eight background samples were collected from four locations for asbestos and one sample was collected downwind from the removal area for particulates. The action level established in the air monitoring plan for on-site asbestos was 0.1 fibers of asbestos per cubic centimeter (f/cc) and for on-site respirable particulates was 5 milligrams per cubic meter (mg/m³). The action level for perimeter asbestos was 0.05 f/cc and for perimeter respirable particulates was 1.5 mg/m³. Sampling locations are shown in Figure 3.

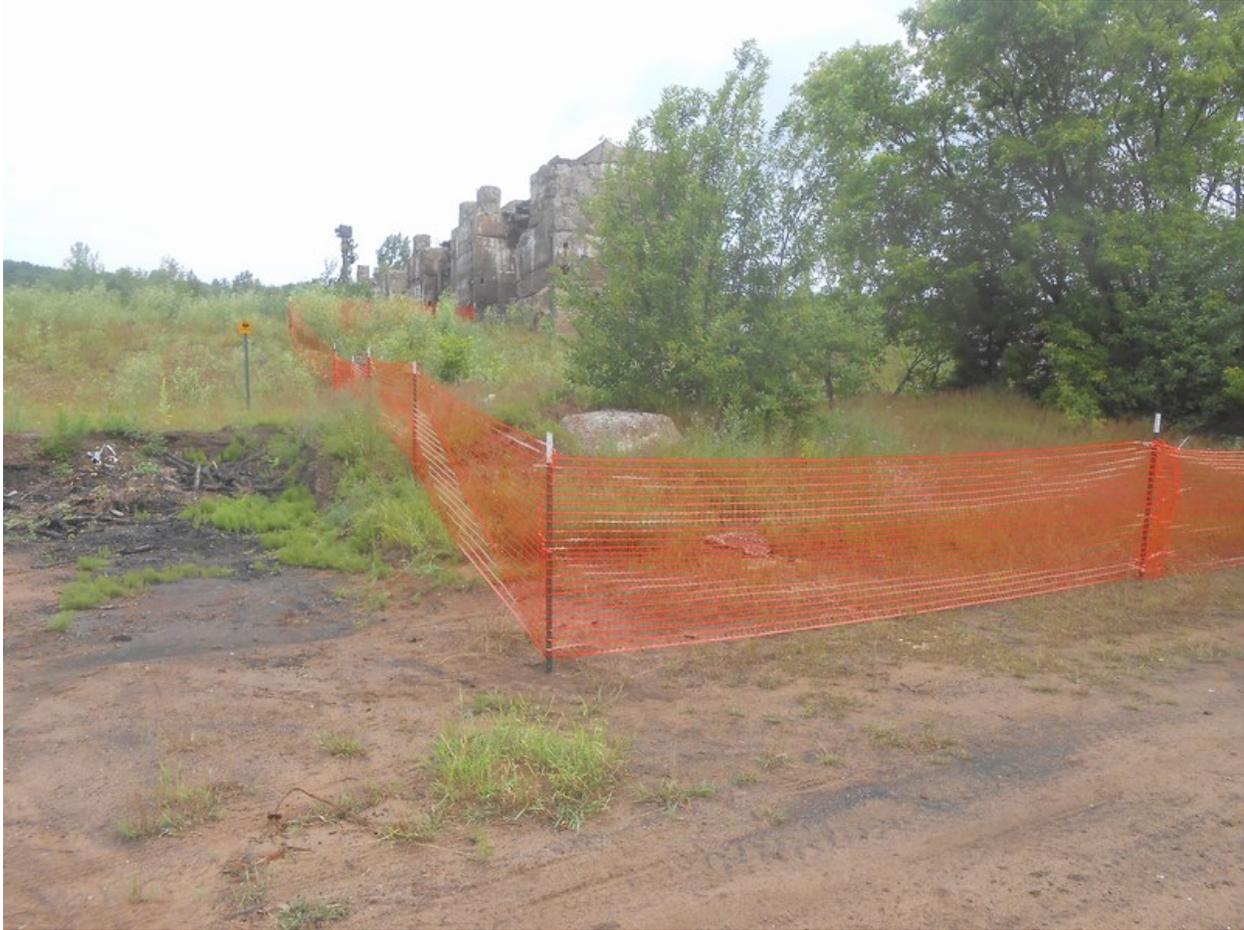
Photograph No.: 1 **Photographer:** Christopher Redfearn **Orientation:** Northwest
TDD Number: TO-01-14-05-1039 **Contract:** EP-S5-10-10 **Date:** 7/29/2014
Site Name & Location: Osceola Township, Houghton County, Michigan
Subject: Fence installed along the perimeter of the Site.

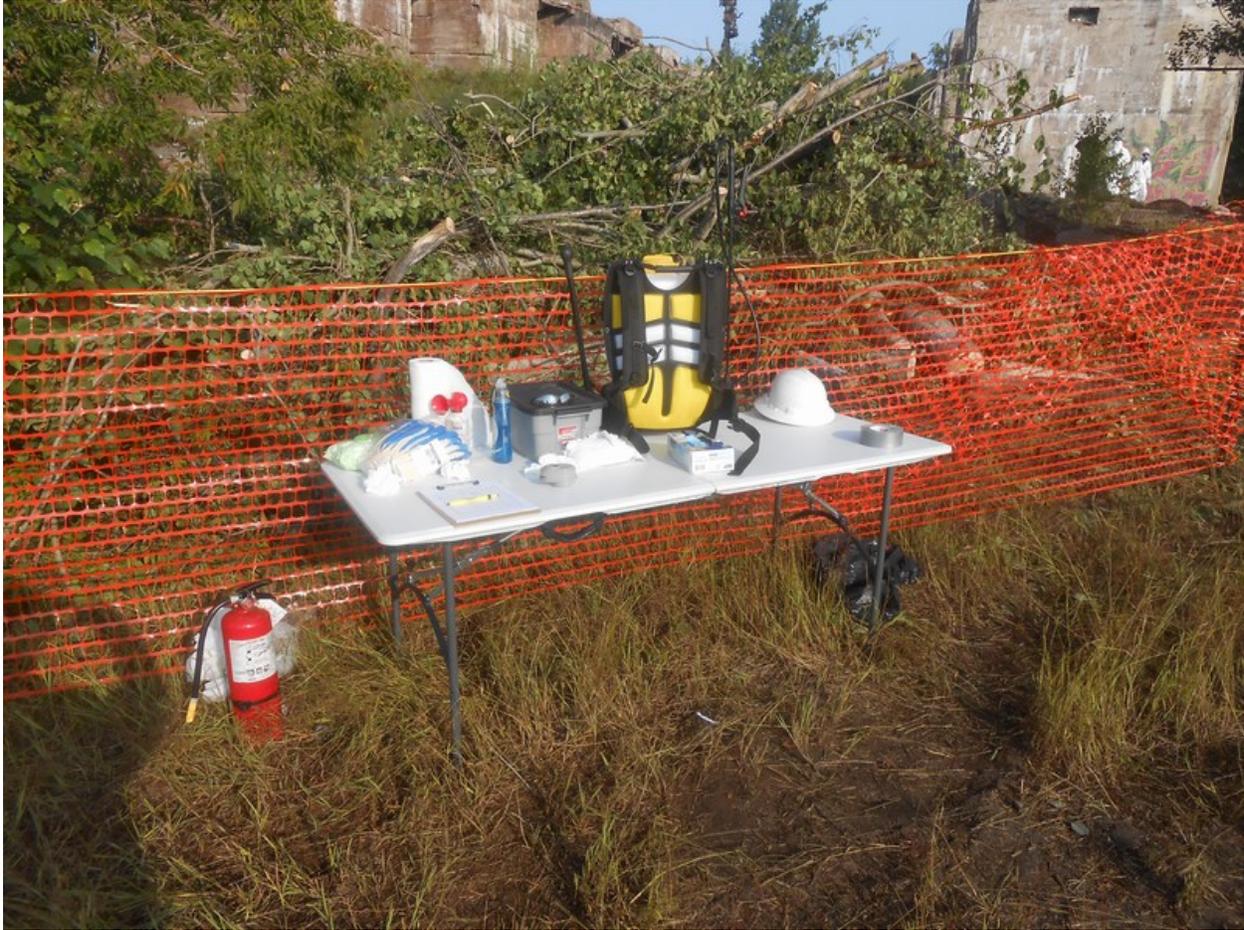
Photograph No.: 2 **Photographer:** Christopher Redfearn **Orientation:** Northeast
TDD Number: TO-01-14-05-1039 **Contract:** EP-S5-10-10 **Date:** 7/29/2014
Site Name & Location: Osceola Township, Houghton County, Michigan
Subject: Exclusion zone staged outside of removal action area.

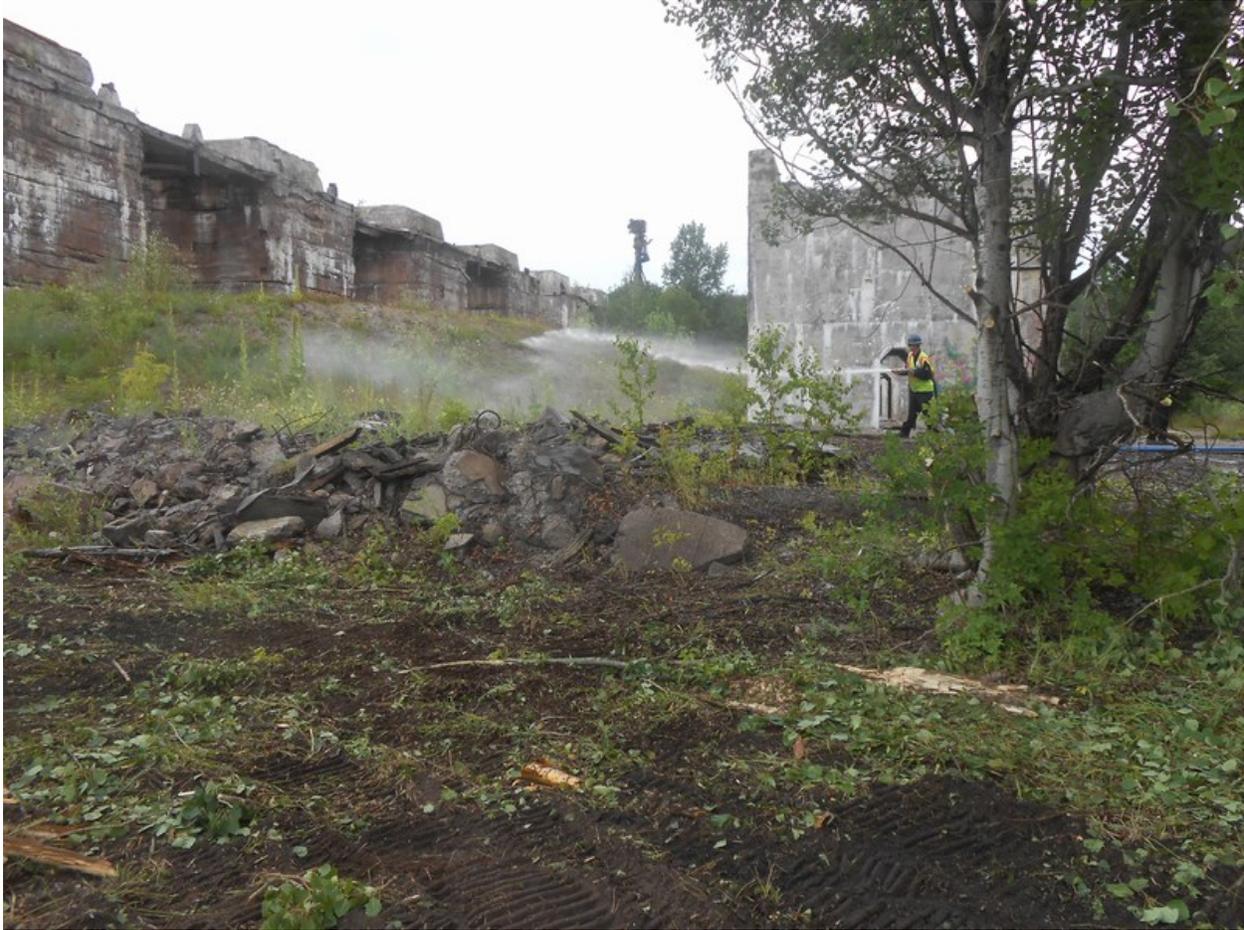
Photograph No.: 3 **Photographer:** Christopher Redfearn **Orientation:** Southwest
TDD Number: TO-01-14-05-1039 **Contract:** EP-S5-10-10 **Date:** 7/29/2014
Site Name & Location: Osceola Township, Houghton County, Michigan
Subject: ERRS soaking debris piles with water using hydraulic hose.

During these removal activities, START conducted health and safety air monitoring for asbestos and particulates. These activities are further discussed in later sections of this report. All debris piles were thoroughly soaked with water using a hydraulic hose. Debris was gathered from inside the foundations

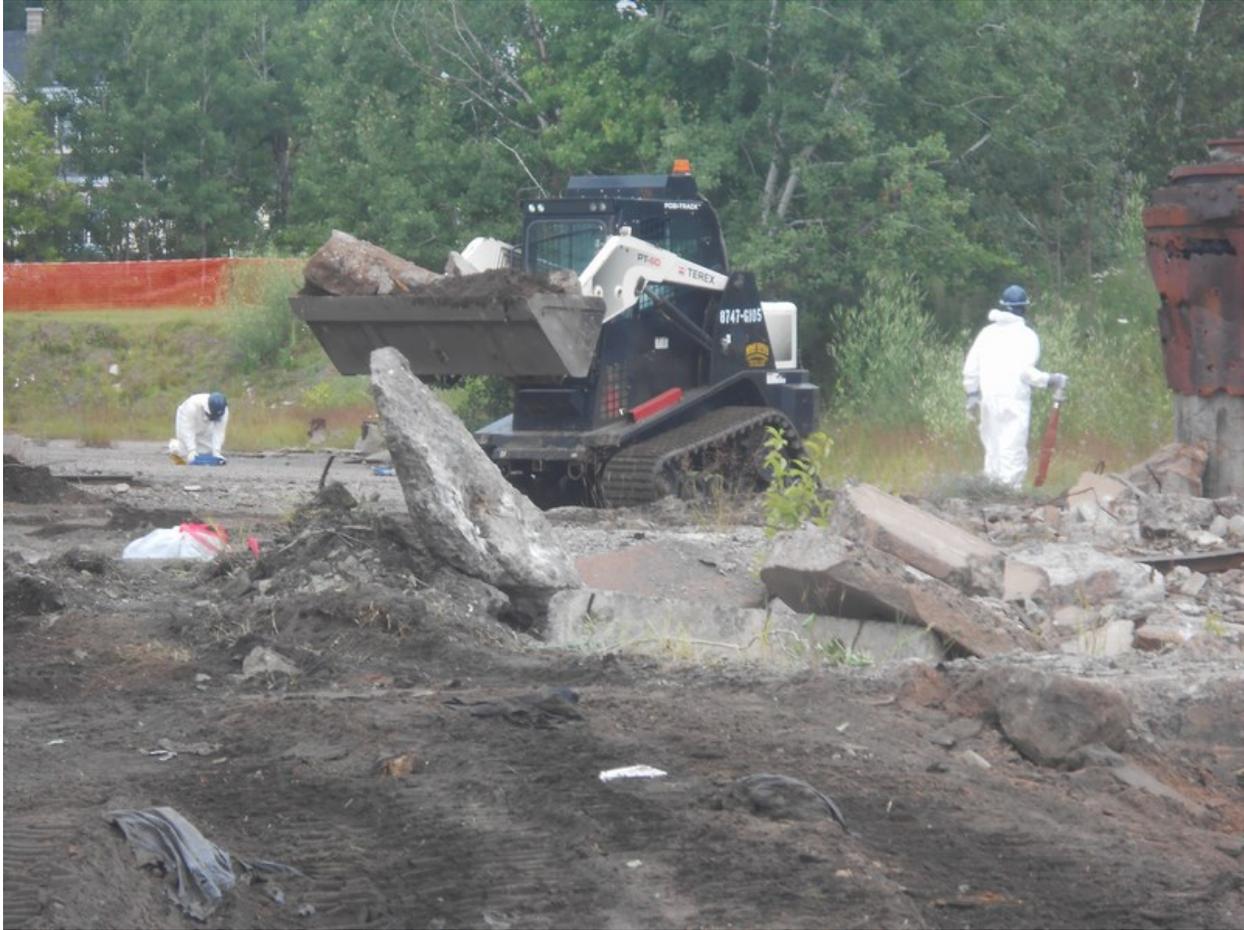
Photograph No.: 4 **Photographer:** Christopher Redfearn **Orientation:** Northwest
TDD Number: TO-01-14-05-1039 **Contract:** EP-S5-10-10 **Date:** 7/30/2014
Site Name & Location: Osceola Township, Houghton County, Michigan
Subject: ERRS gathering debris around Site using Bobcat skid steer loaders.

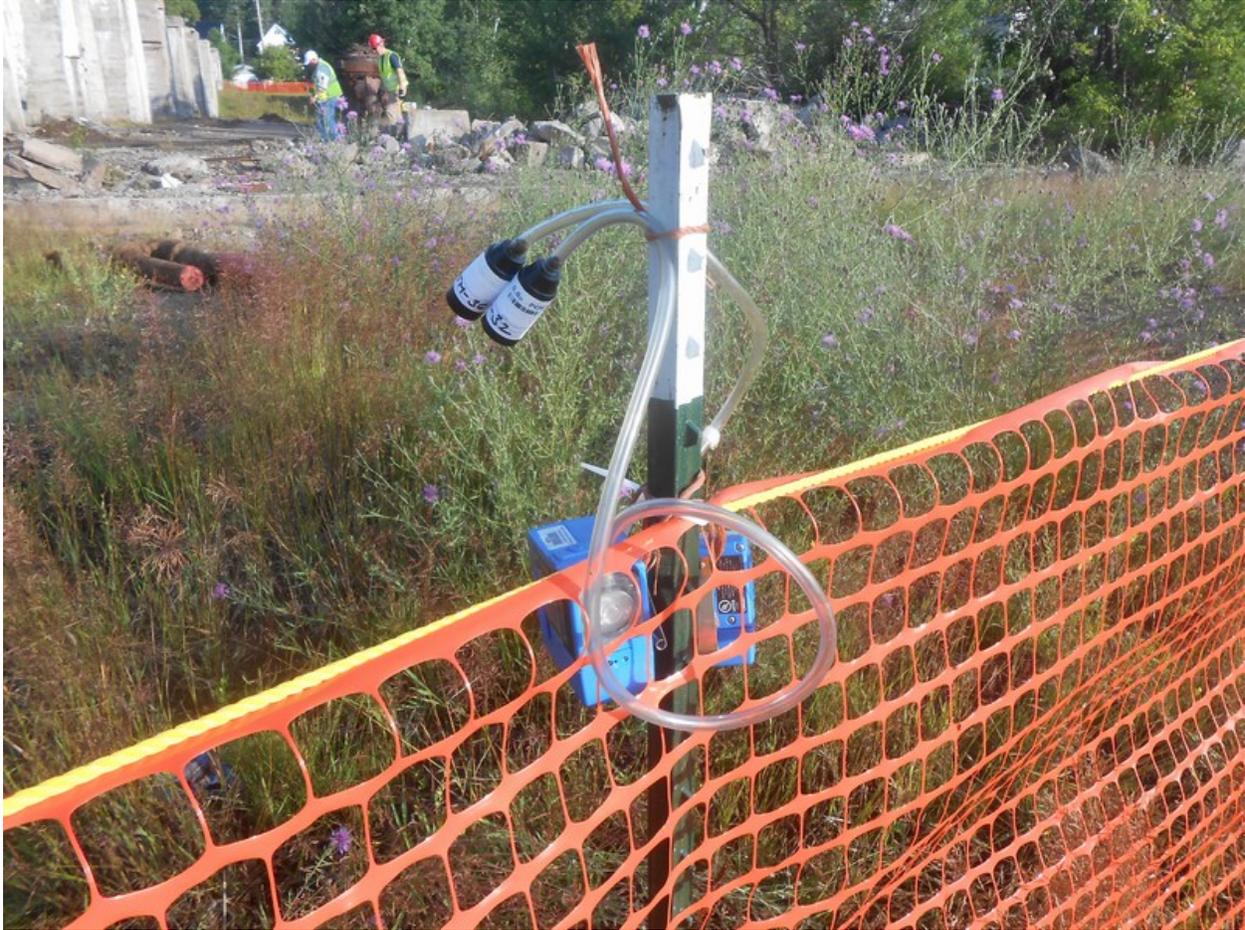
Photograph No.: 5 **Photographer:** Christopher Redfearn **Orientation:** Southwest
TDD Number: TO-01-14-05-1039 **Contract:** EP-S5-10-10 **Date:** 7/30/2014
Site Name & Location: Osceola Township, Houghton County, Michigan
Subject: Gilian air sampling pumps staged along perimeter fence.

START conducted asbestos sampling at the perimeter of the work area fence-line and the downwind location in order to document ACM levels per U.S. EPA approved sampling and analytical methods. Sampling was conducted daily during the duration of removal activities throughout each day. Daily air samples over an 8-hour period were collected with low flow Gilian Air Pumps using 0.8-micron pore size mixed cellulose ester (MCE) filters enclosed in a 25 mm diameter cassette with a diffuser pad. START subcontractor calibrated the air sampling pumps to flow rates between 2.3 liters per minute (lpm) and 3.0 lpm with the use of an onsite precision rotameter daily prior to Site activities being conducted. Once calibrated, 8 air sampling pumps were co-located and staged around the perimeter of the removal action area and samples were collected daily.

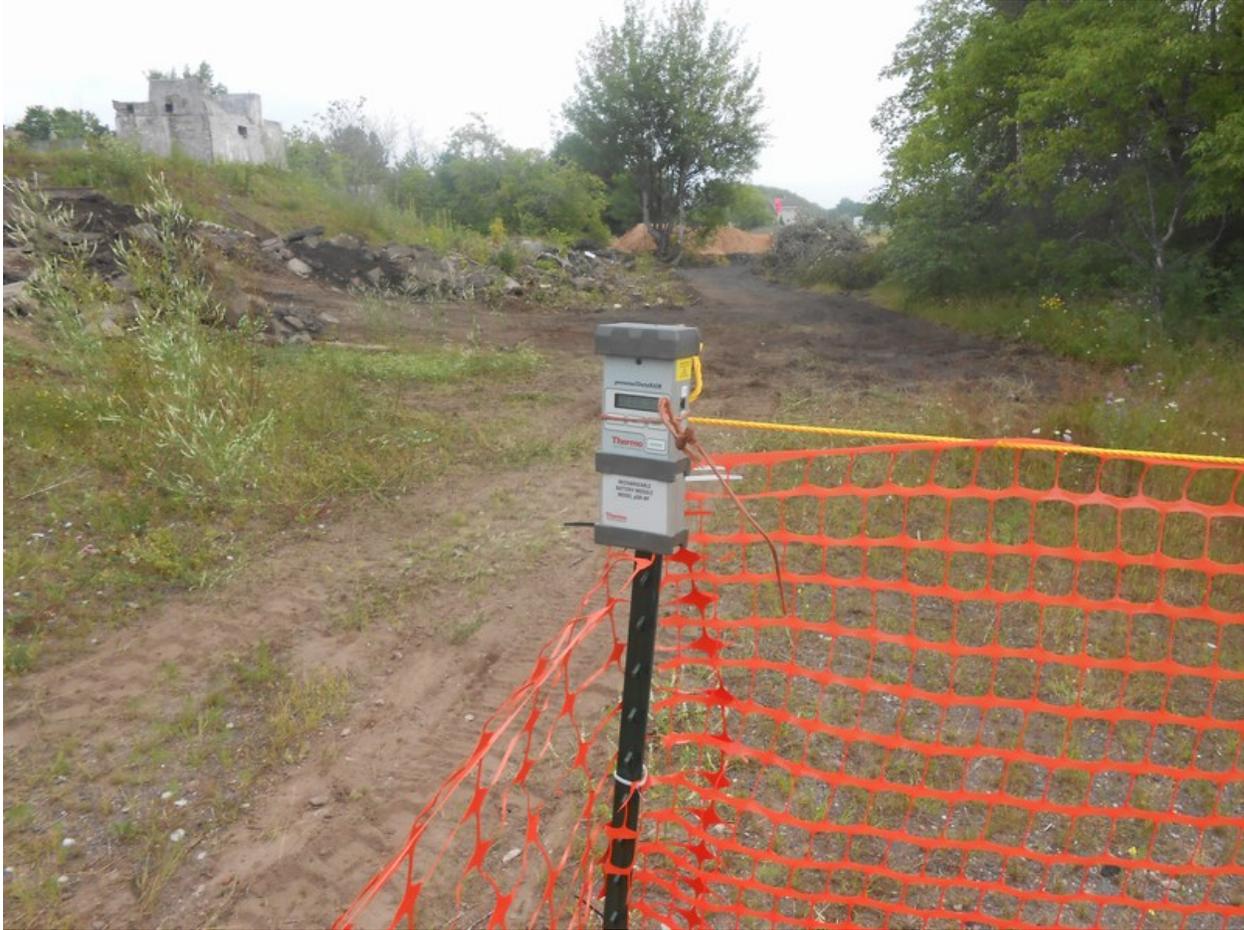
Photograph No.: 6 **Photographer:** Christopher Redfearn **Orientation:** Southwest
TDD Number: TO-01-14-05-1039 **Contract:** EP-S5-10-10 **Date:** 7/30/2014
Site Name & Location: Osceola Township, Houghton County, Michigan
Subject: Data Ram staged in the downwind location along perimeter fence.

Daily perimeter monitoring was conducted using a Data Ram 4000 (DR4) to monitor perimeter air quality. The Data Ram equipment monitored particulate matter and was used to measure nuisance/fugitive dust. The DR4 was calibrated daily per manufacturers' instructions by START prior to conducting air monitoring. The DR4 was zeroed out daily prior to Site activities and staged downwind of the removal action area. During the beginning of the removal action, a wind sock was installed on the perimeter of the site to constantly monitor wind direction for conducting air monitoring and sampling. Sampling locations were determined based on the wind direction and were relocated as the wind direction changed during removal activities. START provided real time updates on air quality to the ERRS crew to ensure that appropriate PPE and engineering controls were implemented at all times. During the entirety of this removal action, at no time did particulate matter and fugitive dust levels exceeded applicable removal action levels.

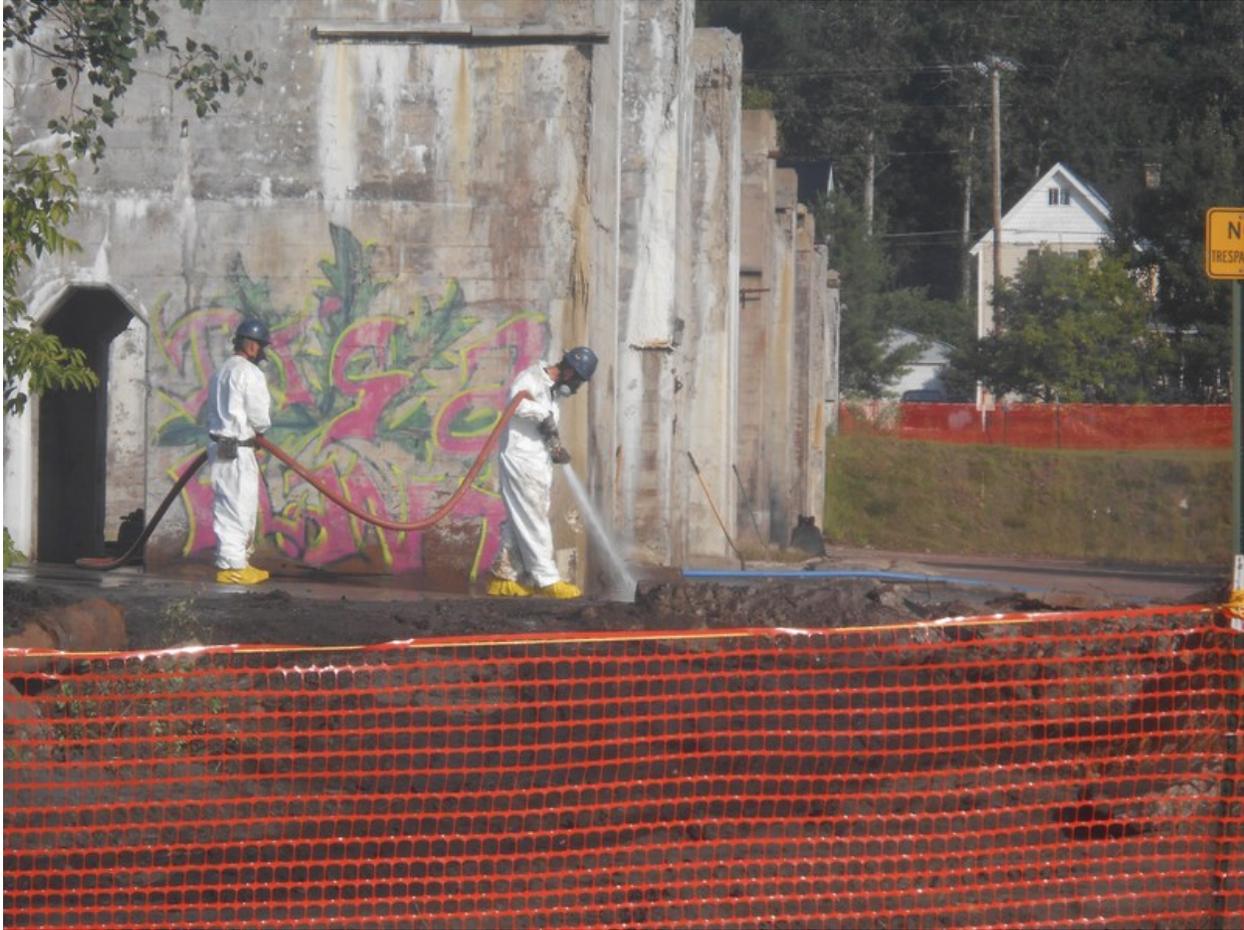
Photograph No.: 7 **Photographer:** Christopher Redfearn **Orientation:** Southwest
TDD Number: TO-01-14-05-1039 **Contract:** EP-S5-10-10 **Date:** 8/2/2014
Site Name & Location: Osceola Township, Houghton County, Michigan
Subject: ERRS using hydraulic hose to wash the exterior of concrete foundations.

and staged adjacent to the pillars. The interior and exterior areas of the foundations were then washed with water using a hydraulic hose. ERRS donned level C personal protective equipment (PPE) and removed debris piles from the southeast area of the Site along with the debris removed from the pillars using the Bobcat skid-steer loaders and staged the waste for later disposal. Once the debris was segregated and staged, clean off-site backfill material procured from a local vendor was delivered to the Site by B & B Trucking Inc. The backfill was placed in the areas of formerly existing debris piles in the southeast portion of the Site and surrounding the pillars.

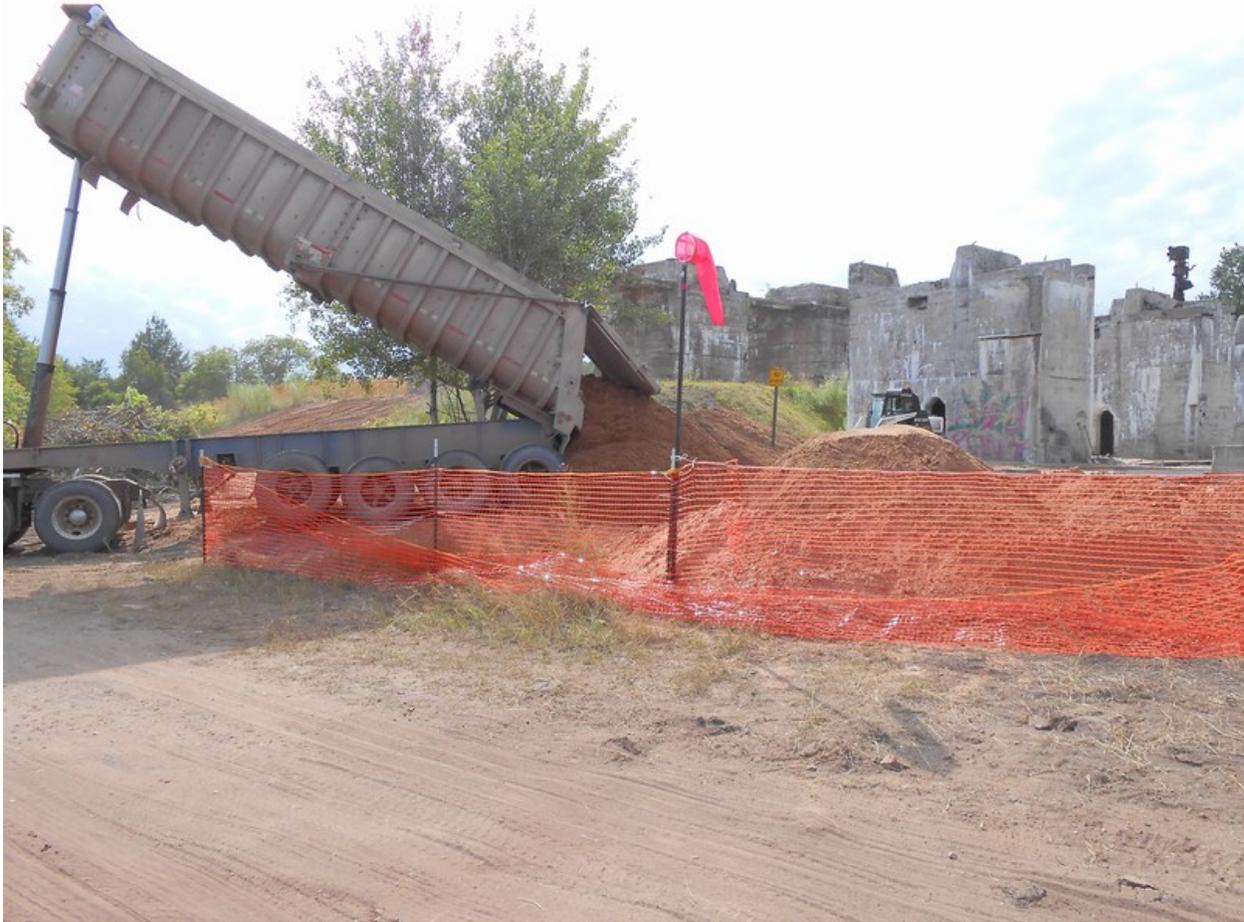
Photograph No.: 8 **Photographer:** Christopher Redfearn **Orientation:** East
TDD Number: TO-01-14-05-1039 **Contract:** EP-S5-10-10 **Date:** 8/2/2014
Site Name & Location: Osceola Township, Houghton County, Michigan
Subject: Clean soil being delivered to the Site by B & B Trucking.

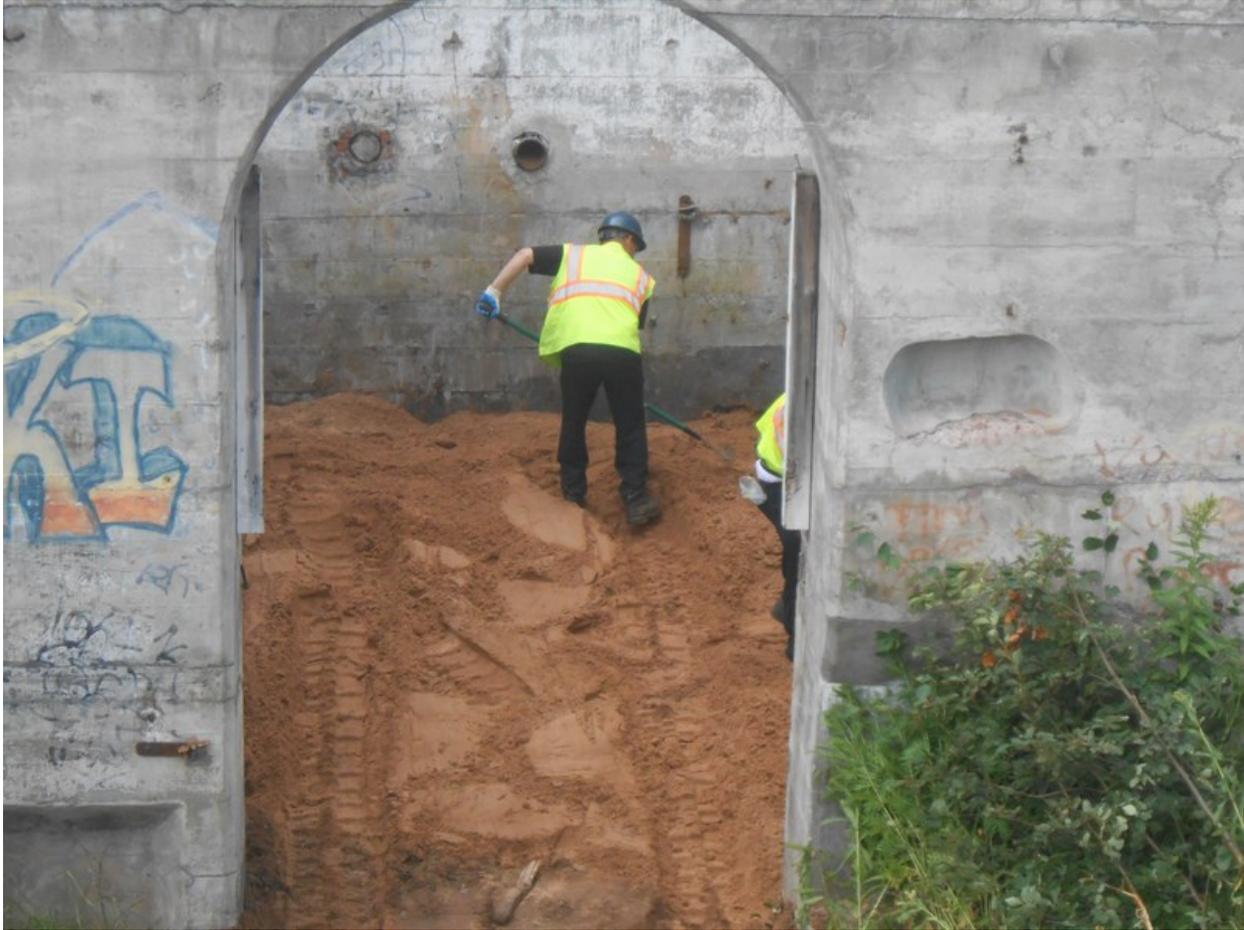
Photograph No.: 10 **Photographer:** Christopher Redfearn **Orientation:** North
TDD Number: TO-01-14-05-1039 **Contract:** EP-S5-10-10 **Date:** 8/3/2014
Site Name & Location: Osceola Township, Houghton County, Michigan
Subject: ERRS leveling soil in backfill area.

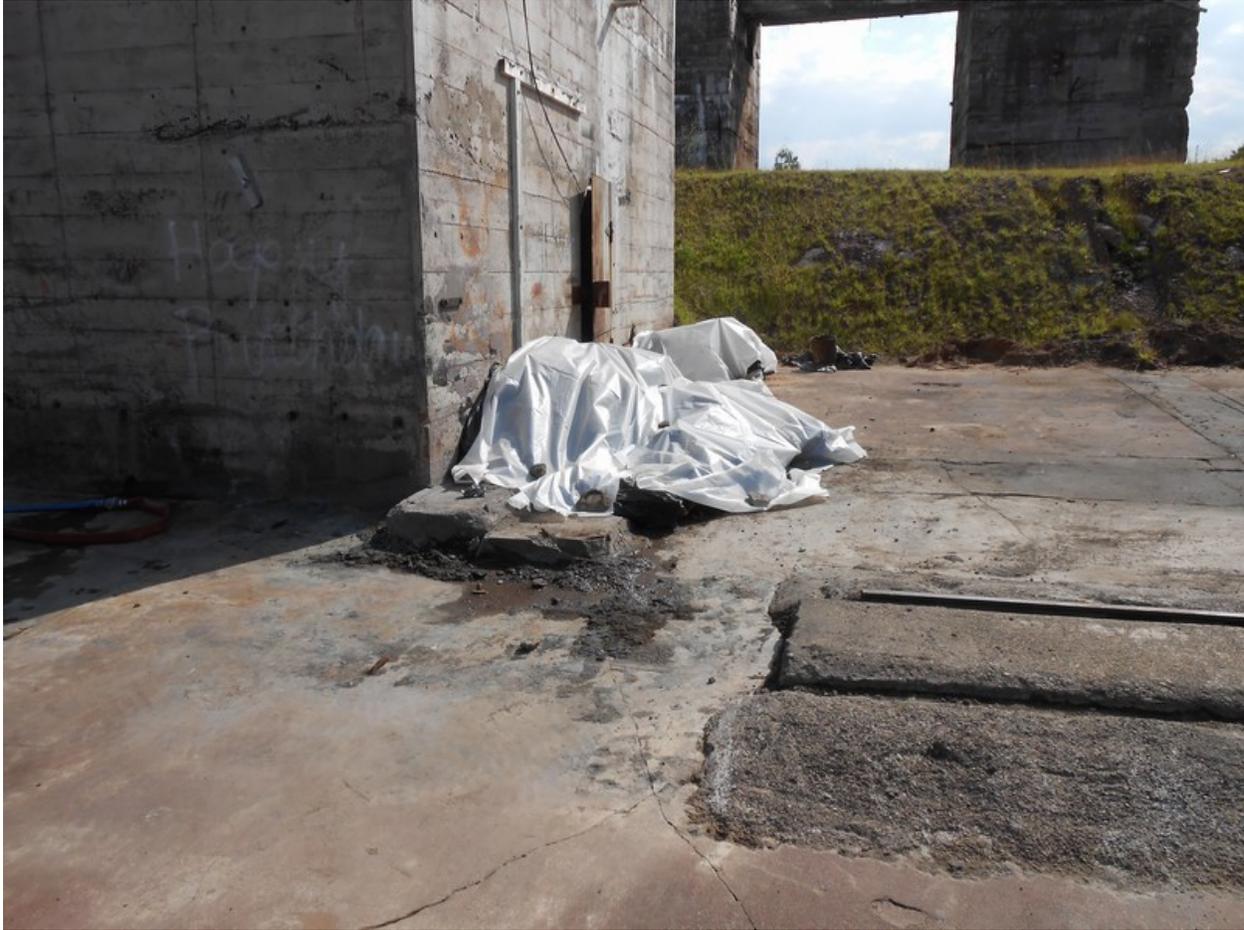
Photograph No.: 11 **Photographer:** Christopher Redfearn **Orientation:** Northwest
TDD Number: TO-01-14-05-1039 **Contract:** EP-S5-10-10 **Date:** 8/3/2014
Site Name & Location: Osceola Township, Houghton County, Michigan
Subject: ACM bagged and staged adjacent to concrete foundations pending disposal.

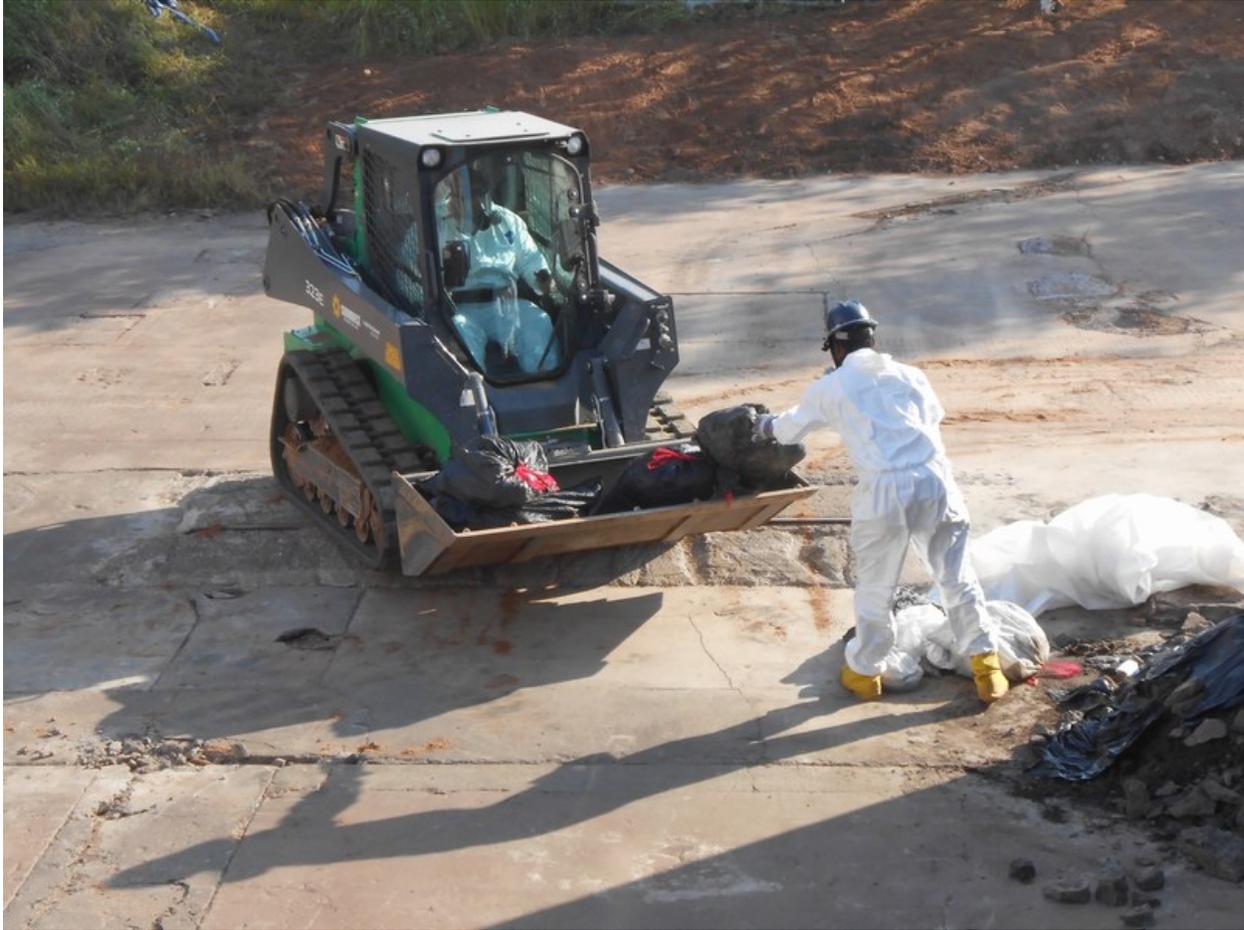
Photograph No.: 12 **Photographer:** Christopher Redfearn **Orientation:** Northwest
TDD Number: TO-01-14-05-1039 **Contract:** EP-S5-10-10 **Date:** 8/7/2014
Site Name & Location: Osceola Township, Houghton County, Michigan
Subject: Bagged ACM being loaded onto Bobcat skid steer loader.

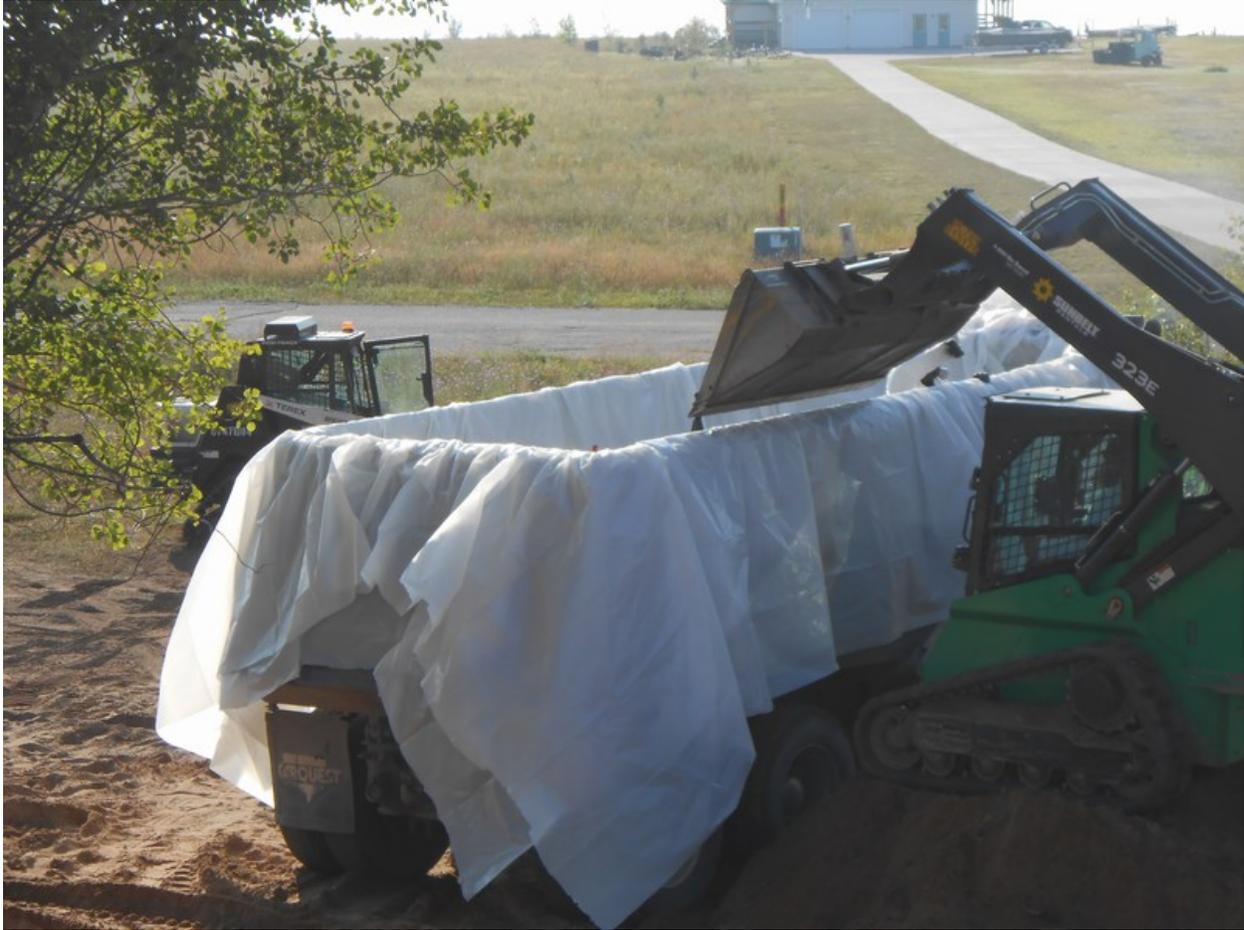
Photograph No.: 13 **Photographer:** Christopher Redfearn **Orientation:** Northwest
TDD Number: TO-01-14-05-1039 **Contract:** EP-S5-10-10 **Date:** 8/7/2014
Site Name & Location: Osceola Township, Houghton County, Michigan
Subject: ERRS loading bagged ACM into bed of disposal truck using the Bobcat skid steer loader.

A total of 4 cubic yards of friable asbestos material accumulated from the removal action was shipped to K & W Landfill in Ontonagon, Michigan on August 7, 2014 for landfilling (Table 3).

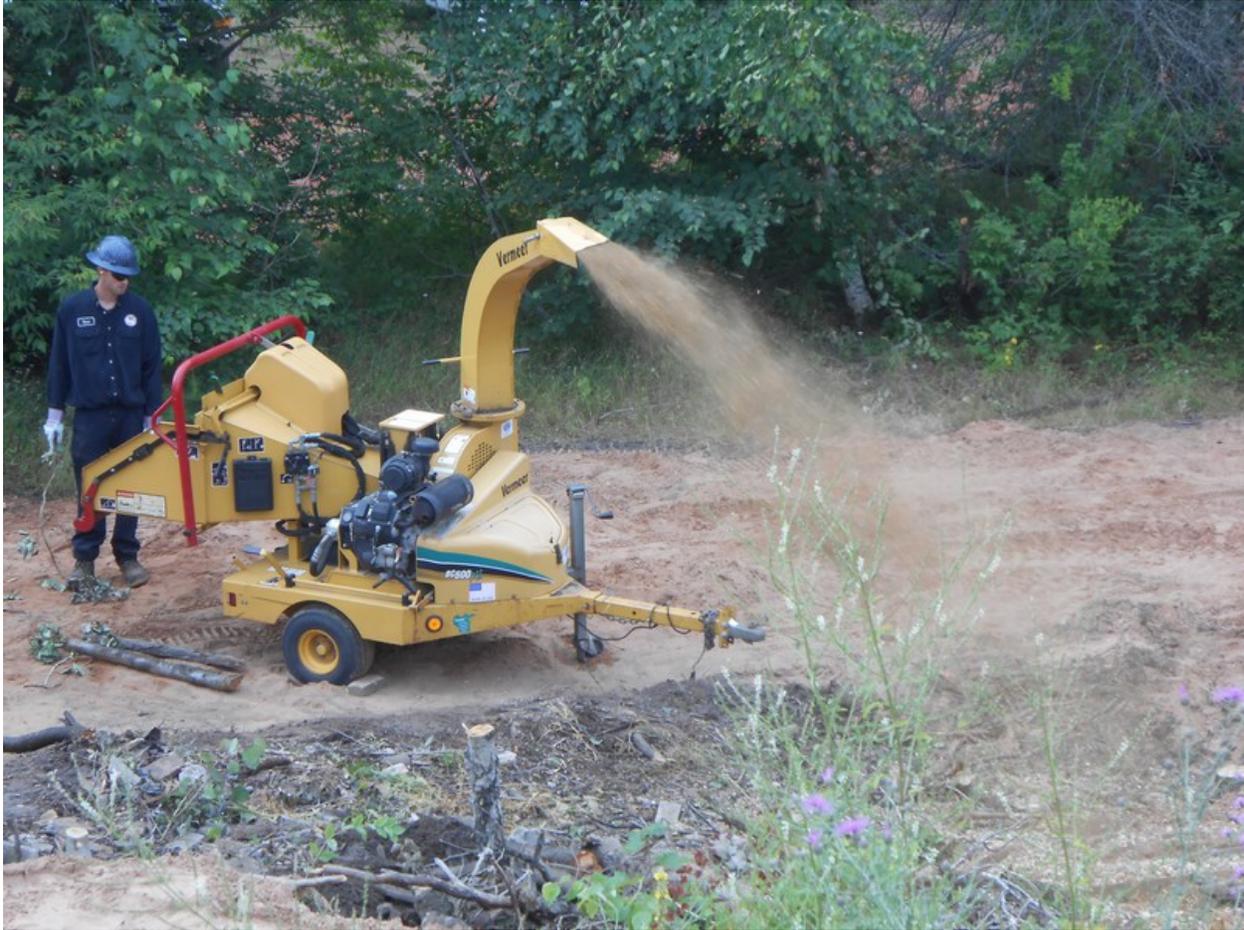
Photograph No.: 14

Subject: ERRS using wood chipper for large vegetation.

Large vegetation debris was consolidated into manageable pieces using a chipper/shredder and staged for disposal. ACM debris collected and staged during the removal action was loaded into a double-lined bed of a dump truck for disposal. On August 7, 2014 a total of 4 cubic yards (Yd³) of friable asbestos material was shipped to K & W Landfill in Ontonagon, Michigan for landfill disposal. ERRS cleaned the work areas and removed the fence around the perimeter of the Site. After the conclusion of the removal activities, START subcontractor and ERRS contractors demobilized from the Site on August 14, 2014.

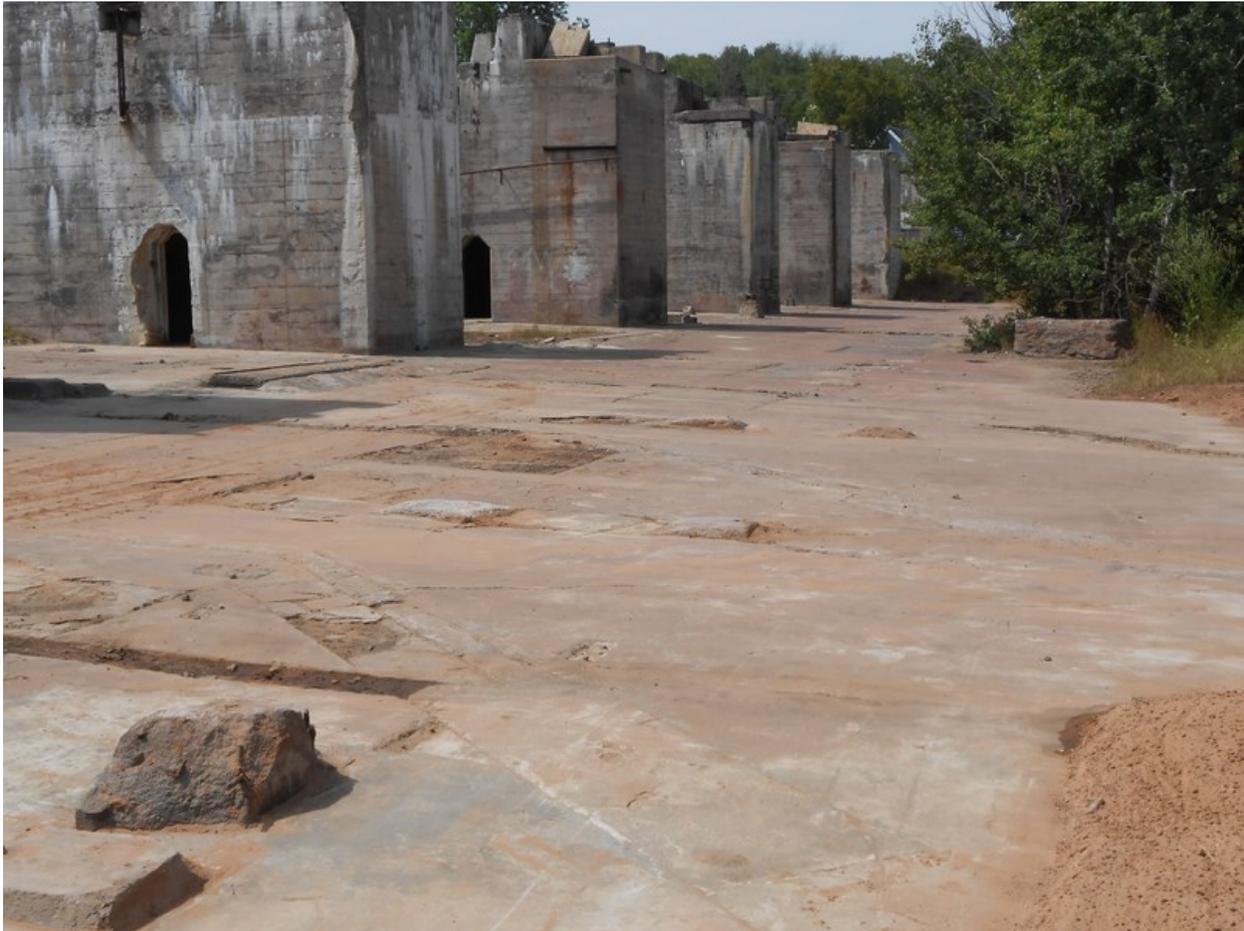
Photograph No.: 15 **Photographer:** Christopher Redfearn **Orientation:** Southwest
TDD Number: TO-01-14-05-1039 **Contract:** EP-S5-10-10 **Date:** 8/7/2014
Site Name & Location: Osceola Township, Houghton County, Michigan
Subject: The site post –removal.
