Report: **Weekly Progress Report**

Project: **Former Two Rivers MGP Site
Removal Action Construction
Two Rivers, Wisconsin**

Date: October 31, 2014

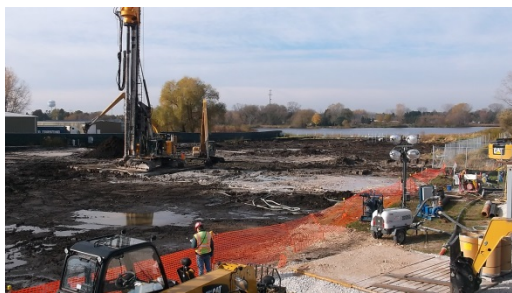
Photo 2: Excavation of peat material in the eastern portion of the ISS Area.

Direction: Facing east

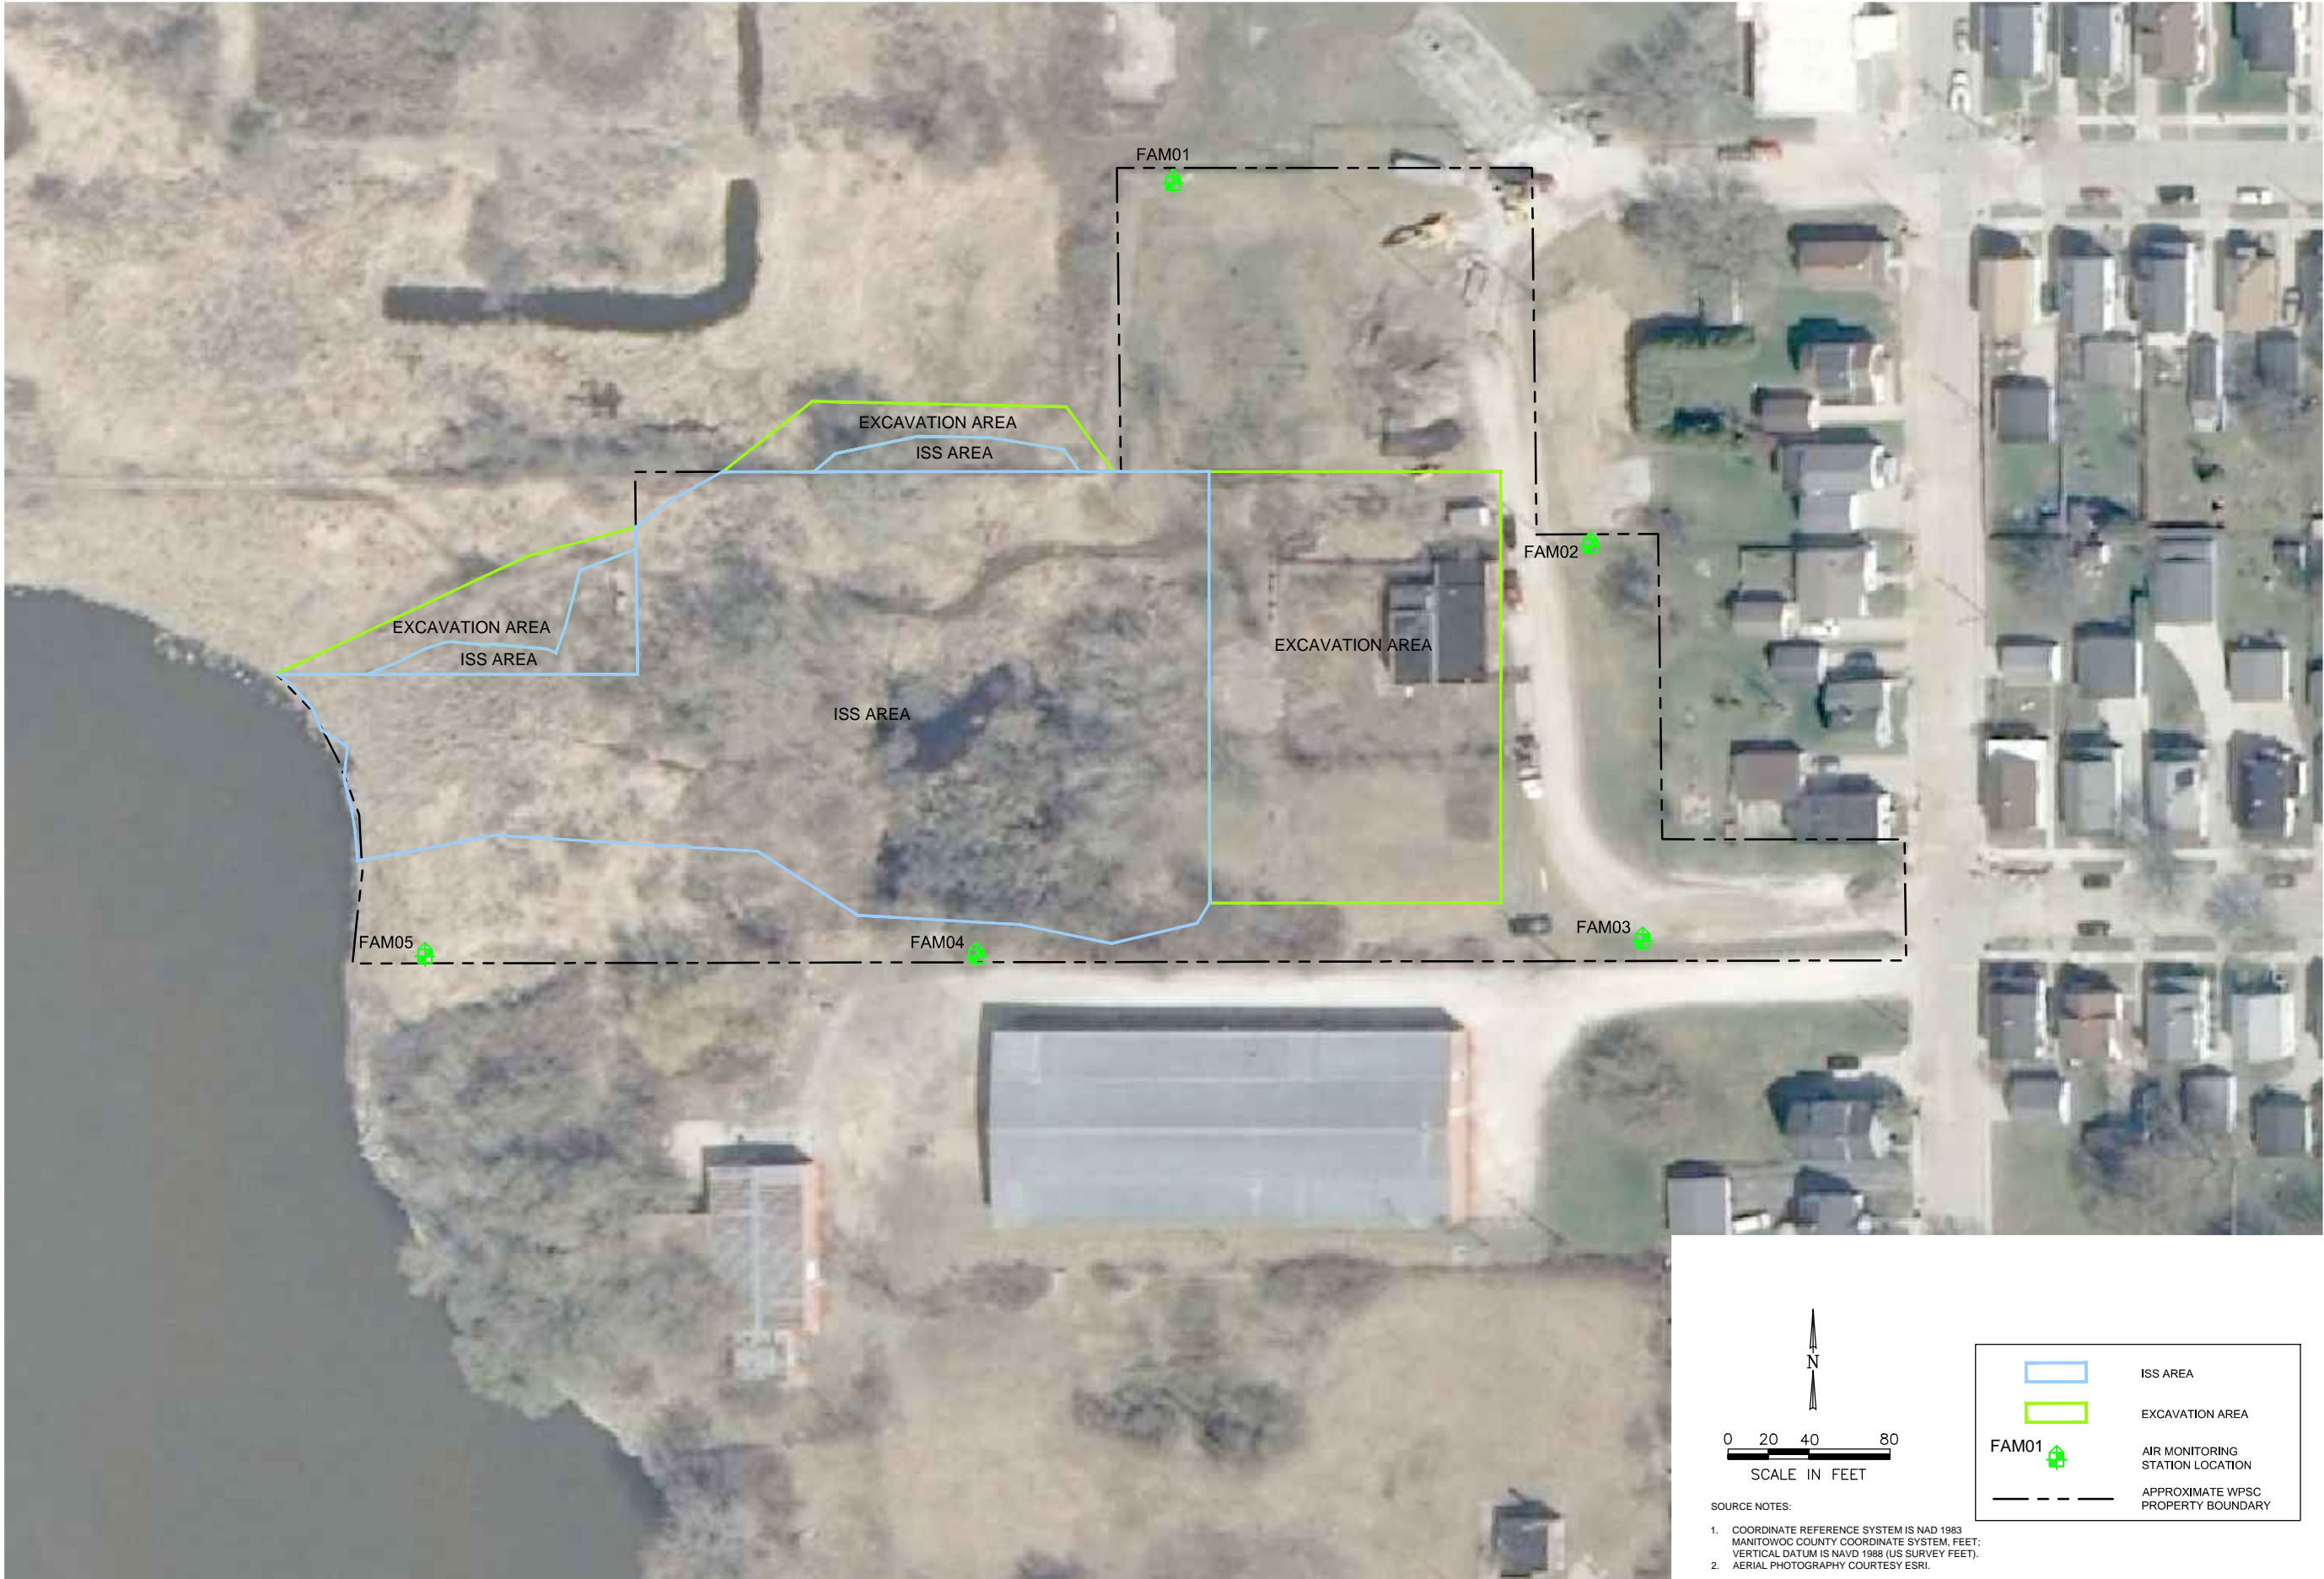
FIGURE NO.
1

- Real-time site perimeter air monitoring for TVOCs and PM₁₀ was conducted 24 hours per day, all seven days of the week. The locations of the perimeter air monitoring stations are shown on Figure 1.
- A total of 11 SUMMA canister samples were collected, including two samples at each of the five air monitoring station locations and one field blank sample. SUMMA canister samples were analyzed for BTEX compounds and naphthalene. A summary of the analytical results is presented in Table 1.
- A total of six PUF samples were collected, including one sample at each of the five air monitoring station locations and one field blank sample. PUF samples were analyzed for PAH compounds. A summary of the analytical results is presented in Table 1.

AIR MONITORING STATION LOCATIONS
