**FIGURE X**  
 XRF Screening and Sample Results  
 10/2/14, 10/22/14, 3/24/15

**TDD Name:** Wiley Property  
**TDD No.:** TT-02-002

**City:** Hartford    **County:** Ohio    **State:** Kentucky

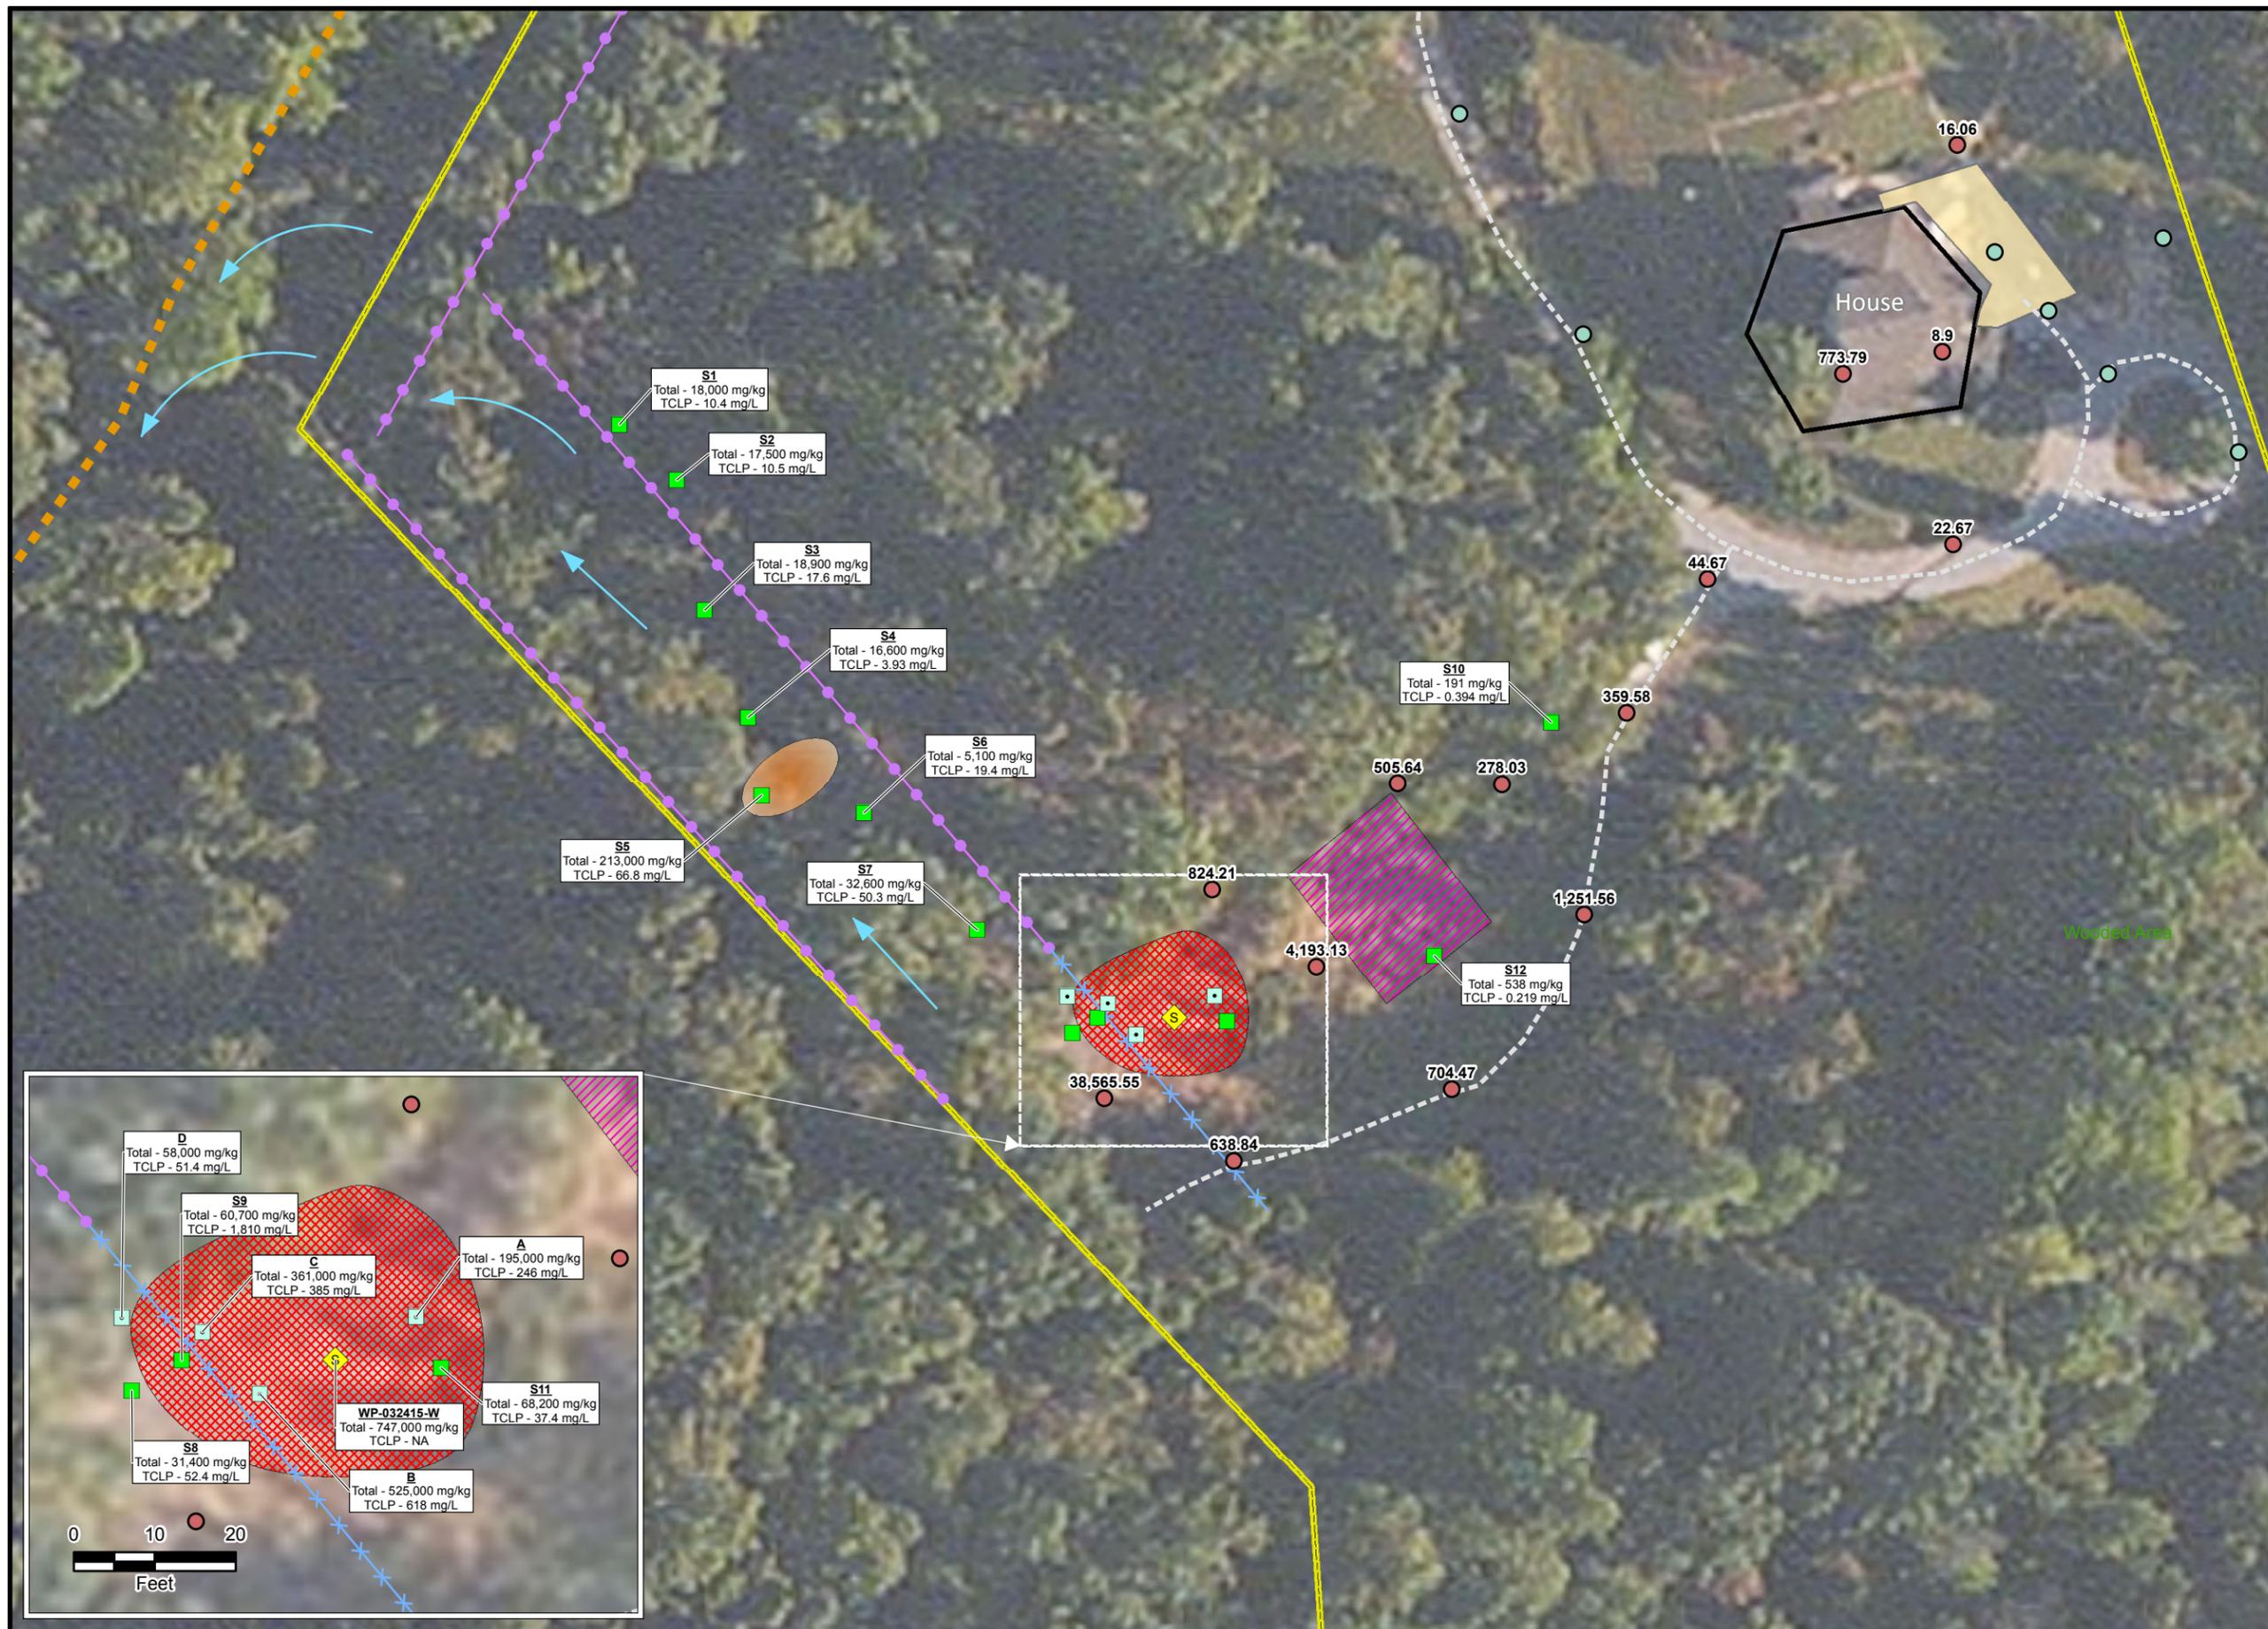
**Notes:**  
 LOD - Level of Detection  
 TCLP - Toxicity Characteristic Leaching Procedure  
 XRF screening results in ppm
