Perimeter Air Sampling Results Summary  
October 15, 2015  
Princeton Recycles Site  
Princeton, NJ

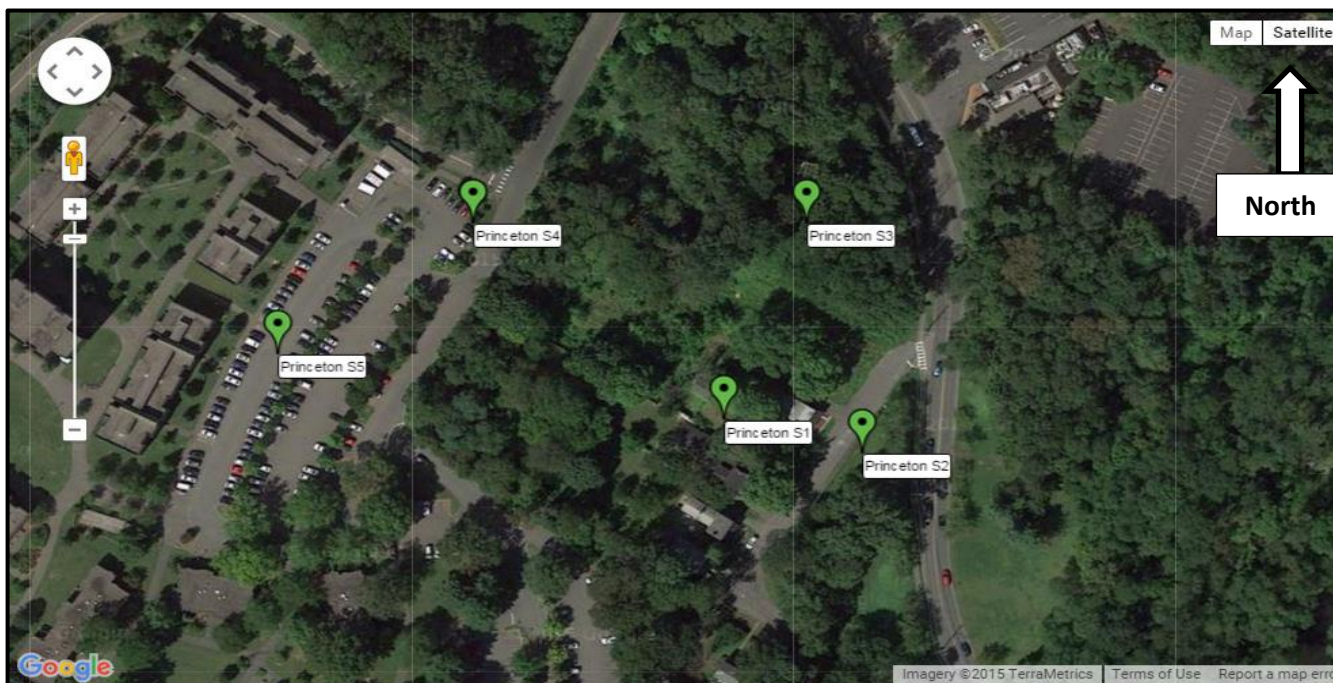
Sample Location	Benzo[a]pyrene	PCBs	Lead
Action Levels	0.1 ug/m <sup>3</sup>	0.5 ug/m <sup>3</sup>	0.15 ug/m <sup>3</sup>
Princeton S1	ND (0.10 ug/m <sup>3</sup> )	ND (0.051 ug/m <sup>3</sup> )	0.072 ug/m <sup>3</sup>
Princeton S2	ND (0.098 ug/m <sup>3</sup> )	ND (0.046 ug/m <sup>3</sup> )	ND (0.048 ug/m <sup>3</sup> )
Princeton S3	ND (0.17 ug/m <sup>3</sup> )	ND (0.050 ug/m <sup>3</sup> )	ND (0.047 ug/m <sup>3</sup> )
Princeton S4	ND (0.19 ug/m <sup>3</sup> )	ND (0.053 ug/m <sup>3</sup> )	ND (0.051 ug/m <sup>3</sup> )
Princeton S5	ND (0.19 ug/m <sup>3</sup> )	ND (0.050 ug/m <sup>3</sup> )	ND (0.051 ug/m <sup>3</sup> )

Comments: Excavation activities continue at the northwest portion of the site. Wind direction primarily out of the NW, background data based on S4.
