**PROGRESS REPORT #46 - MARCH 2017**

**RE: Milwaukee Die Casting Company (MDCC) Site**  
Milwaukee, Wisconsin  
CERCLIS ID#WIN000510552  
RCRA ID#WID006102305

**GEOSYNTEC CONSULTANTS**  
**Photographic Record**

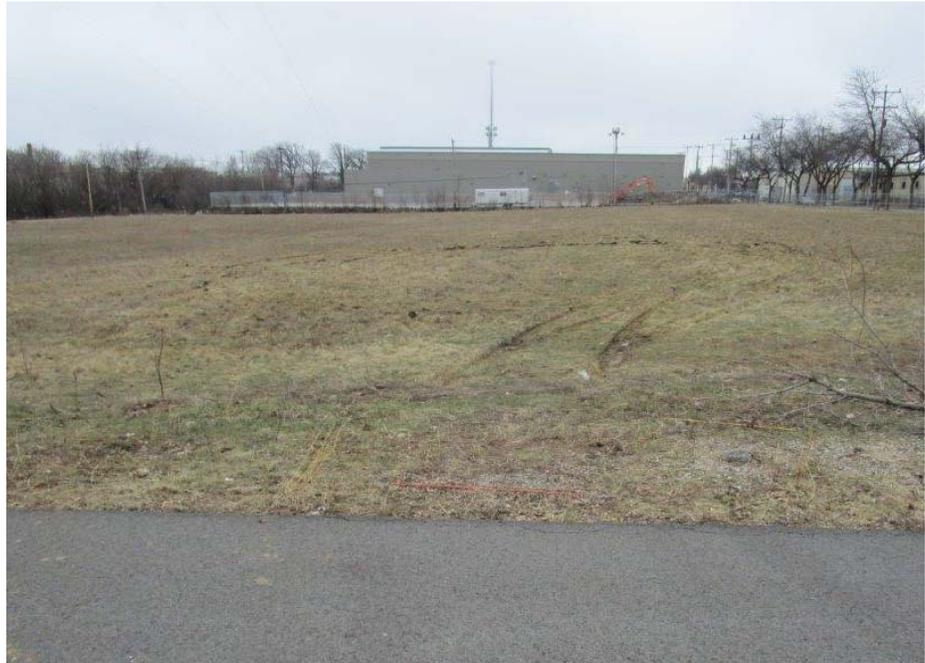
**Photograph 1**

During the March 28, 2017 cap inspection, vehicle tracks were observed entering the Site from the north off-Site property parking lot. The vehicle tracks were limited to an isolated area in the northwest/north-central portion of the Site. The disturbance to the vegetative cover was less than ½-inch for the most part, with a small portion of the disturbance being not more than 1-inch. The cap remains intact; no material beneath the topsoil is exposed. Photographs of the disturbed topsoil are attached.

**Comments:** Cap inspection observation - vegetative cover disturbance; vehicle tracks in an isolated area in the northwest/north-central portion of the Site.

The draft Cap Maintenance Plan submitted to the USEPA proposed that minor repairs will be completed as soon as practicable or no later than 72 hours after discovery. Repair activities, if necessary, will include raking and re-seeding the disturbed area. The topsoil across the cap and Site is currently too wet to rake due to recent heavy rain. Necessary restoration to the vegetative cover will be made as soon as conditions allow. Restoration activities will be documented in the corresponding Progress Report following the work.

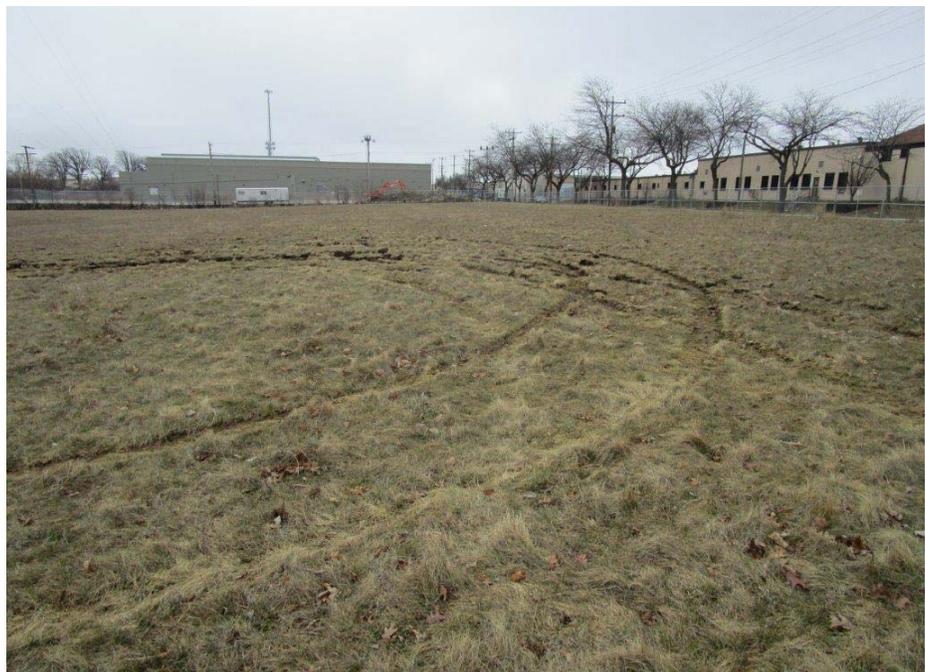
**Photograph 2**

**Comments:** Cap inspection observation - vegetative cover disturbance; vehicle tracks in an isolated area in the northwest/north-central portion of the Site.
