# Airborne Spectral Photometric Environmental Collection Technology

## ASPECT Air Quality Survey after Hurricane Ida Baton Rouge, LA September 4, 2021

# **ASPECT Air Quality Survey**

## **Hurricane IDA**

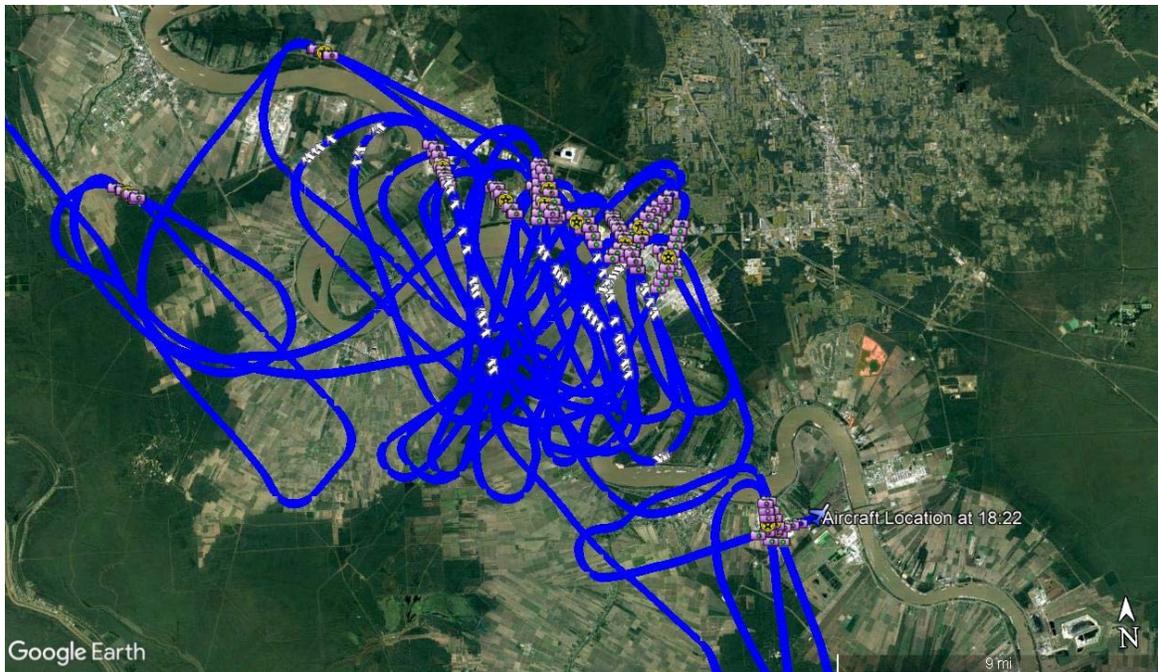
Wide, slow turns are required to be made in between runs to keep the instruments stable. The blue lines indicate the flight path while the green lines indicate the specific sections of the flight where chemical data was collected and processed. On Flights 5 and 6 the Baton Rouge area was surveyed, and the flight paths are shown in Figures 1 and 2.

Figure 1. Data Collection Flight Path over the Baton Rouge Area Flight 5, September 4, 2021

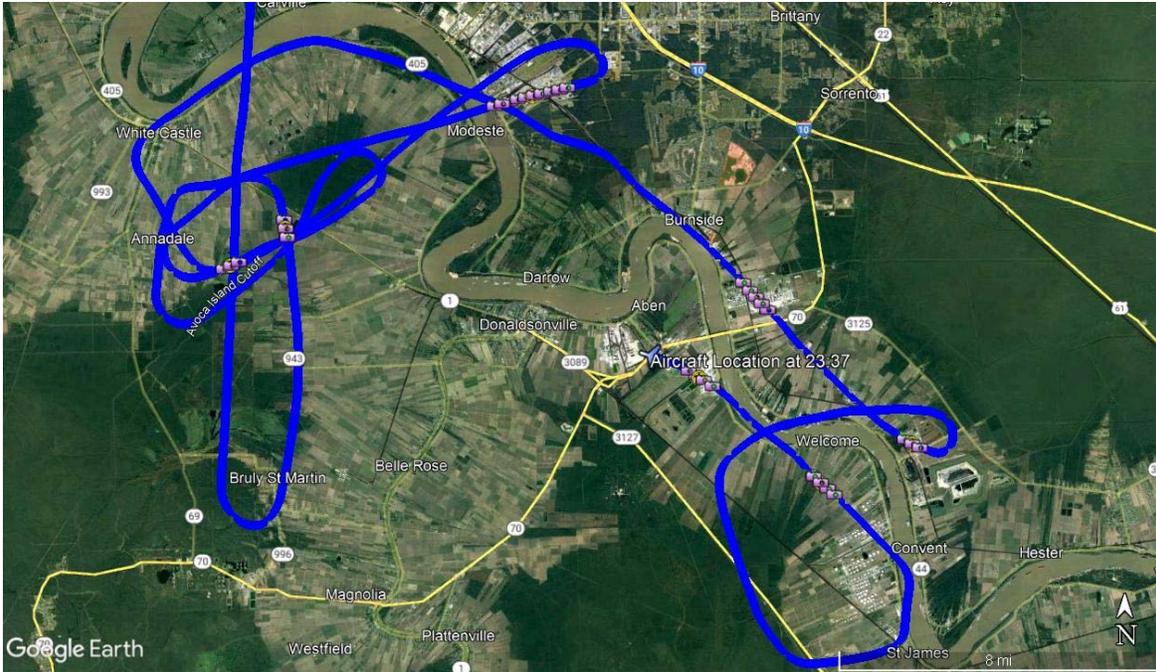
Figure 2. Data Collection Flight Path over the Baton Rouge Area Flight 6, September 4, 2021

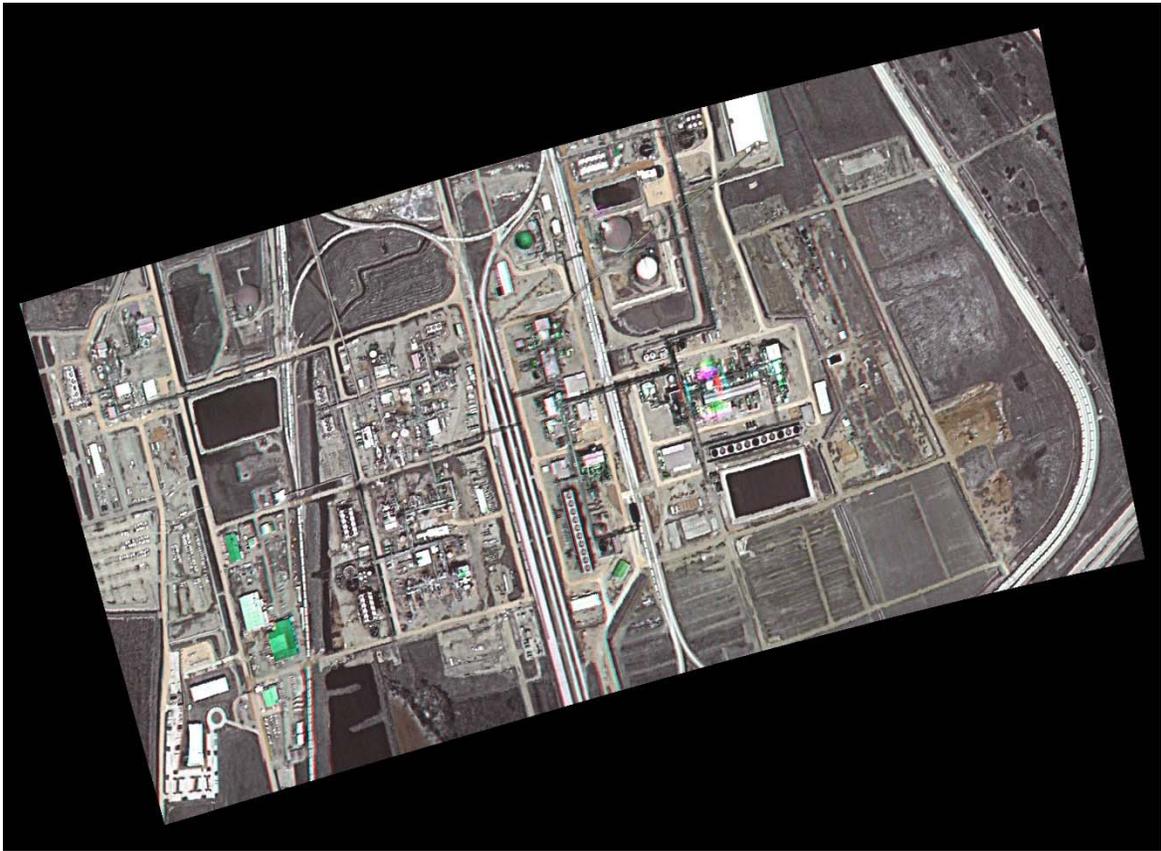
A total of 31 data collection runs were made over the target facilities and an infrared line scanner image was generated for each collection run. Figure 3 shows a 3-band infrared image collected over the CF Industries facility. Thermal analysis shows that many of the facilities are showing process units have some activity. The process unit located in the middle of Figure 3 indicates hot units and hot piping. Other than thermal, no chemical plumes can be observed being emitted from the facility. Figure 4 shows a similar image collected on Flight 6 over the Occidental Chemical facility.

Figure 3. Three band IR image, CF Industries in the Baton Rouge Area, Run 23, Flight 5, September 4, 2021

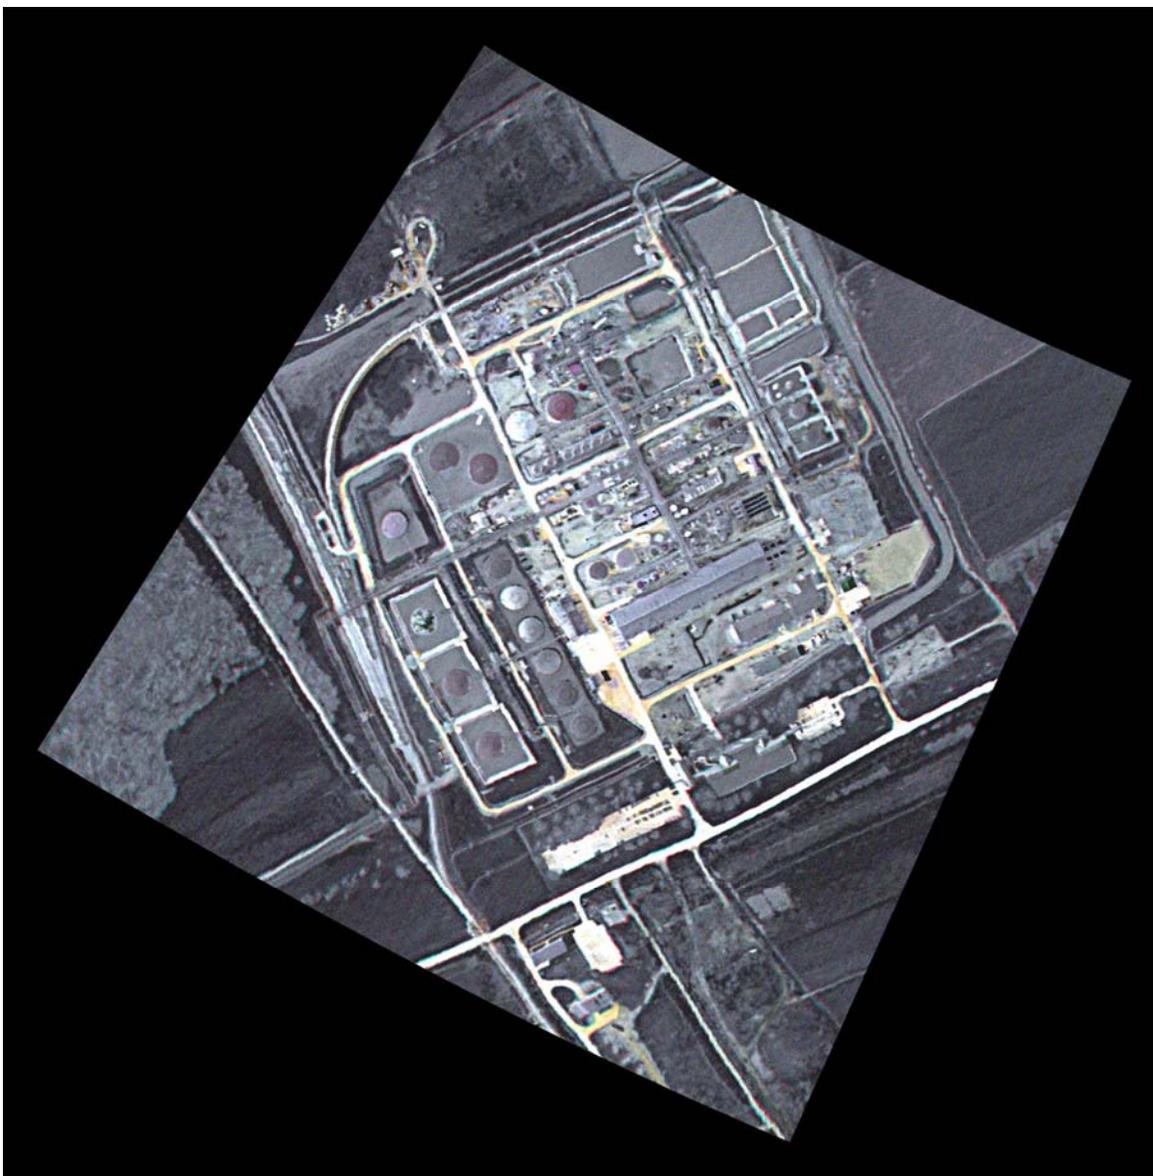
Figure 4. Three band IR image, Occidental Chemical Facility in the Baton Rouge Area, Run 5, Flight 6, September 4, 2021

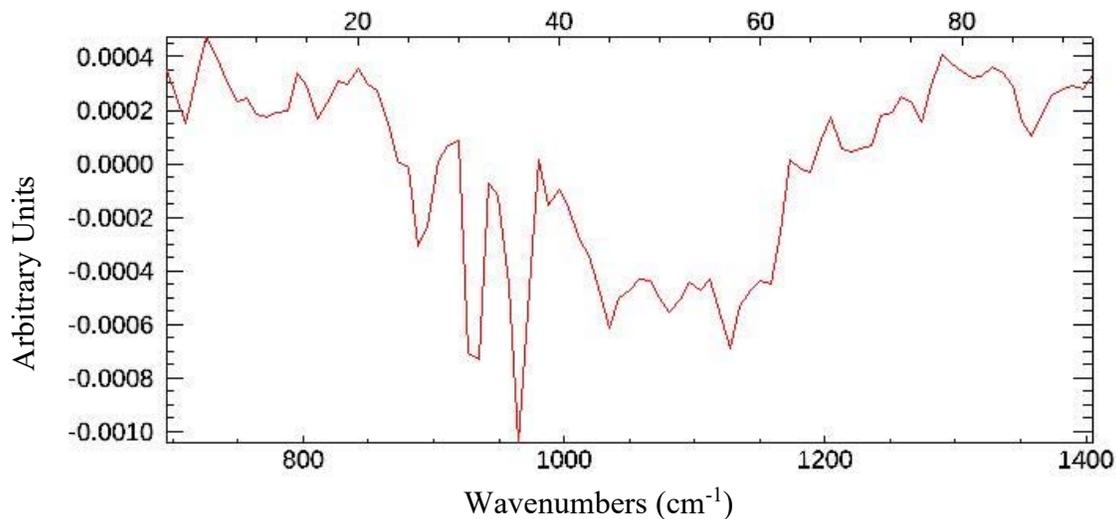
Ground analysis and confirmation of airborne data found detectable quantities of ammonia on passes 10 and 11 at a maximum concentration of approximately 14.7 ppm. Figure 5 shows a plot of detected ammonia with the characteristic peaks at 930 and 960 wavenumbers. Figure 6 shows the locations of the ammonia detections. No other significant detections were noted in the survey. Details of the monitoring results can be found in Tables 4 and 5.

Figure 5. Ammonia Spectrum Flight 5, Run 10

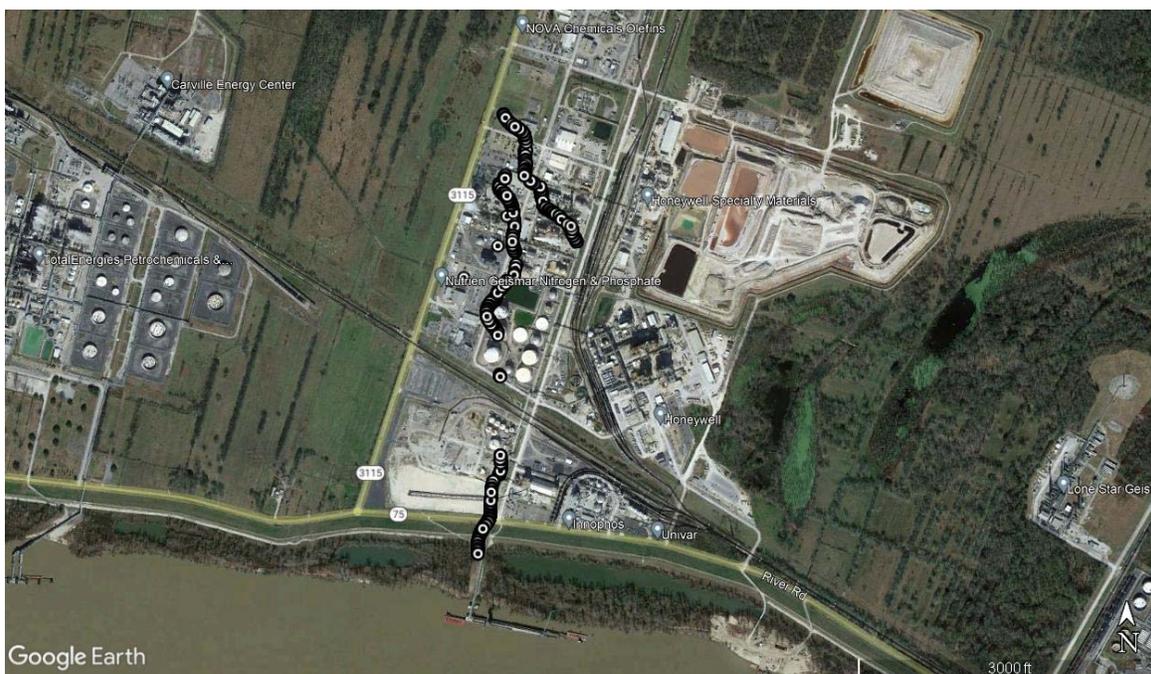
Figure 6. Ammonia Detection Locations, Flight 5, Runs 10 and 11

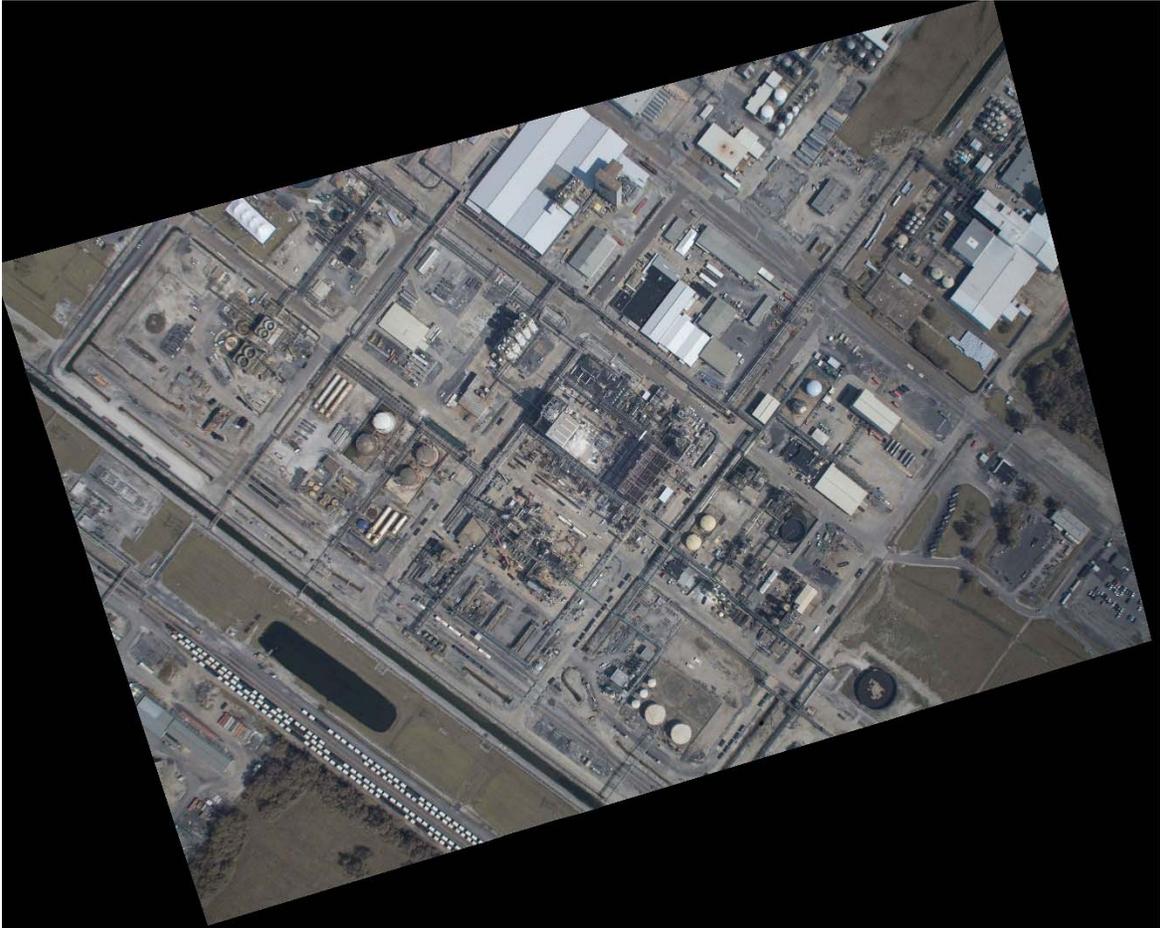
A full set of high-resolution aerial digital photography were collected as part of each data collection pass. Weather conditions over the Baton Rouge area allowed high quality aerial images to be collected. Figure 7 shows a representative aerial image collected over the

Figure 7. MSIC image of the Syngenta Crop Protection facility, Flight 5, September 4, 2021

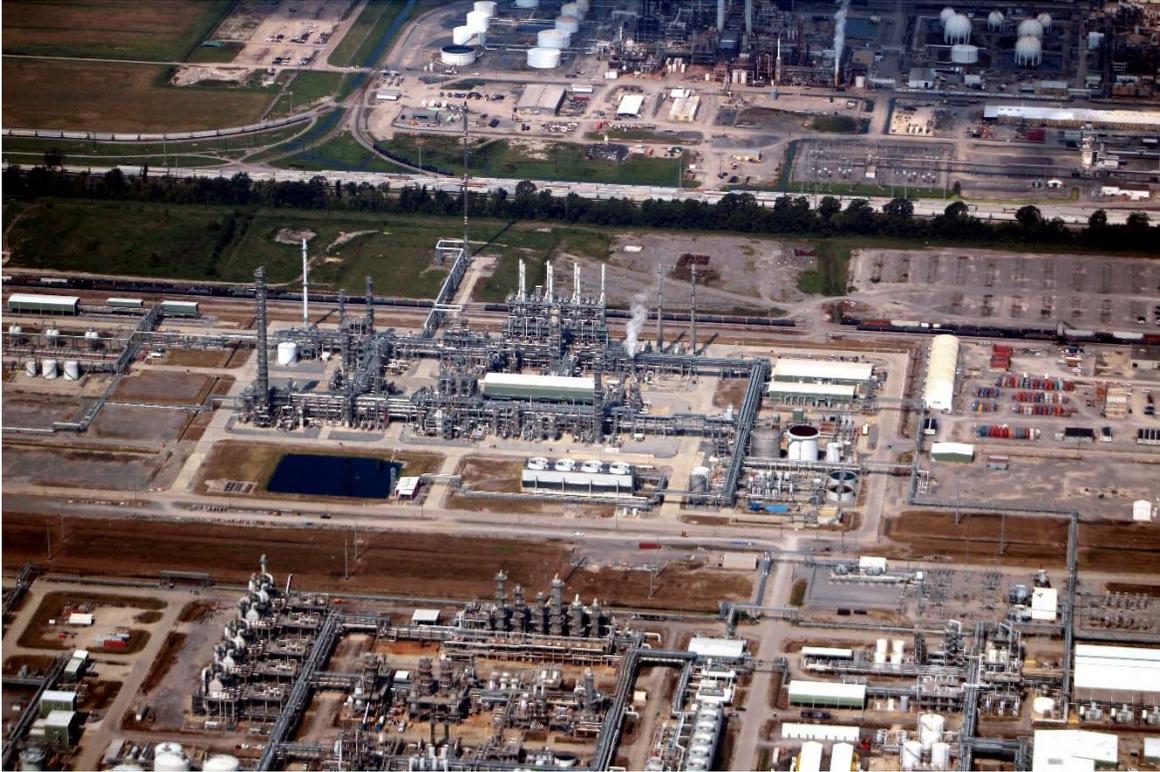
Syngenta Crop Protection facility. Figure 8 shows a representative oblique with evidence of plant activity due to the steam plume.

Figure 8. Oblique photo taken over the Shintech Facility as part of Flight 5, September 4, 2021
