# **Airborne Spectral Photometric Environmental Collection Technology**

## **ASPECT Air Quality Survey Hurricane Ida Baton Rouge, LA September 5, 2021**

# **ASPECT Air Quality Survey**

## **Hurricane IDA**

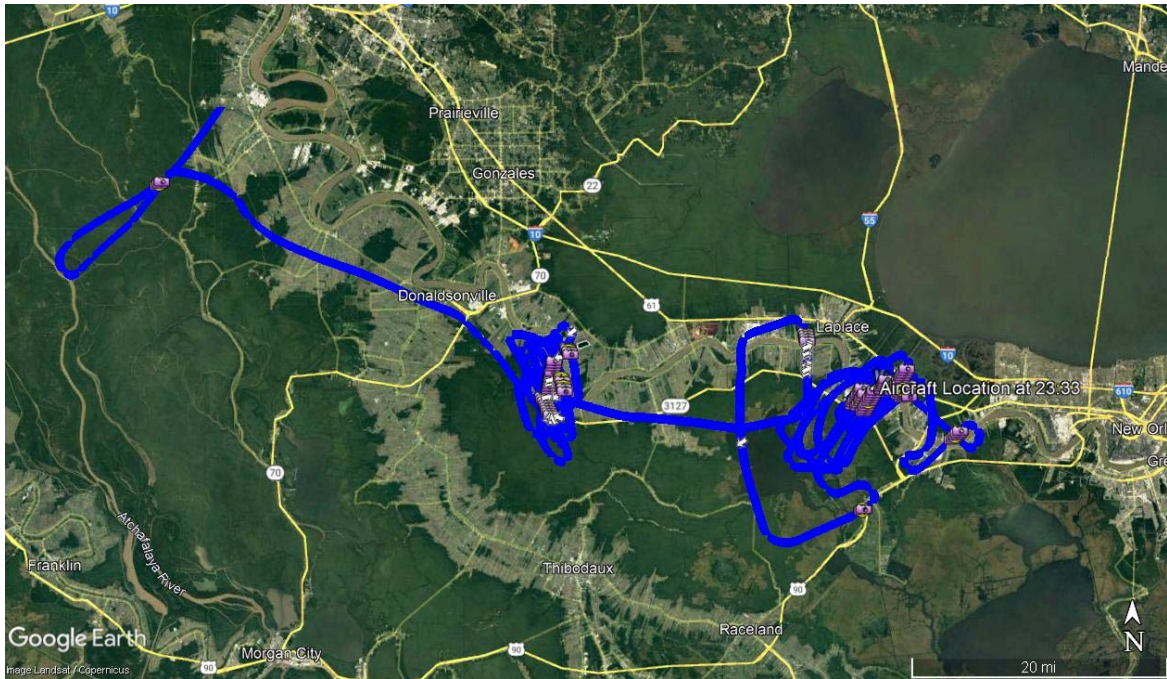
Figure 2. Data Collection Flight Path, St. Bernard, Terrebonne, St. Charles, and St. James, Flight 8, 5 September 2021

Wide, slow turns are required to be made in between runs to keep the instruments stable. The blue lines indicate the flight path while the green lines indicate the specific sections of the flight where chemical data was collected and processed. On Flight 7 the Houma and Louisiana coastline areas were surveyed, and on Flight 8 the St. Bernard, Terrebonne, St. Charles, and St. James areas were surveyed. The flight paths are shown in Figures 1 and 2.

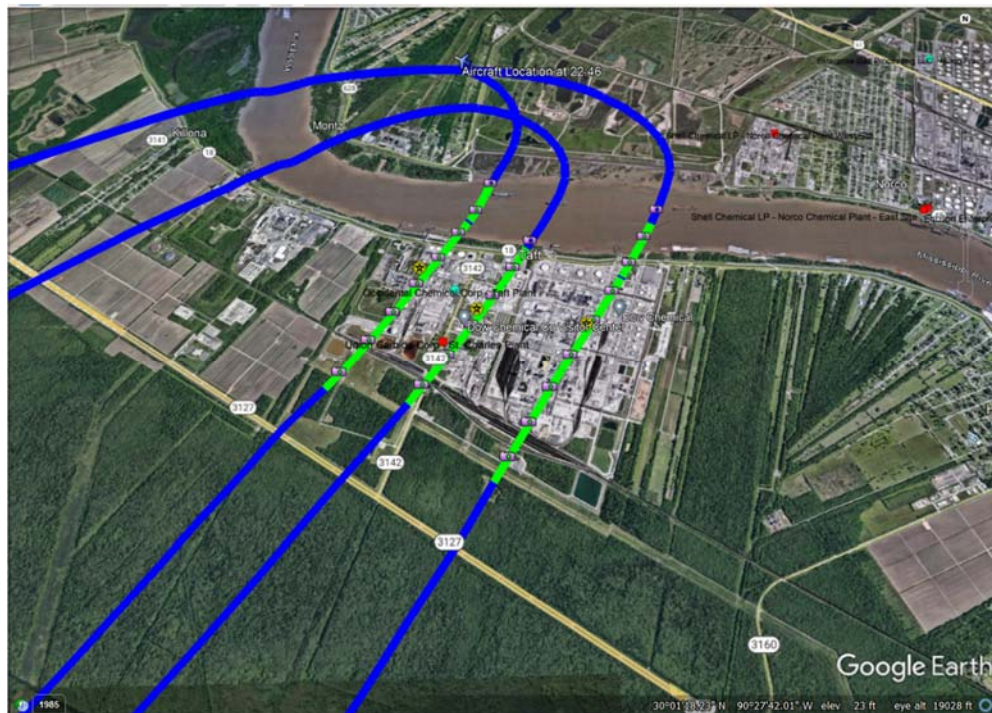
Figure 3 shows a closeup detail of a portion of the mission for Flight 8 showing the flight path of the aircraft, the locations of the aerial photos, the portion of the flight line in which the FTIR was active (green) and the center point of the IRLS image (star).

Figure 3. Detail of the Flight Path Data for Flight 8, September 5, 2021

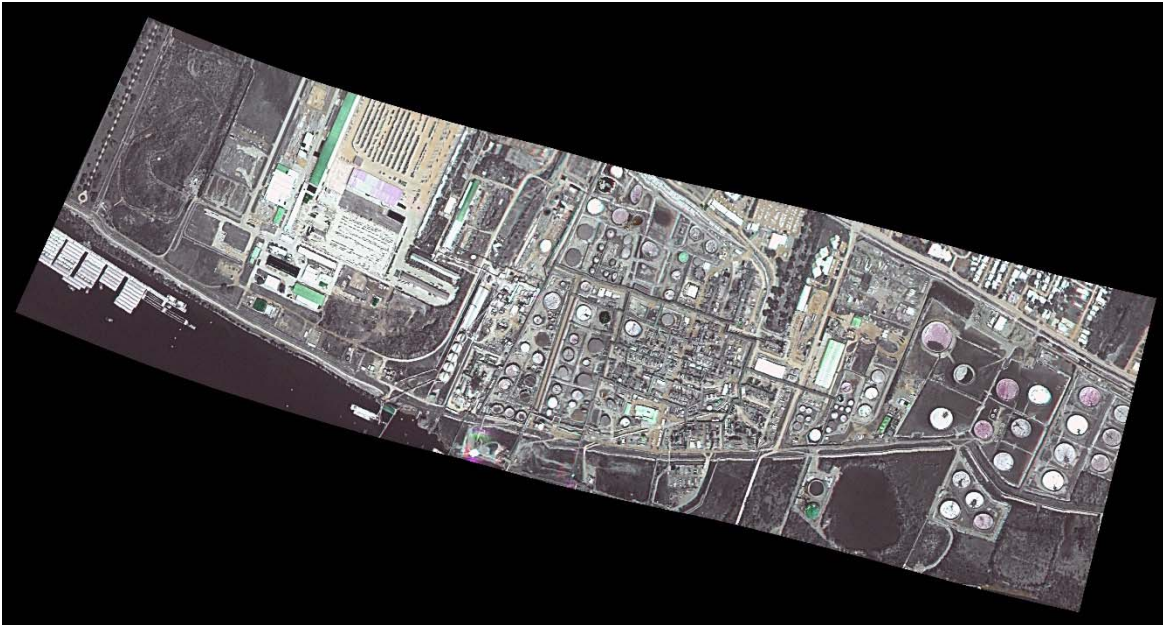
A total of 34 data collection runs were made over the target facilities and an infrared line scanner image was generated for each collection run. Figure 4 shows a 3-band infrared image collected over the Chalmette Refinery. Thermal analysis of the imaged tended to show little with exception of a flare on the bottom of the image. No discharges were observed being emitted from the facility. Figure 5 shows an ASPECT pattern recognition product for oil detection of a light sheen observed near Port Fourchon.

Figure 4. Three band IR image, New Orleans Area, Run 16, Flight 7, September 5, 2021

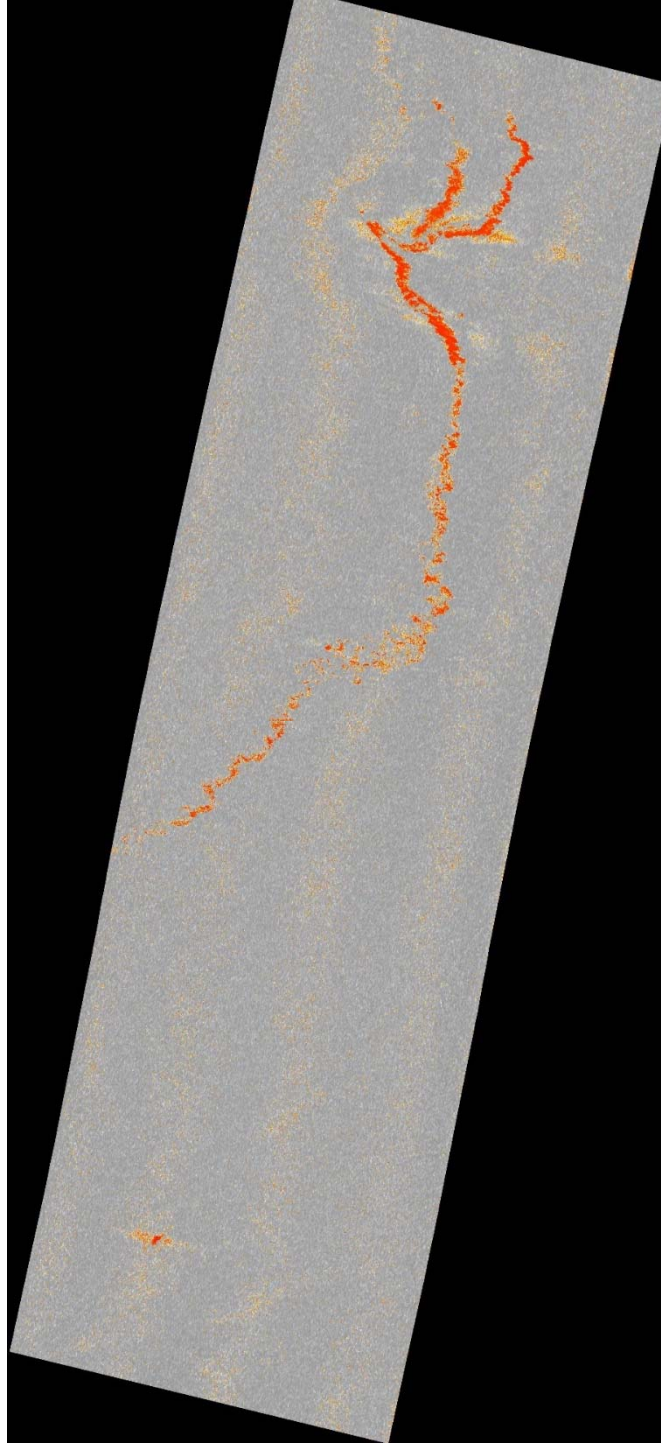
Figure 5. Pattern Recognition Oil Detection Near Port Fourchon Flight 7, September 5, 2021

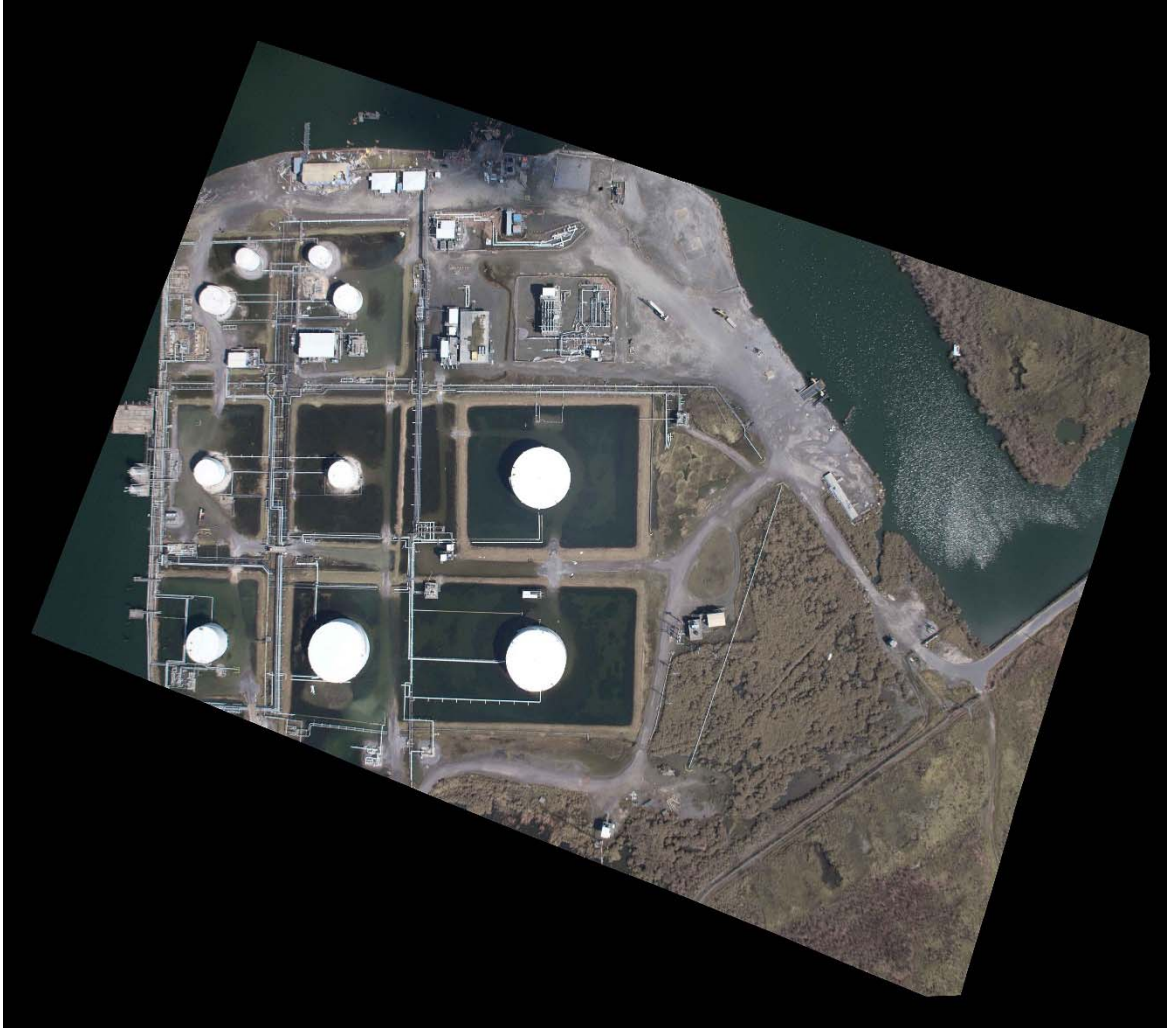
A full set of high-resolution aerial digital photography were collected as part of each data collection pass. Weather conditions over the survey had some low ceilings but a set of aerial images were collected at each location. Figures 6 shows a representative aerial image collected near Venice, LA. Standing water is present in the secondary containment. Figure 7 shows an oblique image of a damaged oil facility showing what appears to be product within the facility containment structure.

Figure 6. MSIC image of process unit/tank battery near Venice, LA, Flight 7, September 5, 2021

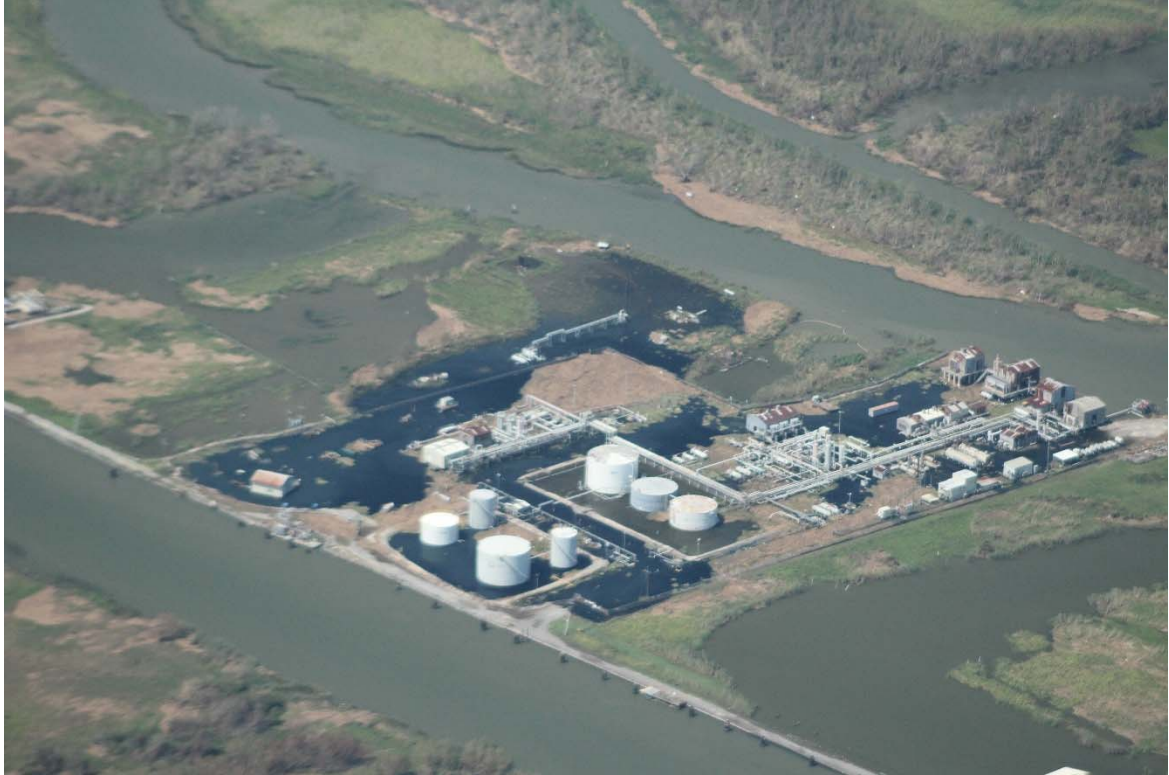
Figure 7. Oblique photo of a damaged oil facility, Flight 7, September 5, 2021
