EPA Emergency Response Site Update
Stillwater Train Derailment
June 26, 2023, Operation Period 3

Site Description

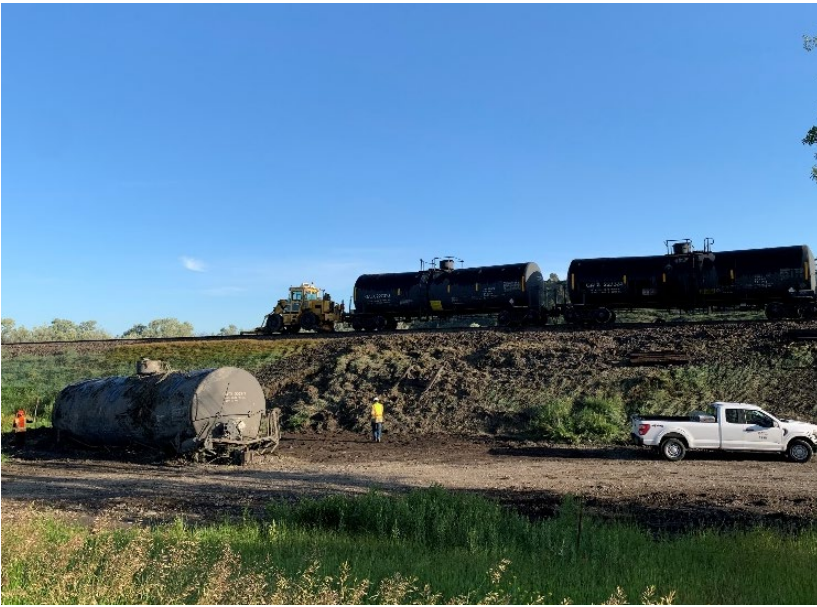
Photo of empty rail car that previously contained sodium hydrosulfide, bottom left, and the two new rail cars containing the sodium hydrosulfide.

- The contents of both railcars containing sodium hydrosulfide, that were located on the west side of the bridge, have been successfully transferred into stable railcars and moved to safety.
