EPA Emergency Response Site Update
Stillwater Train Derailment
June 30, 2023, Operation Period 7

Site Description

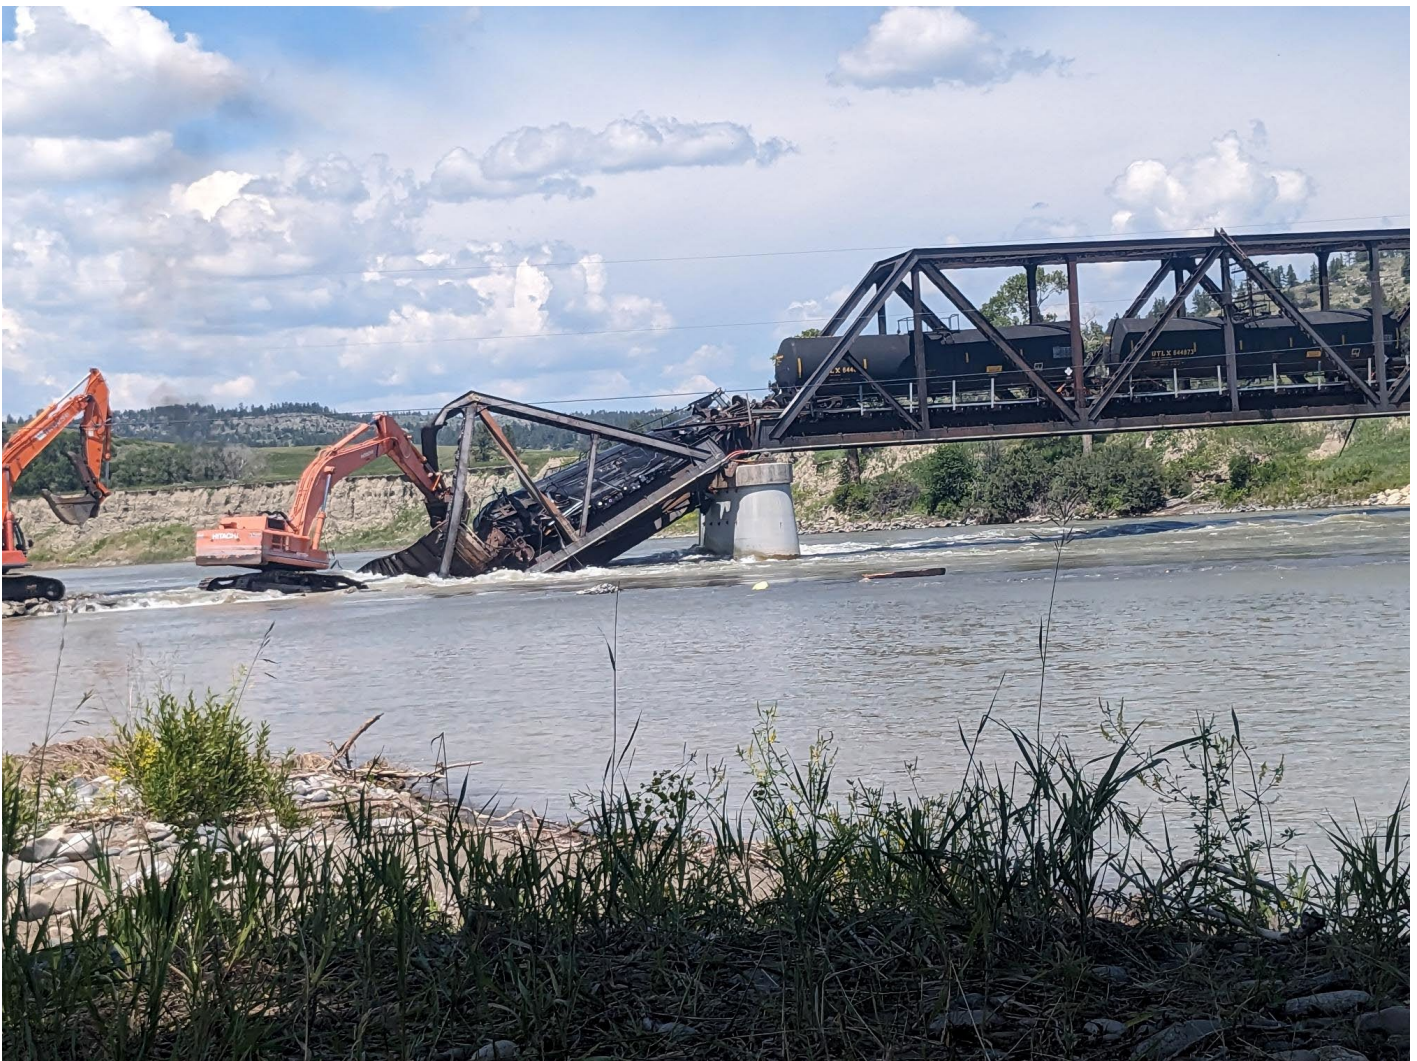
Construction crews work on removing liquid asphalt petroleum car that has been hanging off of the bridge since the derailment.

- Construction crews removed one rail car containing molten sulphur and portions of a rail car containing scrap metal from the river. One liquid asphalt petroleum car that was hanging off of the bridge was removed from the bridge and then removed from the water. Both removed rail cars were then transported to a temporary waiting area. One molten sulphur rail car and portions of the scrap metal car remain in the river. Three cars remain on the eastern portion of the track, awaiting transloading and removal.
- Crews segmented and removed portions of the bridge that were in the river and temporarily placed them on the west riverbank.

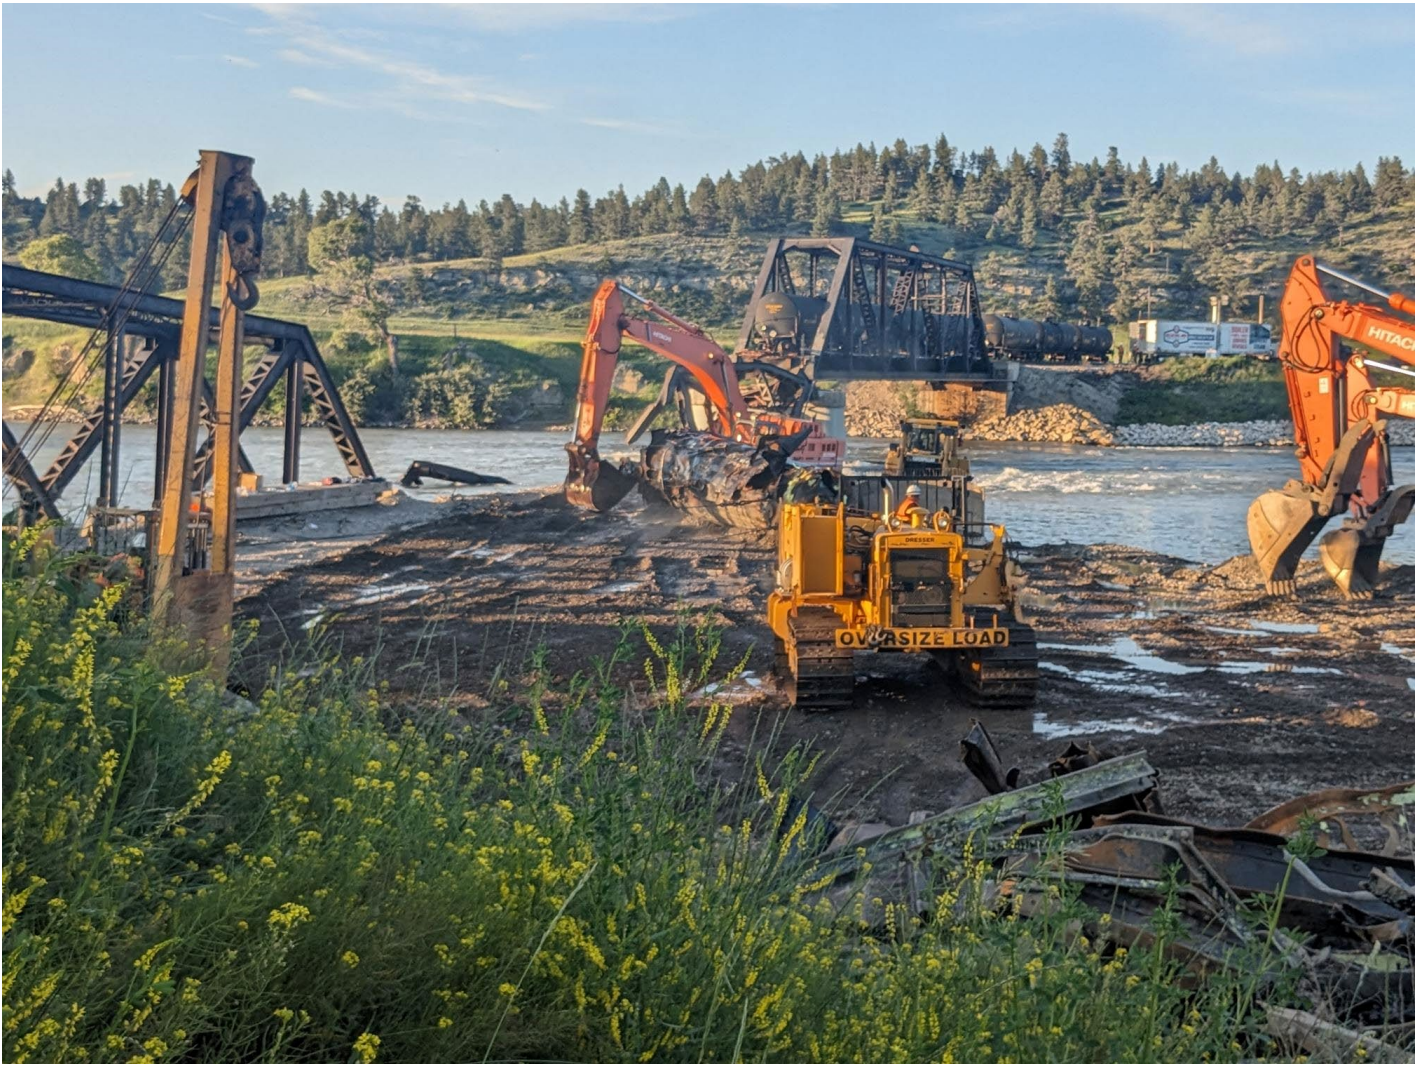
Construction crews pull a molten sulphur rail car onto the shore.
