Site Update Silver Dyke Adit and Drainage Site

Operational Period 5

August 14 - 20, 2023

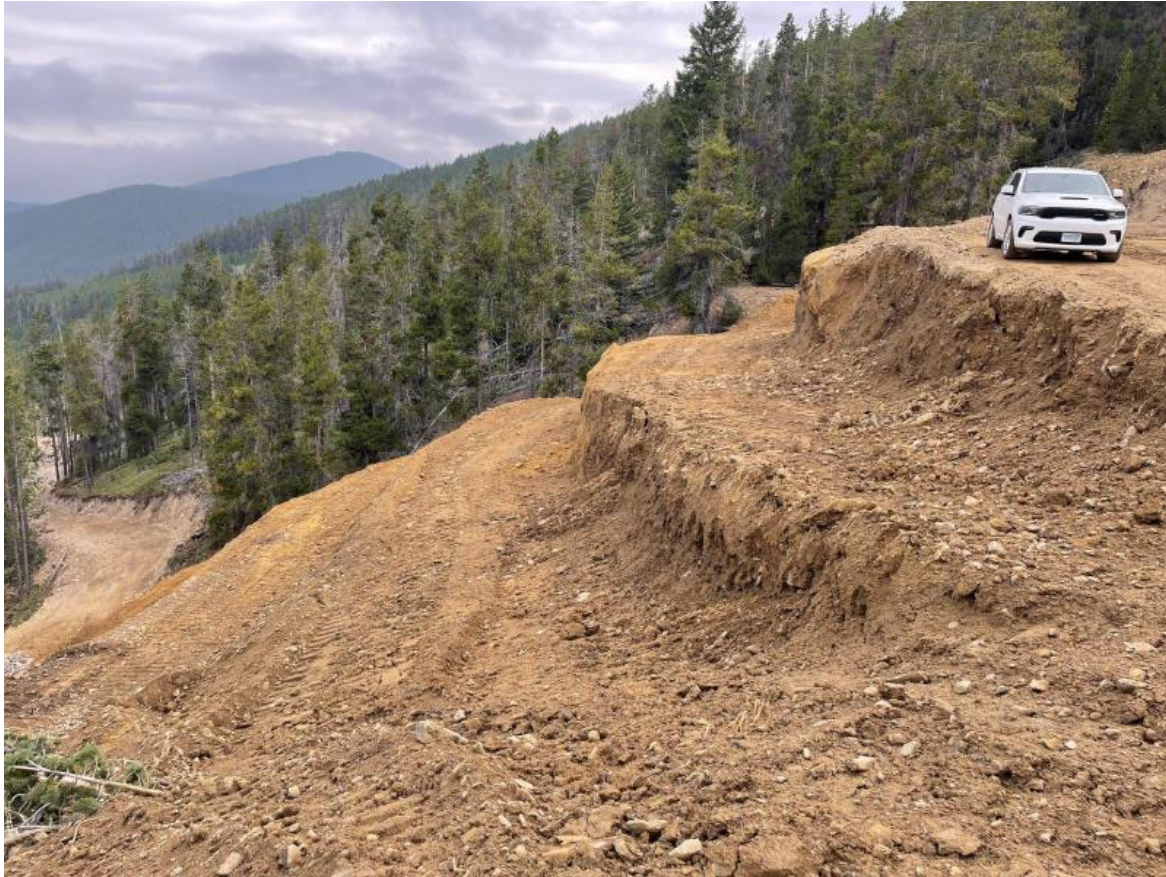
Erosion benches above the adit.

1. Another bench was cut into the slope above the adit. All benches are being reshaped and will be eventually capped and reseeded. The drainage of this slope is being improved to move runoff away from the adit.

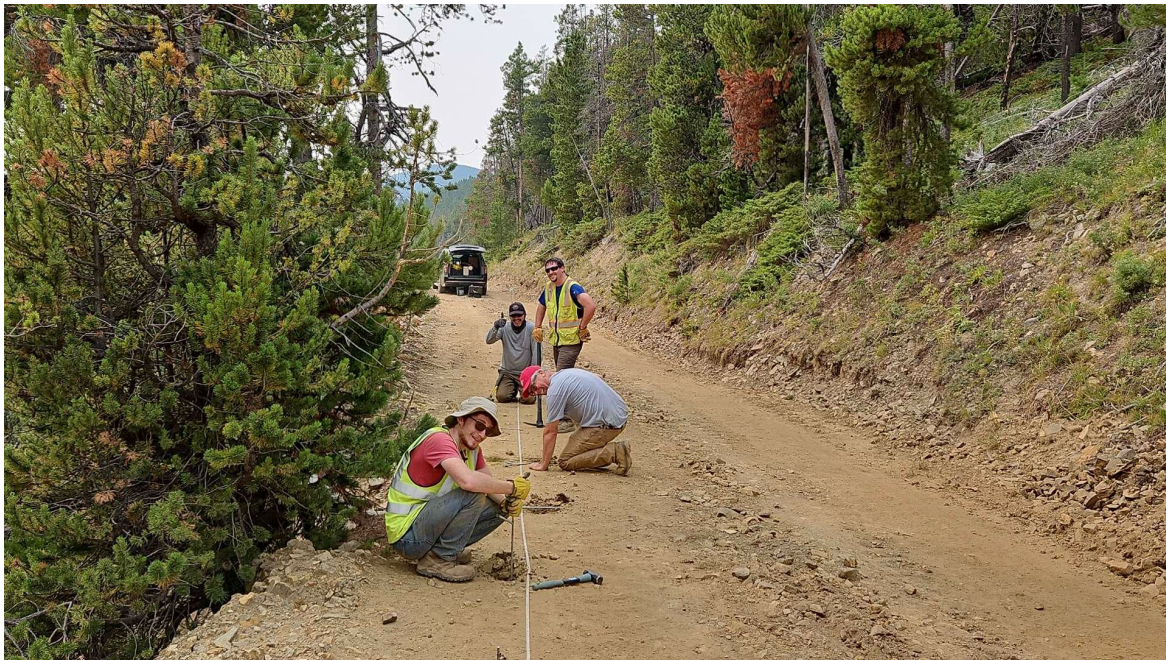
Geophysical survey work.

4. Electrical Resistivity Tomography (ERT) and Electromagnetic (EM) Digital Geophysical Mapping Surveys were conducted during this Operations Period in an effort to locate the adit so that a well can be drilled into it. Historic mining maps were used to establish three separate survey transects. Preliminary data indicates that the location of the adit was detected on one of the three transects (the transect closest to the adit). The adit's location must be detected on two of the transects to create a line which indicates the adit's direction. The data is continuing to be processed.

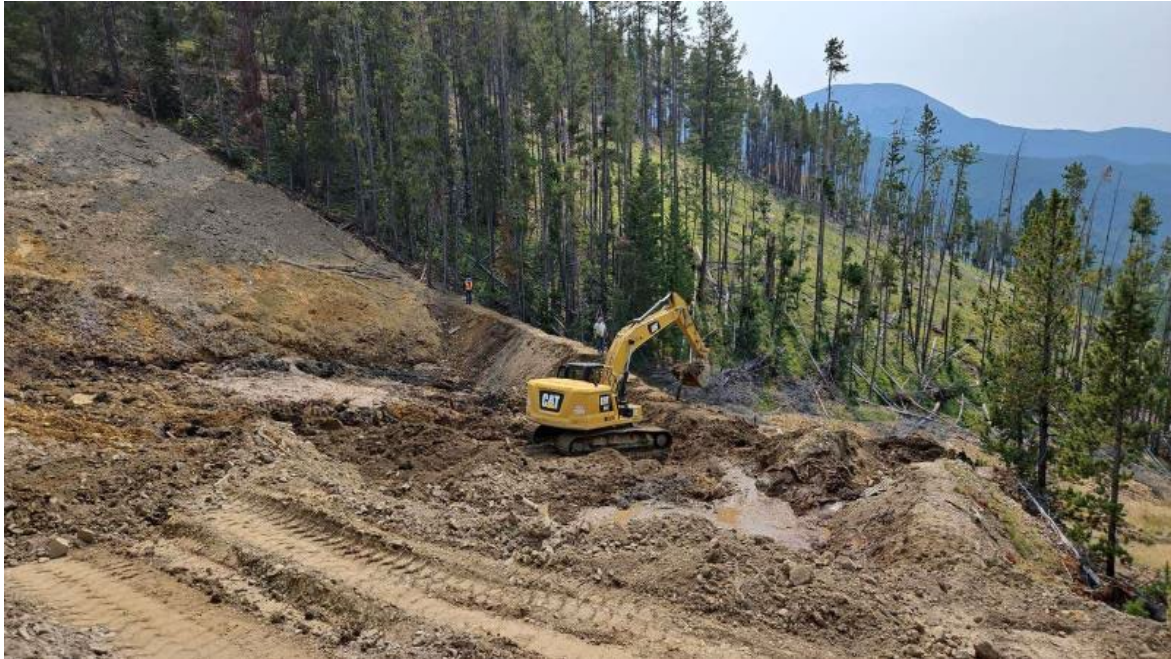
Containment pond berm construction.

2. A large water management pond was constructed below the road that passes the adit to support the eventual opening of the adit. Approximately 450 yds³ of waste rock was moved from this area to the Glory Hole to make room for the pond (9,270 yds³ of waste rock has been moved to date). A large berm was then constructed across the adit's drainage using native soil cover trucked in from surrounding areas. A culvert and spillway were installed in the resulting water management pond to control the flow of water when the adit is opened.

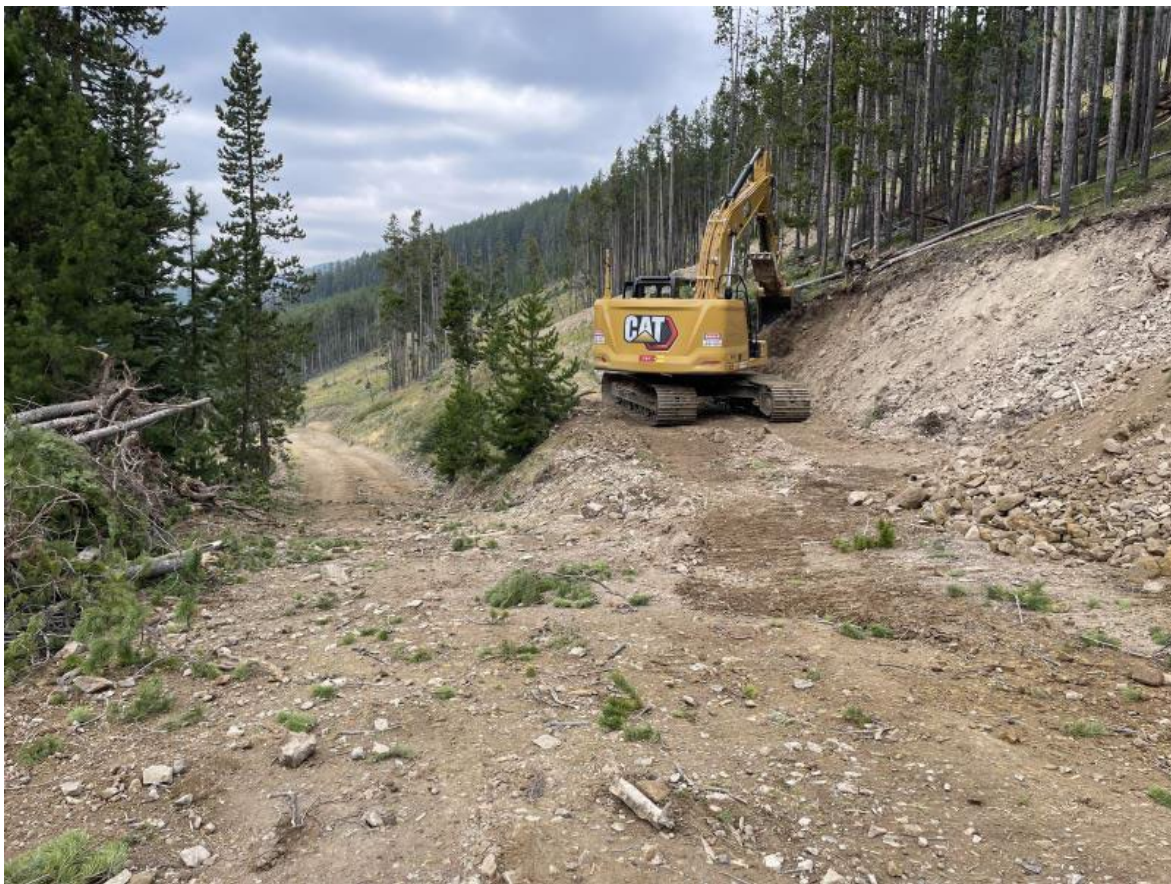
Drill rig access work.
