# Site Update

## Silver Dyke Adit and Drainage Site

### Operational Period 6

August 21 - 27, 2023

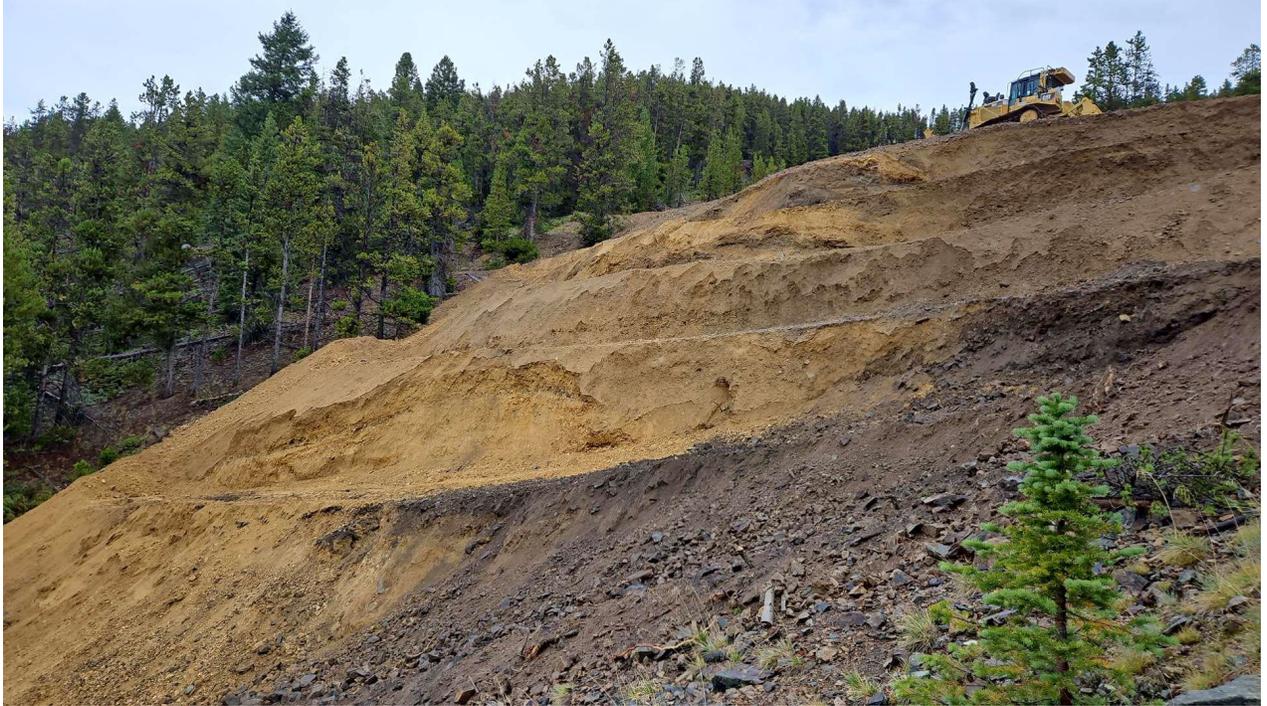
Erosion benches above the adit.

1. The final bench configuration and grading has been completed on the slope above the adit. Crews began cutting and rocking the drainage channels on the upper section. In addition, woody debris was embedded along the upper slope to provide for protection against erosion, and a soil cover was placed over the upper portion of the slope.

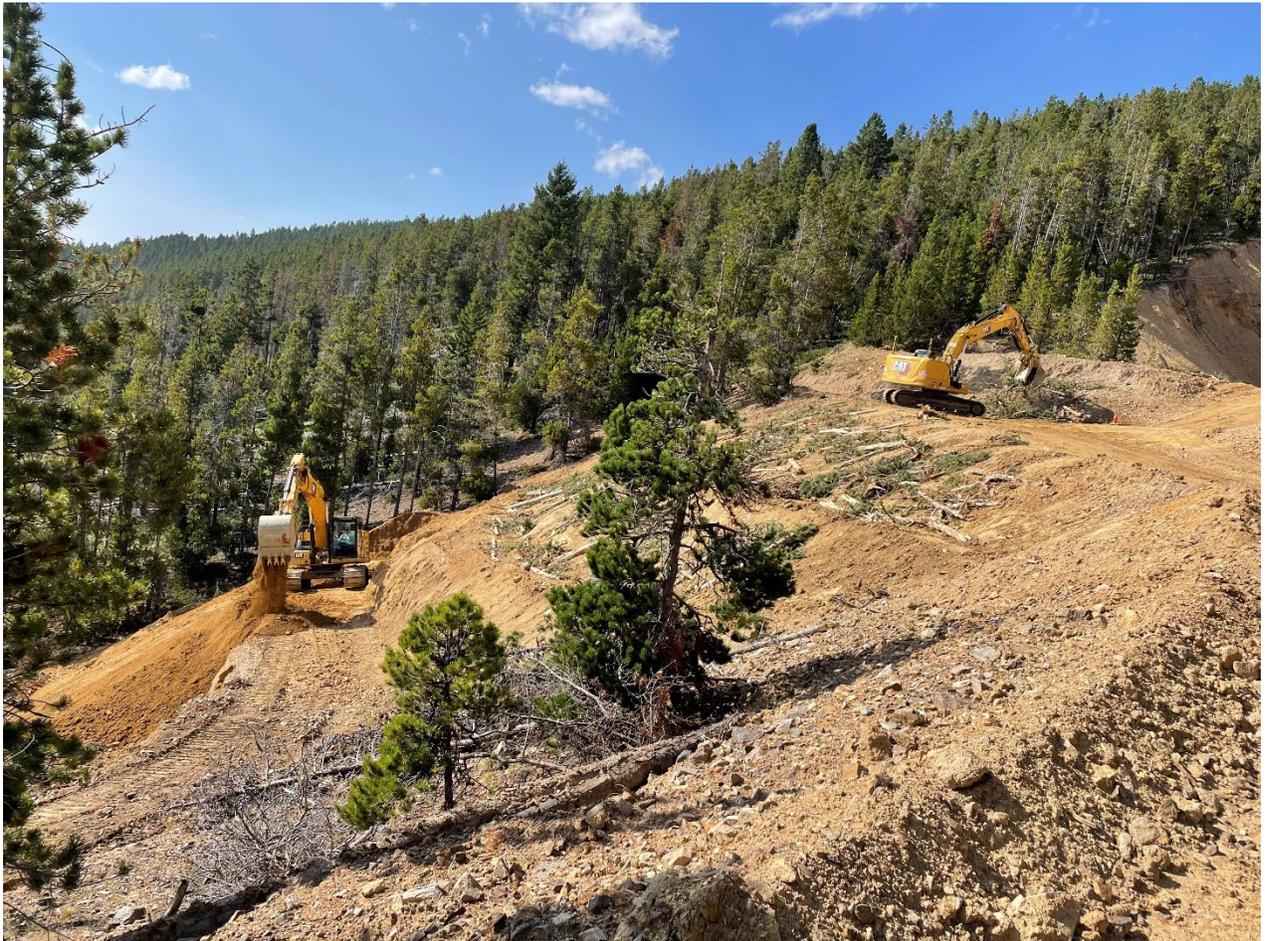
Erosion work above the adit.

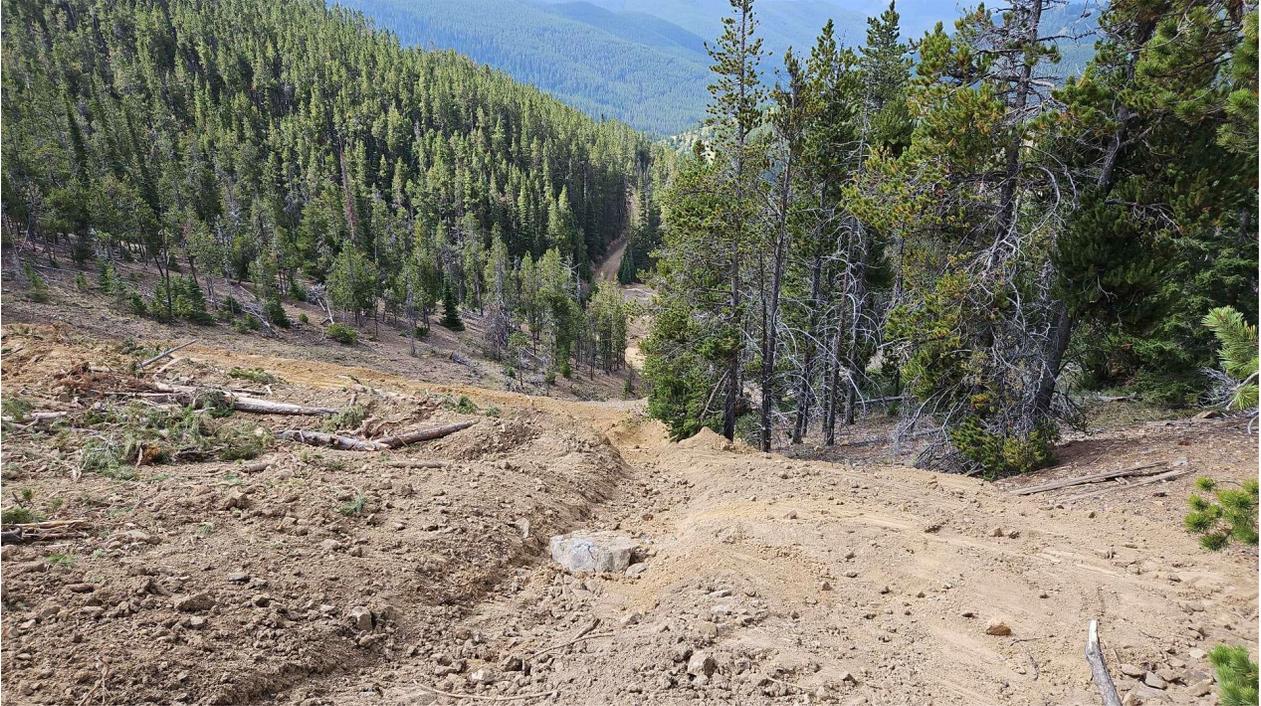
Channel along West side of benches above adit to divert surface water runoff away from adit. Channel will eventually be lined with rip-rap.

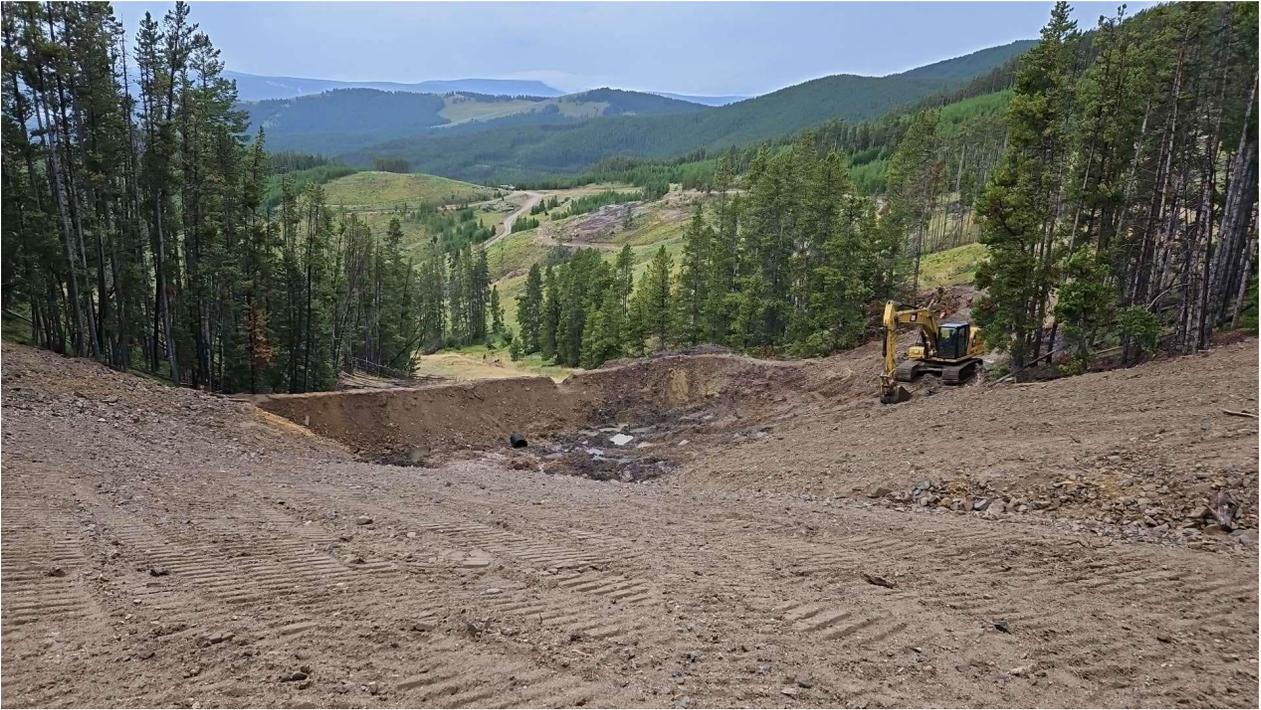
Lower containment pond.

2. The lower containment pond was given its final grading and a spillway completed. This pond has a capacity of approximately 200,000 gallons. Work on the pond immediately adjacent to the adit portal was begun. However, this work was paused as the crew was needed to repair two culverts that handle adit drainage and the flow in Sih-men Creek that had been damaged by heavy rain. These repairs were completed and work on the upper pond will resume on August 28<sup>th</sup>.
