# Site Update

## Silver Dyke Adit and Drainage Site

### Operational Period 7

August 28 – September 3, 2023

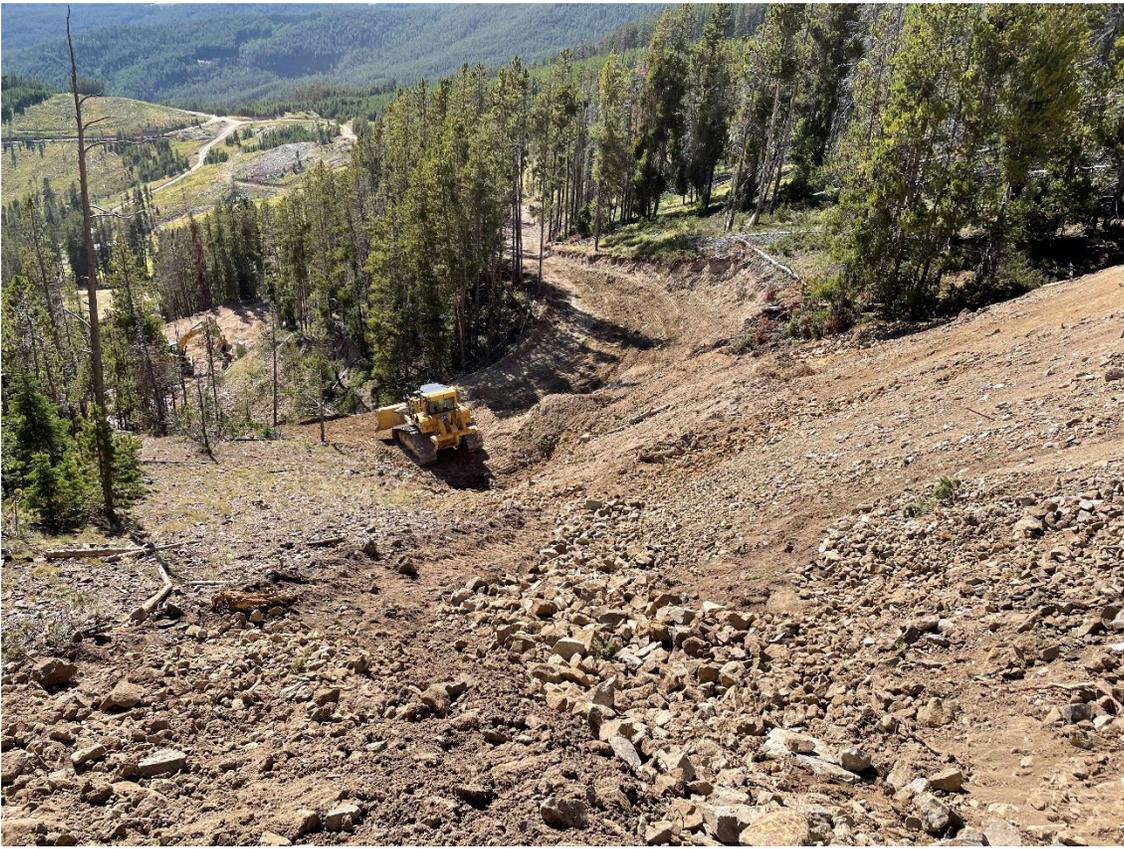
Work on drill pad.

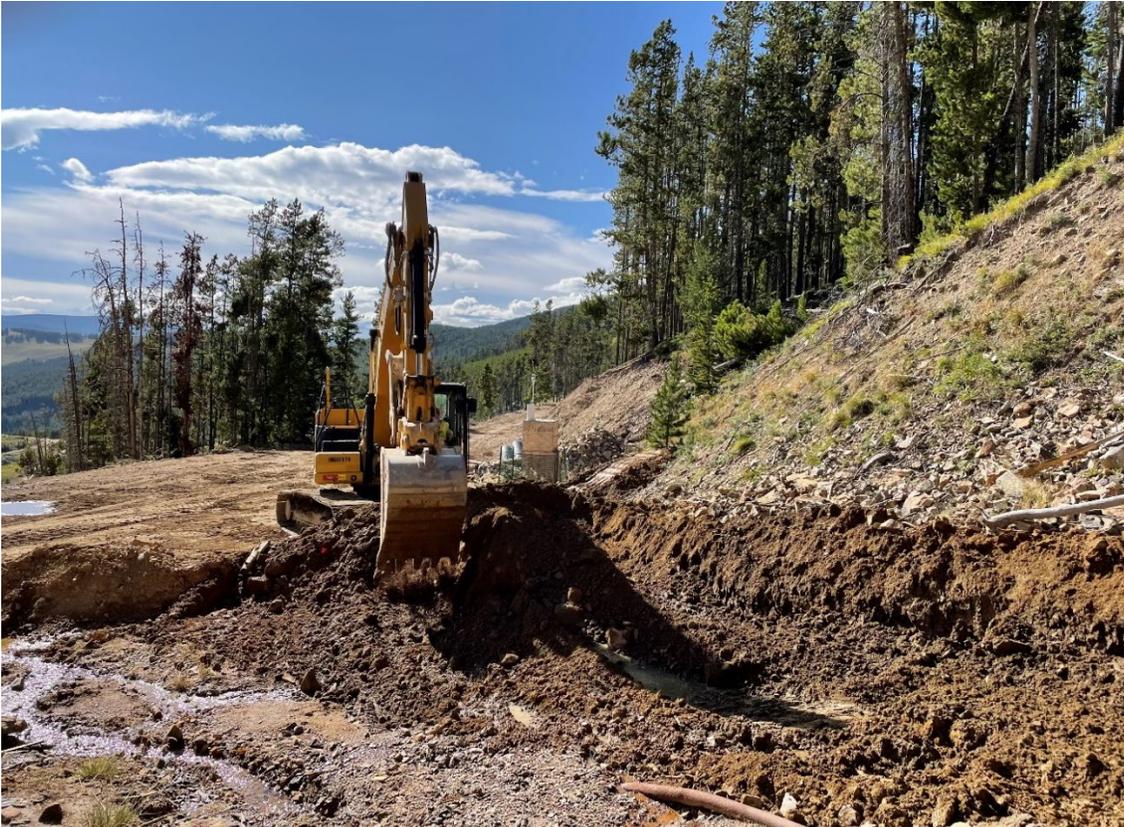
Work on the upper containment pond.

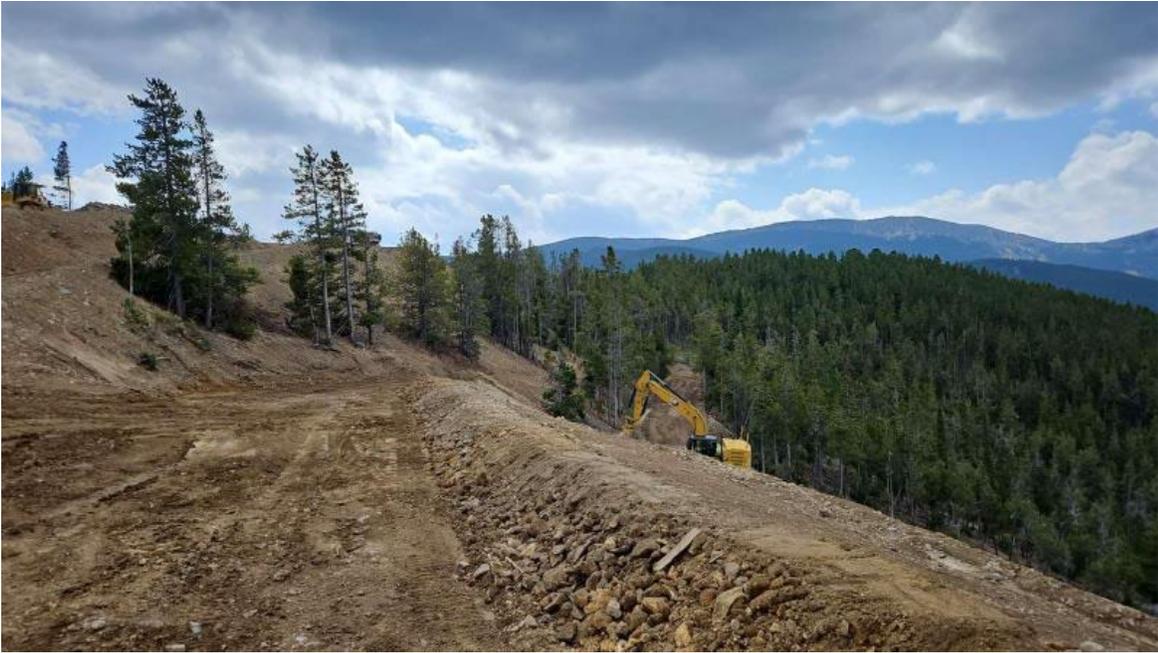
Completed berm above benches.

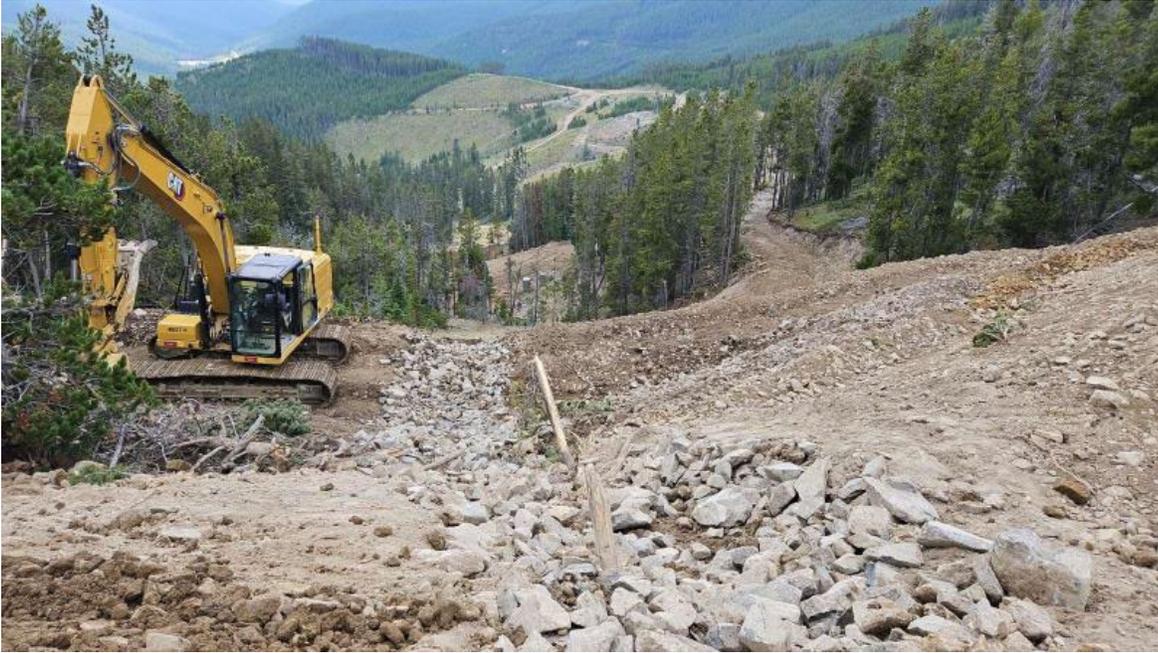
Rock-lined channel on East side of benches.
