# Lane Plating Removal Action

## Perimeter Air Monitoring Daily Report (6/2/2023)

### For Location LP-1

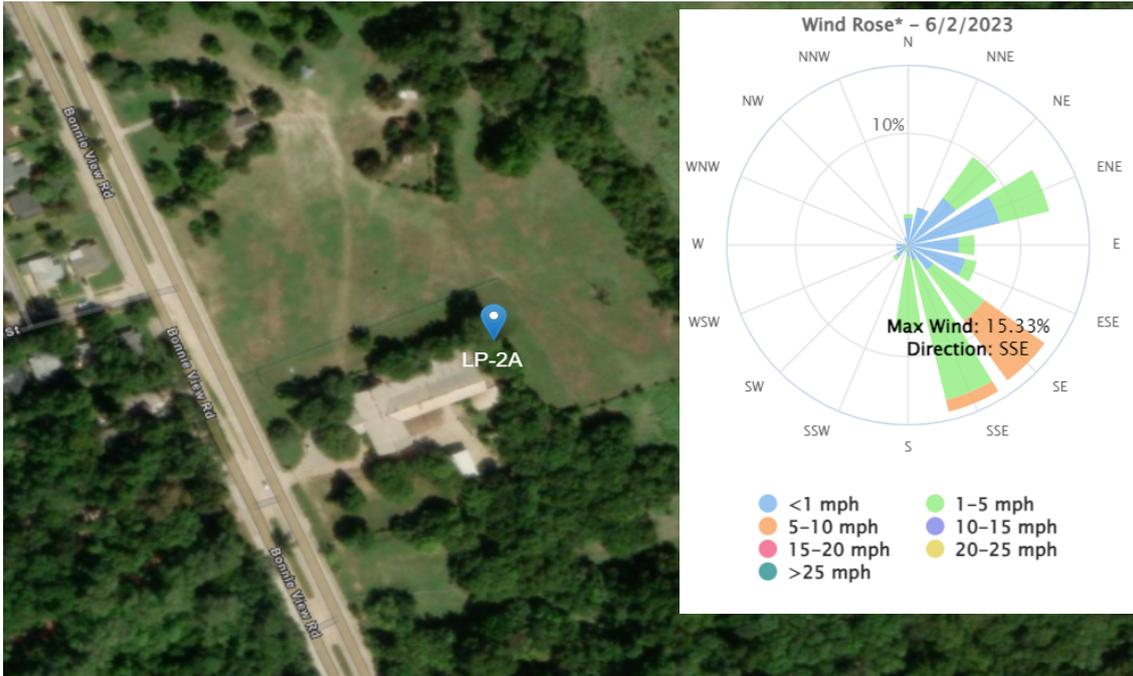
### For Location LP-2

To better understand in what direction and how strong the wind is blowing at the Lane Plating Site, please see the Wind Rose (shown in the top righthand corner of the map). A Wind Rose is a vivid chart showing the wind's direction, its frequency, and its speed at a specific location. A Wind Rose shows the direction of the wind by the length of the "bars" or "petals." A day with consistent wind directions will have one or two long petals. A day with different wind directions will have many shorter similar-length petals. For instance, a day with one long petal pointing north (N) means that winds mainly blew from the north in a southerly direction. The Wind Rose also shows a percentage (%) of time during which the wind blew in one direction or another.

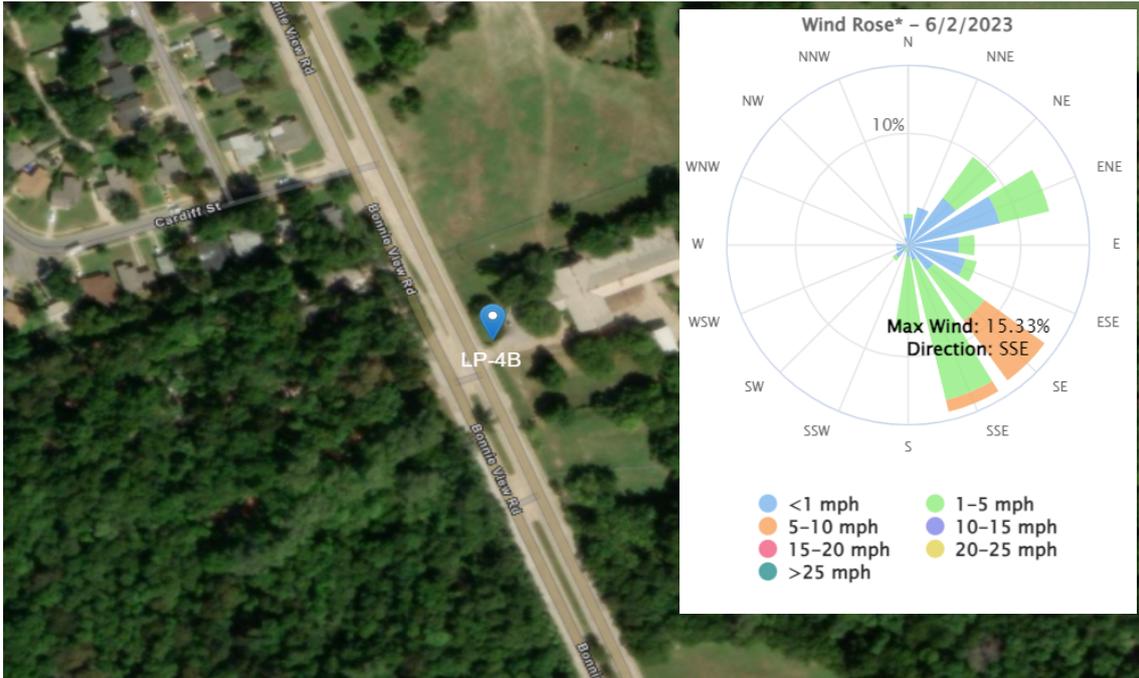
### For Location LP-4

To better understand in what direction and how strong the wind is blowing at the Lane Plating Site, please see the Wind Rose (shown in the top righthand corner of the map). A Wind Rose is a vivid chart showing the wind's direction, its frequency, and its speed at a specific location. A Wind Rose shows the direction of the wind by the length of the "bars" or "petals." A day with consistent wind directions will have one or two long petals. A day with different wind directions will have many shorter similar-length petals. For instance, a day with one long petal pointing north (N) means that winds mainly blew from the north in a southerly direction. The Wind Rose also shows a percentage (%) of time during which the wind blew in one direction or another.
