## **EPA and EGLE Update: Pilot Diesel Spill, Ottawa Lake, MI**

*This document provides daily on-site activities in response to the Pilot diesel spill in Ottawa Lake, Michigan.*

**Wednesday, April 10, 2024**

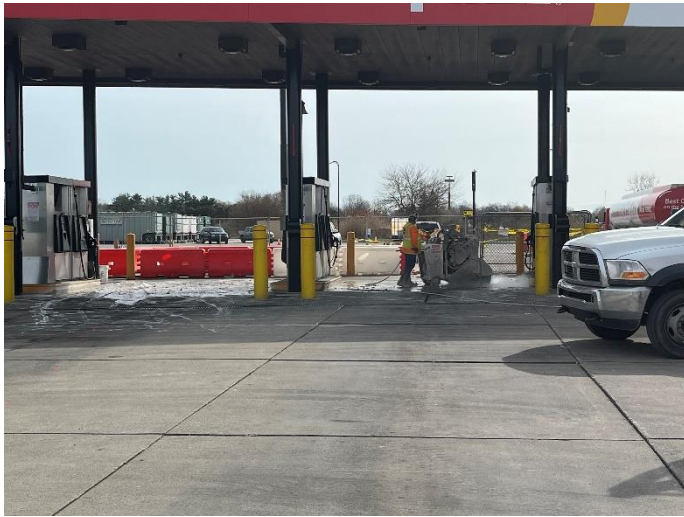
Duffey conducting concrete cutting activities at diesel pumps island

- Pilot began the initial stages of disassembly of the diesel pumps island at the parking lot north of the station. Activities included cutting concrete and disassembly of fuel pumps.

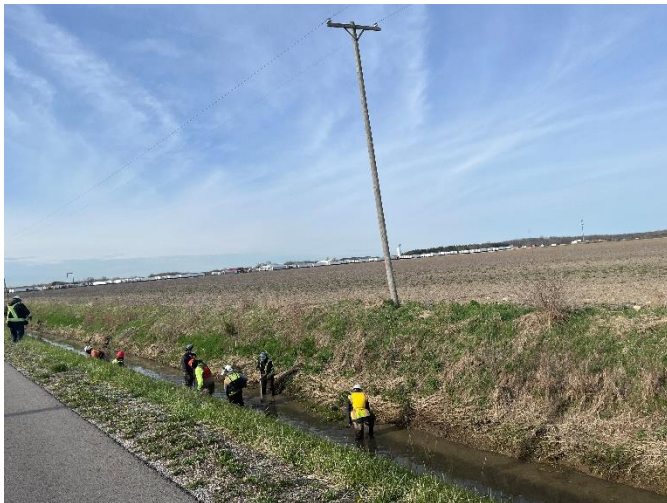
Vegetation clearing continues along Tenmile Creek south of Jeffs Doty Road

- Contaminated vegetation removal continues along North Tenmile Creek and in the on-site retention/environmental control pond.
- The on-site subsurface investigation is ongoing to determine the extent of contamination, which includes collection of soil samples, groundwater samples, and installation of recovery wells where product is encountered.
