Site Name: Historic Potteries RV2 Site

Title: Historic Potteries RV2 Site, Administrative Record Index of Documents

Title: Confirmation of Verbal Authorization for a Comprehensive Environmental Response, Compensation and Liability Act (CERCLA) Emergency Removal Action at the Historic Potteries (RV2) Site, Trenton, Mercer County, New Jersey

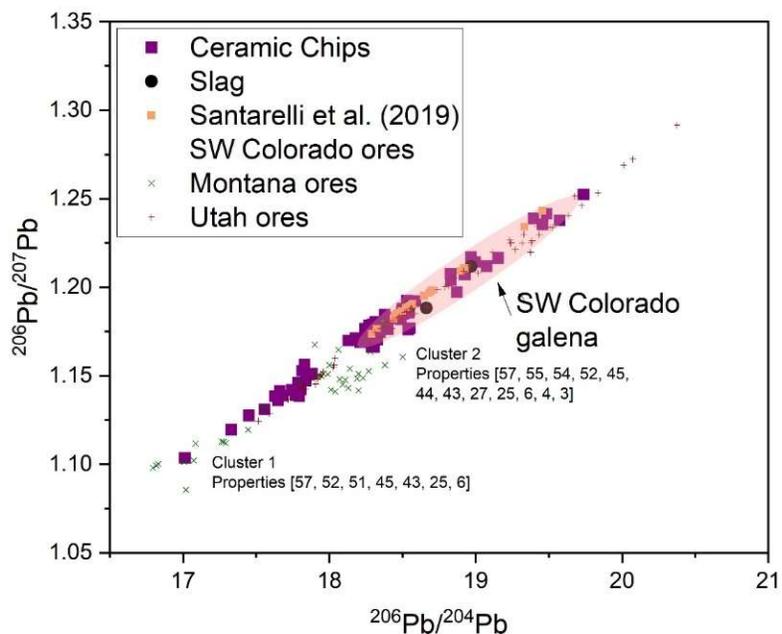
Figure 1. Pb isotope data for ceramic chips collected from the Historic Potteries site (East Trenton, NJ; purple squares). Pb isotope data for ores in Colorado, Montana, and Utah are taken from the literature.

Pb isotope ratios of ceramic chips fall within two separate clusters, labeled Cluster 1 and Cluster 2 on Figure 1. These separate clusters indicate that multiple sources of Pb were used to produce ceramic glaze in the historic Trenton potteries industry. Chip Cluster 2 Pb isotope ratios match with lead ores from SW Colorado, consistent with historical reports and literature references [13-15]. Chip Cluster 1 Pb isotope ratios overlap with ores from Colorado, Utah, and Montana. Cluster 1 chips are less radiogenic (i.e., lower $^{206}\text{Pb}/^{204}\text{Pb}$) compared to Cluster 2 chips. The Pb isotopic compositions of the ceramic chips serve as a point of reference to compare with the Pb isotope signature determined in soils and other potential Pb sources.

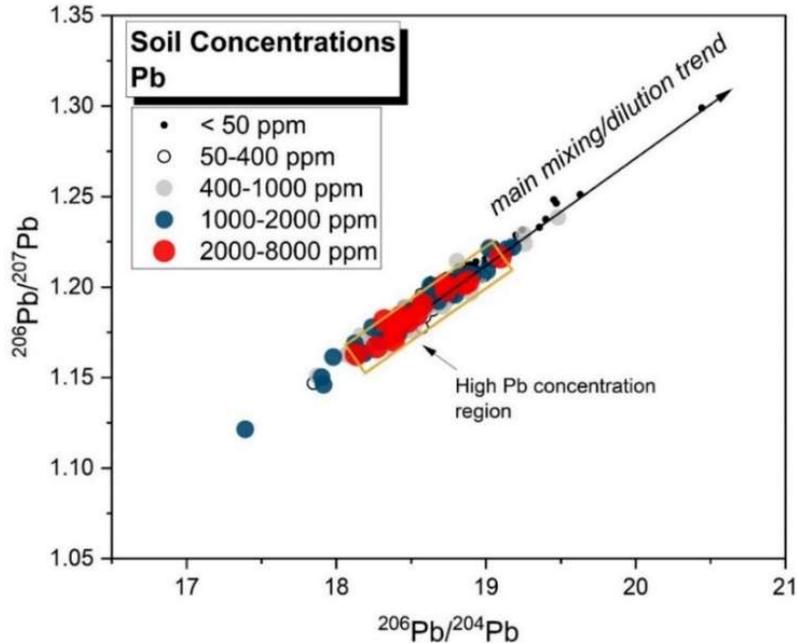
Figure 2. Pb isotope data for soils collected from the Historic Potteries site; plotting symbols represent the Pb concentration.

Figure 2 summarizes soil Pb isotope data, again using a $^{206}\text{Pb}/^{204}\text{Pb}$ versus $^{206}\text{Pb}/^{207}\text{Pb}$ plot. The plot also groups the isotopic data into 5 concentration ranges. Soils with $\text{Pb} > 2,000$ mg/kg show a range of Pb isotope ratios, e.g., $^{206}\text{Pb}/^{204}\text{Pb}$ from ~18.1 – 19.1. This indicates that there is heterogeneity in Pb sources to the sampled properties, i.e., the high Pb concentrations are made up from multiple sources, or from a single product that had an isotope signature that changed over time, for example, a changing isotopic signature of a product could result from a switch in the raw ore material used in a manufacturing process. The highest Pb concentrations ($\text{Pb} > 2,000$ mg/kg) are mainly from properties P041 (yard soil), P043 (park soil; high ceramic chip count), P046 (yard soil), P055 (railway), P056, and P057 (former potteries).

Note that properties P050 and P051 are excluded from this analysis. The former smelter (P050) and adjacent property (P051) have high soil Pb concentrations with distinctive Pb isotope signatures that are unrelated to the isotopic signatures observed in the residential soils of East Trenton. Residential soils with lower Pb concentrations tend to be more radiogenic, i.e., higher ratios of $^{206}\text{Pb}/^{204}\text{Pb}$, $^{207}\text{Pb}/^{204}\text{Pb}$, and $^{208}\text{Pb}/^{204}\text{Pb}$. These lower concentration soils tend to plot on the upper righthand portion of the data trend shown in Figure 2 and they can be considered to represent a dilute endmember composition and isotopic signature. Similarly, soils collected at deeper intervals (>1-2 ft) tend to have lower Pb concentrations with more radiogenic isotopic signatures; thus, radiogenic composition and low Pb concentration are diagnostic of the natural (geogenic) Pb signature in this area. As a point of reference, Ma et al. [16] reported low concentration soils with radiogenic isotopic signatures as being representative of pre-industrial soils from central Pennsylvania. Ault et al. [17] made a similar observation in a region of New Jersey just to the northeast of East Trenton; low concentration soils reflective of native conditions ($\text{Pb} < 20 \text{ mg/kg}$) were noted to have a radiogenic isotopic signature ($^{206}\text{Pb}/^{204}\text{Pb}$ values up to 19.6).

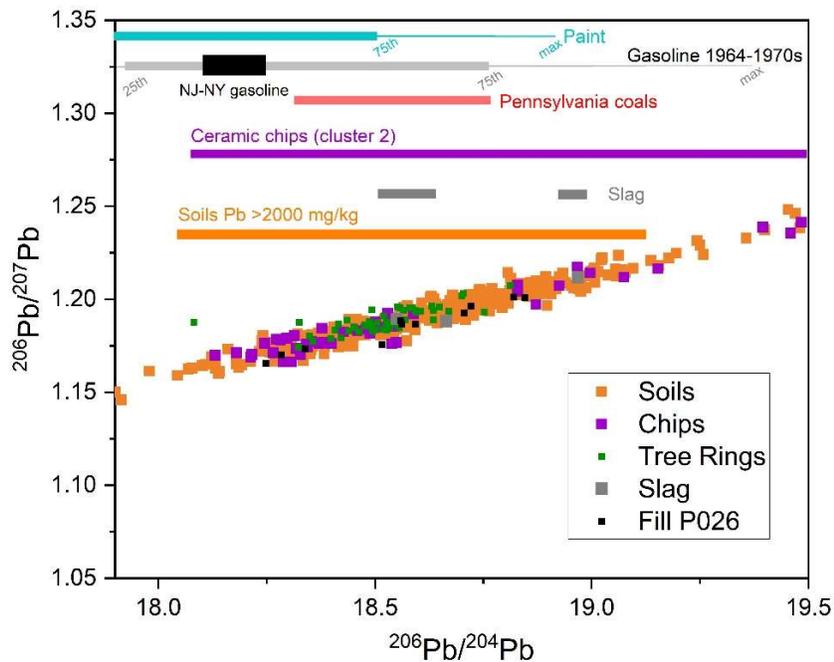
Figure 3. Pb isotope data for a focused isotopic region including >95% of the soil data. The plot shows the overlap between the soil Pb data and ceramic chip Pb as well as Pb from gasoline, coal and paint.

Figure 3 shows Pb isotope data for multiple sample types, including soils, ceramic chips, and tree ring digestates. The plot also shows the ranges of $^{206}\text{Pb}/^{204}\text{Pb}$ in potential urban sources of Pb. The data trends indicate that leaded gasoline, coal combustion products, industrial products,

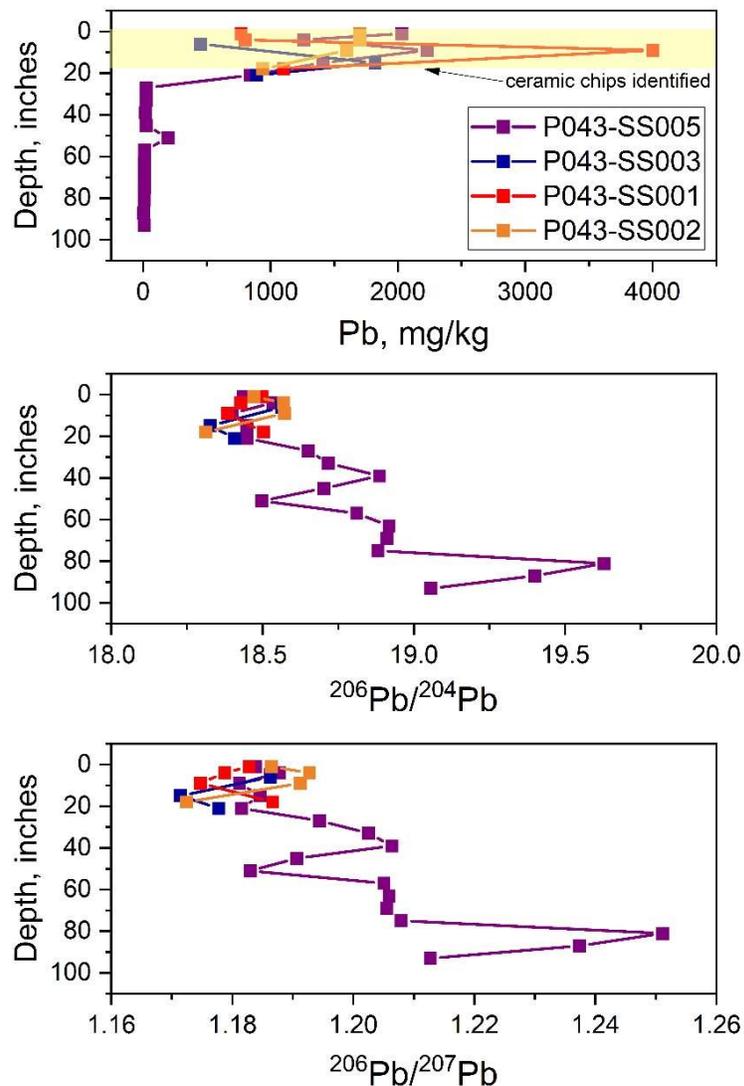
Figure 4. Soil Pb concentrations and isotopic compositions ($^{206}\text{Pb}/^{204}\text{Pb}$ and $^{206}\text{Pb}/^{207}\text{Pb}$) with depth for property HP001-P043 (park located amongst residential properties).

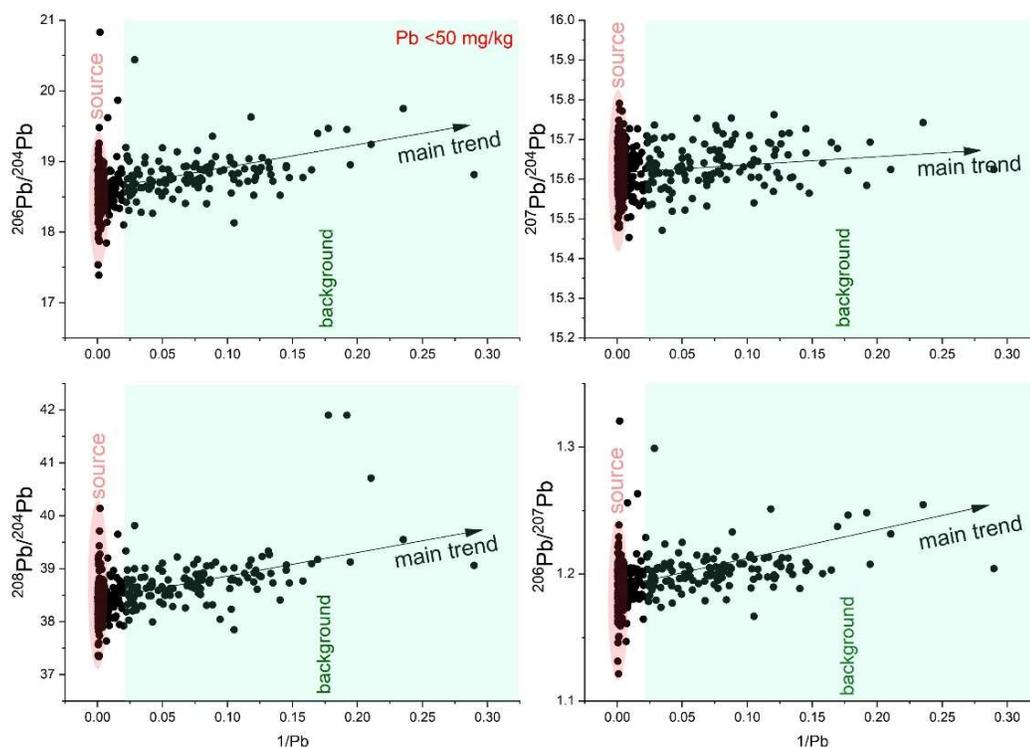
Figure 5. Isotopic ratio of Pb vs $1/\text{Pb}$ in soil samples. The green shaded region represents soil Pb concentrations < 50 mg/kg. The pink-shaded ovals represent the isotopic variability at the highest levels of soil Pb.

A common method for using Pb isotope data for source attribution utilizes the equation: $(^{206}\text{Pb}/^{204}\text{Pb})_{\text{mixture}} = (a/\text{Pb}_{\text{mixture}}) + b$, where a and b are constants that specify concentrations of Pb and $^{206}\text{Pb}/^{204}\text{Pb}$ of end member components in a binary mix. Thus, plotting $1/\text{Pb}$ versus $^{206}\text{Pb}/^{204}\text{Pb}$ (or any other Pb isotope ratio) can be useful in fitting Pb isotope data. Figure 5 shows plots of $1/\text{Pb}$ versus different isotopic ratios of Pb. In all cases, with increasing $1/\text{Pb}$ (decreasing Pb concentration), Pb isotope ratios become more radiogenic, i.e., ratios shift to higher levels of ^{206}Pb , ^{207}Pb , and ^{208}Pb relative to ^{204}Pb . Notice that the green shaded field shows Pb concentrations <50 mg/kg; this concentration range would normally be viewed as representing unimpacted soils. However, the data trend indicates continuous mixing to the lowest Pb concentrations observed. The other key observation from Figure 5 is that as $1/\text{Pb}$ approaches 0 (the highest Pb concentrations, typically representative of Pb contamination sources), isotopically variability is wide. In the simplest case where a single source of Pb was

released to the environment, the isotopic ratio on the y-axis intercept would represent the isotopic ratio in the source material. The isotopic variability (pink oval) along the y-axis at $1/\text{Pb} < 0.0025$ indicates that multiple Pb sources were present or that the main contributing source of Pb was isotopically heterogeneous.

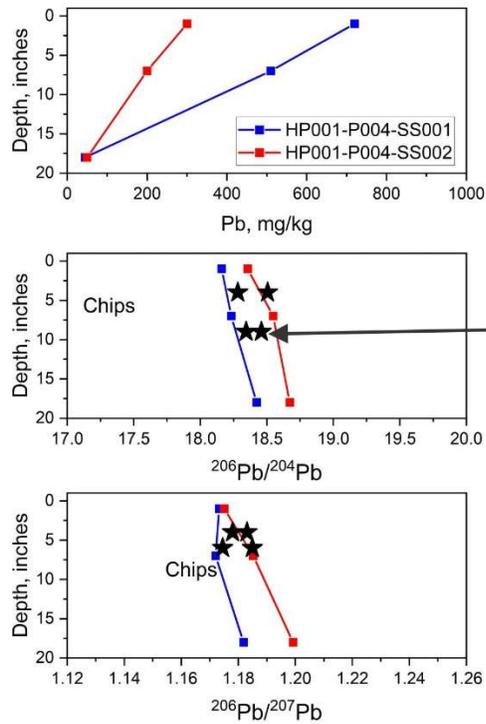
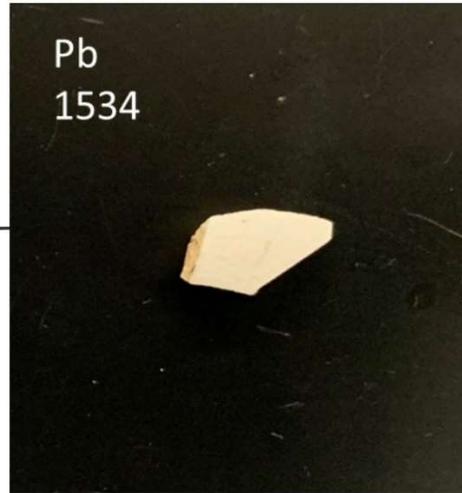
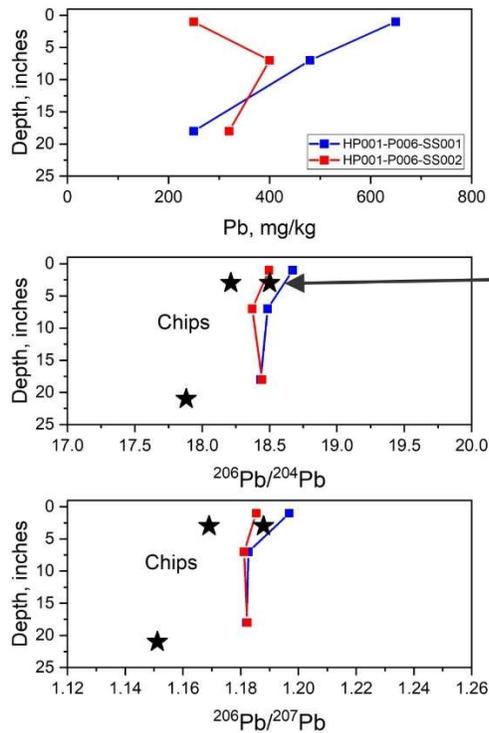
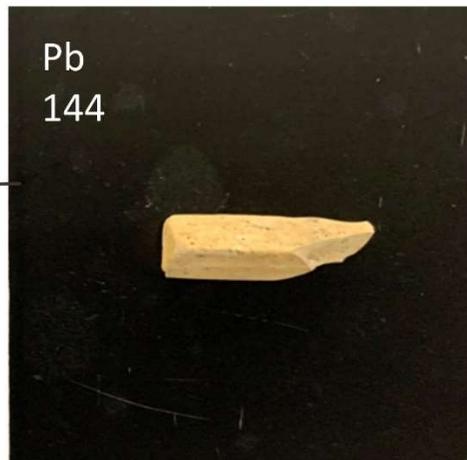
Property 4 example
soil data and pottery

Property 6 example
soil data and pottery

Figure 6. Co-located ceramic chip and soil isotopic compositions in residential soils P004 and P006.

One example of the comparison between the Pb isotopic composition of soil and co-located ceramic chips is property HP001-P004 (Figure 5a). Four pottery chips that were collected from the 2-6" and 6-12" intervals were analyzed for isotopic lead and the lead ratios of $^{206}\text{Pb}/^{204}\text{Pb}$ ranged from 18.28 to 18.51. The lead isotope ratios of the ceramic chips are within the narrow range of the two soil samples which provides evidence of a relationship between the lead in the ceramic chips and soils. Figure 5b shows data for HP001 property P006. In this case, one of three ceramic chips had an isotopic composition that matched soil data for Pb. Six of seven of the properties where co-located soil and ceramic chips were collected had at least one ceramic chip with an isotopic composition that correlated with the isotopic ratios of Pb in soil.

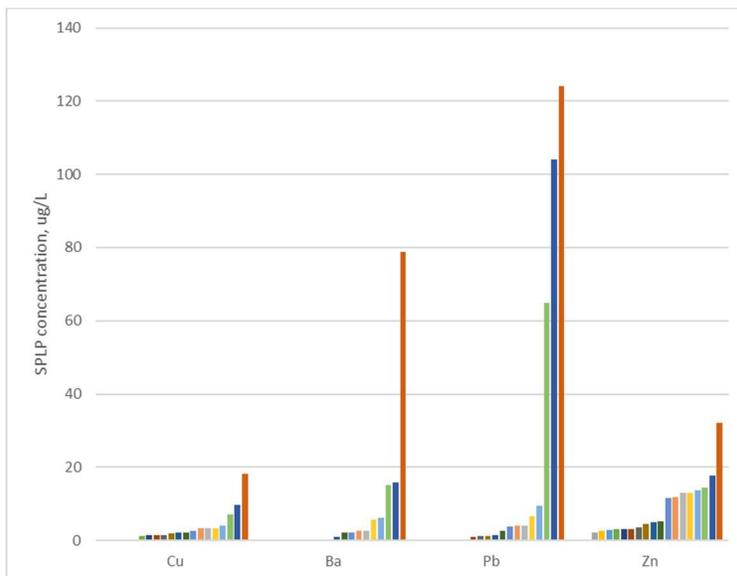
Figure 7. SPLP results for selected metals: Cu, Ba, Pb, and Zn. For each metal the samples are ranked from lowest to highest leaching potential.

Synthetic Precipitation Leaching Procedure (SPLP EPA Method 1312): SPLP analysis was performed on 20 ceramic chip samples to determine if Pb or other metals would readily leach from the samples tested. Samples were selected based on XRF-determined Pb concentrations and the characteristics of the glazed portion of the ceramic chips. Samples were chosen from a range of Pb levels including five samples from 100 to 1,000 mg/kg, four samples from 1,000 to 10,000 mg/kg, eight samples from 10,000 to 100,000 mg/kg, and three samples over 100,000 mg/kg. The SPLP analysis included antimony, arsenic, barium, beryllium, cadmium, cobalt, copper, chromium, lead, manganese, molybdenum, nickel, silver, thallium, tin, uranium, vanadium, and zinc. Of these metals, lead, barium, zinc, vanadium, and copper (presented in order of highest leachate concentration) were the most leachable (Figure 7). Lead results for the SPLP analysis ranged from less than 1 to 124 $\mu\text{g}/\text{L}$ and was the most leached metal in the SPLP analysis. The ceramic chips that were found at all properties at varying quantities have likely leached over time, especially during periods of acidic rain. Thus, it is possible that higher concentrations of metals could have been leached to the environment prior to the ceramic chips being collected. On the other hand, in order to provide a consistent testing of materials the SPLP was performed on crushed ceramic chips, which increased surface area and the potential for metals leaching.

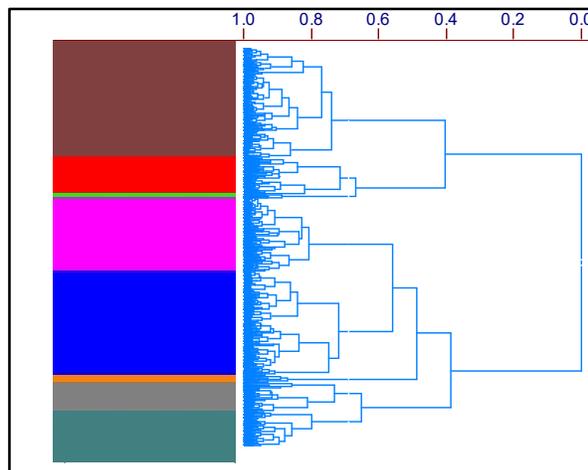
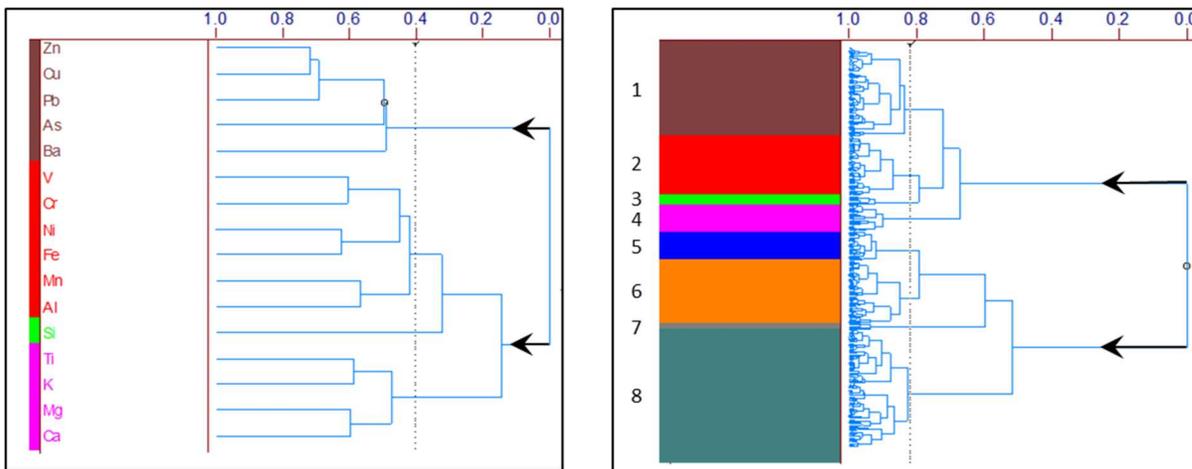
Figure 8. Statistical dendrograms that illustrate the differentiated clusters of samples across the entire data set. Right: sample dendrogram shows the outcome using all metals and 0.7 similarity index. Lower left: parameter dendrogram shows the interacting groups of metals that influence the clusters. Lower right: sample dendrogram shows the outcome using just the metals from the upper branch of the parameter dendrogram (As, Ba, Cu, Pb, Zn).

Multivariate Statistics: Multivariate statistical analysis was conducted using the commercial software Pirouette (Version 4.5). Total extractable metals concentrations from discrete soil samples for residential, recreational, municipal, and commercial properties were compiled and processed to include only those metals which had a detection rate >90% for all sampled properties. The metals that satisfied this criterion included aluminum (Al), arsenic (As), barium (Ba), calcium (Ca), chromium (Cr), copper (Cu), iron (Fe), lead (Pb), magnesium (Mg), manganese (Mn), nickel (Ni), potassium (K), silicon (Si), titanium (Ti), vanadium (V), and zinc (Zn). For this subset of metals, the laboratory quantitation limit value for each metal was used for the non-detect results. Prior to analysis, metal concentrations were transformed to logarithmic (Log10) values. Program settings for the HCA analysis included autoscale preprocessing, Euclidean distance metric, and incremental linkage method.

For this analysis, the compositional variables (i.e., metal concentrations) can be viewed as the fixed set of ingredients of a recipe for each soil sample. Samples with statistically similar compositions are assigned to subsets (i.e., clusters) of the entire set of samples. Samples within a cluster have similar compositions when compared to other samples in the entire population. The Pirouette software allows the user to assess changes in the populations of each cluster with greater restrictions on compositional variability for each cluster. The metric that defines within cluster similarity is referred to as the “similarity index” which varies from a value of zero to one. A similarity index of zero is the least restrictive with all samples being classified as similar. A similarity index of one is the most restrictive where samples within a cluster must have identical composition. The initial HCA analysis using all metal concentration data resulted in eight statistical clusters when the similarity index was set to 0.7 (Figure 8, upper panel). The statistical analysis can also be implemented to assess what subsets of metals are interacting to influence the groupings of individual samples. Assessment of the HCA output with respect to the metal concentrations revealed that As, Ba, Cu, Pb, and Zn grouped as a branch separate from the other metals (Figure 8, lower left panel). This set of metals includes four of the metals (Ba, Cu, Pb, Zn) that showed the highest leaching potential for ceramic chips subjected to the SPLP. Subsequent statistical analysis of all samples using only this subset of metals as the variables resulted in eight statistical clusters differentiated at a similarity index greater than 0.82 (Figure 8, lower right panel). These clusters initially grouped separately into two primary branches that were subsequently distributed among clusters 1-4 and 5-8 at the higher similarity index.

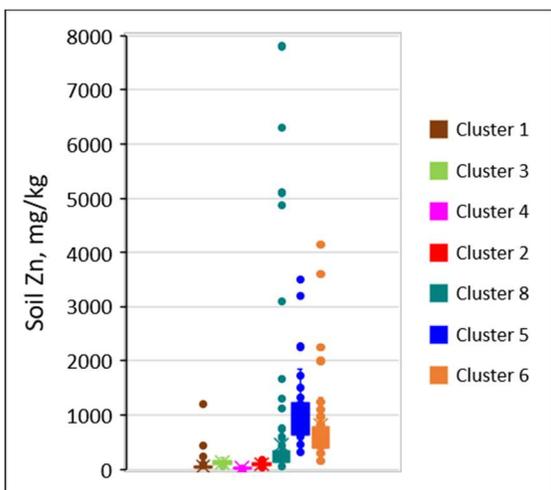
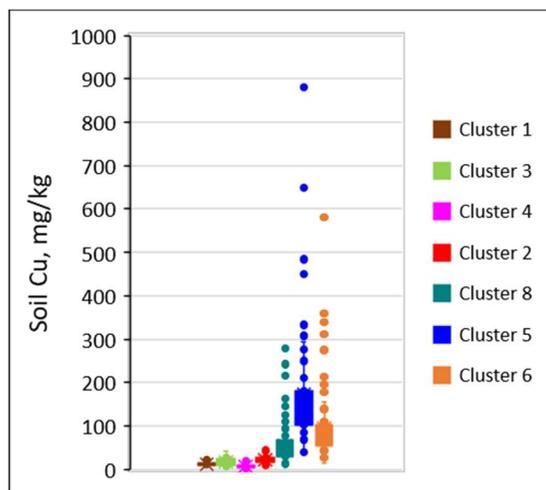
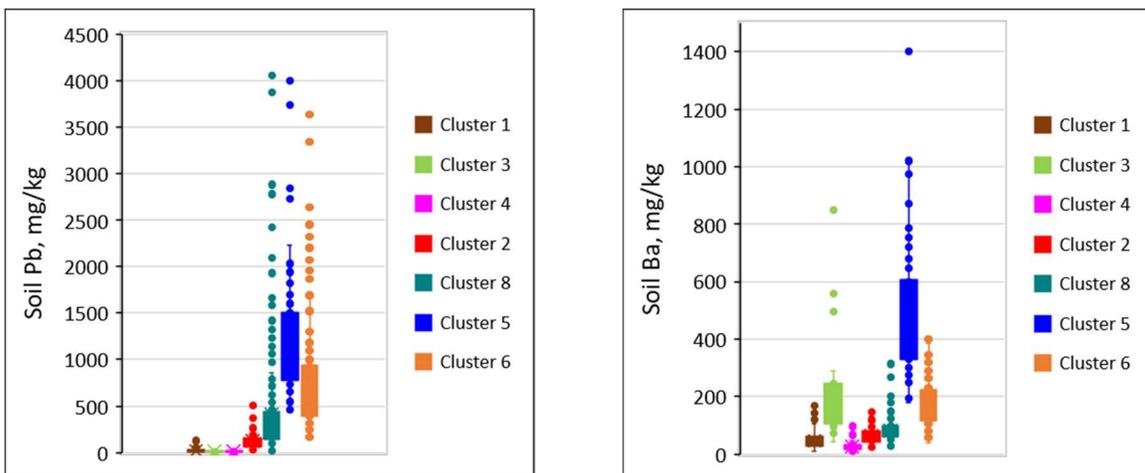
Figure 9. Distribution of metal concentrations for the statistical groups identified at a similarity index of 0.82 when only As, Ba, Cu, Pb, and Zn were used as variables. Metal concentrations that are shown correspond to those that were observed to leach from ceramic chips to greatest extent in the SPLP procedure.

The distribution of concentrations for a subset of metals for seven of the eight clusters is shown in Figure 9 to illustrate distinctions across statistical clusters. Clusters with the lowest Pb concentrations had similar or higher concentrations of other metals (e.g., Ni and Ti, not shown), which were not observed to leach significantly from ceramic chips. The statistical groups can be classified as: 1) no impact from Pb contamination (Clusters 1, 2, 3, 4), 2) significant impact from Pb contamination (Clusters 5, 6 and 7), and 3) a transitional group with varying level of potential impact (Group 8). Metal concentration distributions are not shown for Group 7 since this constituted a small group with only 14 samples from properties HP001-P050 and HP001-P051. This cluster had anomalously high metal concentrations and Pb isotope ratios that were inconsistent with the other soil samples.

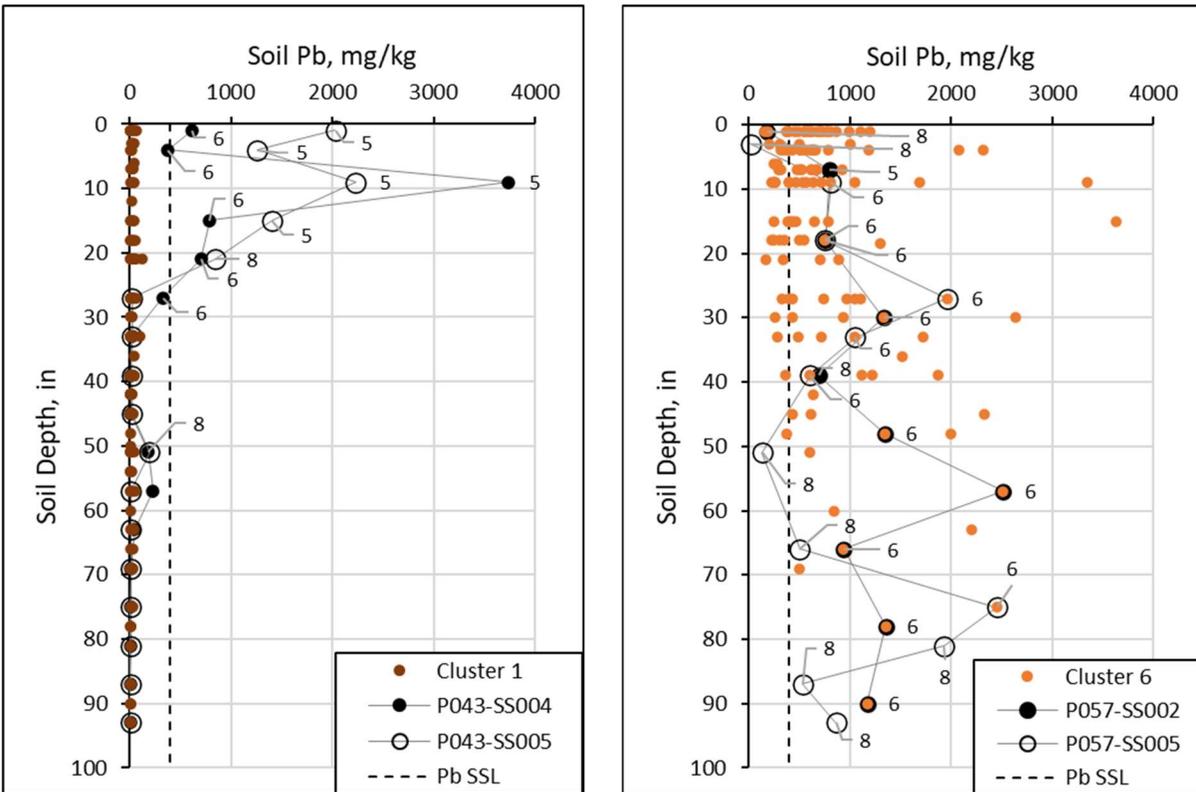
Figure 10. Soil Pb concentrations with depth for two locations sampled within area HP001. Left panel: Property P043 is a park (recreational) nestled amongst residential properties. Right panel: Property P057 is the location of a large former pottery facility that was north-northwest of the residential properties within area HP001.

A common pattern observed for many of the residential and recreational properties within sampling area HP001 was higher concentration of Pb at shallow depths (<30 inches) that rapidly decreased for depth >30 inches (Figure 10, left panel). At depths >30 inches, both Pb concentrations and isotope ratios transitioned to those anticipated for geogenic background. This vertical pattern was also reflected in the statistical clusters that were assigned as a function of depth. Shallow depths were assigned to statistical clusters associated with contamination impact (Clusters 5 and 6), while deeper depths were assigned to Clusters 1 and 2 (not labeled). For soil core location P043-SS005, the depth interval at about 50-inches is assigned to Cluster 8, which is consistent with the less radiogenic Pb isotope ratio for this sample. The presence of elevated Pb concentrations at shallow depths is consistent with the presence of ceramic chips at similar depths and/or aerial deposition of kiln emissions from upwind historical pottery operations. The pattern in Pb concentration at depth differs for multiple sampling locations within Property P057, which is the former location of a large pottery facility north-northwest of residential properties (Figure 10, right panel). For this property the distribution of Pb concentration with depth is erratic. For the two sampling locations, all depths were assigned to either statistical clusters indicative of contamination (Clusters 5 and 6) or a transitional condition represented by Cluster 8. The depth heterogeneity observed at property P057 is more consistent with a property where Pb-bearing materials have been processed and entrained within the soil profile over years of property transition and redevelopment.

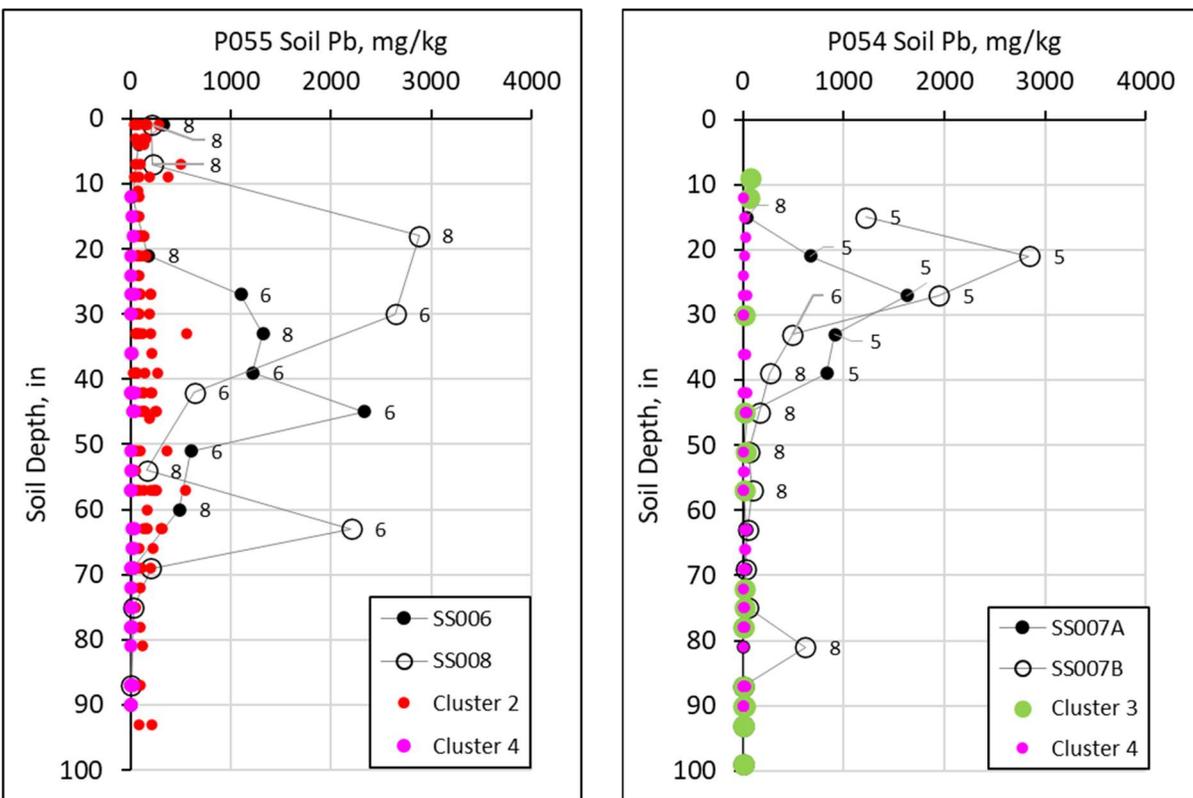
Figure 11. Soil Pb concentrations with depth for two locations sampled within area HP001. Left panel: Property P055 is the former location of a railway area adjacent to the locations of large historic pottery facilities (P056, P057). Right panel: Property P054 is the former location of a coal yard located between property P055 and the residential/recreational properties (including P043).

Intervening commercial/municipal properties between the large historic pottery facilities (P056, P057) and residential/recreational properties also had elevated Pb concentrations indicative of contamination. Property P055 was the location of a railway area that was used for transporting materials to and from the historic potteries. Soil Pb concentration data are shown in Figure 11 (left panel) for two sampling locations within property P055. The depth distribution of elevated Pb is consistent with what was observed for property P057, indicating potential contribution from fill. Property P054 was the location of a coal yard that has been redeveloped for municipal use. Much of this property is currently paved, so soil samples start at depths >10 inches. Elevated Pb concentrations primarily occur at depths <40 inches (Figure 11, right panel). Both properties have soil samples indicative of contamination based on statistical cluster assignments (Clusters 5, 6, and 8). The remaining deep intervals were assigned to Clusters 2, 3, or 4, indicative of background conditions.

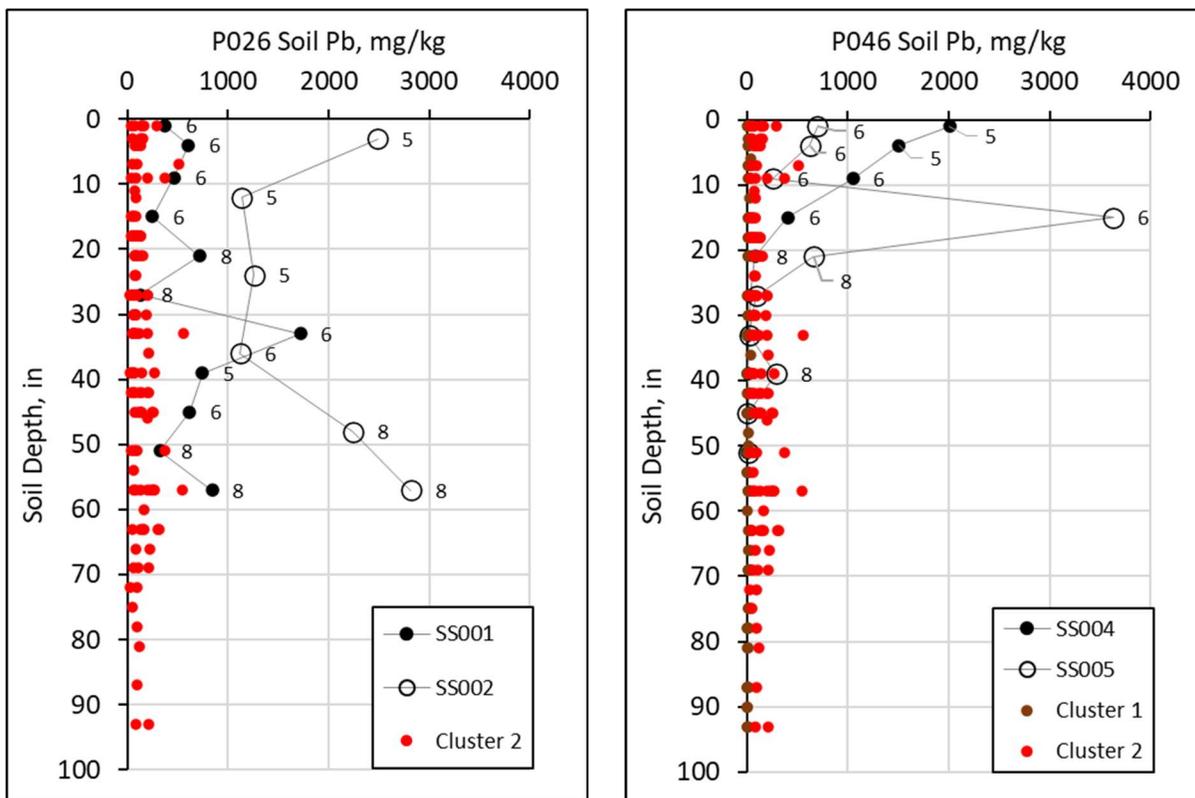
Figure 12. Soil Pb concentrations with depth for two locations sampled within area HP001. Left panel: Property P026 is in Mulberry Street Park; an area known to have received fill. Right panel: Property P046 is a vacant residential property south of property P054 (municipal) and west of property P043 (recreational).

The following figure shows soil data for two other properties within HP001 that are further away from the two large historical properties. Property P026 is in Mulberry Street Park adjacent to Assunpink Creek. This property is known to have received fill; confirmed by observations of rubble (including ceramic materials) at multiple depths during sampling. For the two locations shown in Figure 12 (left panel), all soil samples appear to be contaminated to varying extent and were assigned to statistical Clusters 5, 6, or 8. Property P046 (Figure 12, right panel) is a vacant residential property south of property P054 (municipal) and west of property P043 (recreational). In contrast to property P026, elevated Pb concentrations were primarily observed at depths <20 inches. The samples from the shallow depth interval were assigned to statistical Clusters 5, 6, or 8. At greater depth, the soil samples were assigned to Clusters 1 or 2, indicative of a transition to background. Ceramic chips observed in soil samples from property P046 had elevated concentrations of Pb. These properties highlight potential sources of Pb beyond aerial deposition of stack emissions from historical pottery manufacturing.

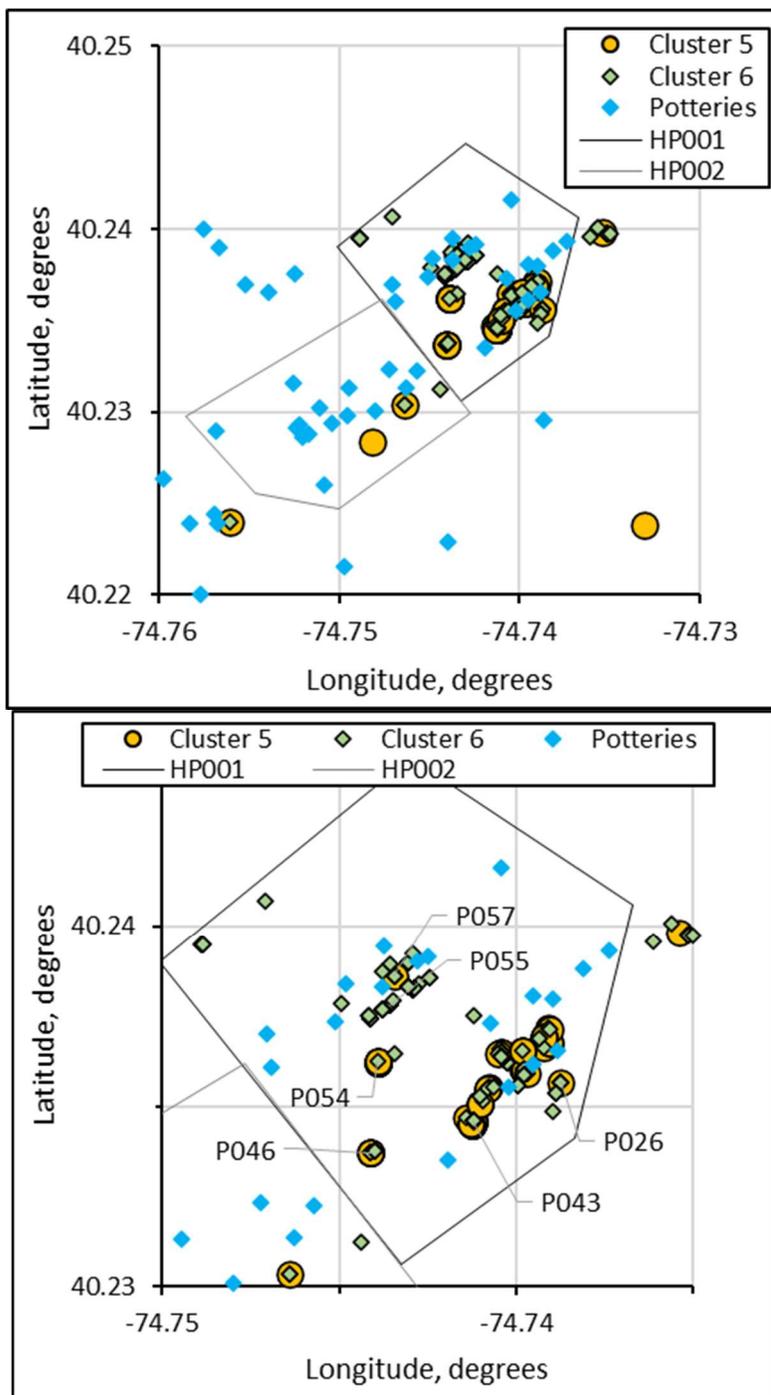
Figure 13. Summary of soil sample locations that were assigned to statistical Clusters 5 and 6. Top panel: Aerial view showing the distribution of potentially contaminated properties within sampling areas HP001 and HP002. Bottom panel: Aerial view of sampling area HP001 with identification of properties for which soil Pb concentration data were highlighted in previous figures. The former locations of historical pottery facilities are also shown.

The locations of all soil samples assigned to Clusters 5 and 6 are shown in Figure 13. For these samples, at least one depth interval was assigned to Cluster 5 or 6 with the majority occurring at depths <24-inches. The top panel shows the locations of historic potteries along with soil sample locations within sampling areas HP001 and HP002. This view highlights the spatial correspondence between historic pottery operations and the properties displaying evidence of Pb contamination. The bottom panel highlights the HP001 sampling area along with identification of property locations for which soil Pb concentration data were presented in Figures 10-12. The apparent spatial correlation between historic pottery locations and potentially contaminated properties indicates that historic pottery operations were a potential source for elevated soil Pb concentrations. This is supported by the correspondence between Pb isotope and soil chemistry data between soils sampled directly from former pottery facilities and residential/recreational properties.

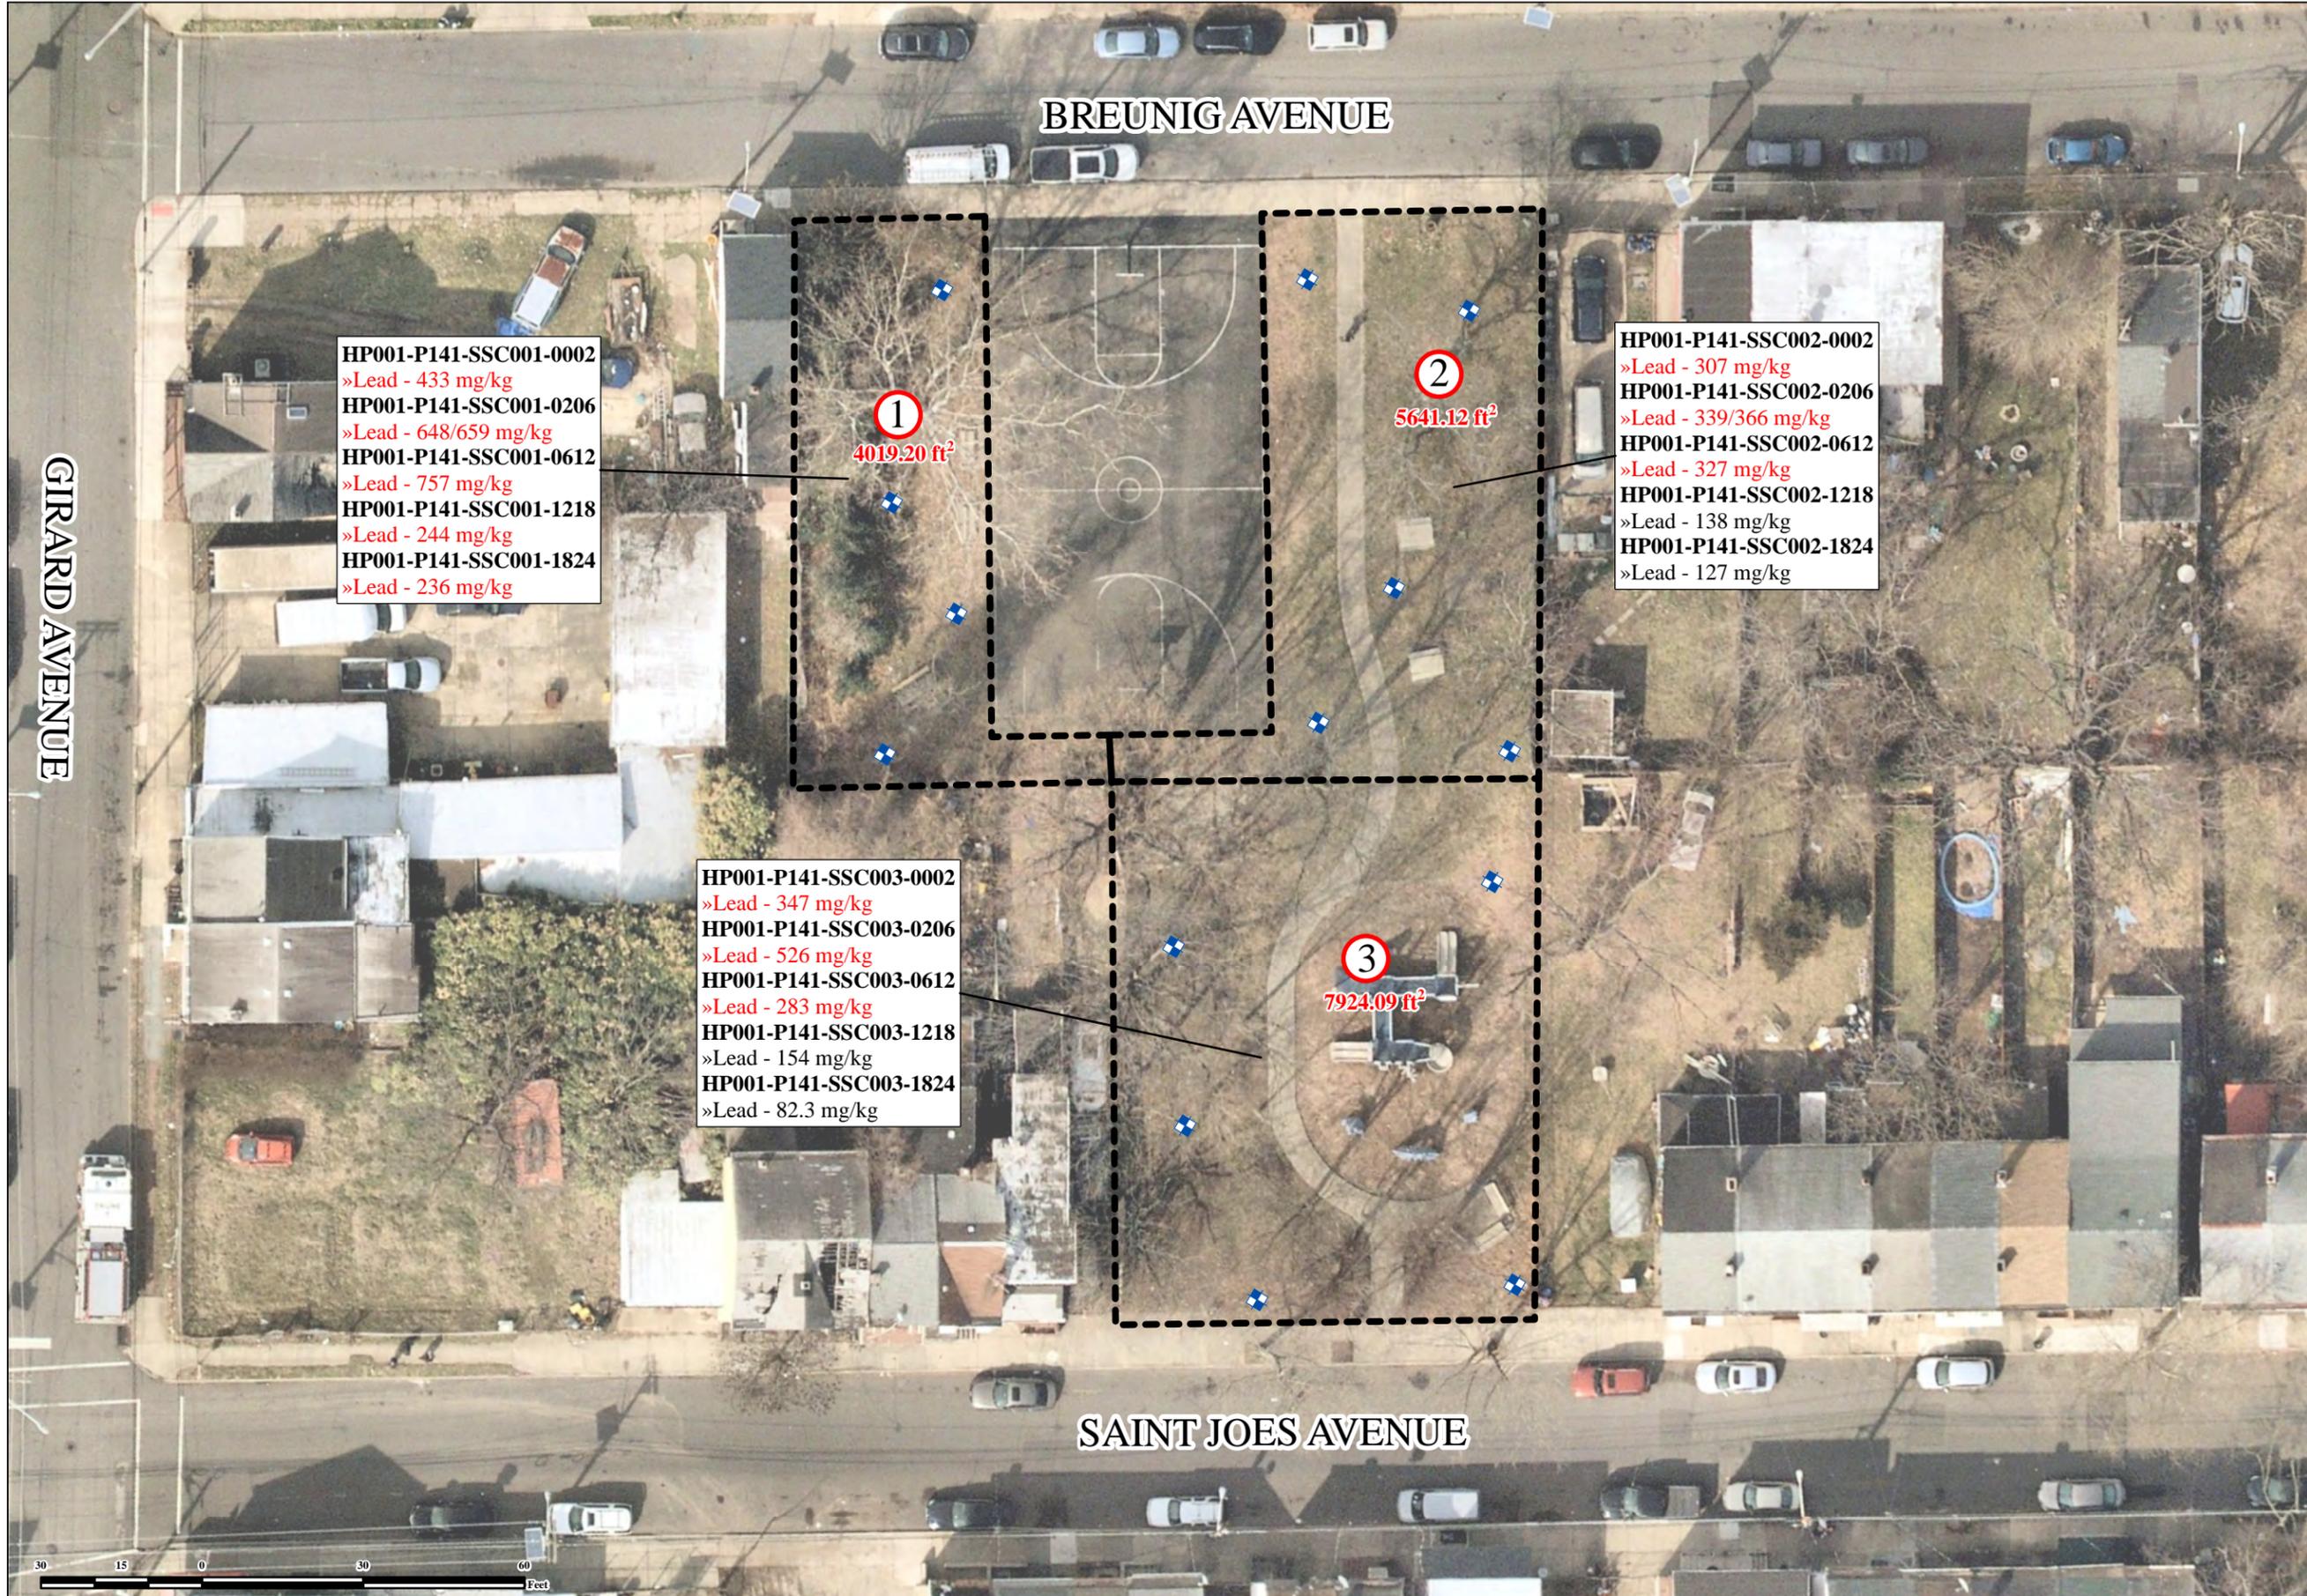
HP001-P141-SSC001-0002
»Lead - 433 mg/kg
HP001-P141-SSC001-0206
»Lead - 648/659 mg/kg
HP001-P141-SSC001-0612
»Lead - 757 mg/kg
HP001-P141-SSC001-1218
»Lead - 244 mg/kg
HP001-P141-SSC001-1824
»Lead - 236 mg/kg

HP001-P141-SSC003-0002
»Lead - 347 mg/kg
HP001-P141-SSC003-0206
»Lead - 526 mg/kg
HP001-P141-SSC003-0612
»Lead - 283 mg/kg
HP001-P141-SSC003-1218
»Lead - 154 mg/kg
HP001-P141-SSC003-1824
»Lead - 82.3 mg/kg
