United States Environmental Protection Agency
AIR MONITORING RESULTS TABLE
Helena Chemical Superfund Removal Site
CERCLIS # TXD980625008

Air Monitoring Results for 3/11/08. Approximate Run Time: 0740 - 1715

**3/11/08
PM¹⁰ MONITORING
LOCATION MAP
HELENA CHEMICAL**
MISSION, HIDALGO COUNTY, TEXAS

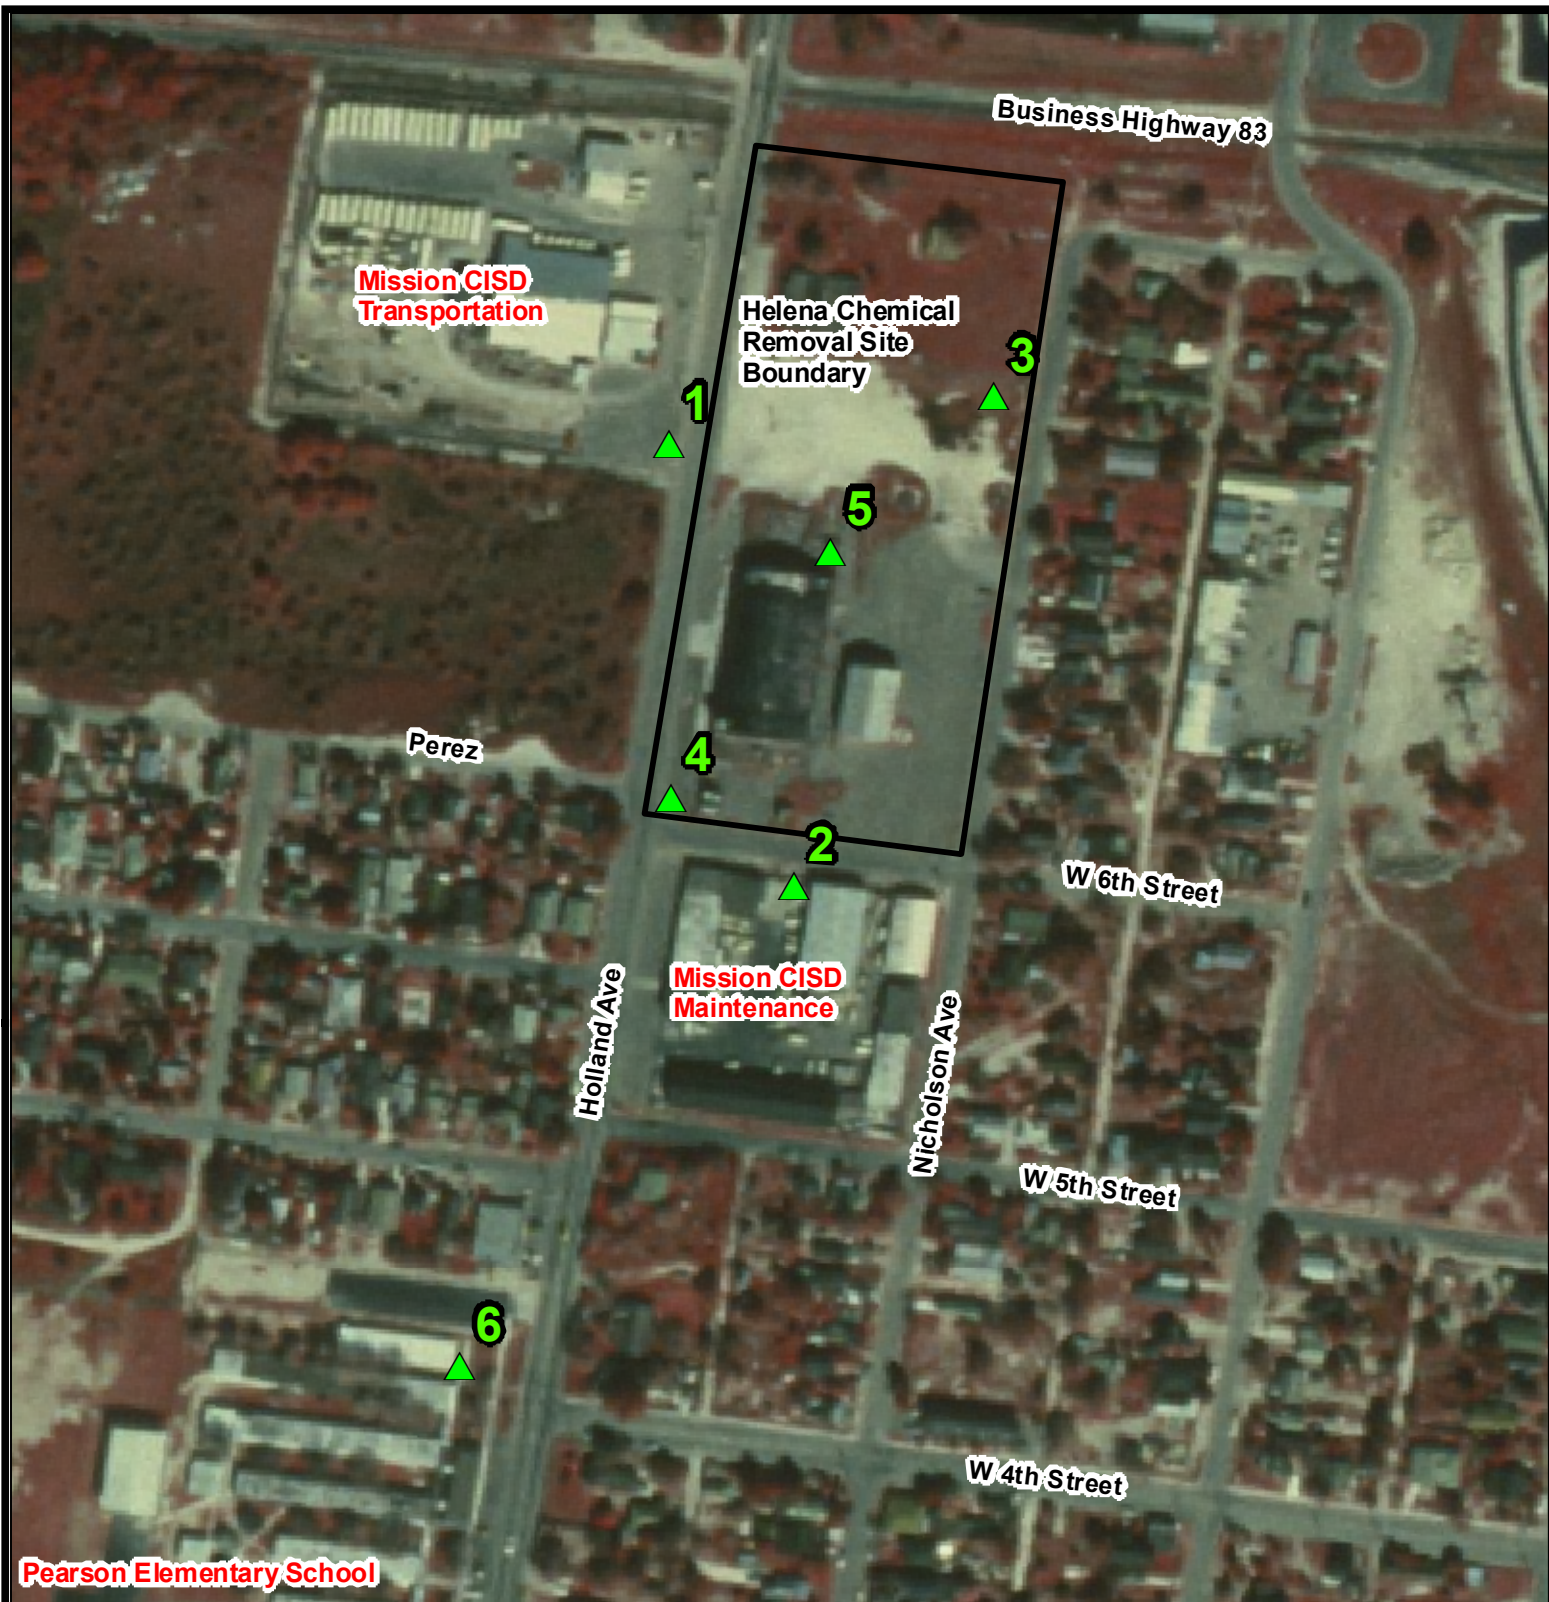
FIGURE 1

EPA National Ambient Air Quality Standard - PM¹⁰ 24 Hr = 150 ug/m³

ID	TWA (µg/m ³)	Location Description
1	34.7	Mission CISD Transportation Yard
2	11.8	Mission CISD Maintenance Yard
3	14.5	Community Relations Trailer
4	18.5	On-site, Southwest
5	13.9	On-site, North
6	15.0	Pearson Elementary
