Health Consultation

Exposure Investigation Report

Drinking Water Sampling from Homes Near the
Kerr McGee Chemical Corporation

COLUMBUS, MISSISSIPPI

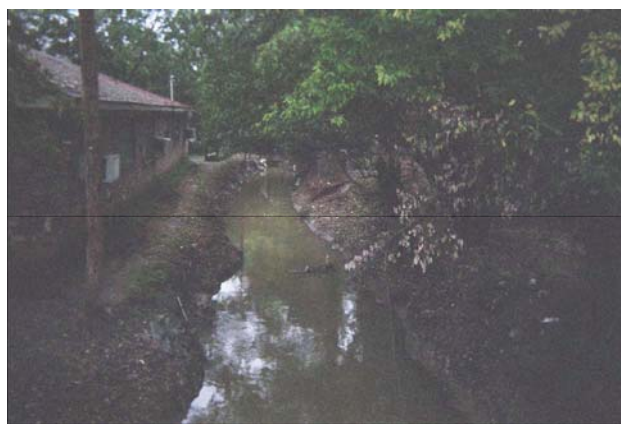
Figure 1. Photograph of houses near ditch

Local residents were concerned that contaminants from the wood treating plant spilled into roadside ditches and washed into their yards (Figure 1). In 2000, blood samples from ten community members were tested and found to contain dioxin and dioxin-like compounds (Dahlgren 2003). The blood results did not identify an exposure source; most people have some measurable level of dioxin and dioxin-like compounds in their blood from multiple environmental sources.¹ Contaminants associated with the plant had been found in ditch sediments near the plant (3TM 2001). In November 2004, Kerr-McGee removed contamination from roadside ditches (ERM 2005).

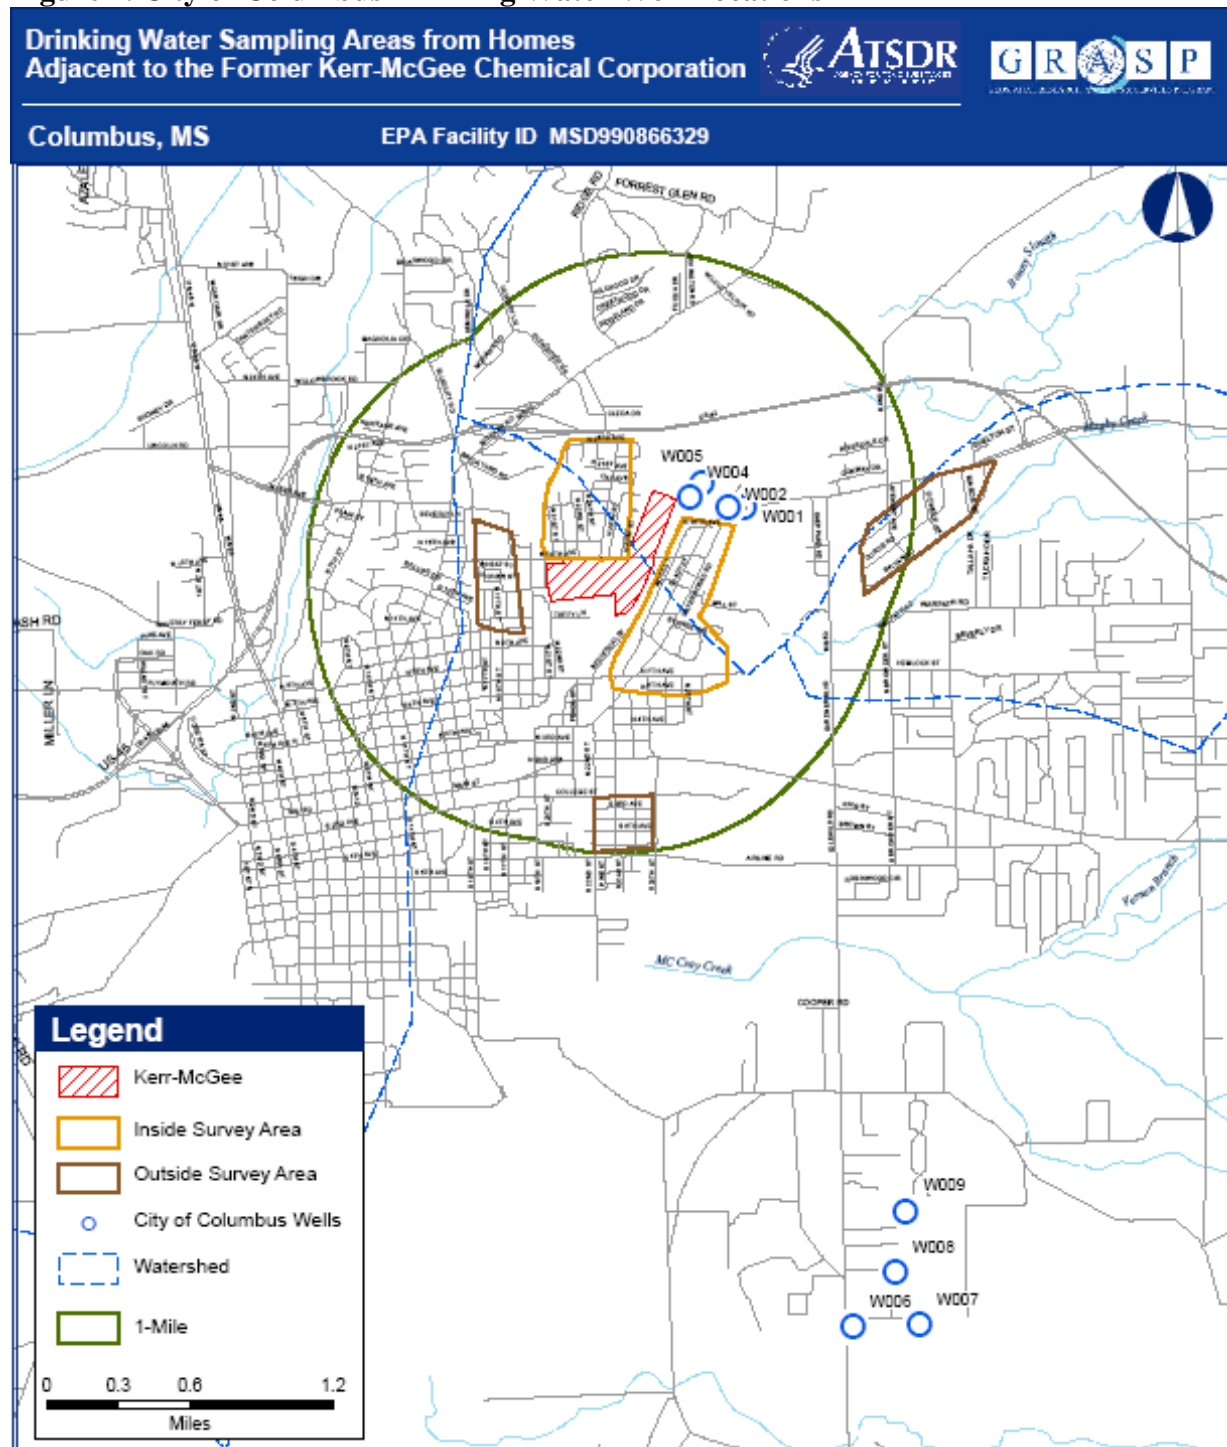
Figure 1. City of Columbus Drinking Water Well Locations

The city of Columbus uses water from two clusters of deep wells (four in each; all greater than 800 feet deep) and has two water treatment plants. One cluster is on Waterworks Road east of the plant (Figure 1 in Appendix B) and the other cluster is roughly three miles south of the plant near the airport. According to the utilities manager, when the Waterworks Road well field is operational (e.g., no scheduled maintenance or unplanned shutdowns), people nearer to the plant get their drinking water from that well cluster (ATSDR 2007).

Source: Well Cluster data from the Mississippi Office of Land and Water Resources (OLWR) through the Mississippi Automated Resource Information System Technical Center, downloaded February 2009. Includes water wells, 6" in diameter or larger permitted and monitored by the OLWR.

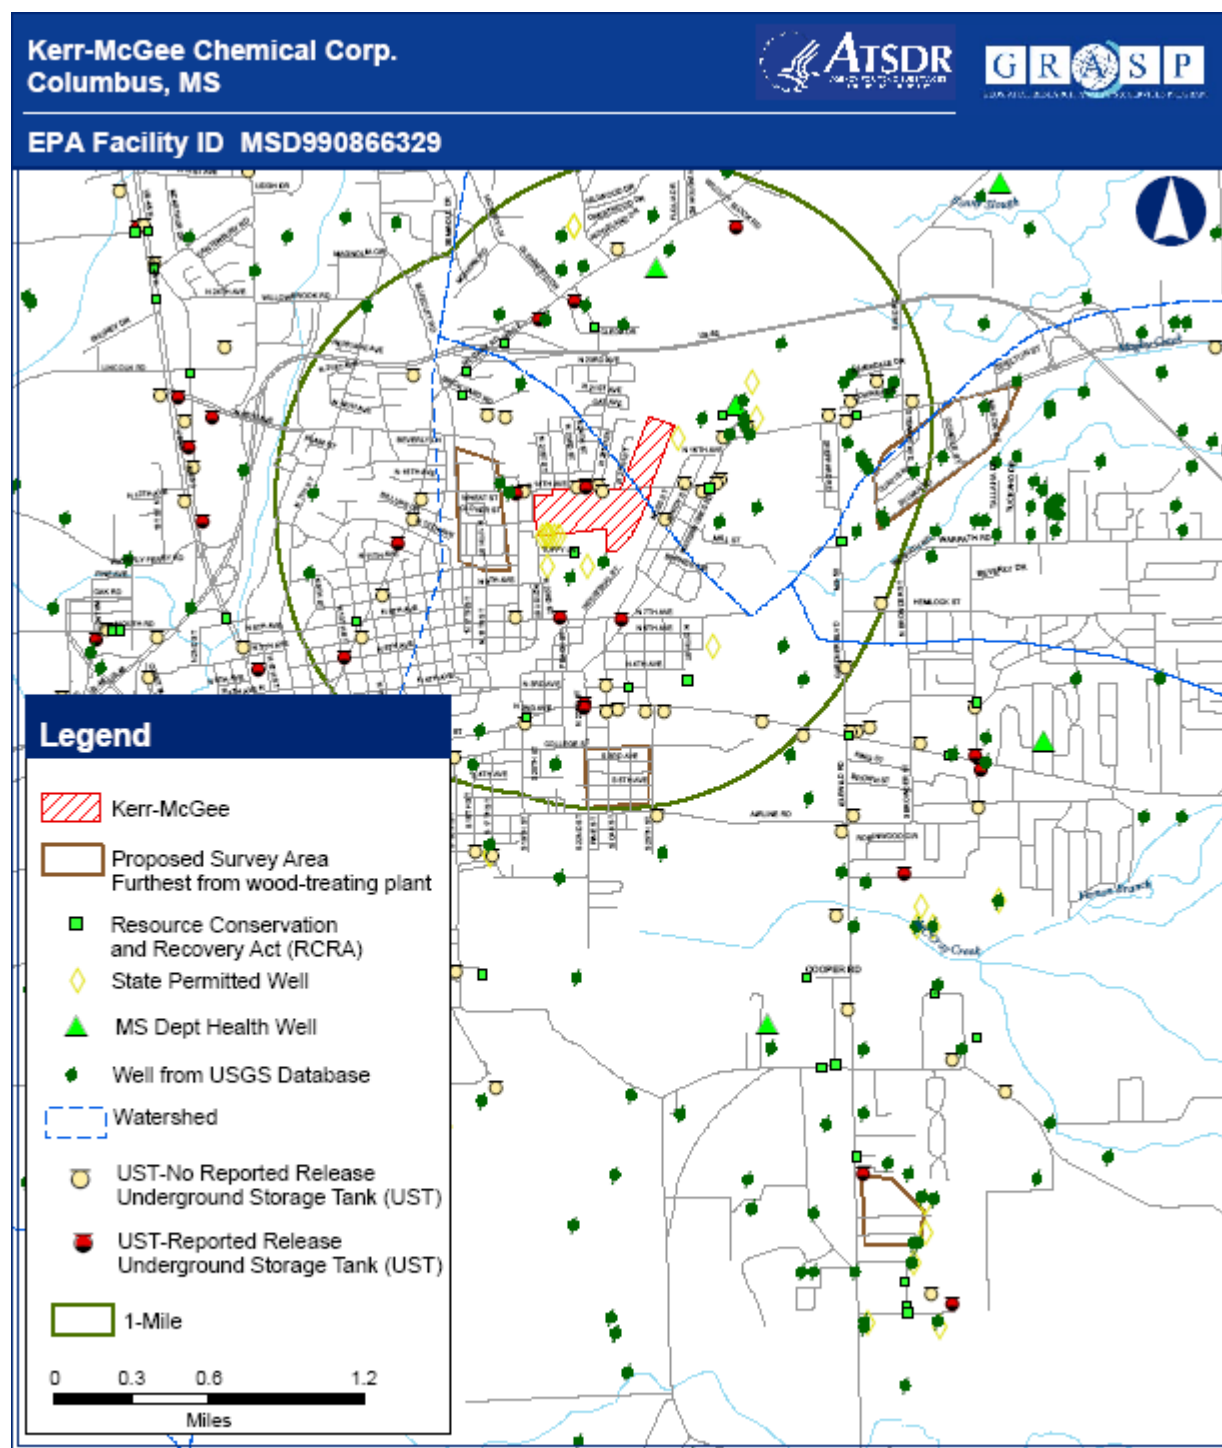
Figure 2. Underground Storage Tank Locations (USTs) near Kerr McGee, Columbus, MS

There are many underground storage tanks in the Columbus area. Some have reported leaks (See Figure 2 in Appendix B). We collected samples away from those areas to avoid interference with our objective to determine if contaminants from the former Kerr McGee plant have infiltrated the local piping network.
