Asbestos Inspection Report

Cone Mills / Old Union Bleachery Site
3335 Old Buncombe Road
Greenville, SC 29617

AECOM Project 60133878.03
Date of Inspection: June 14-16, 2010
Date of Report: July 19, 2010

RE: Asbestos Investigation Report
Cone Mills/Old Union Bleachery Site
Greenville, South Carolina
AECOM Project No. 60133878

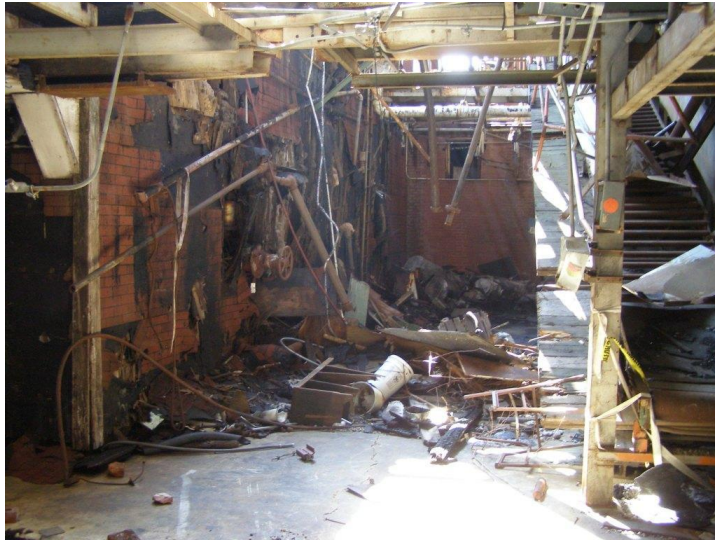
Photo 4. Collapsed Conveyor Belt and Breezeway Area (Figure 1, Area 7)

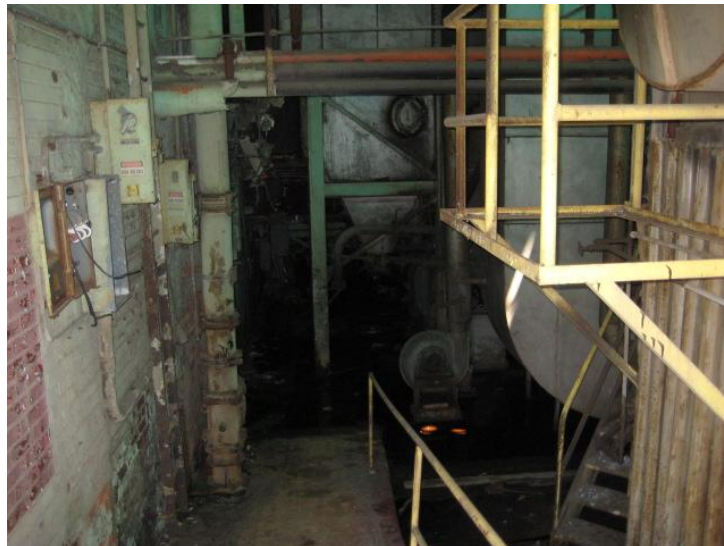
Photo 5. West Entrance to Boiler Room 2 (Figure 1, Area 13).

This entrance (Photo 5) is on the west side of the boiler room. Entrance to Boiler Room #1 (Area 12) is at the bottom of the ramp. At the bottom of the ramp the floor is covered in standing water and the area to the east is all heavy machinery that is inaccessible.

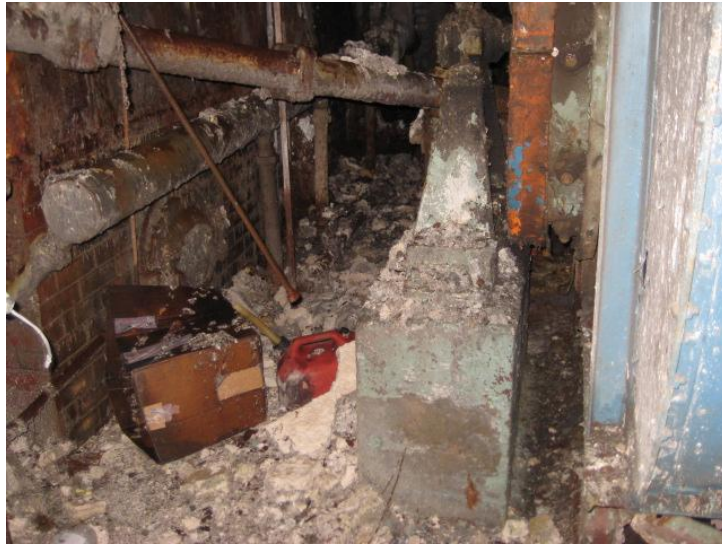
Photo 6. East Entrance to Boiler Room #2 (Figure 1, Area 13)

Photo 6 is an example of the inaccessibility around the boilers and fallen debris. This debris is visible through a large part of the Area.

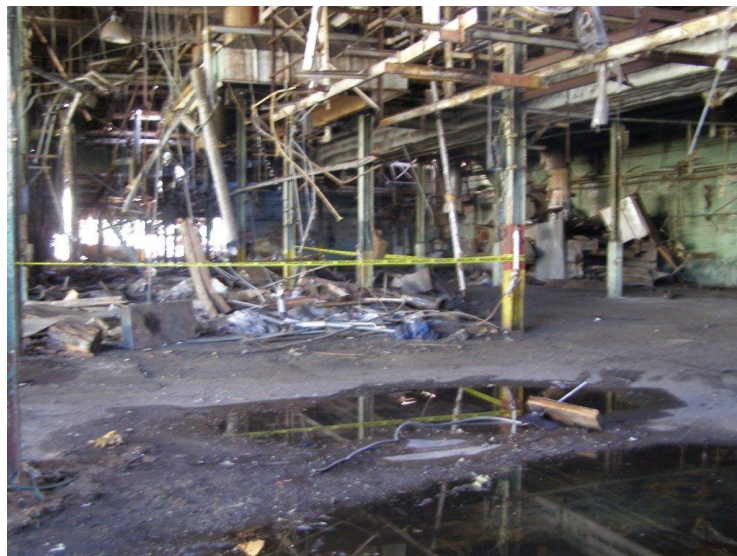
Photo 7. An example of inaccessible portions of areas 17, 18, 19, and 20 (Figure 1) due to the instability of overhead debris.

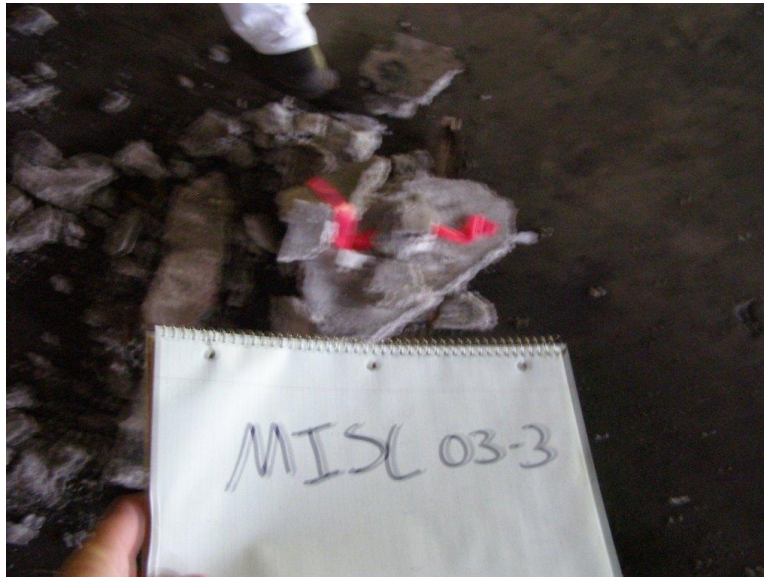
Misc-03-2_Particle Board Appearance

Laboratory analysis determined the sheetrock-like material (noted at Misc 03) and various piping insulation are positive for asbestos. The inspector assumes all inaccessible (un-sampled) materials are asbestos containing including the second floor, basement, and debris piles. Sampling confirmed 2,450 square feet and 5,700 linear feet of ACBM. In addition, approximately 427,000 square feet of material is assumed to be asbestos containing.

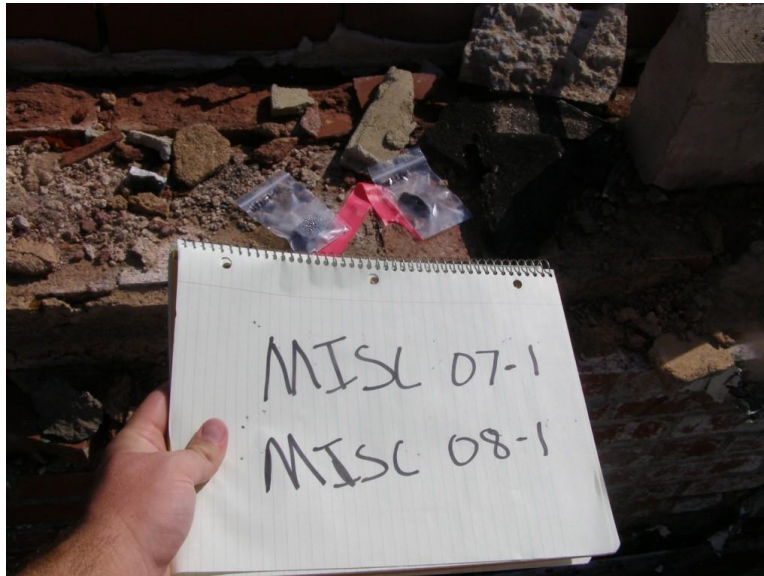
Misc-04-3_Black and White Fibers in Debris Pile at Conveyor Belt

Debris piles are observed to contain wood, ash, metal, roofing materials, plastic, fabric, piping, and insulation. In order to properly sample these piles, the entire pile would need to be sorted. The potential for creating a fiber release was deemed high and would require heavy machinery to move the debris.

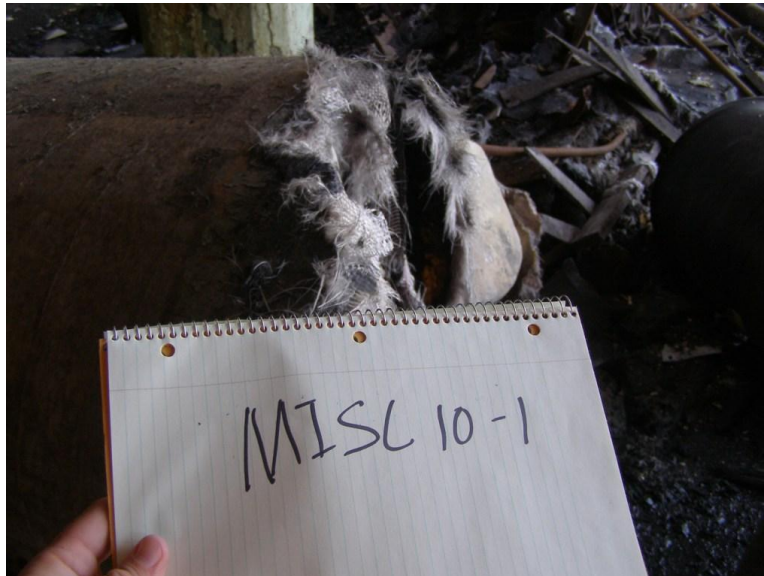
Misc-10-1_Fiber Wrapped Piping

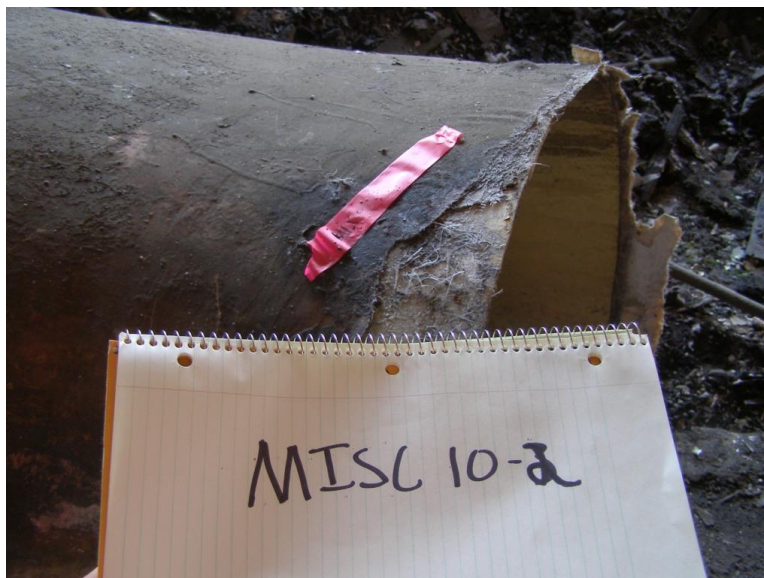
Misc-10-2_Fiber Wrapped Piping

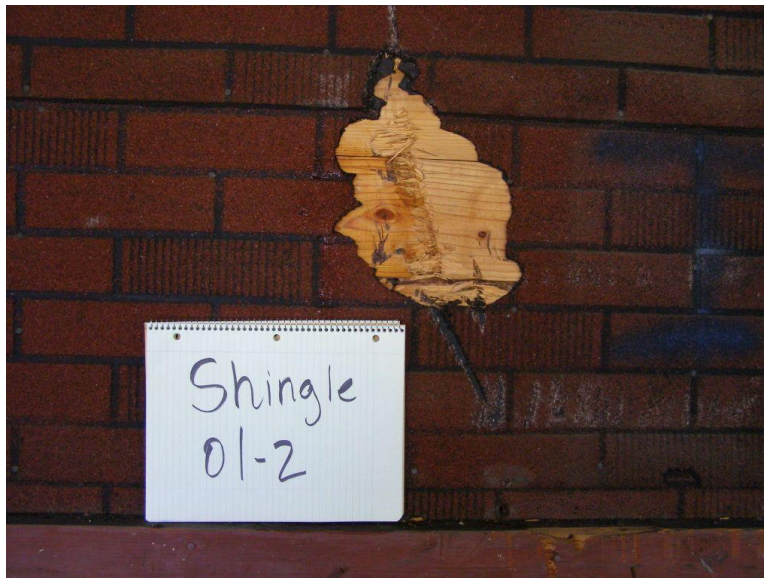
Shingle-01-2_Red/Black Wall Shingle

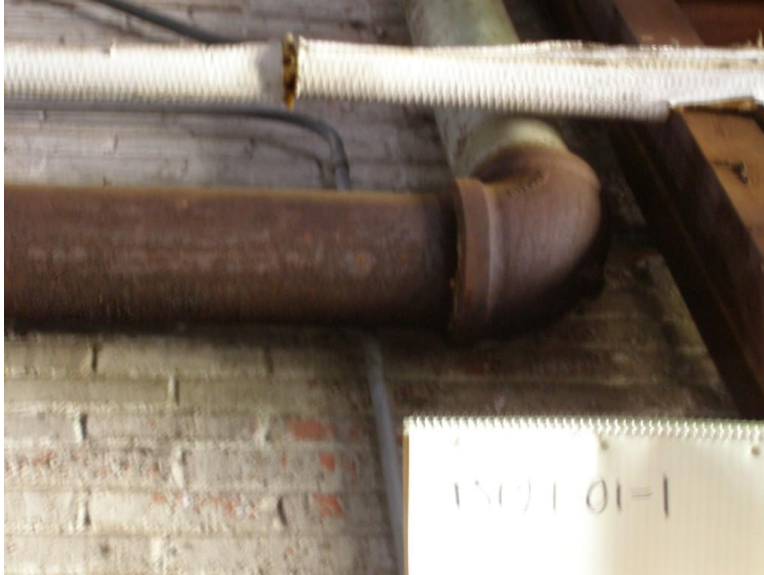
Tsi2i-01-1_2 inch White Wrapped Piping

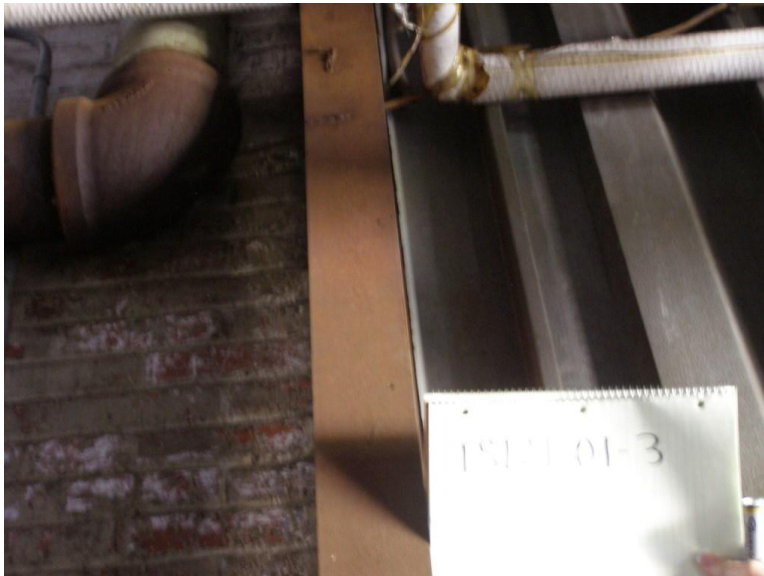
Tsi2i-01-3_2 inch White Wrapped Piping

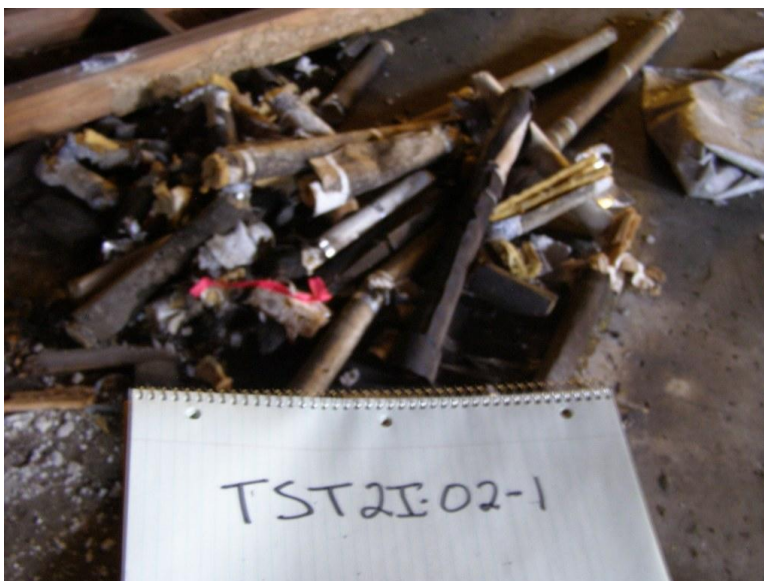
Tsi2i-02-1_2 inch White Wrapped Piping

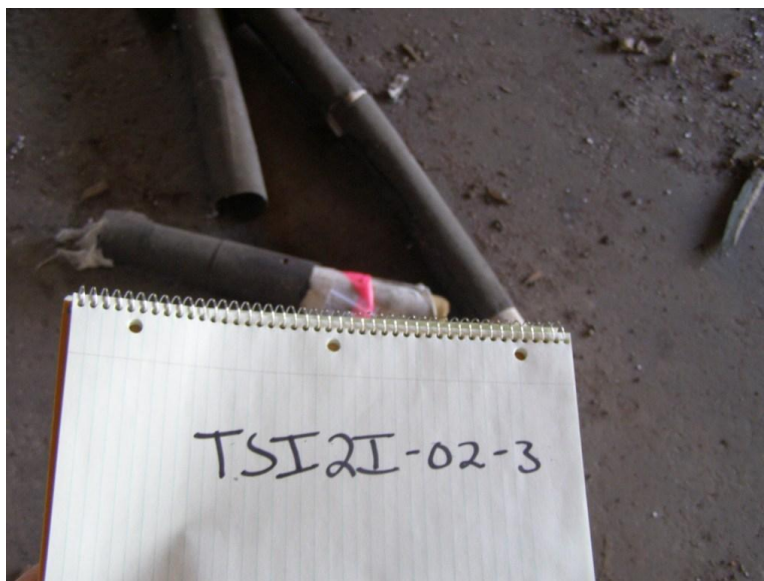
Tsi2i-02-3_2 inch White Wrapped Piping

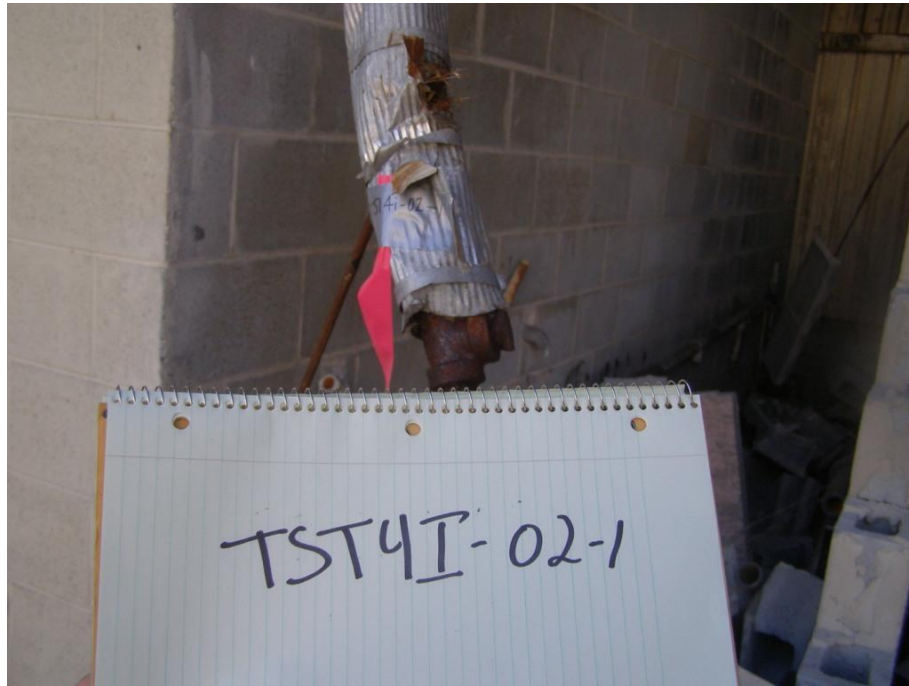
Tsi4i-02-1_4 inch Wrapped Piping

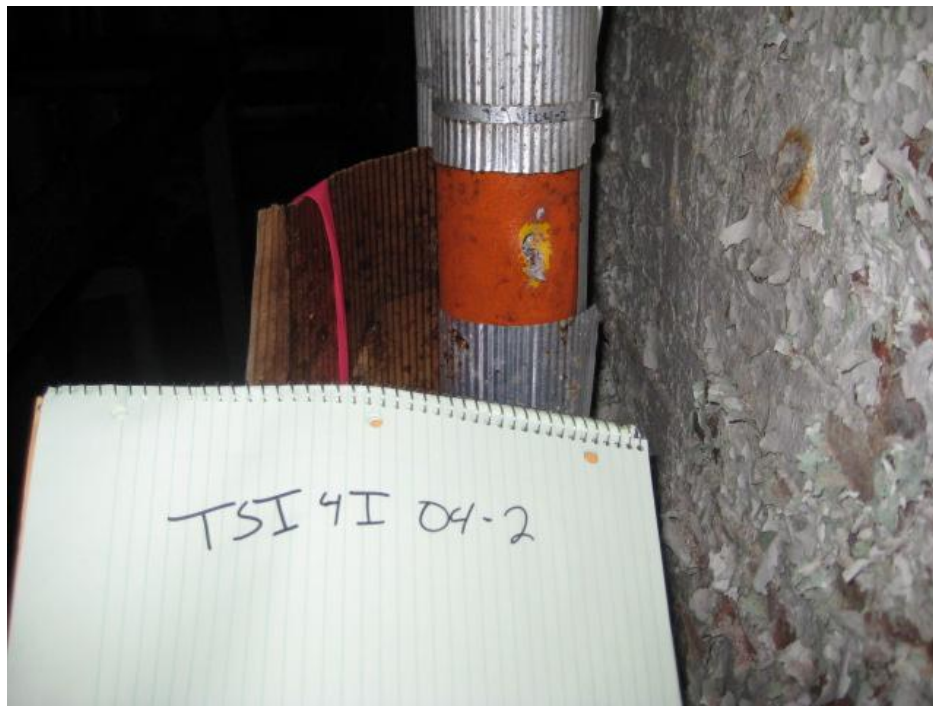
Tsi4i-04-2_4 inch Metal Wrapped with Blue Arrows

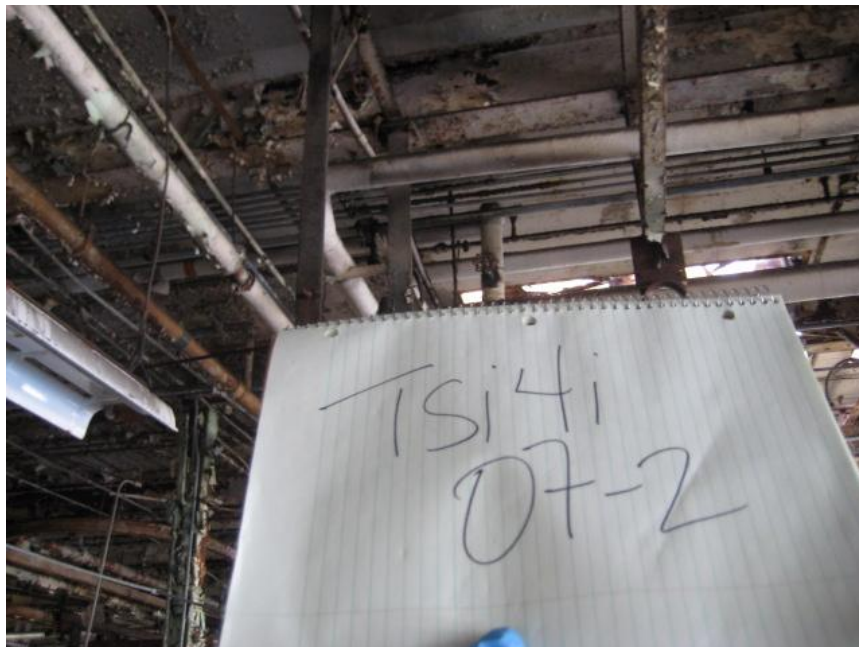
Tsi4i-07-2_4 inch White Wrapped Piping-Green Band

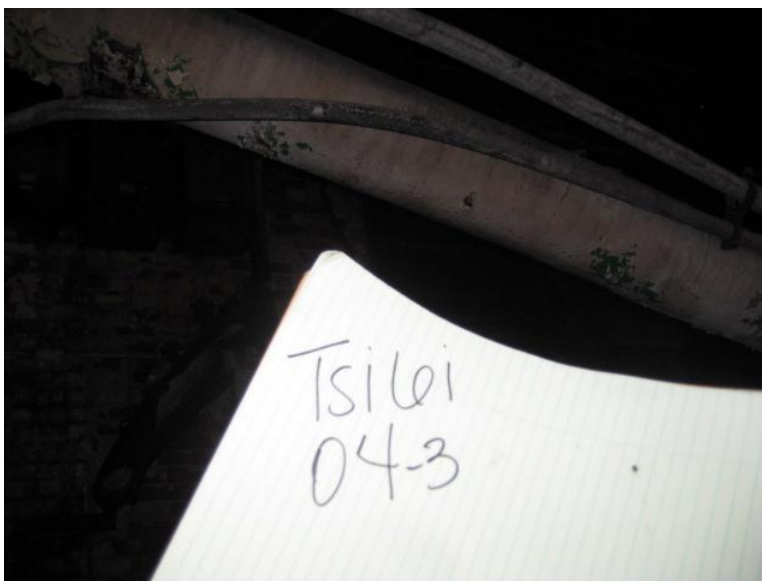
Tsi6i-04-1_6 inch White Wrapped Piping-Green Band

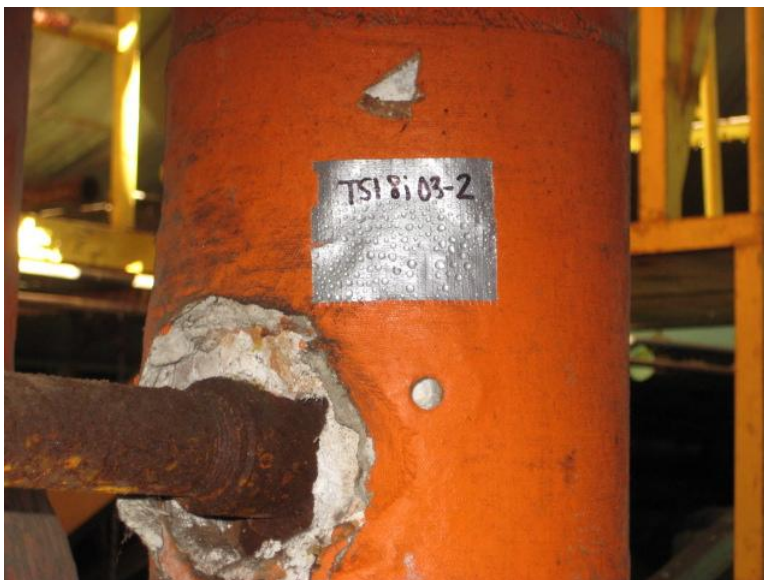
Tsi8i-03-2_8 inch Orange Boiler Wrapped Piping

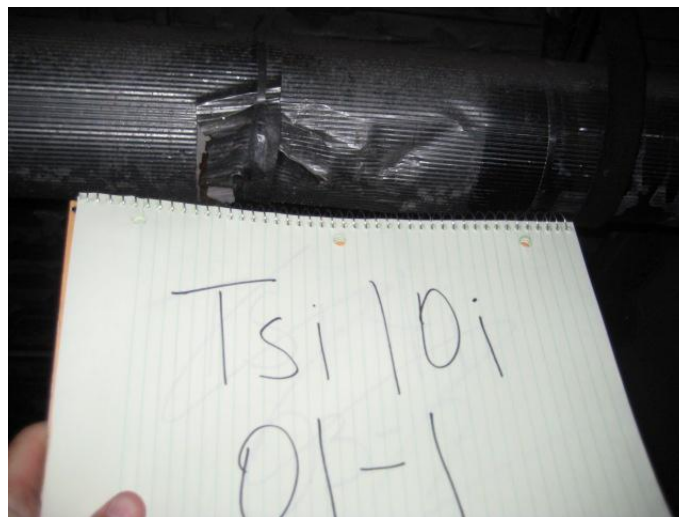
Tsi10i-01-1_10 inch Wrapped Piping

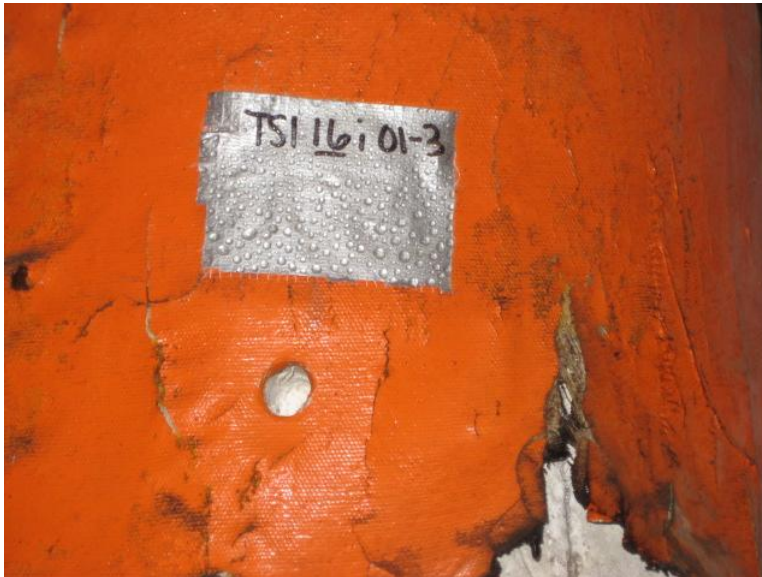
Tsi16i-01-3_16 inch Orange Boiler Wrapped Piping
