August 11, 2008

Subject: Powerhouse And Water Treatment Structures Asbestos Survey Report
Former Liberty Fibers Site; Lowland, Tennessee
A.C.T. Services Proposal No. 08.17.001

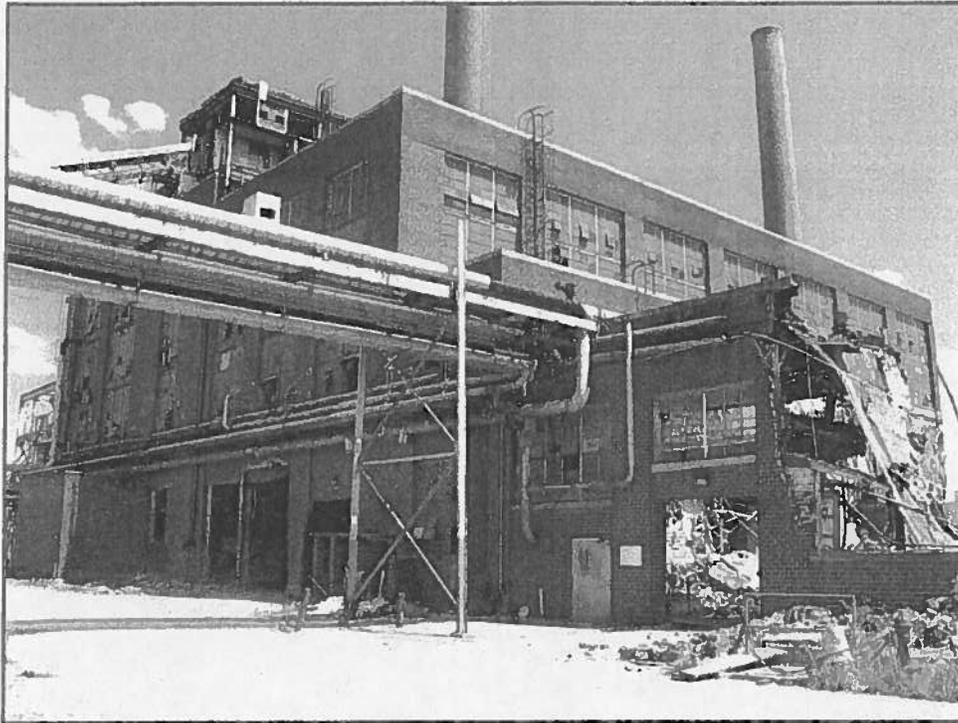
Power House Structure Southeast View of Pump Room, Turbine Room & Boiler Room

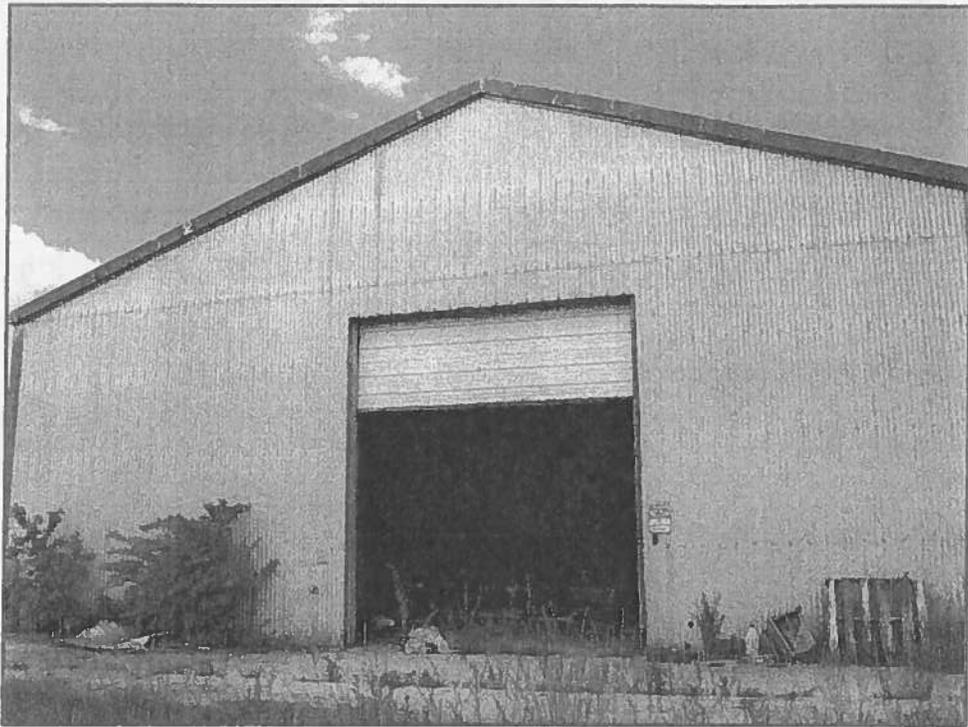
Water Treatment Plant Maintenance Shop & Store Area

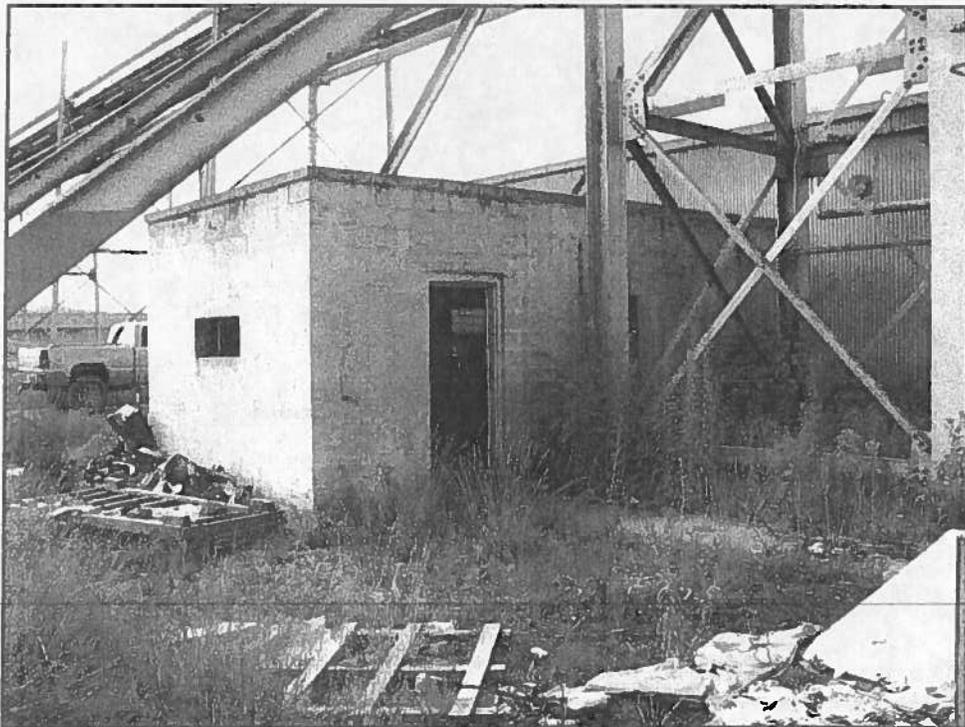
Water Treatment Plant Supervisors Office Structure

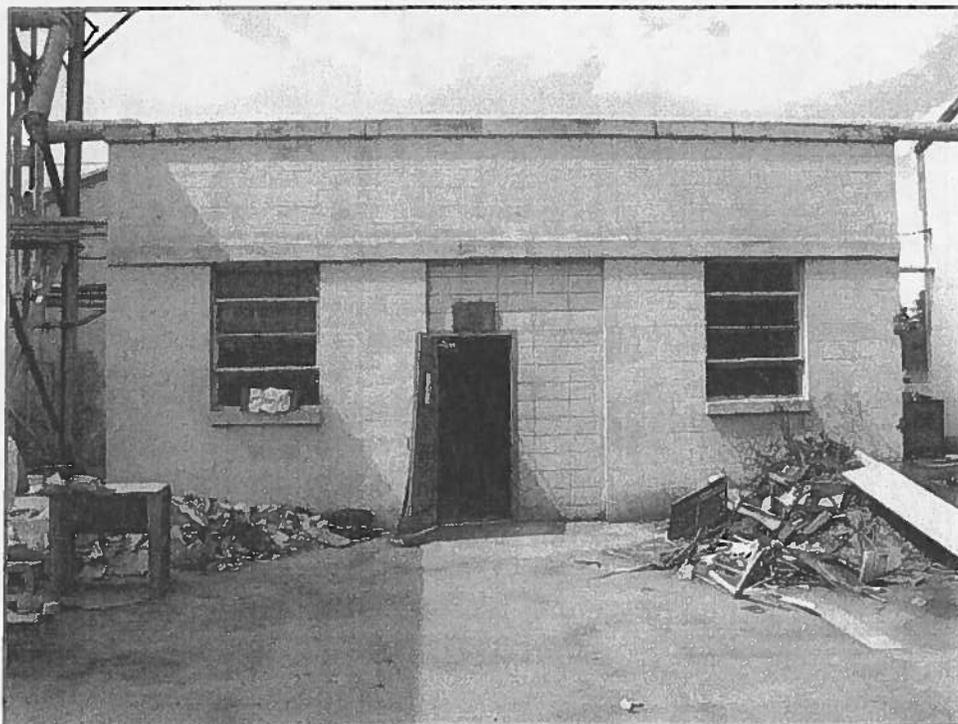
Water Treatment Plant Break Room & Locker Room Structure

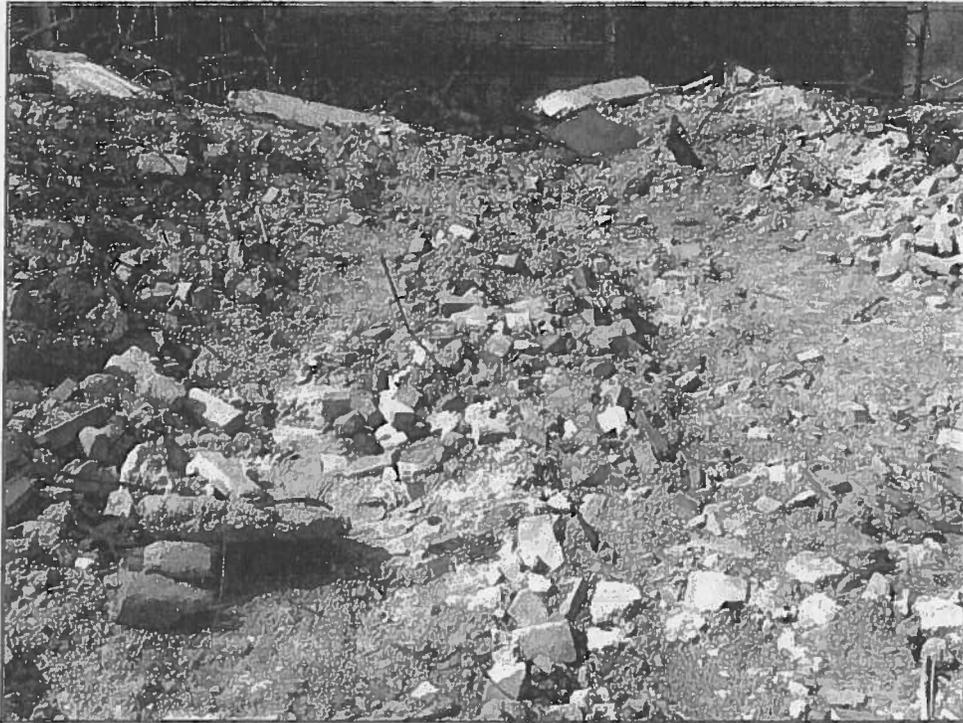
Debris fields containing dispersed quantities of known and/or presumed friable asbestos-containing thermal system insulation debris, in place and in poor condition, would be considered as RACM by NESHAP definition. The known and/or presumed friable asbestos-containing thermal system insulation debris, in its present condition and location, pose a high potential for airborne asbestos fiber exposure.

Boiler Room Exterior – Demolition Rubble South Side of Unit 4

The removal of friable asbestos-containing miscellaneous debris material should be performed by a qualified asbestos abatement contractor under properly controlled conditions in accordance with ADEM and OSHA removal and disposal regulations.

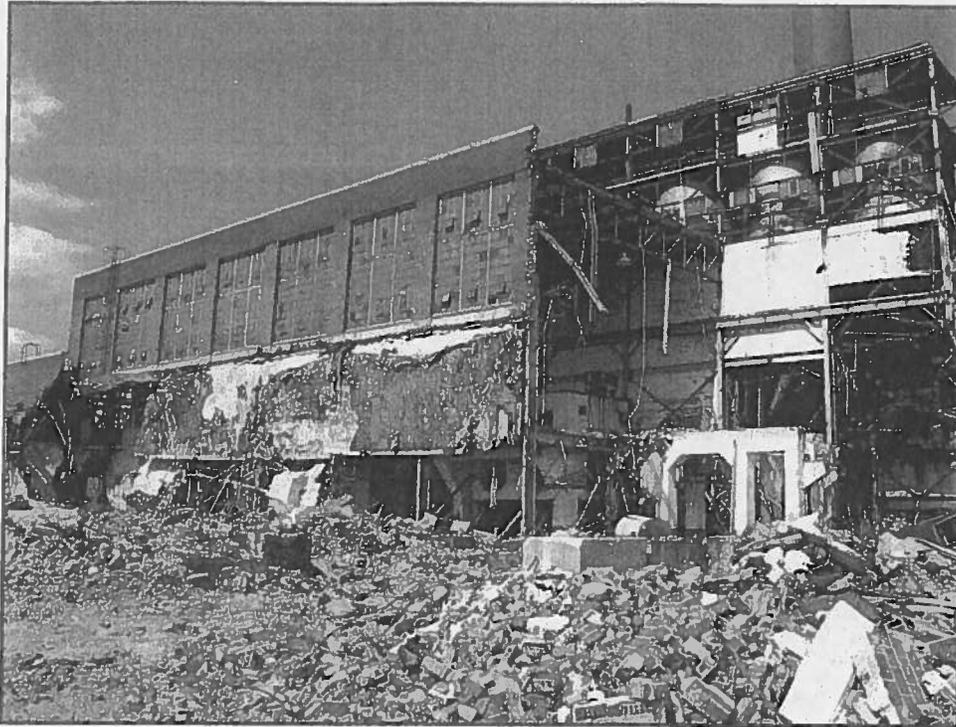
Power House – Northeast View of Pump Room, Turbine Room & Boiler Room Coal Bins

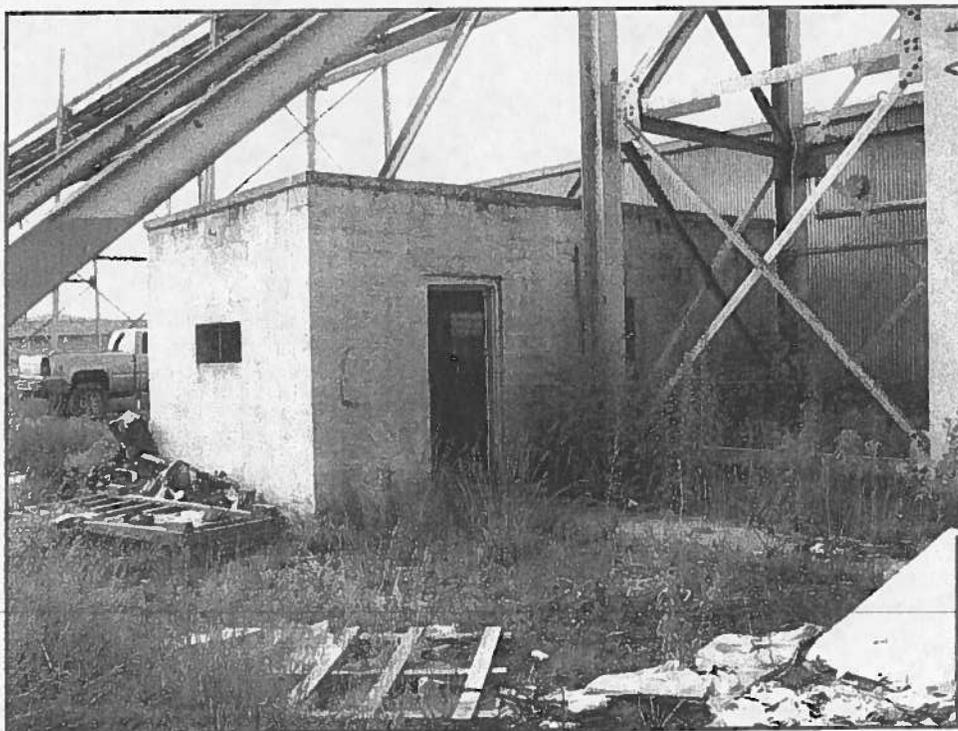
Water Treatment Plant Supervisors Office Structure

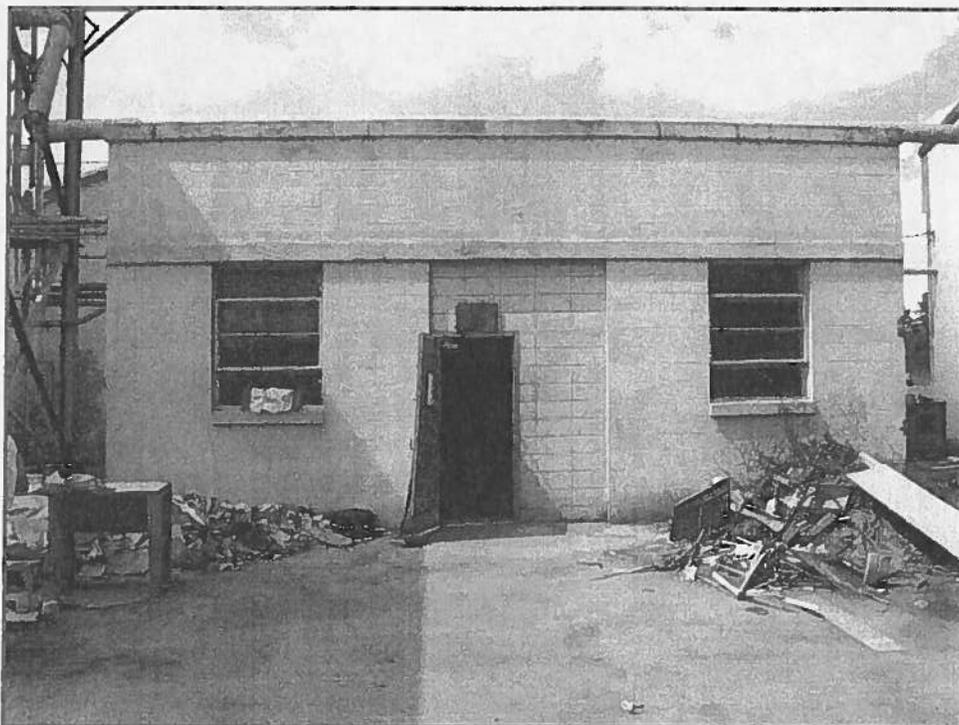
Water Treatment Plant Break Room & Locker Room Structure

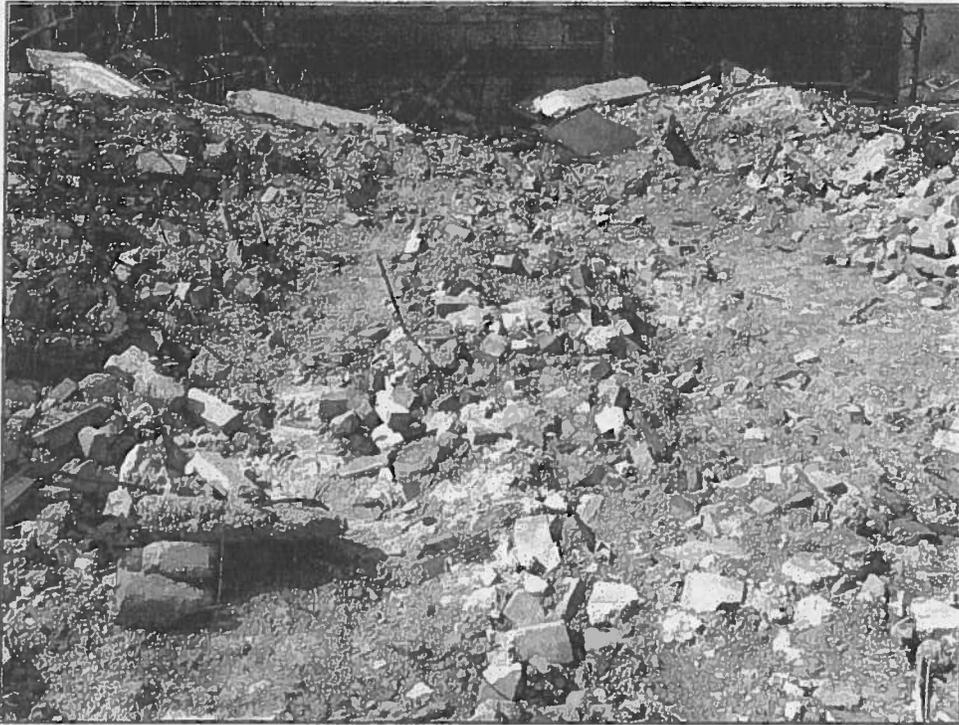
Boiler Room Exterior – Demolition Rubble South Side of Unit 4

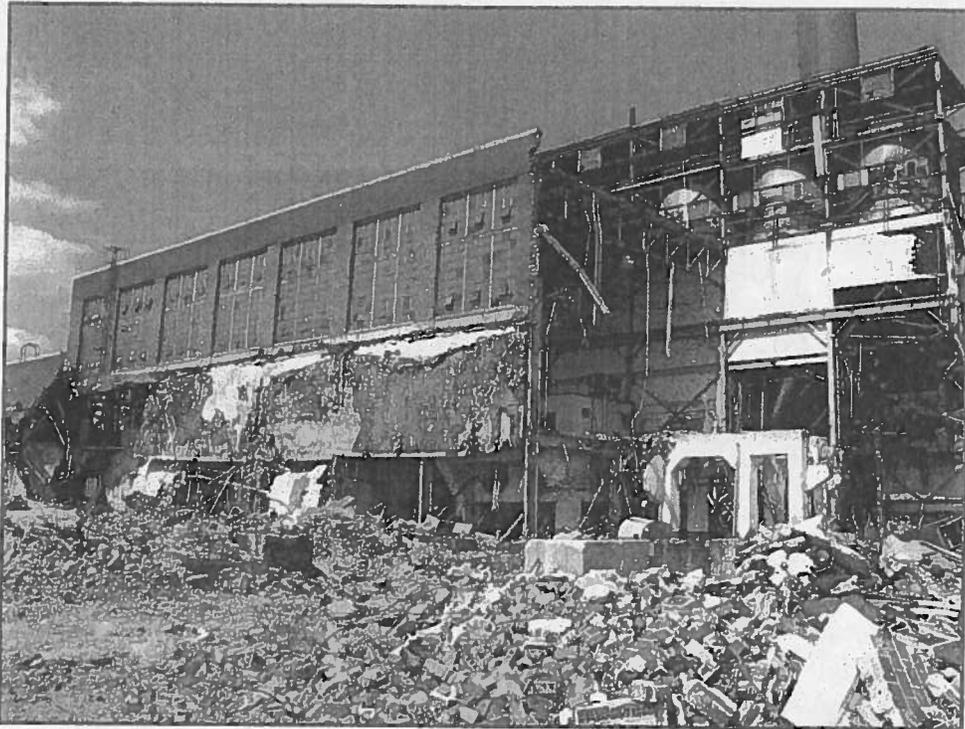
Power House – Northeast View of Pump Room, Turbine Room & Boiler Room Coal Bins

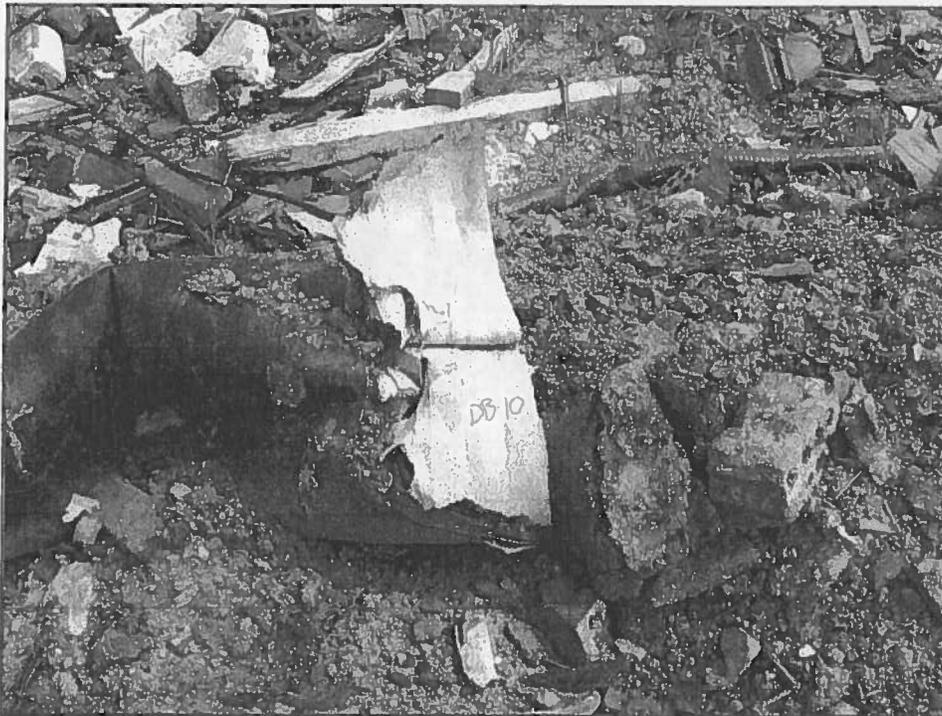
East-West Surveyors Line Sample No. DB-10 – Friable ACM TSI Debris
