MEMORANDUM

RE: Commodore 5 Tunnel Rehabilitation Concept; Creede, Colorado;
D&A Job No. CG-0547.002.00

This updated memorandum is in response to your request of November 29, 2017 to describe a rehabilitation concept for the Commodore 5 Tunnel near Creede, Colorado which could be implemented as a time critical removal action (TCRA). This rehabilitation would complement the Flow Control Interim Action and other options evaluated in the *Focused Feasibility Study for Flow Control; Nelson Tunnel/Commodore Waste Rock Pile NPL Site* by HDR and Deere & Ault Consultants Inc. dated March 27, 2017. The goal of this rehabilitation would be to maintain access from the portal to the Del Monte Shaft, secure the ground to keep material from impounding water in the Commodore 5, and maintain access to the Nelson Tunnel until the longer-term remediation is implemented (assumed to be within 15 years). This memo is intended to be the first step in developing plans for the rehabilitation of the Commodore 5 Tunnel as a TCRA.

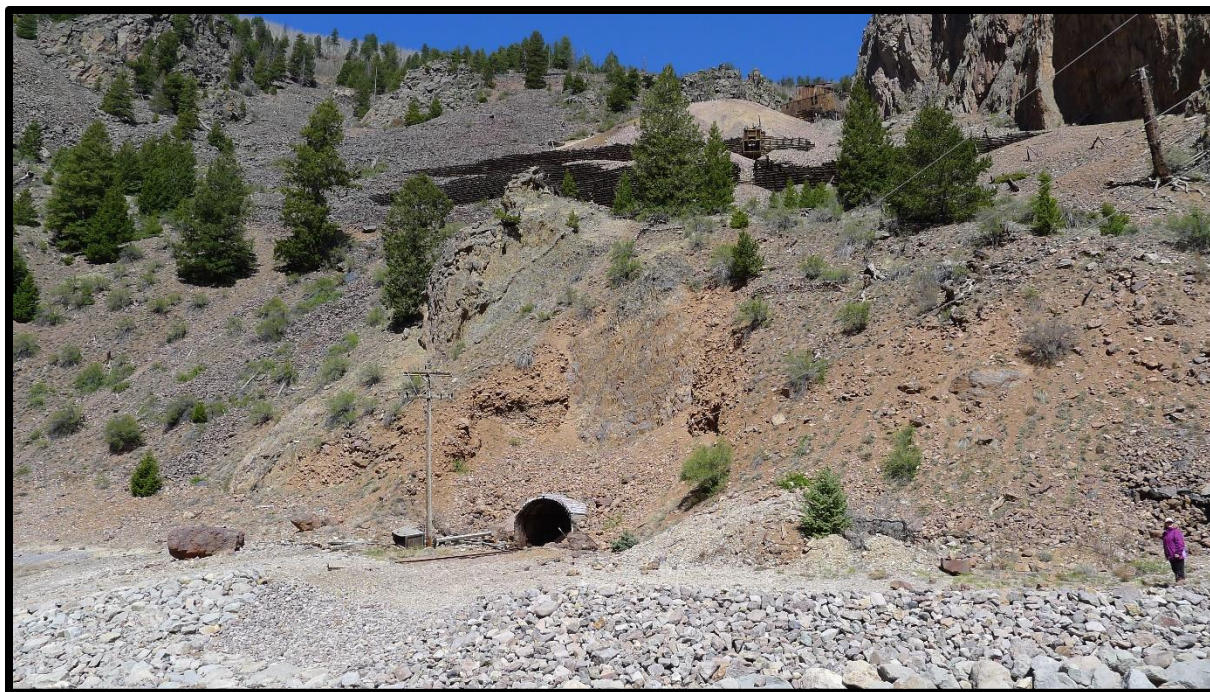
Photo 4: Commodore 5 Portal Area close up

aging wooden planks. Access to the bridge is a narrow trail, inadequate for equipment larger than a small skid steer loader. The contractor should install a temporary bridge of appropriate size and capacity for their equipment and to accommodate seasonal creek flow changes. Other portal area work such as installing generators, lights, storage, offices, etc., would be included in a mobilization cost. See **Photos 1-4**.

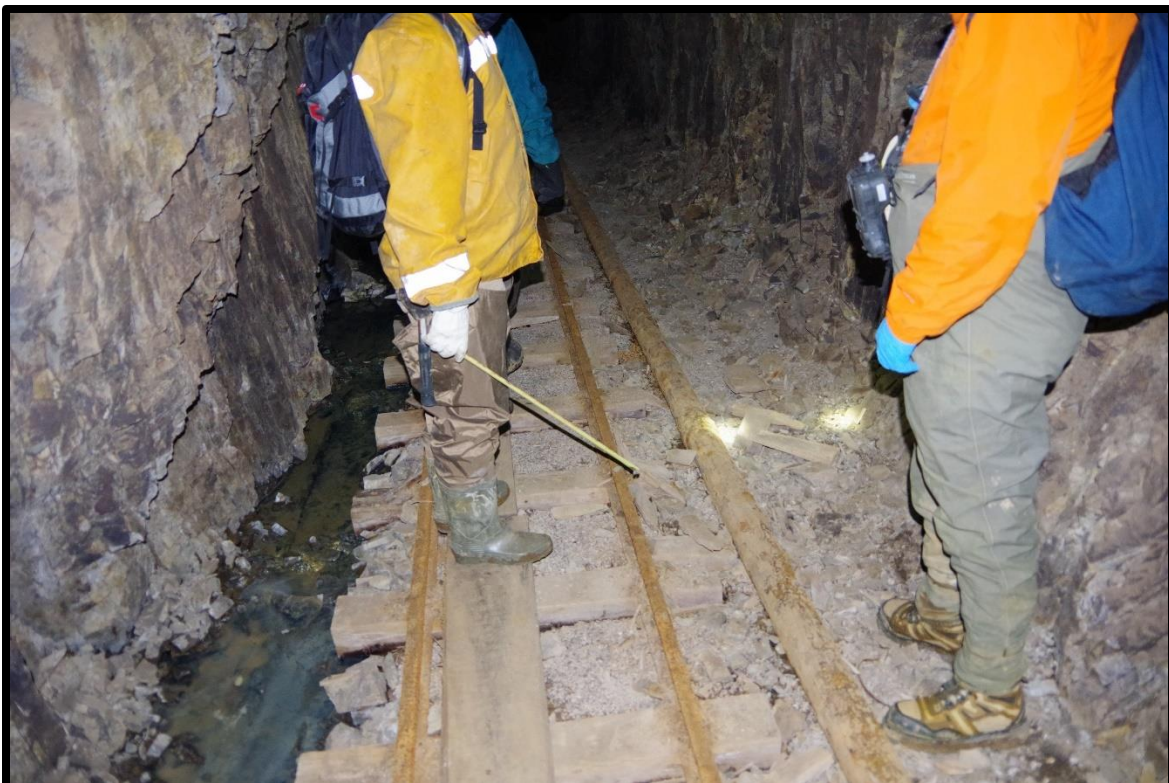
Photo 8: Typical rail, ditch, and invert in Commodore 5 Cross Cut

Rehabilitation in this segment will consist of scaling, mucking, debris removal, ditch cleaning, track repair, replacement of the portal gate, and the installation of two air doors. The Manhattan Drift and another smaller room, near station 12+00, can serve as storage during construction.

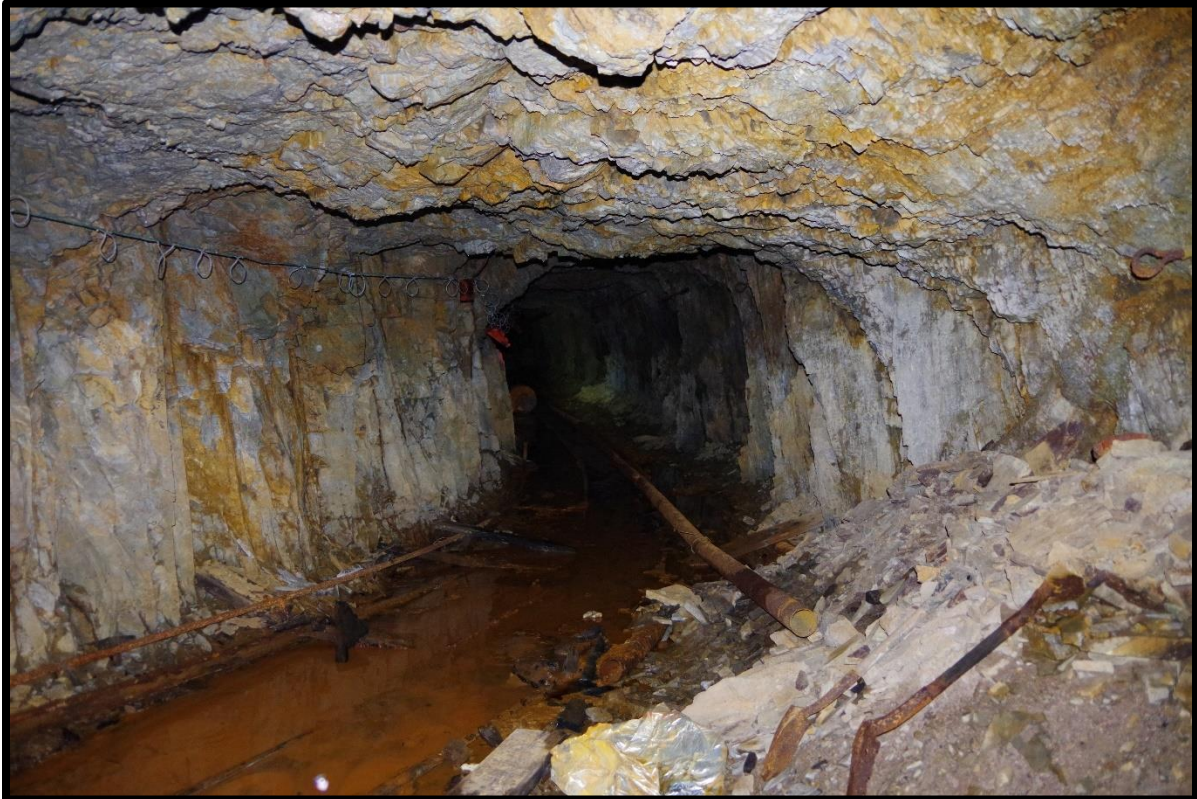
Photo 9: Manhattan Drift

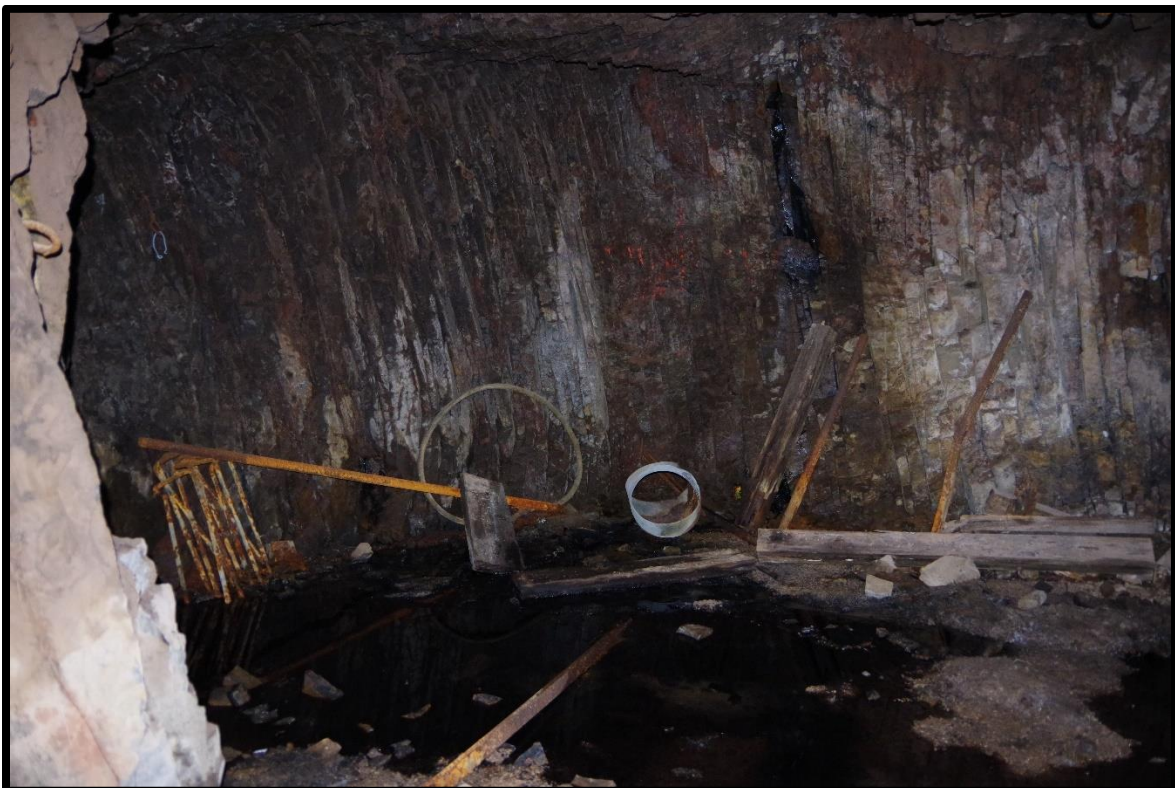
Photo 10: Underground storage chamber along Commodore 5 Cross Cut

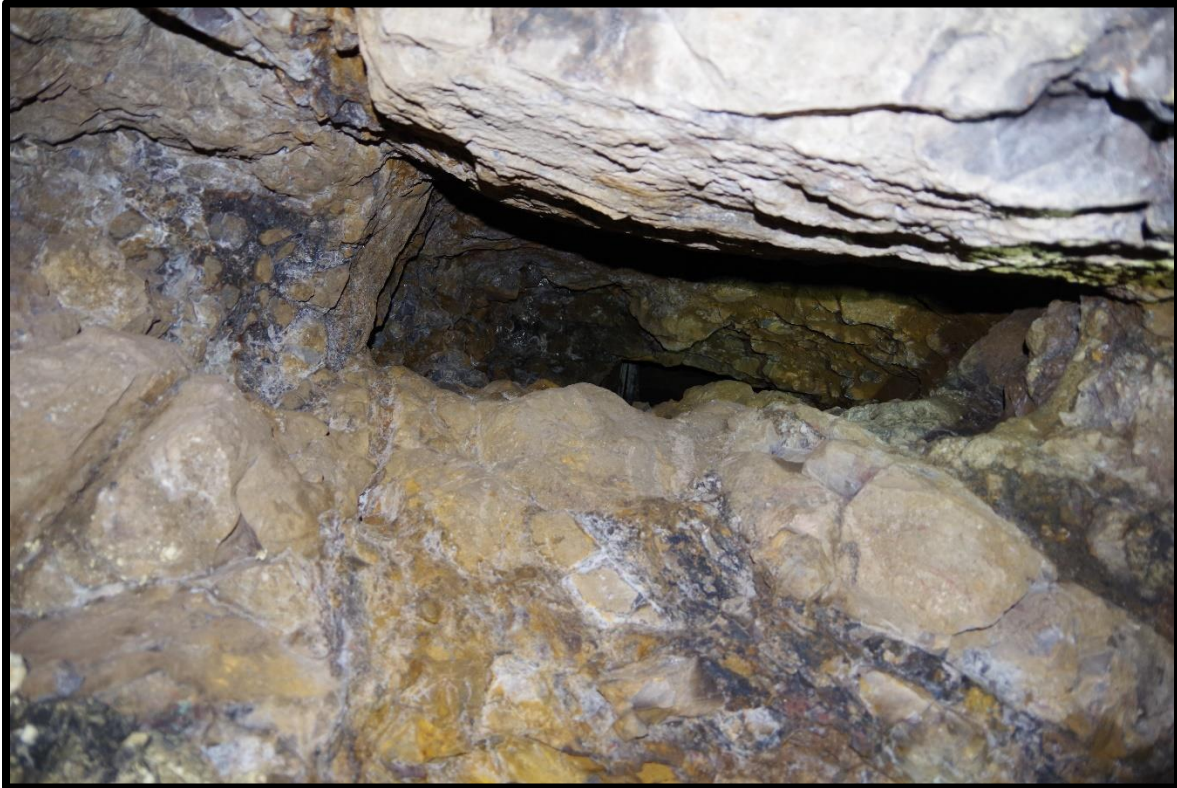
Photo 15: Looking up stope at Daylight intersection

While the rock is generally good, the large span of the intersection and importance of keeping this area accessible leads us to recommend scaling, pattern bolting (6' long), and installing wire mesh. The same applies at the wide section where the collapsed raise from the Nelson intersects the floor (22+10). Two small but high stopes in the middle of this segment should have steel sets, lagging, and foam installed underneath them to limit raveling.

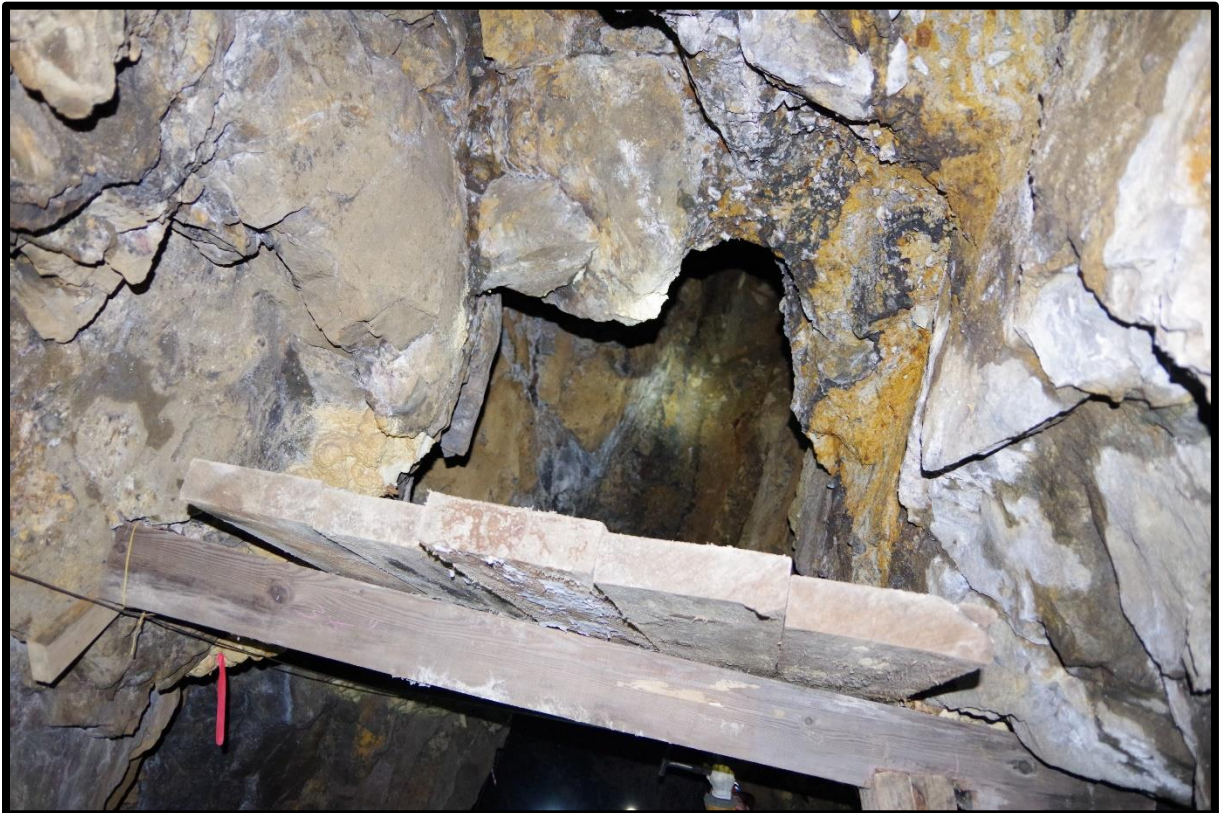
Photo 19: Raise above Daylight Winze: Note Amethyst Vein in center

Significant work is also needed at the Daylight Winze and the raise above it. Due to its importance of acting as the last drain into the Nelson Tunnel, the Daylight Winze should be fully rehabilitated by scaling, bolting, and installing new ladders and landings made of non-decaying or corroding material such as fiber reinforced plastic (FRP). This work would take place above the Nelson Tunnel without impacting the impounded mine pool areas. A cover capable of supporting vehicle traffic and allowing water inflow should also be installed. We anticipate the cover consisting of a concrete collar with coated steel beam supports and grated FRP cover.

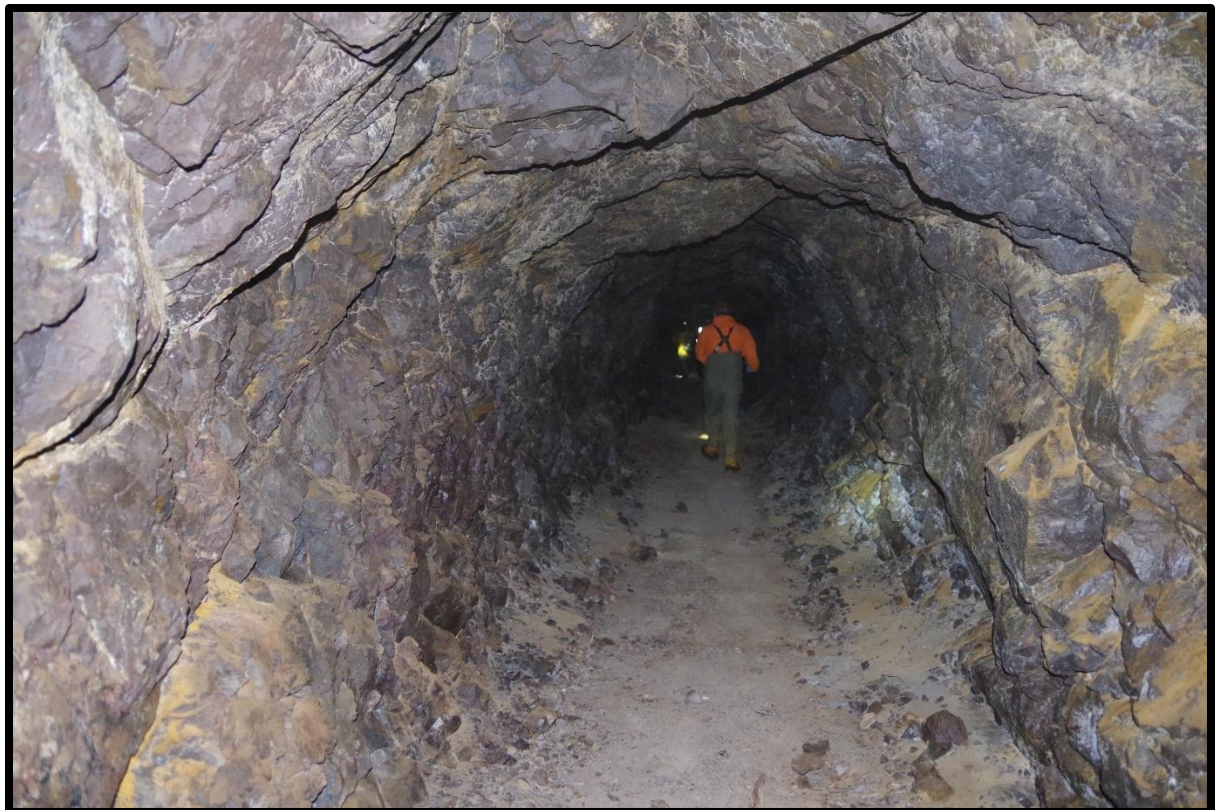
Photo 22: McClure Cross Cut typical view

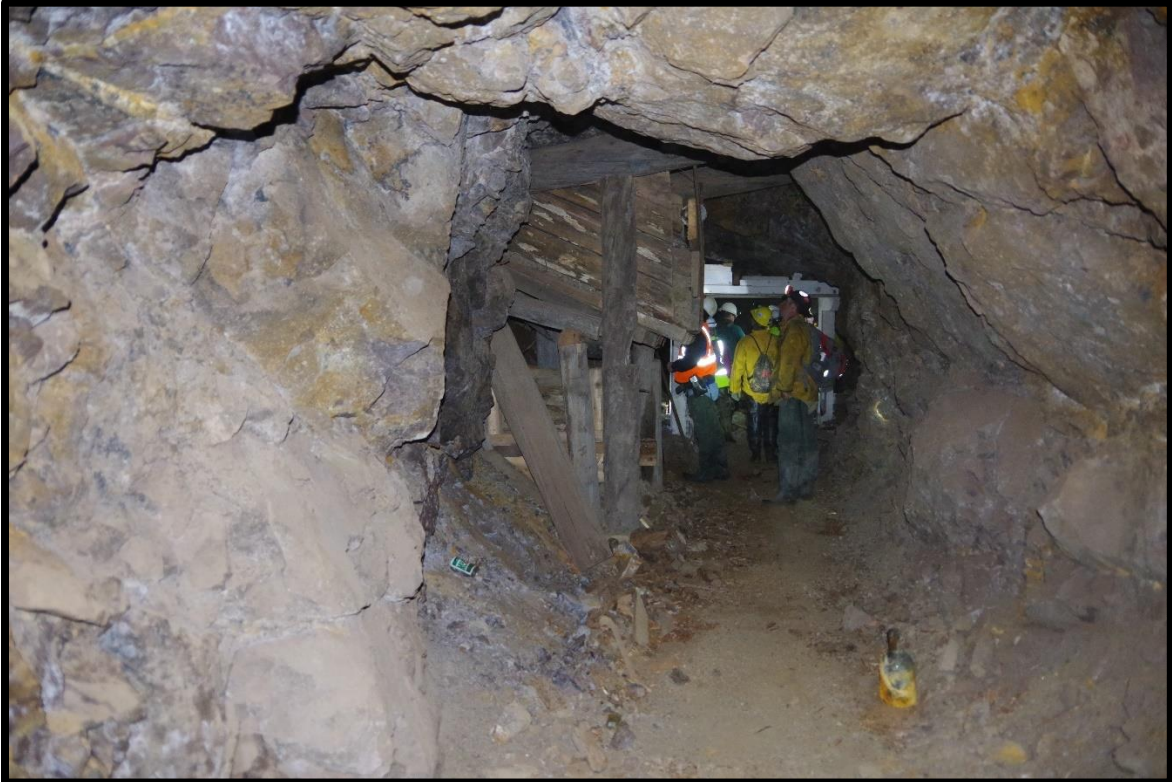
Photo 23: McClure Cross Cut ore chute

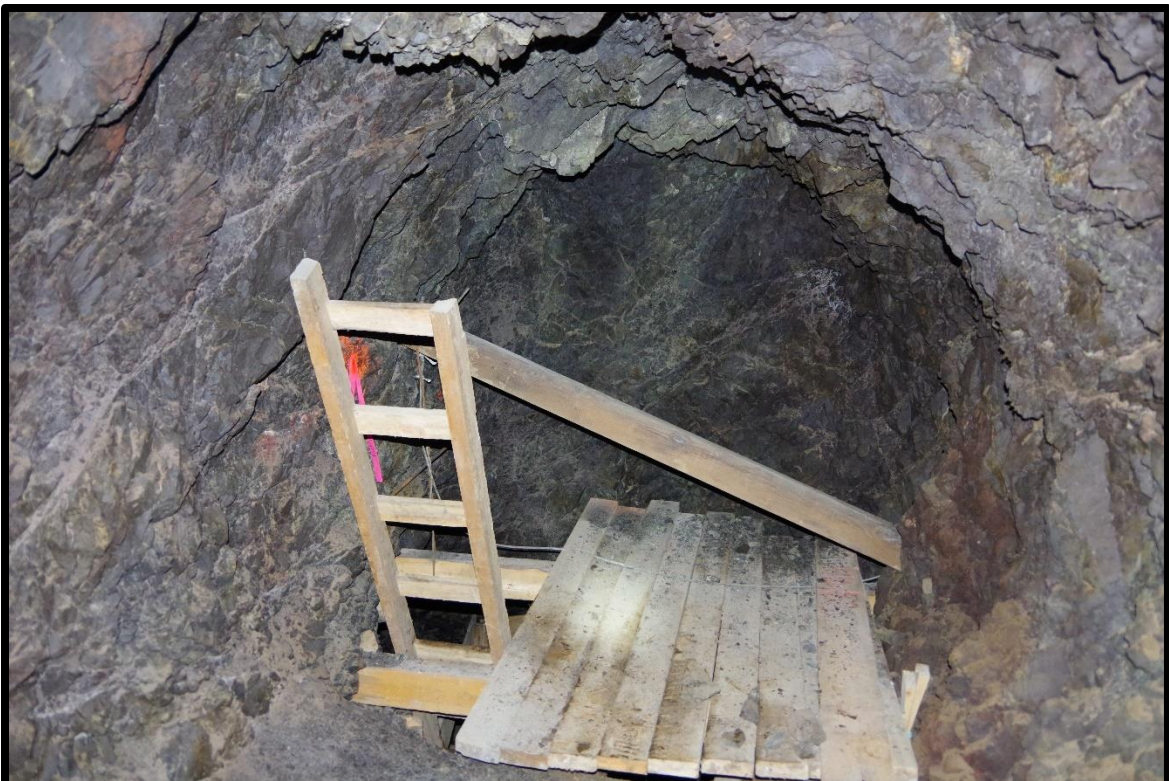
Photo 24: Top of Bachelor Shaft

Based on our observations, only minimal cleanup work will be required in the McClure Cross Cut area. The moldy canopy may have to be removed and replaced with bolts and wire mesh, depending on the ground conditions behind it. The bulk of the work will be in the Bachelor Shaft where the untreated wood ladders and landings should be replaced with fiber glass reinforced plastic ladders and landings, anchored into the rock wall. **Figure 5** shows the Bachelor Shaft in cross section. Note that the work would be limited to the Bachelor Shaft and landing, without impacting or accessing the Nelson Tunnel.

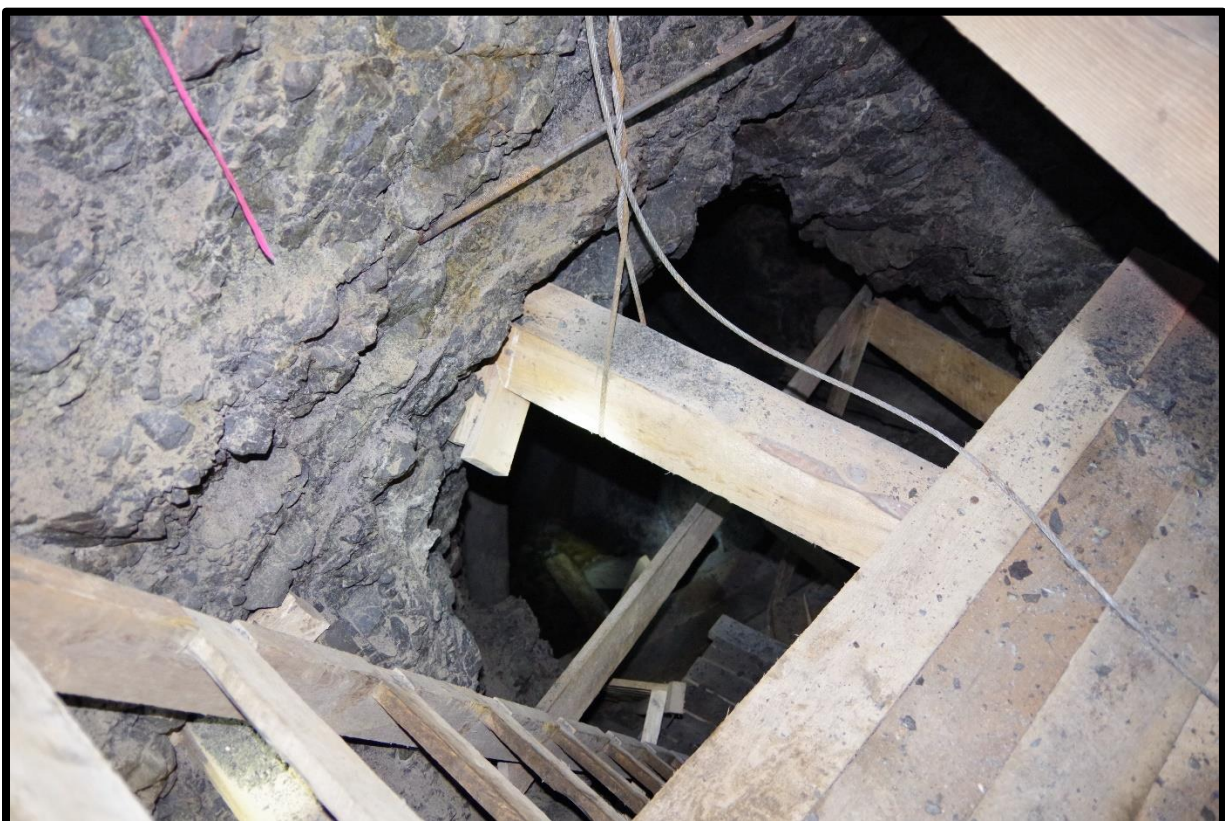
Photo 25: Looking down into Bachelor Shaft; Small first landing visible

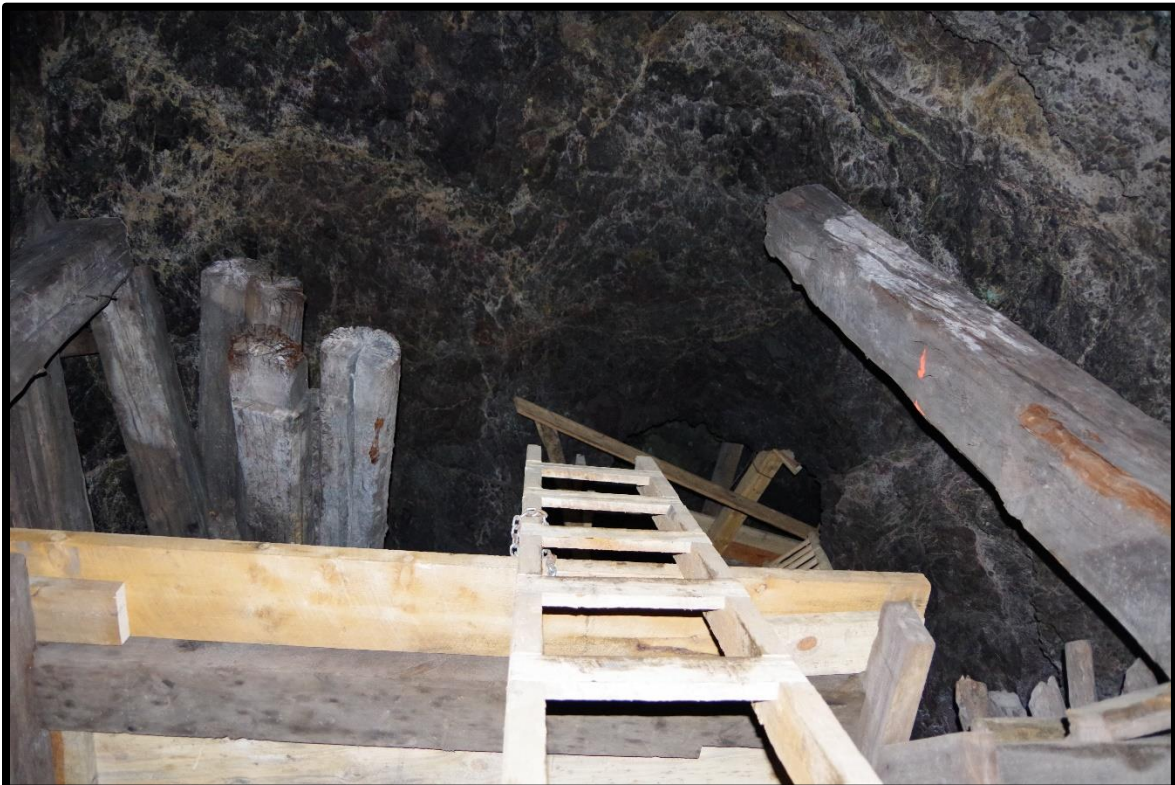
Photo 27: Bachelor Shaft looking up

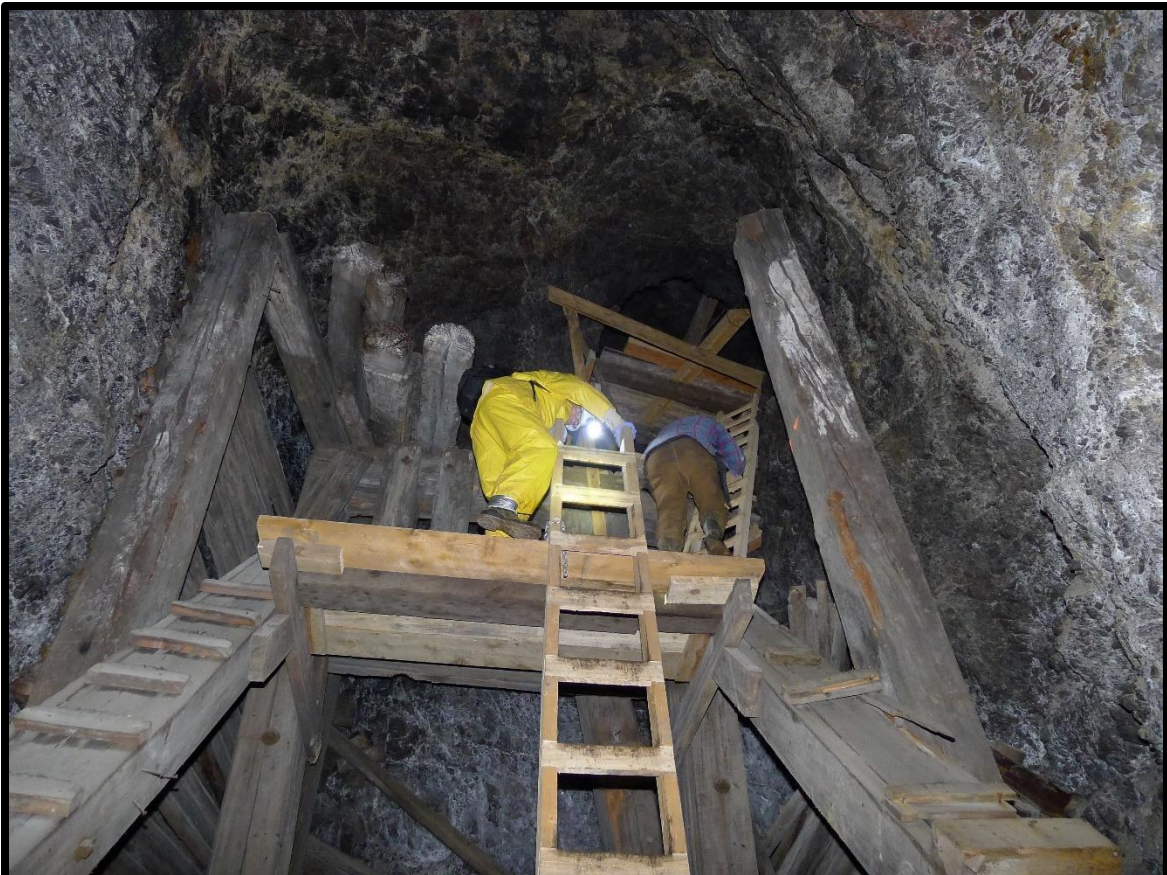
Photo 28: : Bachelor Shaft looking up to second landing

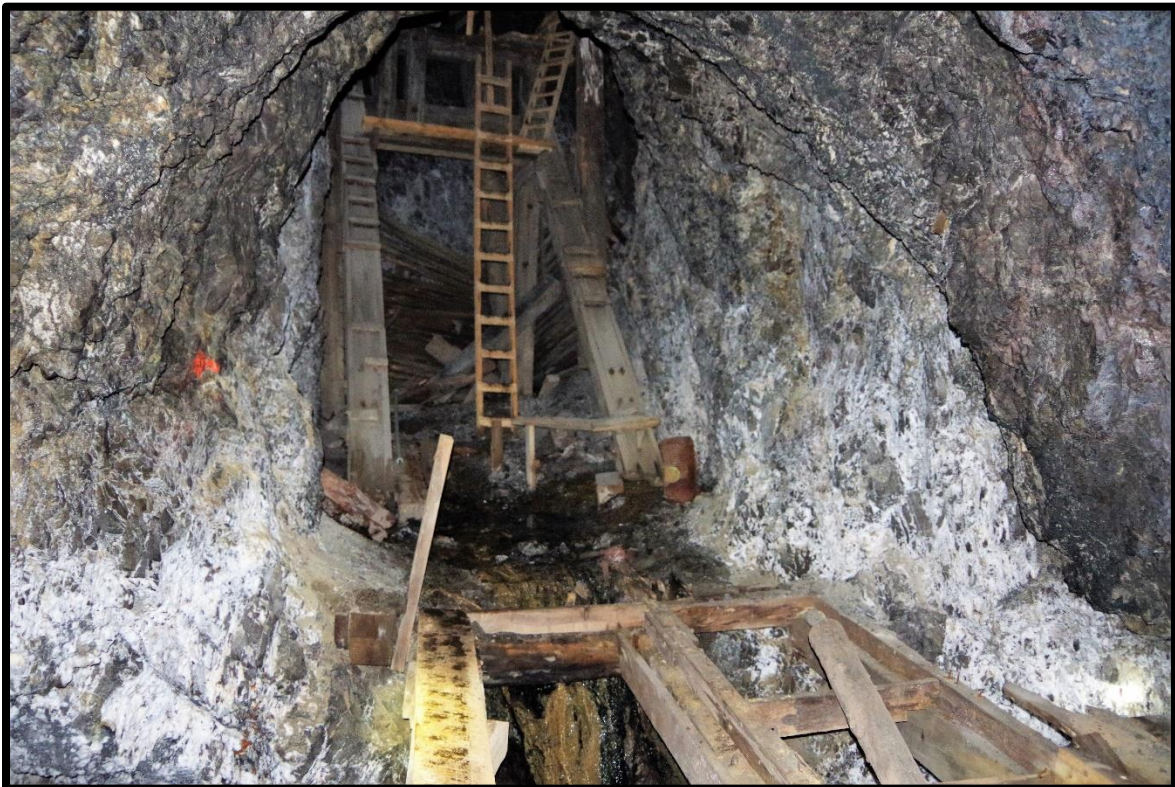
Photo 29: Bachelor Shaft bottom and second landing seen from far side of Nelson Tunnel

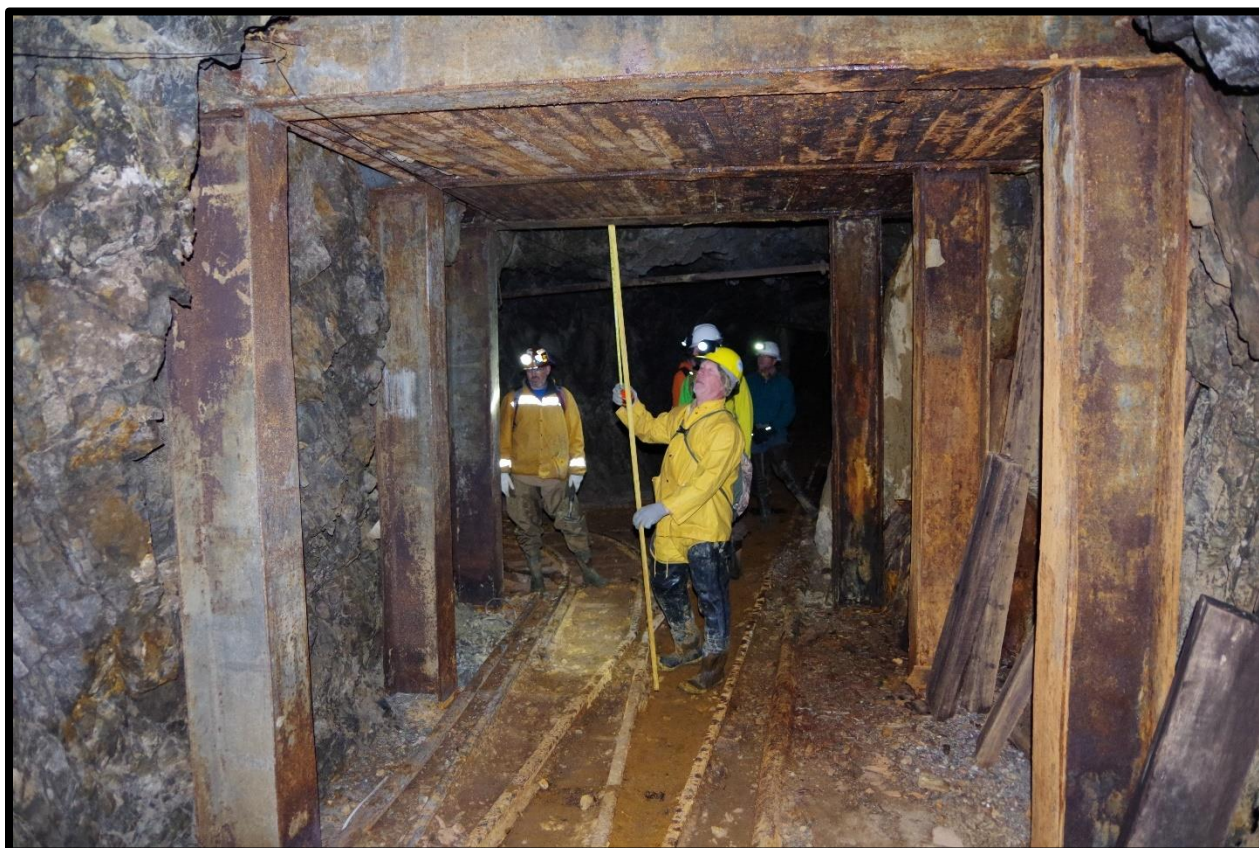
Photo 33: Measuring Archimedes Raise dimensions 26+64

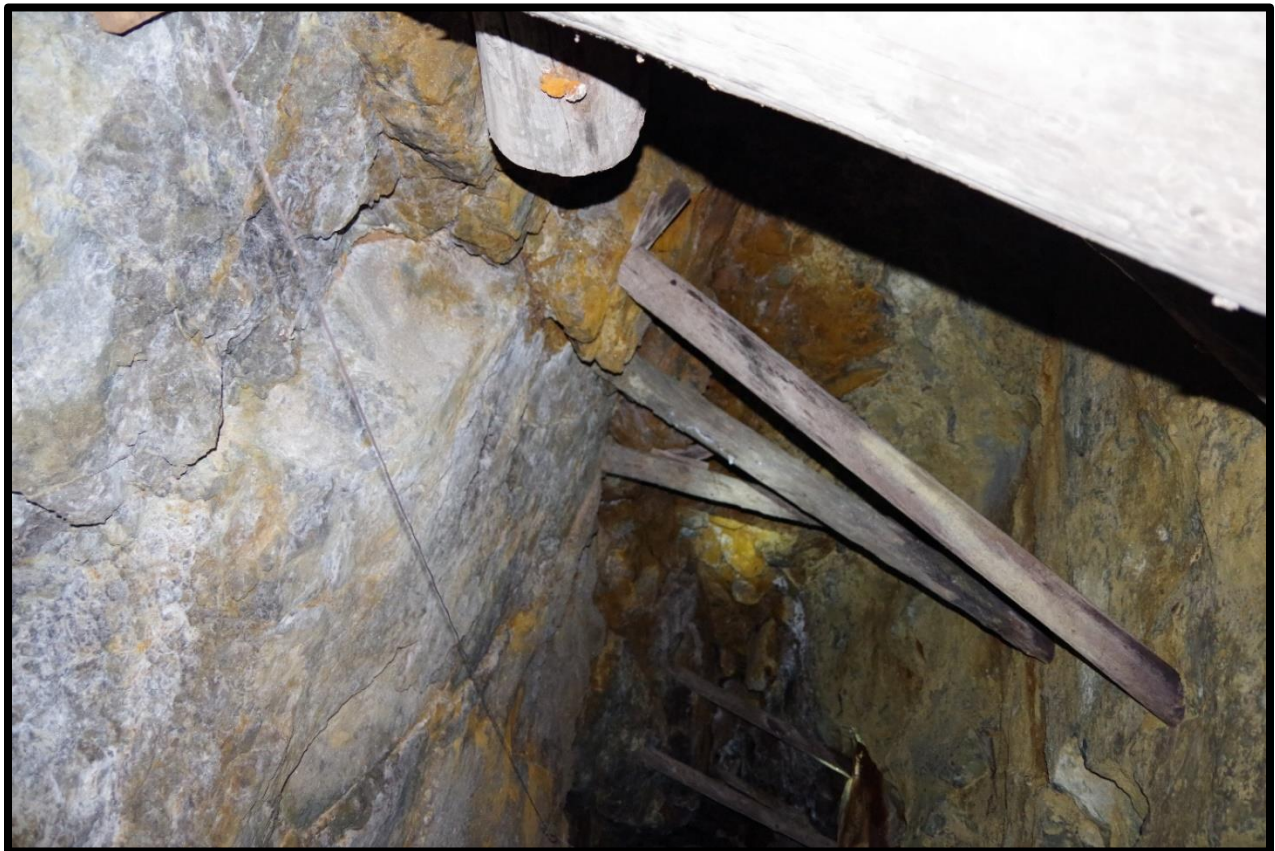
Photo 35: Typical timber stulls; Note hanging wall, Amethyst vein, and foot wall

Rehabilitation work in this segment will require considerable time, cost, and effort. While the removal of the wood and rock debris from the floor is a significant undertaking, the main cost will be in the installation of steel stulls and steel sets. At numerous locations, the back has been stoped up and supported with timber posts. Most of these are rotting and need to be replaced. Removing and disposing of the timber will also be a major cost factor, particularly if they must be removed from site. There are also several raises that ravel down material. For safety and to keep the Commodore 5 open, these areas will need lagged steel sets with foam backfill across the openings. For safety, this work will have to be carried out sequentially from the Daylight Winze to the Del Monte Raise.

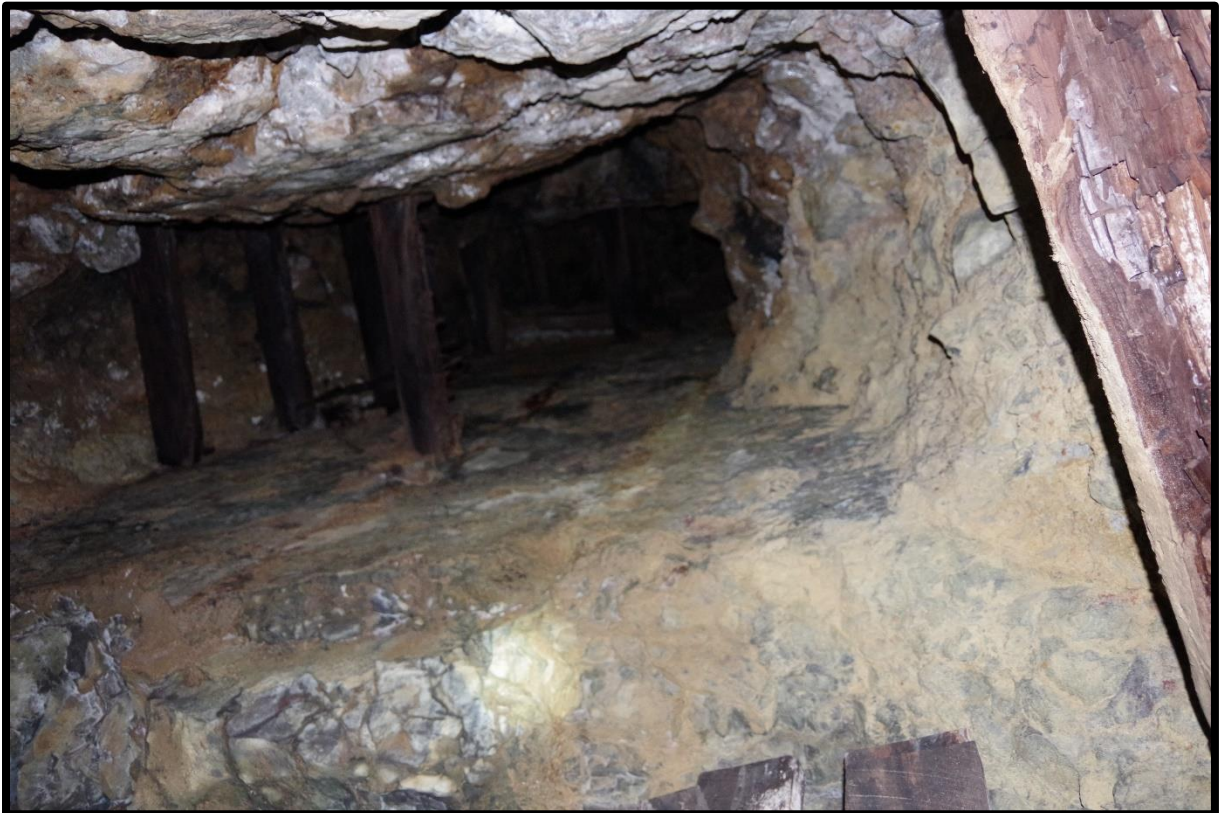
Photo 37: Looking up raise at 30+20

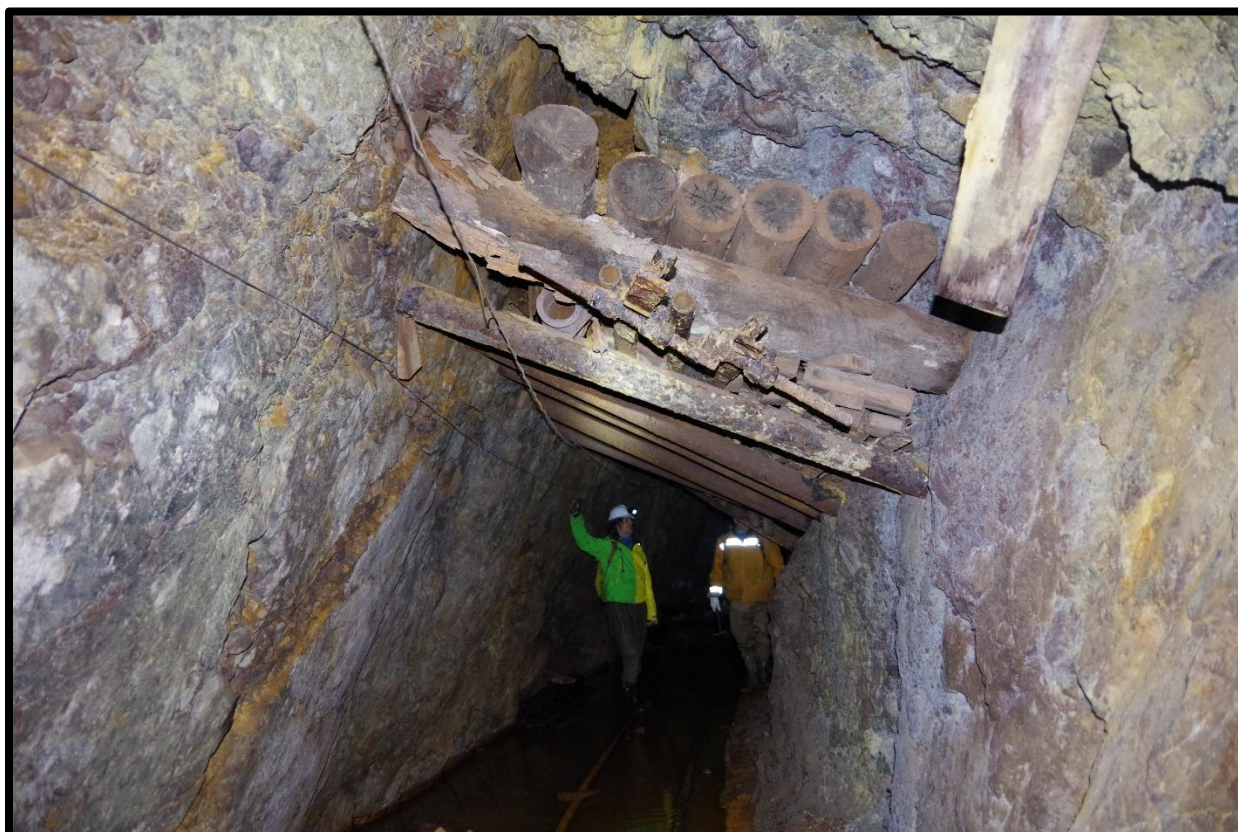
Photo 39: Steel pipe stulls near 32+20; Note pipe cribbing

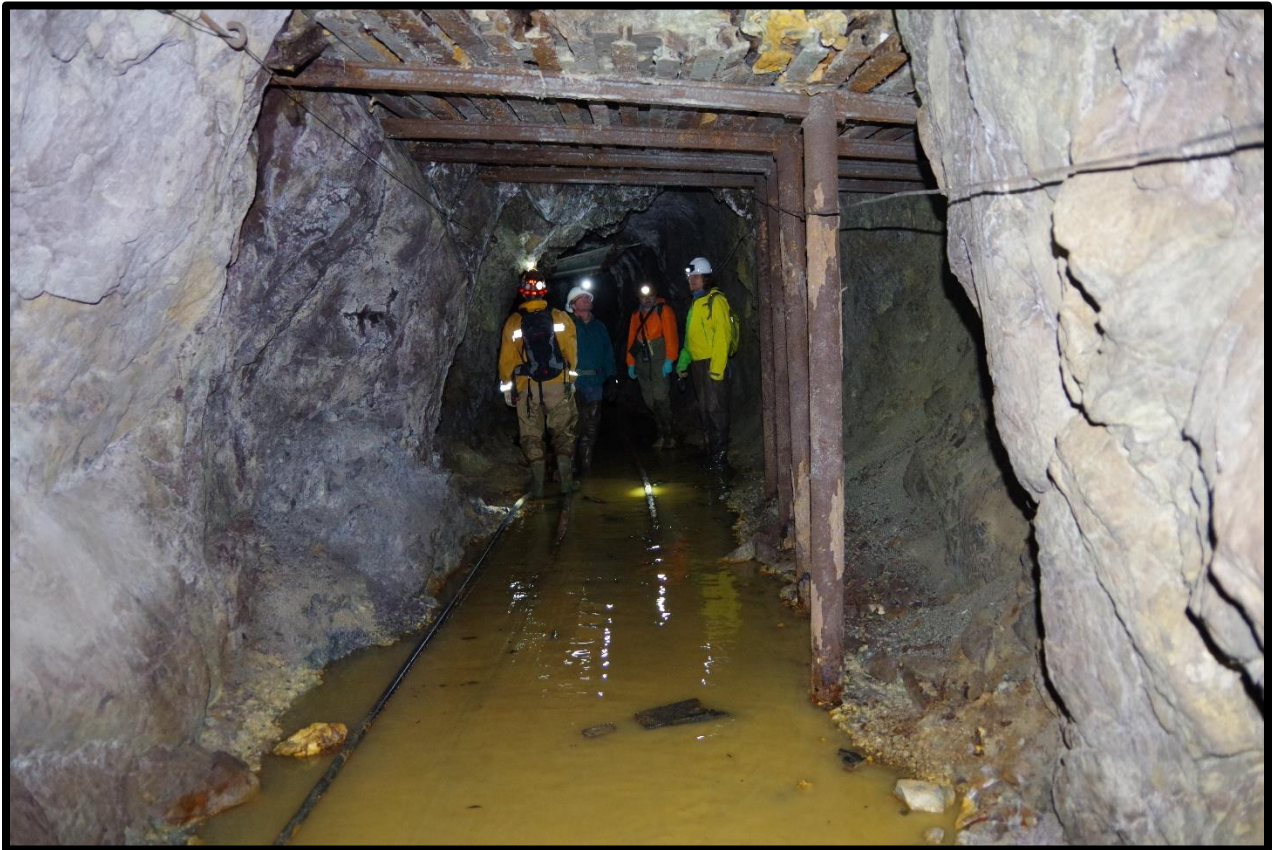
Photo 45: Raise with steel sets and rail near 38+70

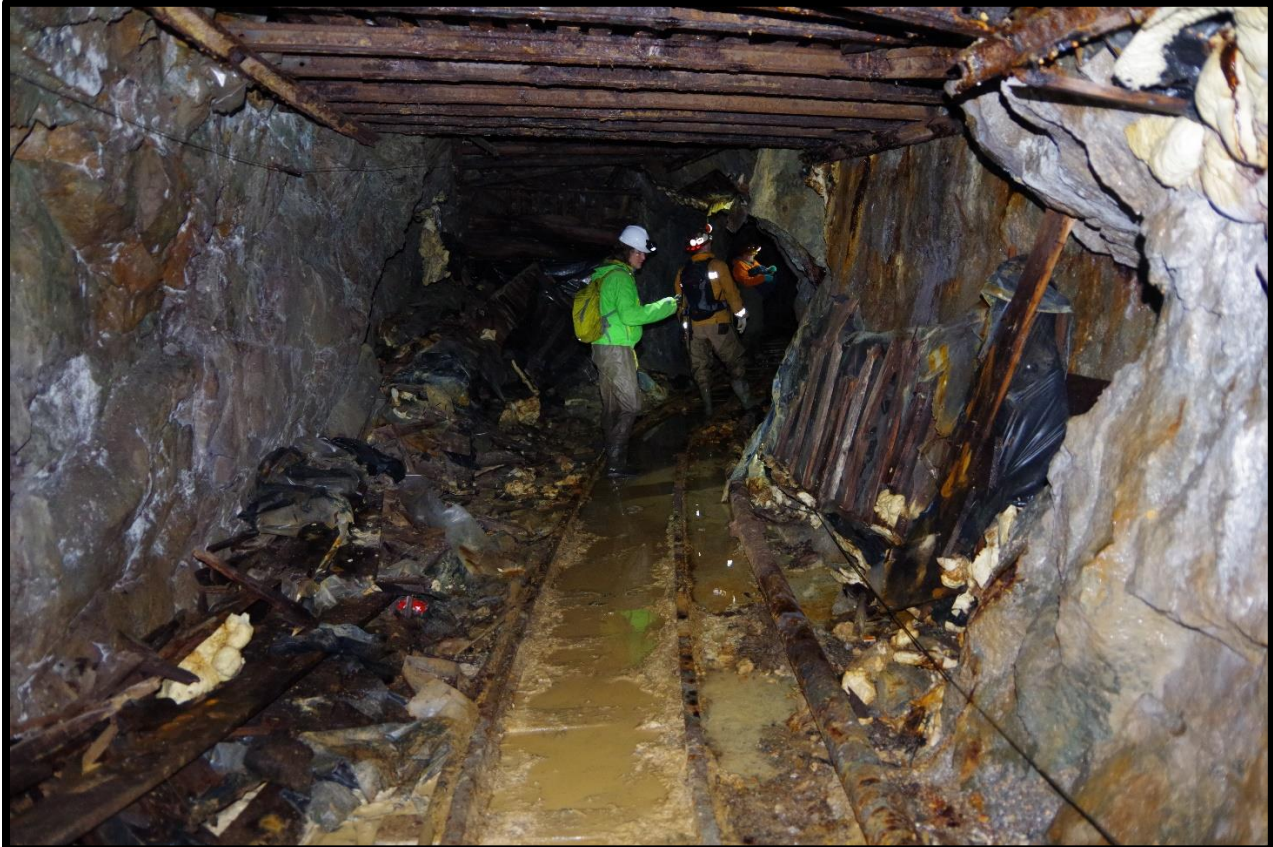
Photo 46: Abandoned heading near 41+00; Drift moves into foot wall

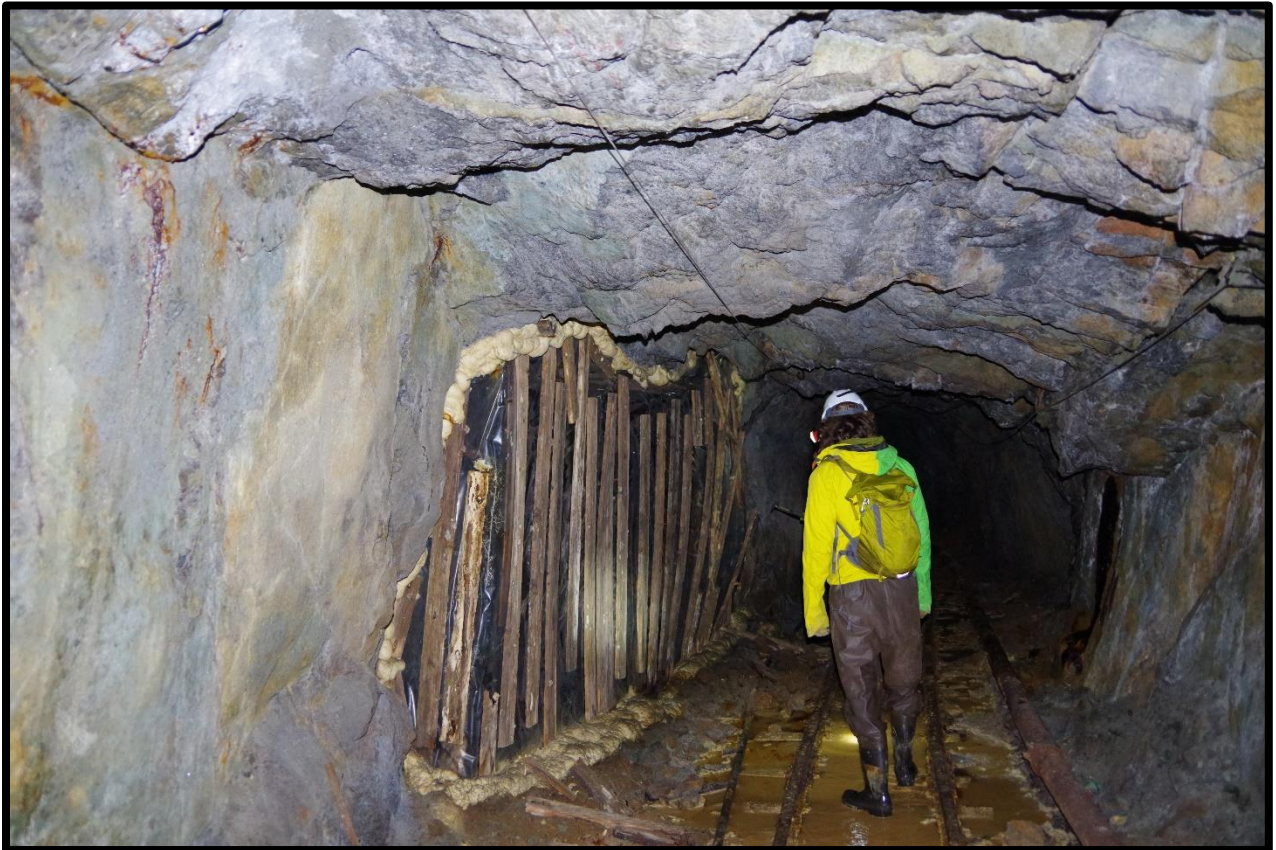
Photo 47: Sealed opening in left rib near 41+50; Loose debris is behind it

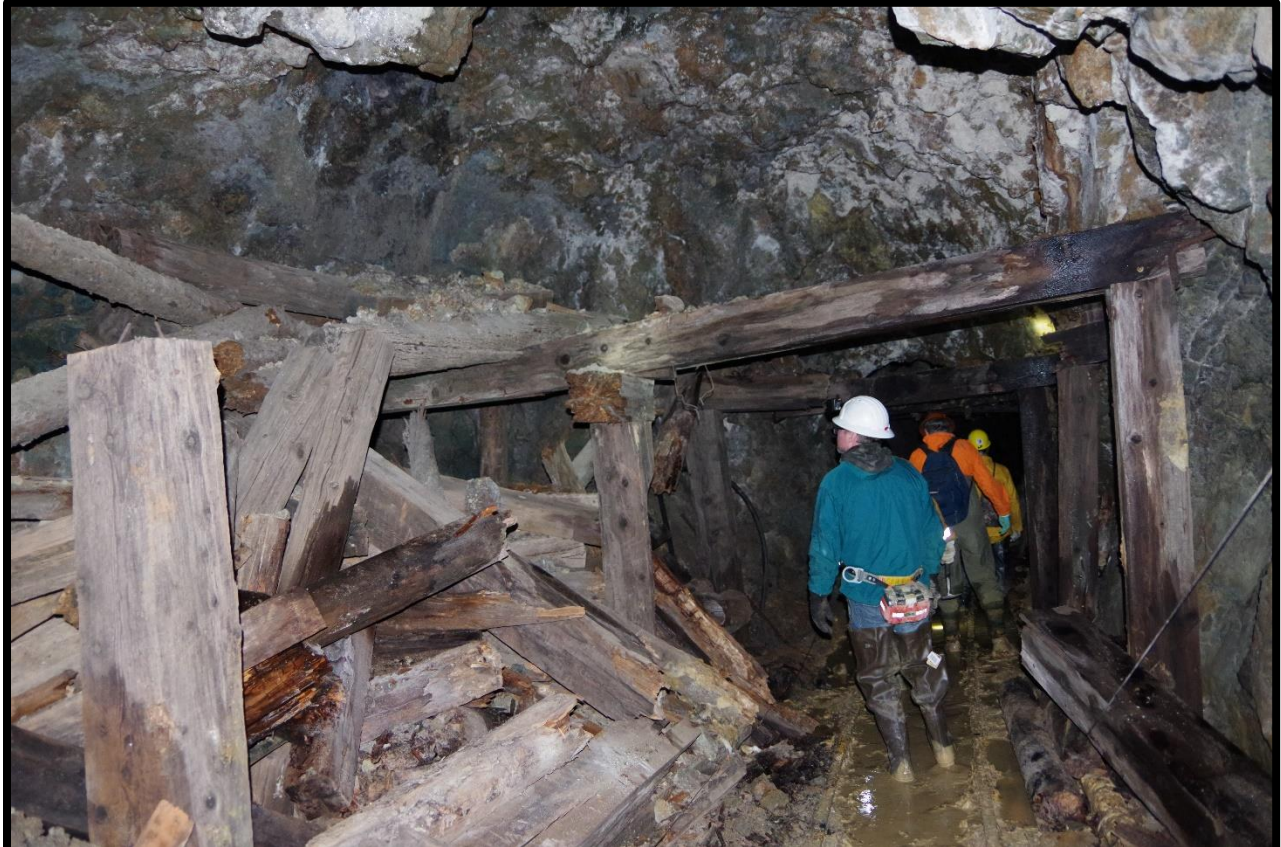
Photo 48: Large chamber and drift in left rib near 42+79
