MEMORANDUM

RE: Commodore 5 Tunnel Rehabilitation Concept; Creede, Colorado;
D&A Job No. CG-0547.002.00

This updated memorandum is in response to your request of November 29, 2017 to describe a rehabilitation concept for the Commodore 5 Tunnel near Creede, Colorado which could be implemented as a time critical removal action (TCRA). This rehabilitation would complement the Flow Control Interim Action and other options evaluated in the *Focused Feasibility Study for Flow Control; Nelson Tunnel/Commodore Waste Rock Pile NPL Site* by HDR and Deere & Ault Consultants Inc. dated March 27, 2017. The goal of this rehabilitation would be to maintain access from the portal to the Del Monte Shaft, secure the ground to keep material from impounding water in the Commodore 5, and maintain access to the Nelson Tunnel until the longer-term remediation is implemented (assumed to be within 15 years). This memo is intended to be the first step in developing plans for the rehabilitation of the Commodore 5 Tunnel as a TCRA.

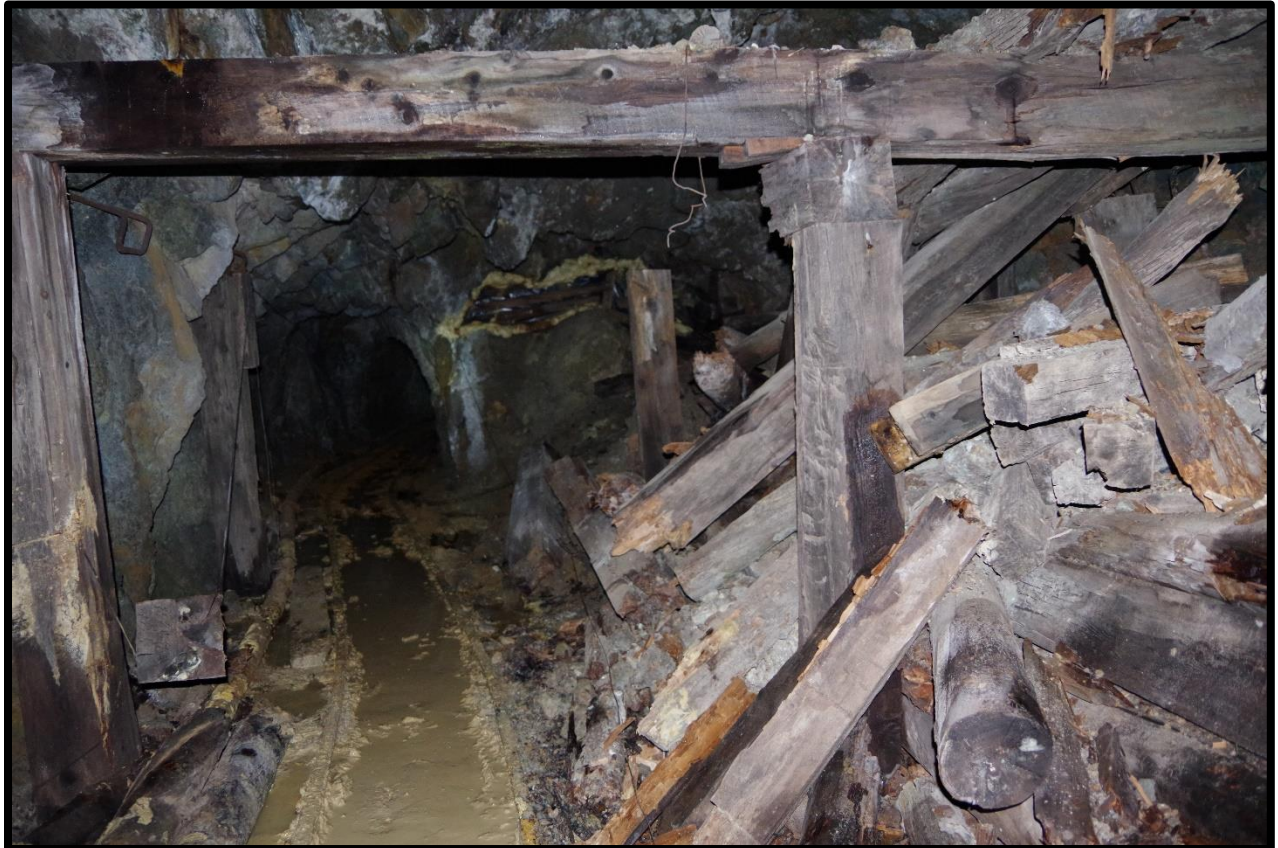
Photo 49: Large chamber and drift in left rib near 42+79 looking outby; Note timber and other debris

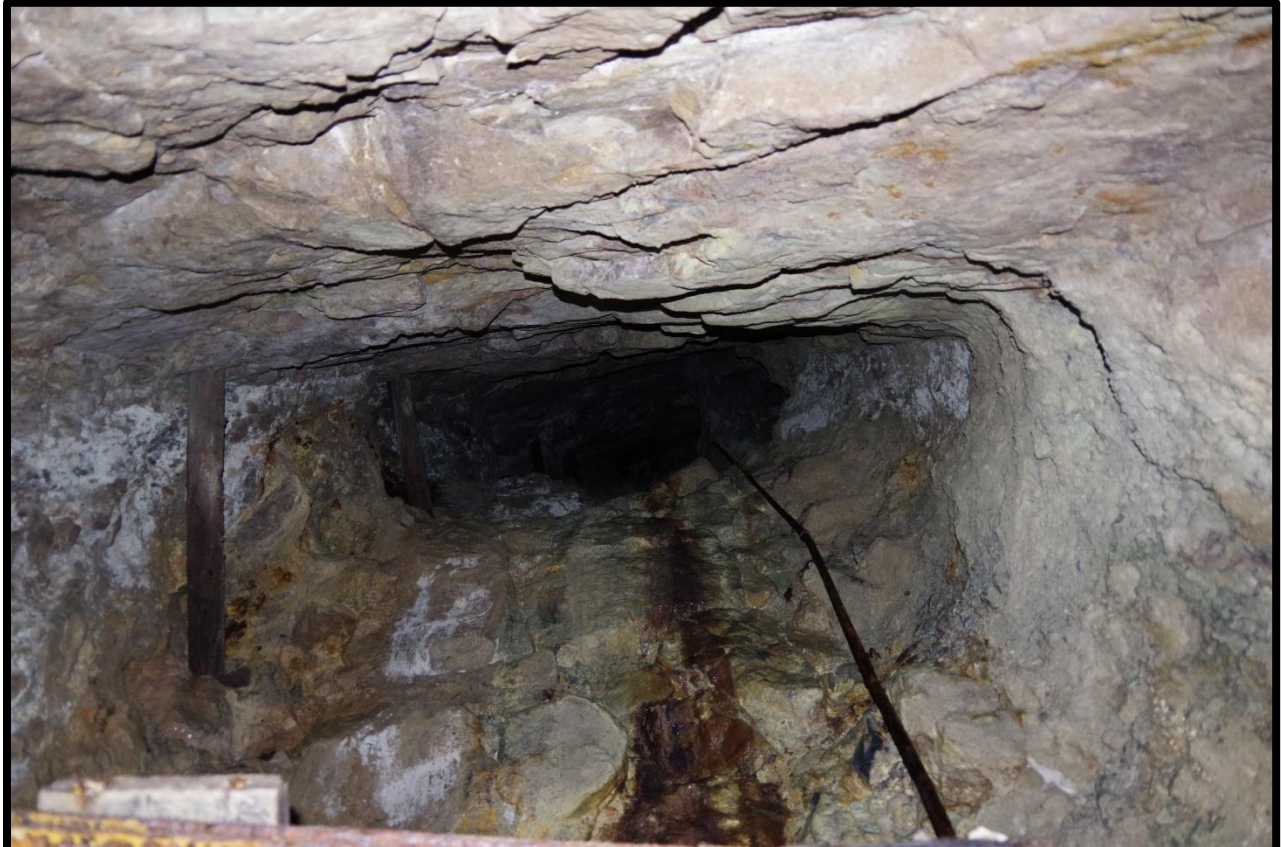
Photo 52: Looking up raise near 44+00

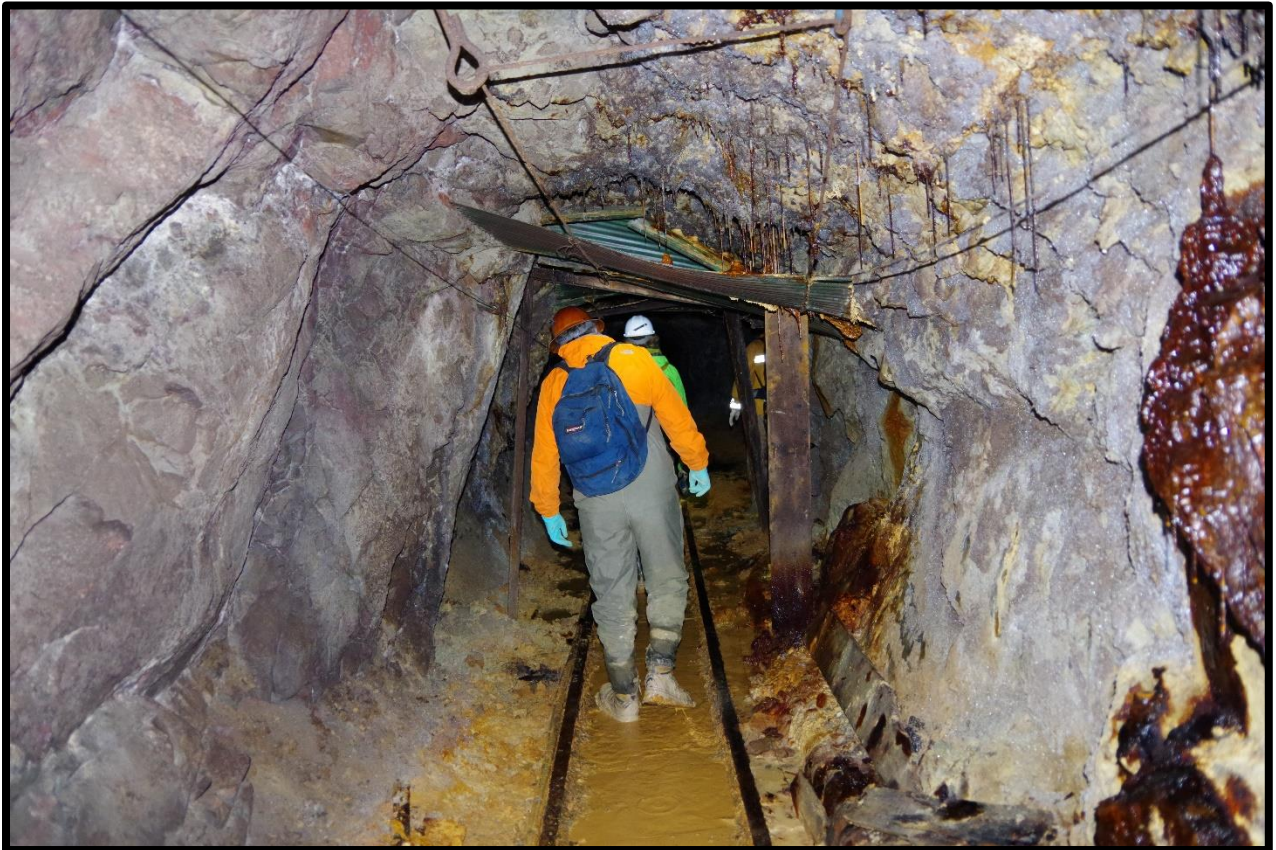
Photo 55: Drip pan in back near 45+45

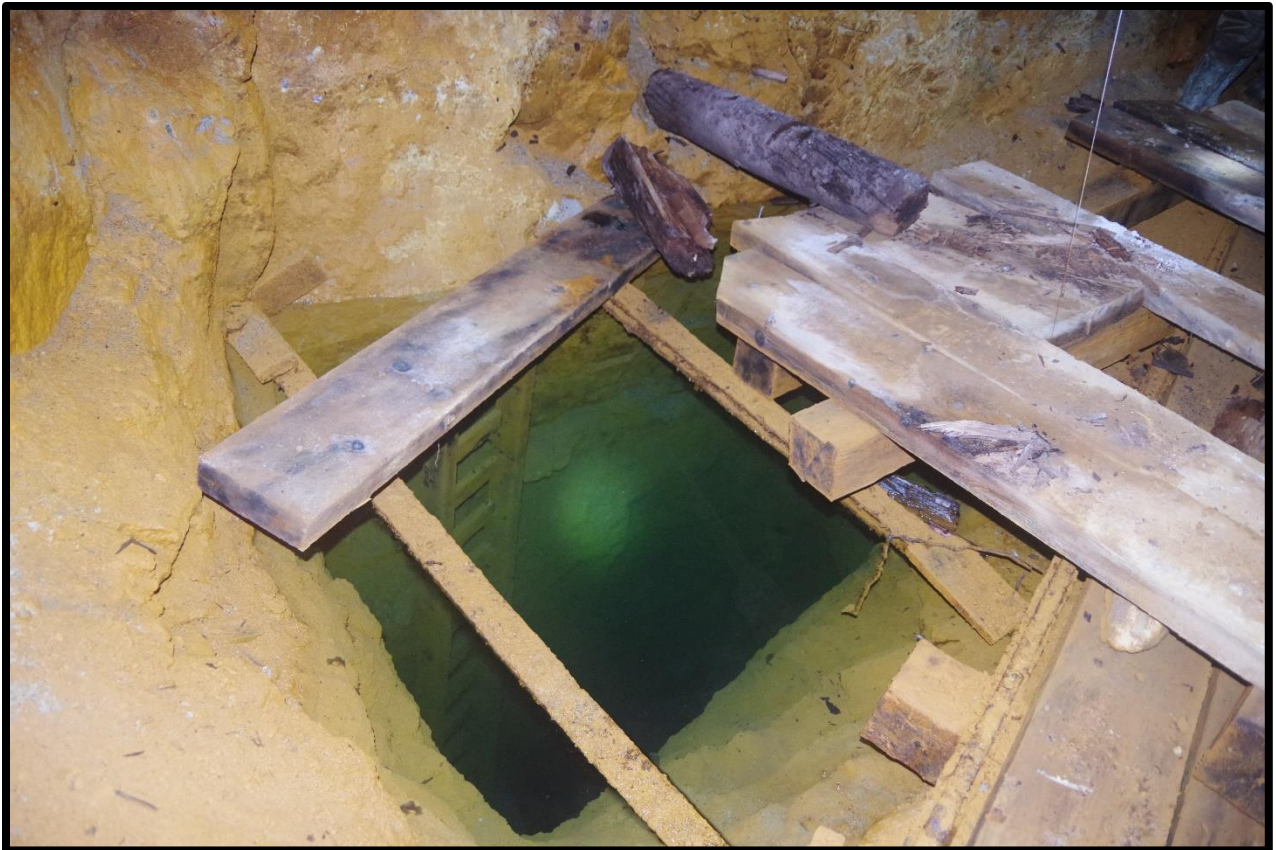
Photo 61: Del Monte Raise 53+15; Note clear water

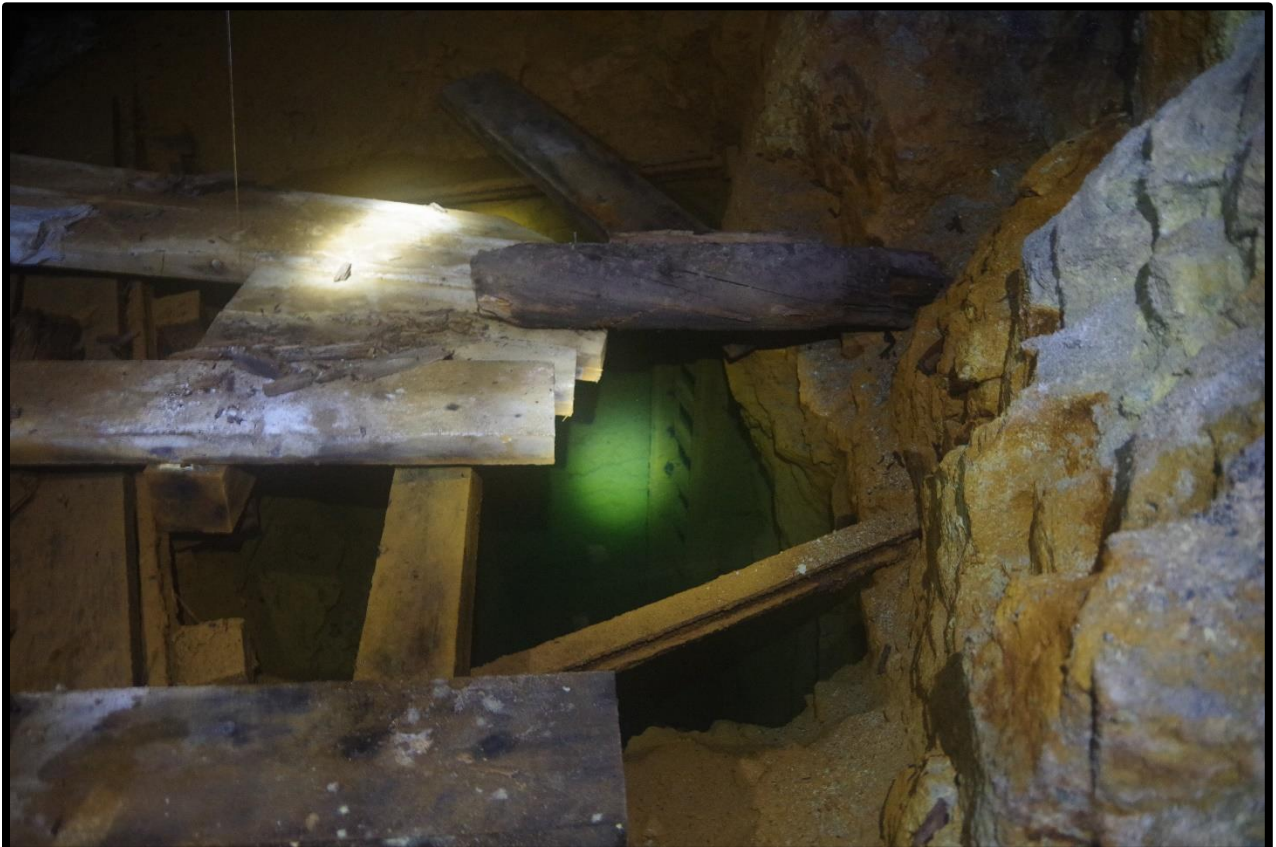
Photo 62: Del Monte Raise 53+15 looking down
