# MicroFab, Inc. Amesbury, MA

## Hazardous Material Survey Report

**Amec Foster Wheeler Environment & Infrastructure, Inc.**  
271 Mill Road  
Chelmsford, MA 01824

December 2016

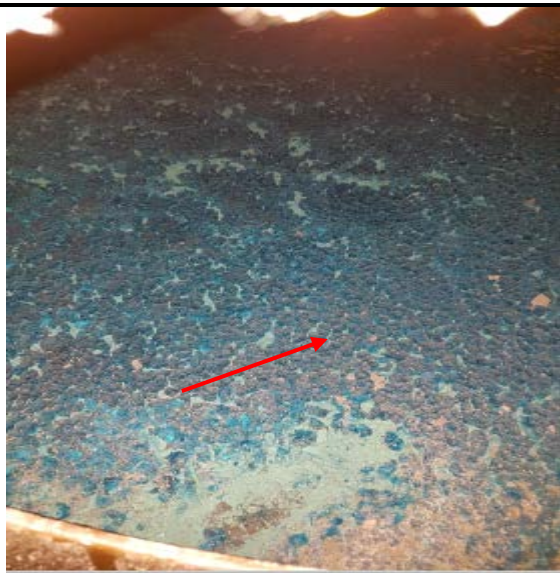
Solid ammonium hydroxide about 1 inch at bottom of tank-1  
Color: blue  
Sample ID: 2-1

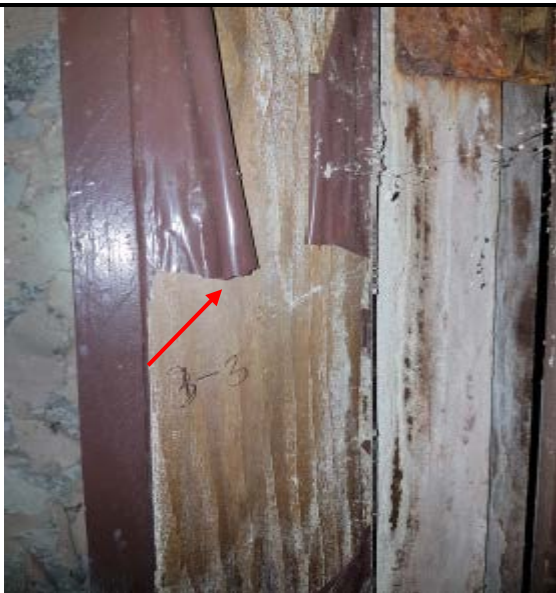
Gray paint on wooden door of dark room  
Sample ID: 3-3

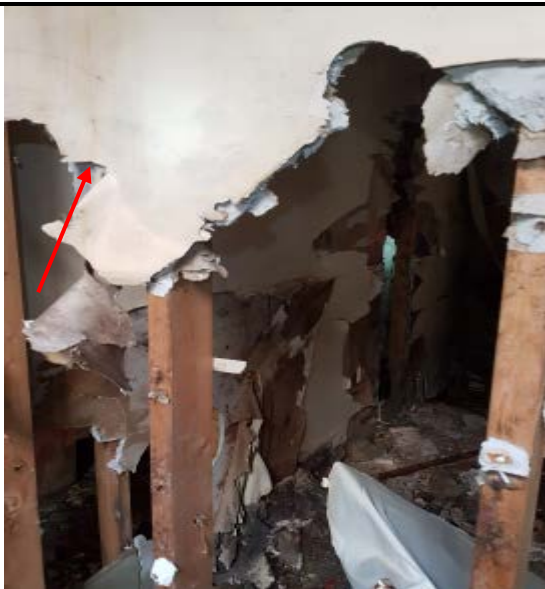
Wall paste on wall of sales room  
Sample ID: 6-1

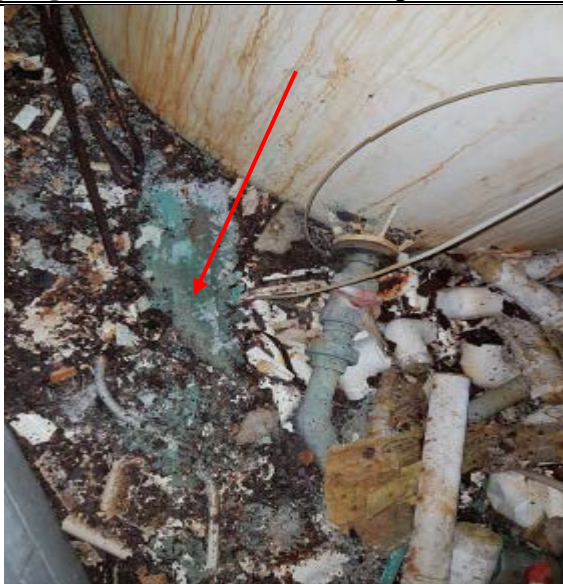
Acid contaminated area of storage room of ground floor  
Sample ID: 7-1

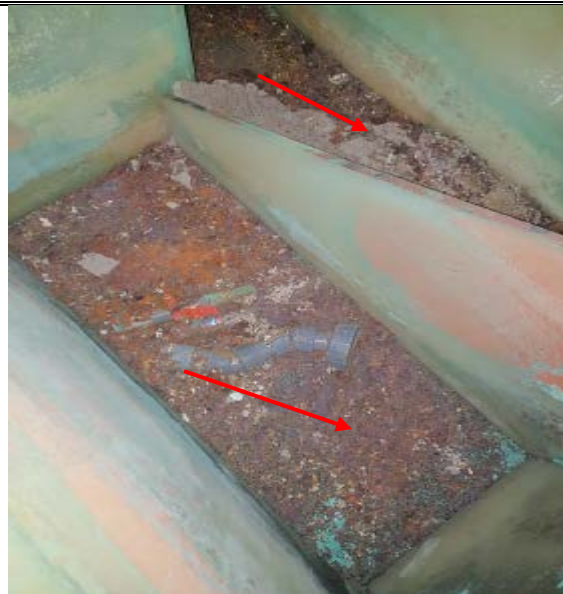
Rectangular plating bath in storage room of ground floor  
Sample ID: 7-2

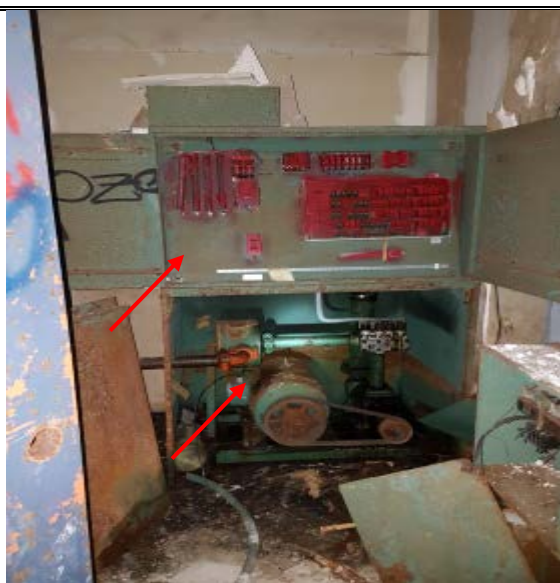
Elevator reservoir having hydraulic Oil in trash room of ground floor  
Volume of oil: 40 gallons (worst case scenario)

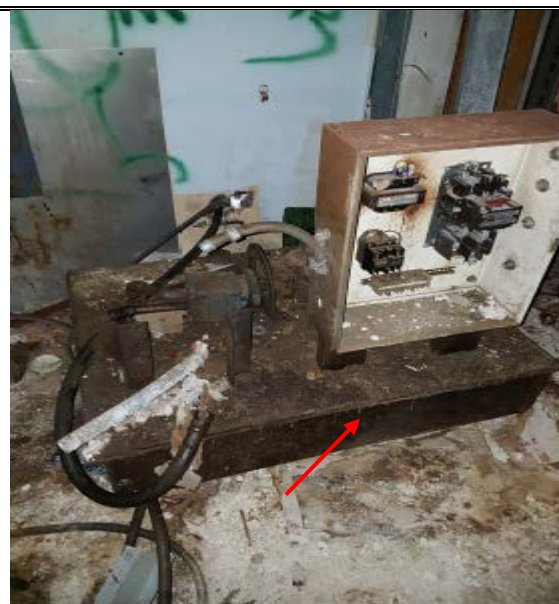
Pump having hydraulic Oil in trash room of ground floor  
Volume of oil: 25 gallons (worst case scenario)

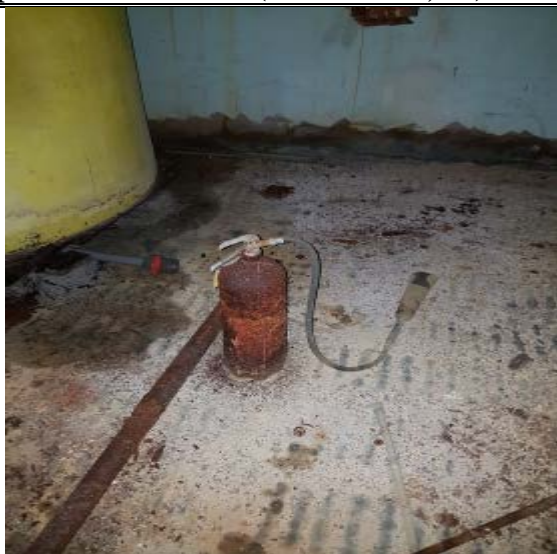
Fire extinguisher inside chemical make-up room of basement

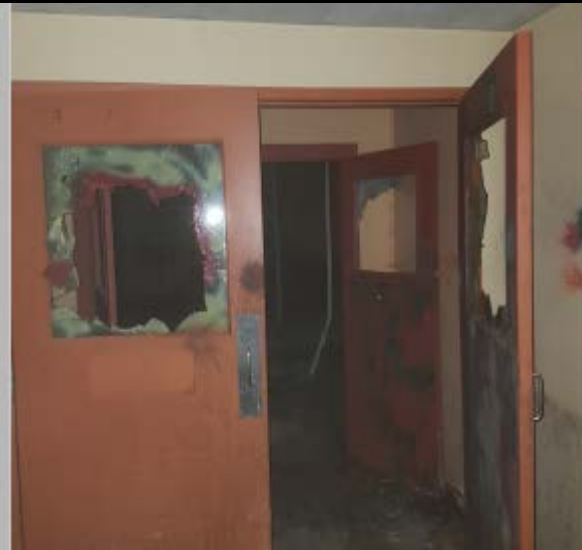
Door with caulking and glazing at touch up room of location 4.

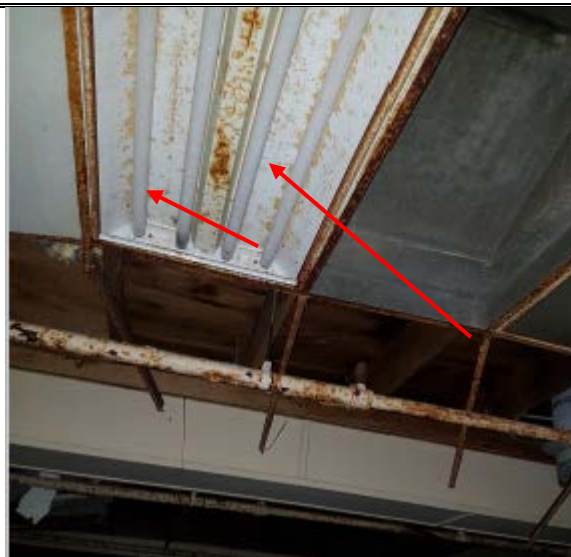
Fluorescent tube with fixtures  
Location: throughout building  
Type: Universal waste.

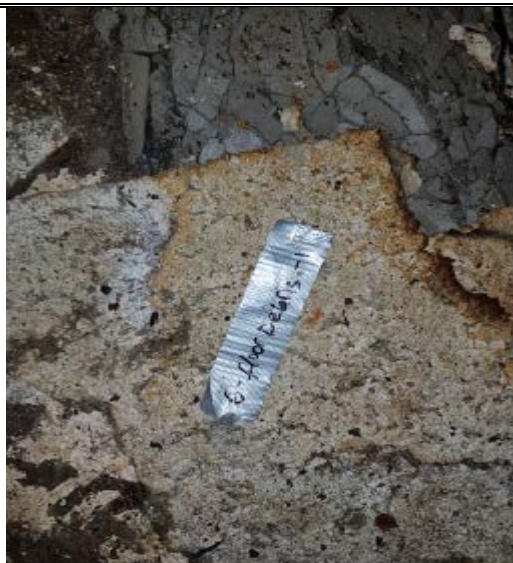
Floor debris from corridor of building

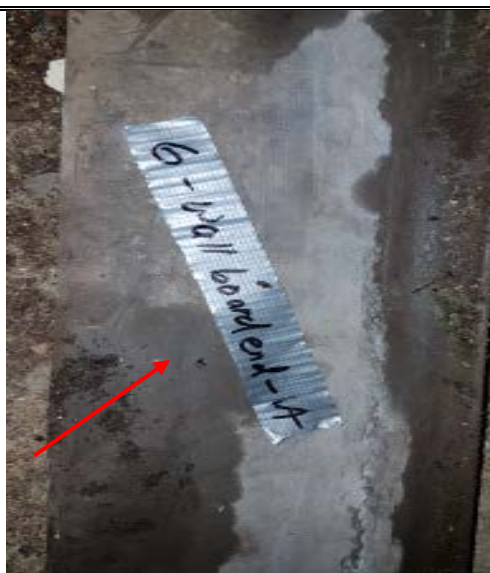
Wall board end from interior office building wall.
